Inspection Photos
Operator: Catamount Energy
Location/API #: 007-06220
Date: 10-8-2019

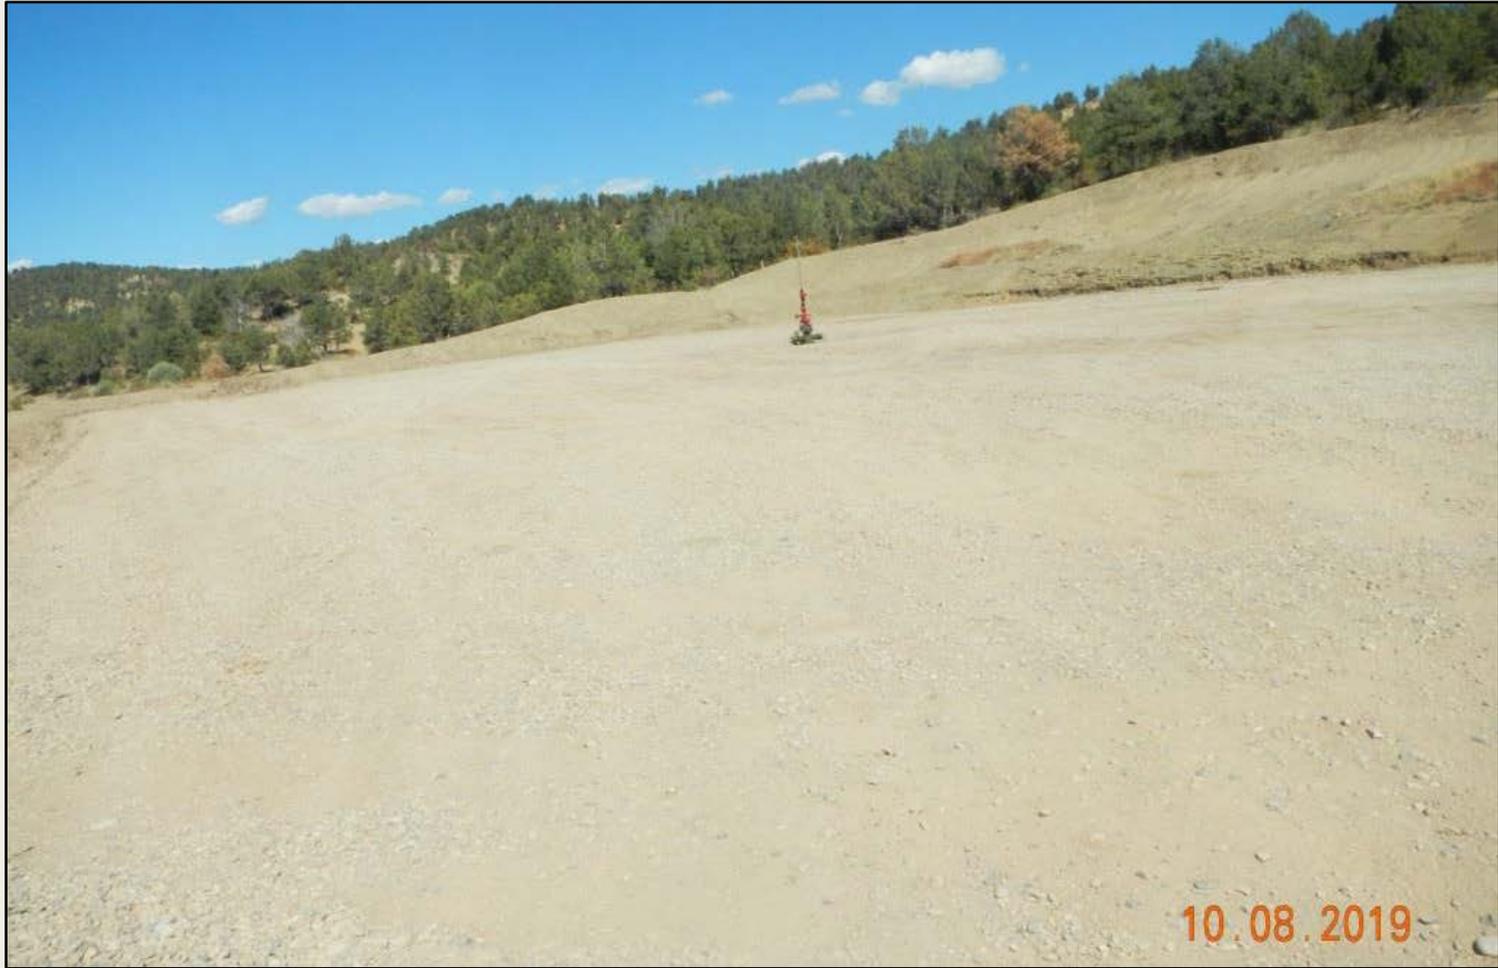
Photo 1. View of the project area from the well pad entrance facing center.

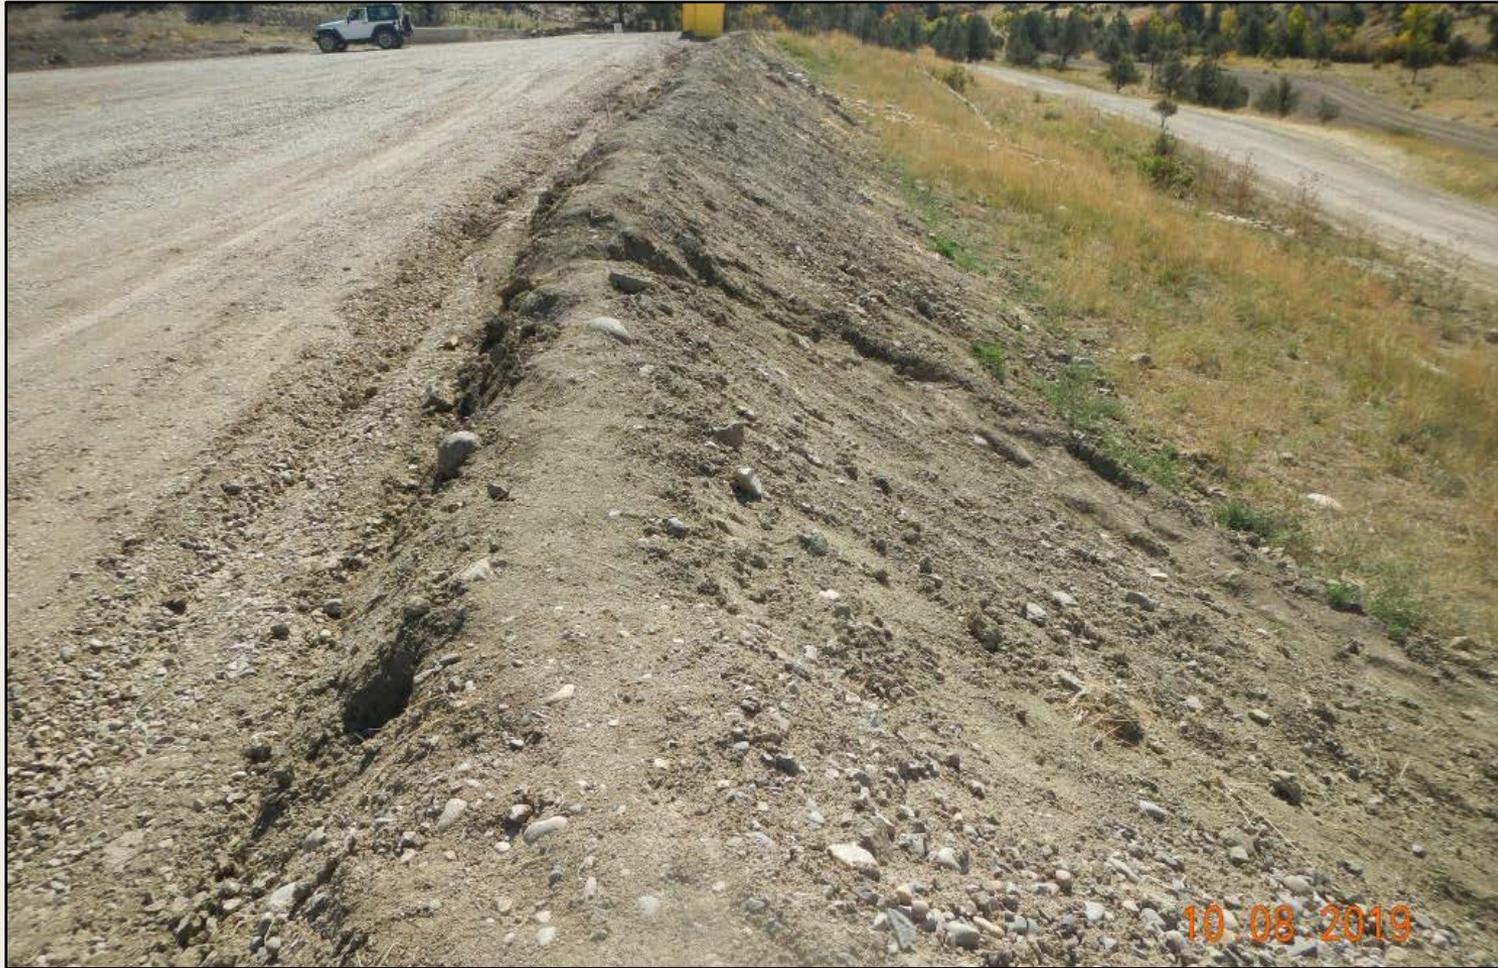
Photo 2. View of the western cut-slope from the northwestern corner facing southward. Bare soils on slope need stabilization.

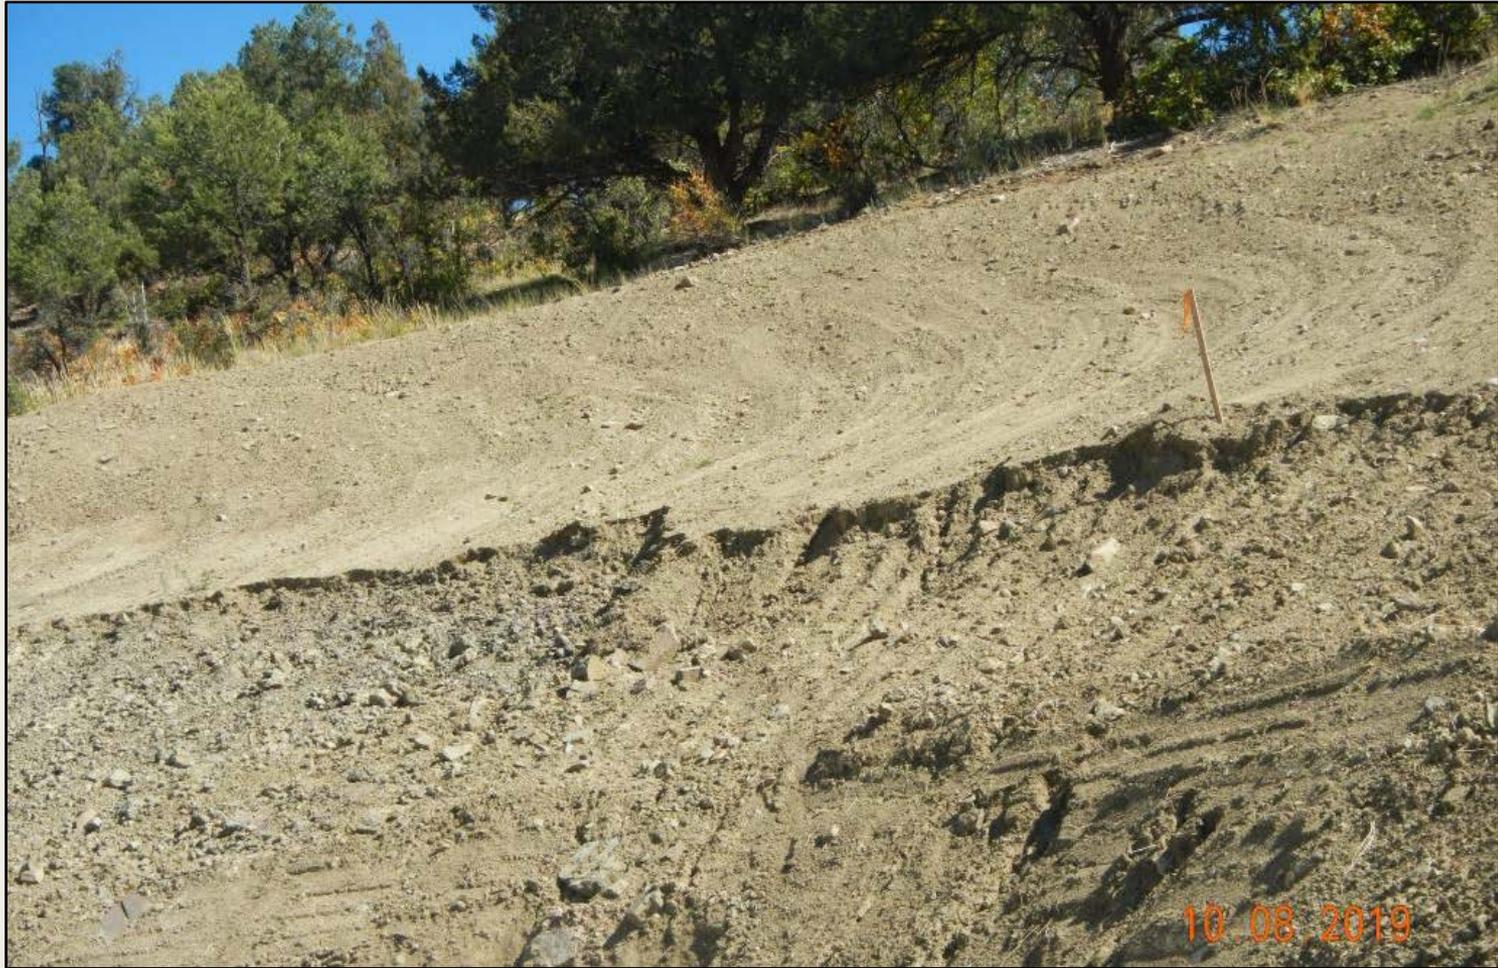
Photo 3. View of the eastern cut-slope facing upslope. Bare soils are not stabilized. Steep slopes will likely need to be reduced for successful revegetation.

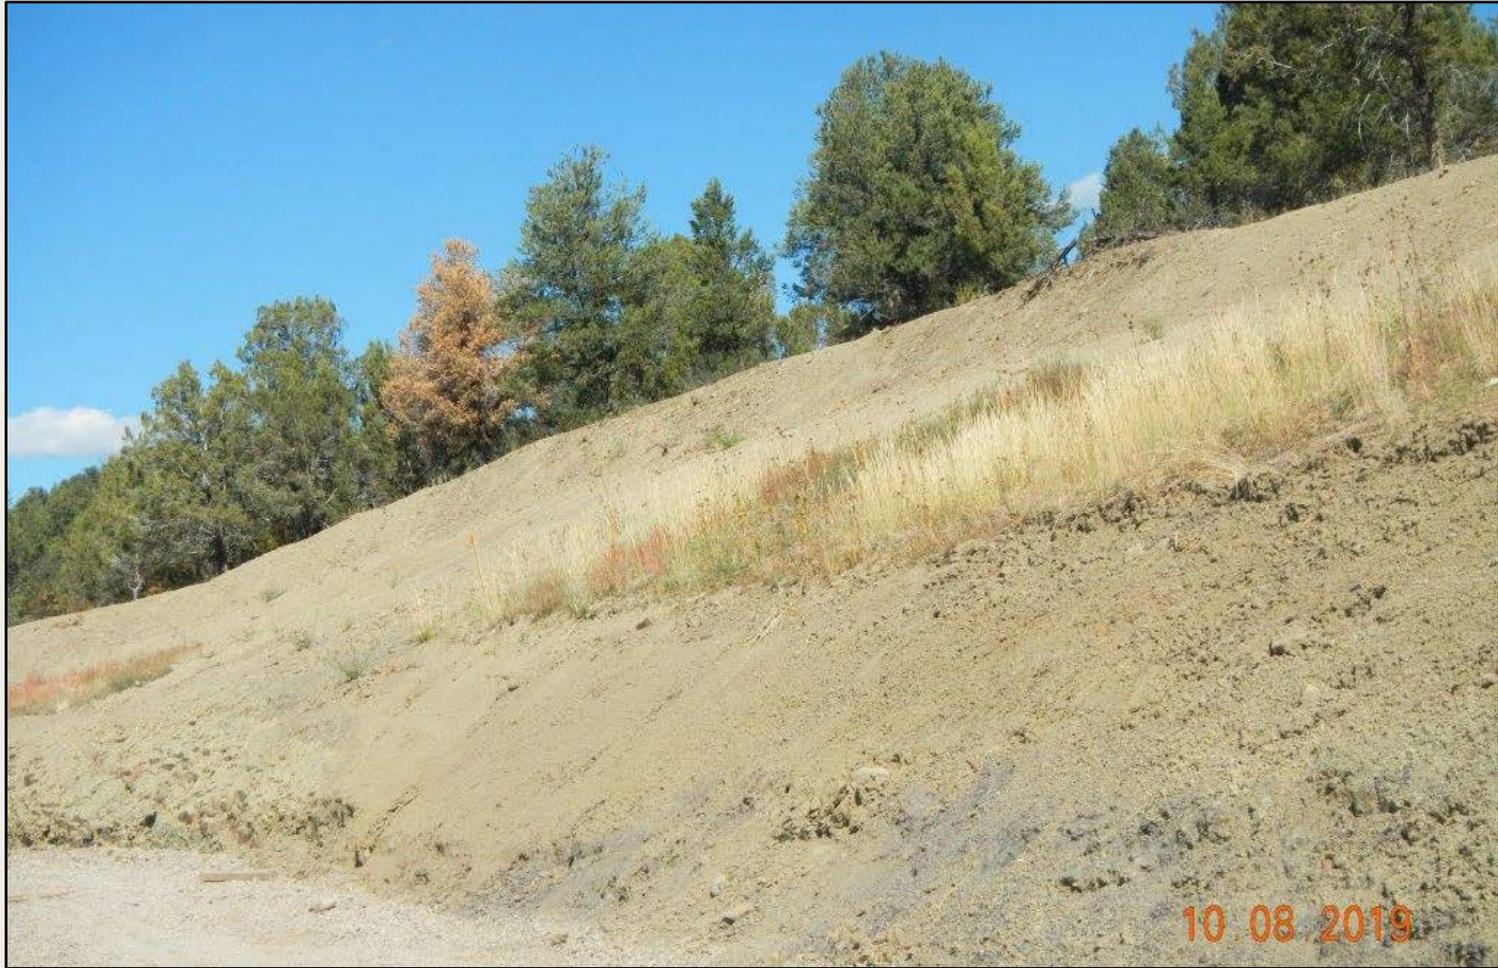
Photo 4. Another view of the eastern cut-slope. Bare soils are not stabilized.

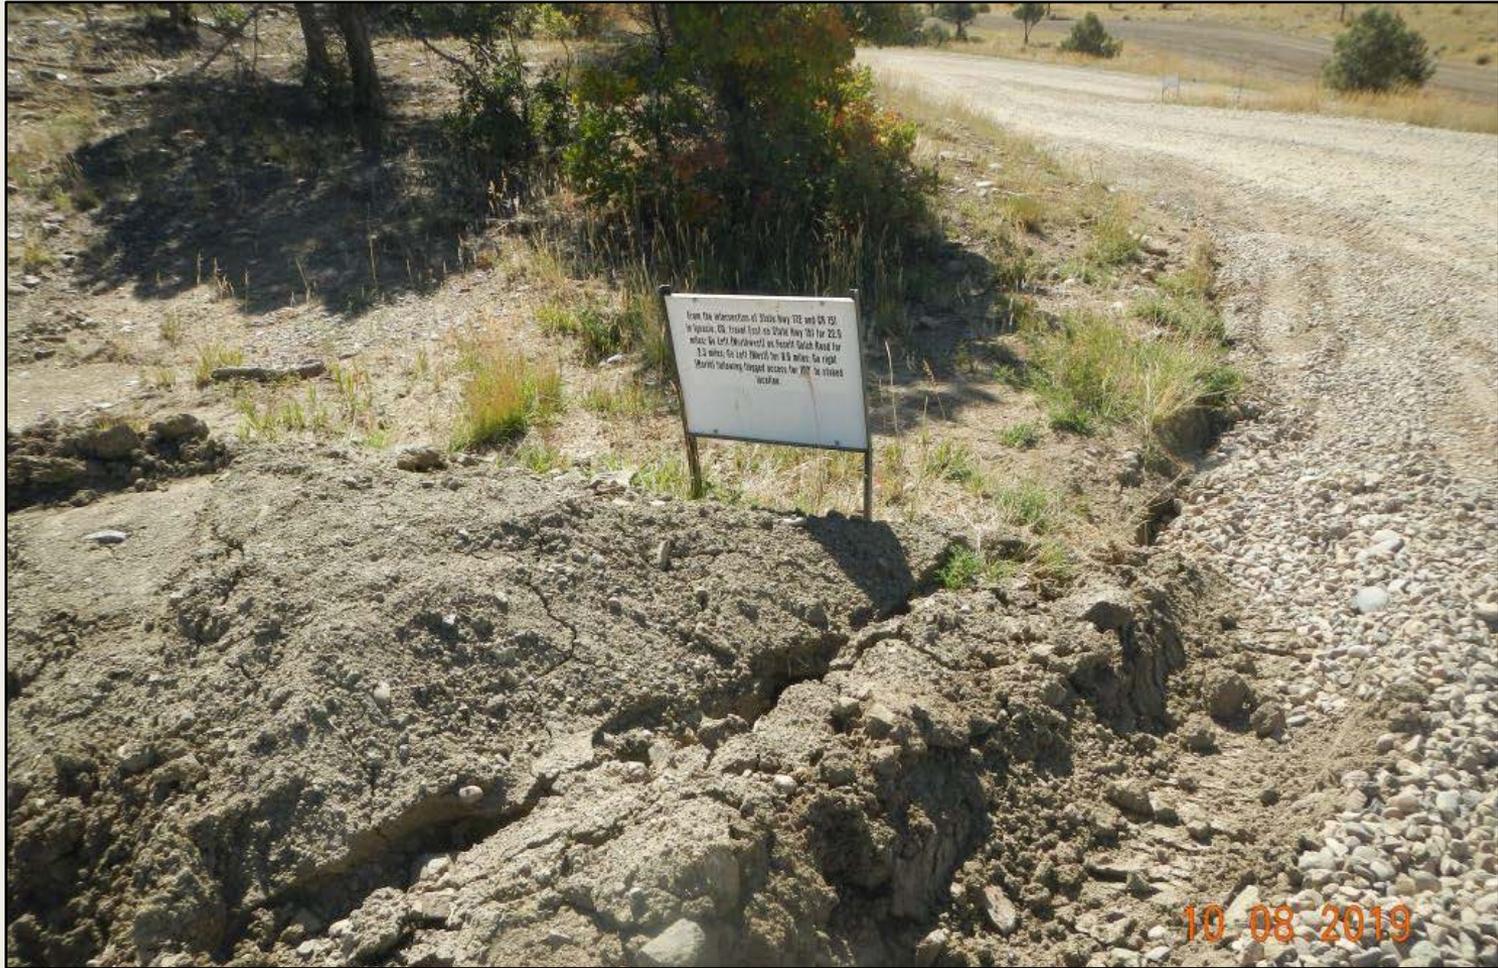
Photo 5. View of erosional channels forming and sedimentation along the access road, at the well pad entrance.

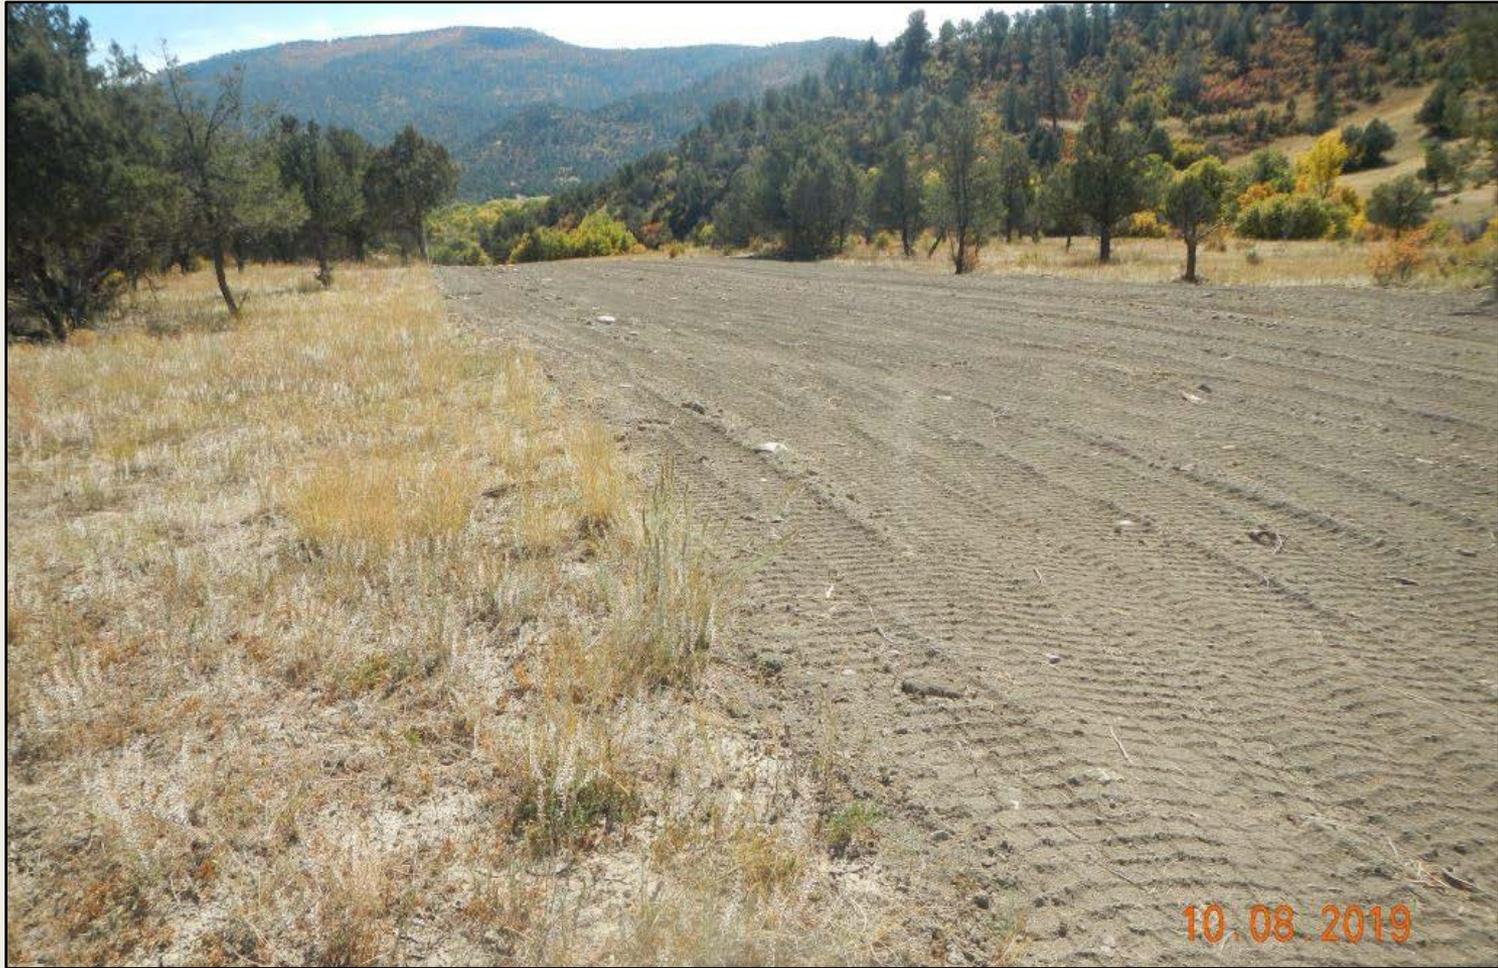
Photo 6. View of pipeline right of way that is not stabilized.

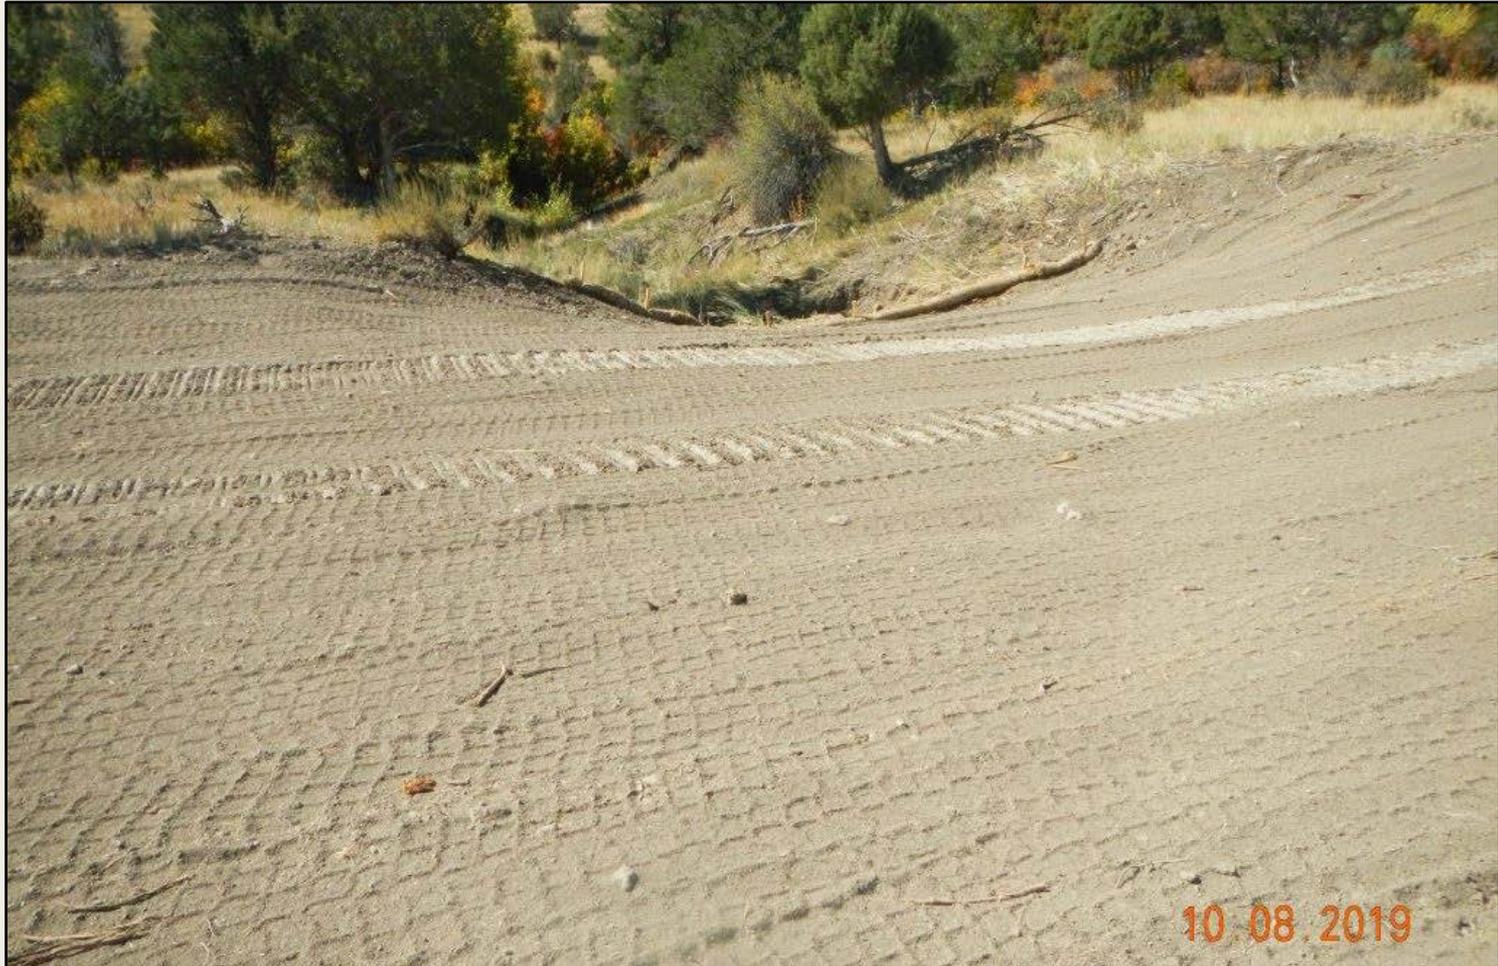
Photo 7. View of another portion of the pipeline right of way, showing bare soils over portion where right of way crosses stream and no insufficient stormwater controls are in place.

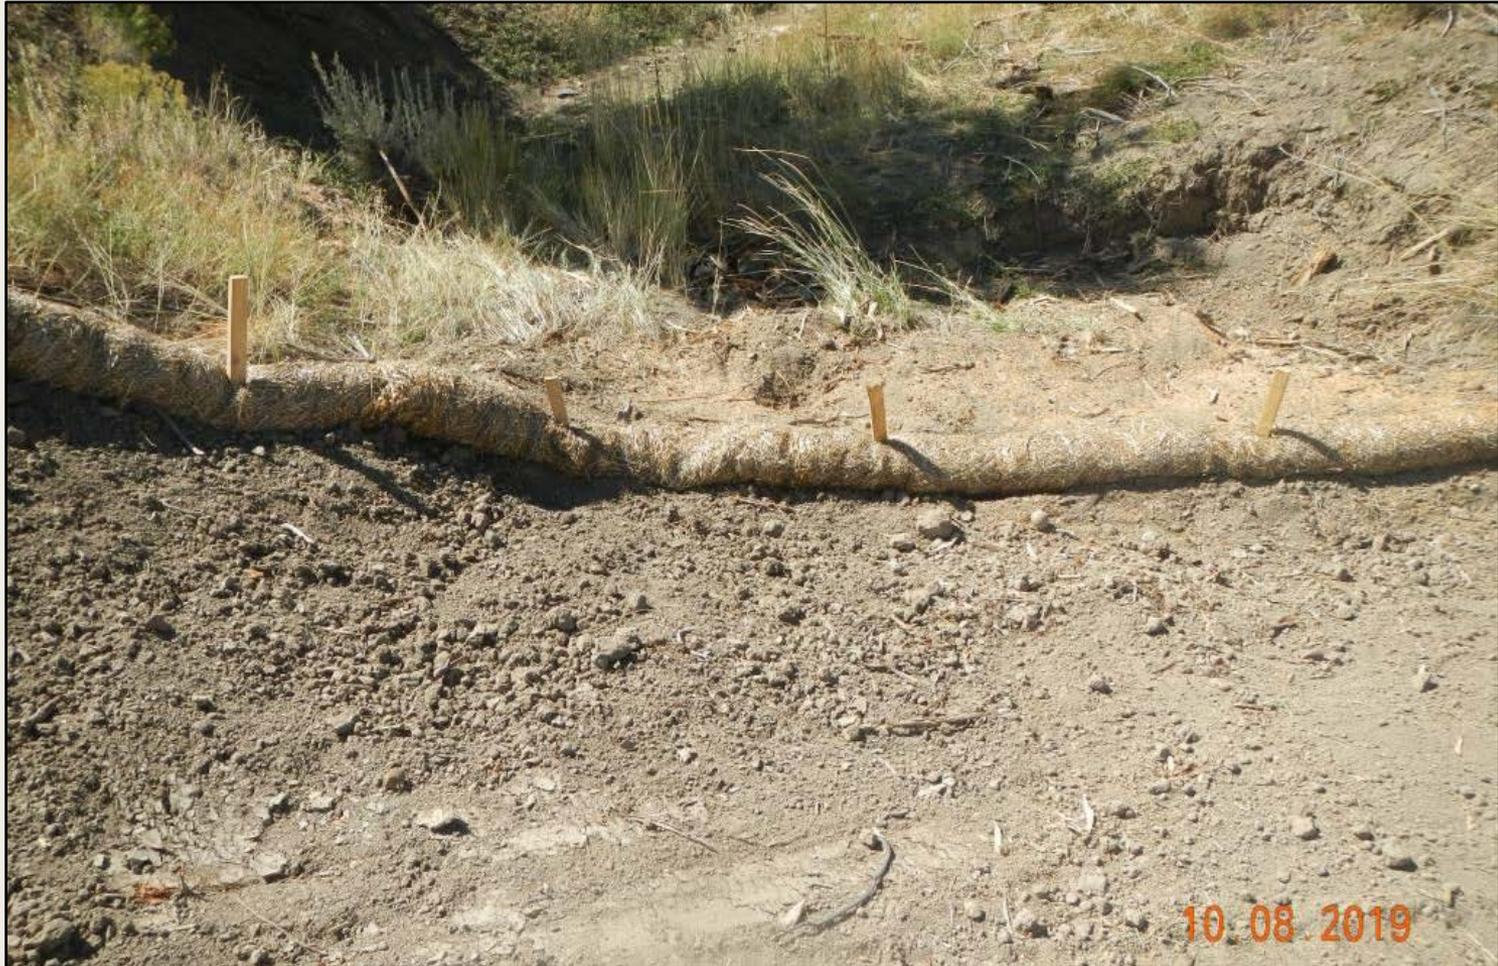
Photo 8. View of wattle down-slope of Photo 6 across stream bed. This is not an appropriate stormwater BMP in this area as it is inadequate and improperly installed (not trenched), as evidenced by flow patterns beneath the wattle.

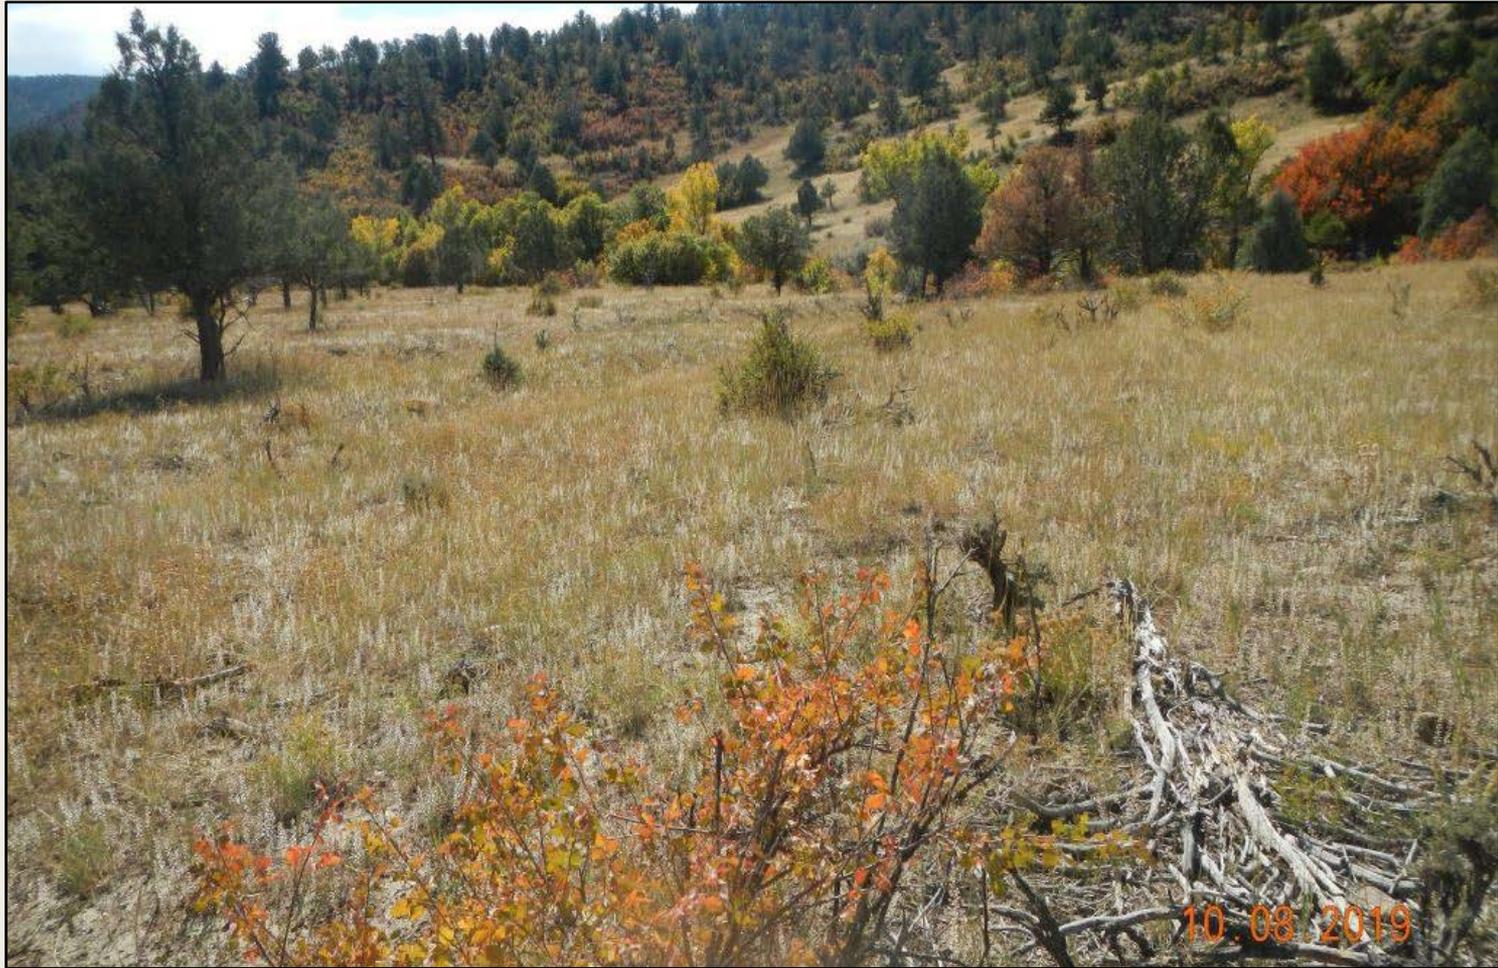
Photo 9. View of reference area vegetation comprised of a mosaic of ponderosa pine, juniper, gambel oak, and open grass fields.
