Final Reclamation Inspection

Operator: HIGHPOINT OPERATING CORPORATION- 10071

Location ID: 323189

Inspection Document #: 697500736

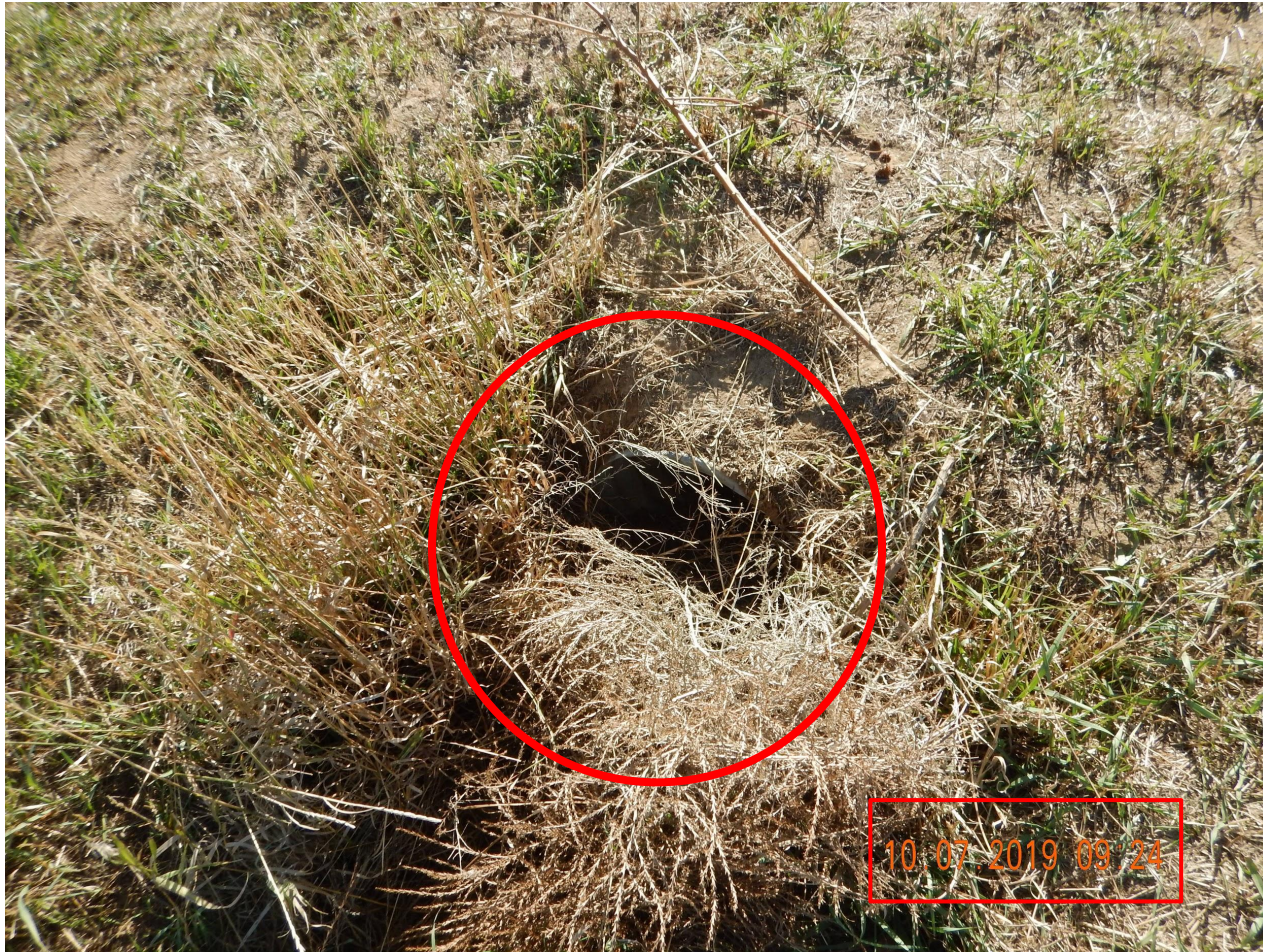
Photo 3. Photo taken on October 7, 2019 of the culvert from the tank battery location that was illustrated in the previous aerial imagery.

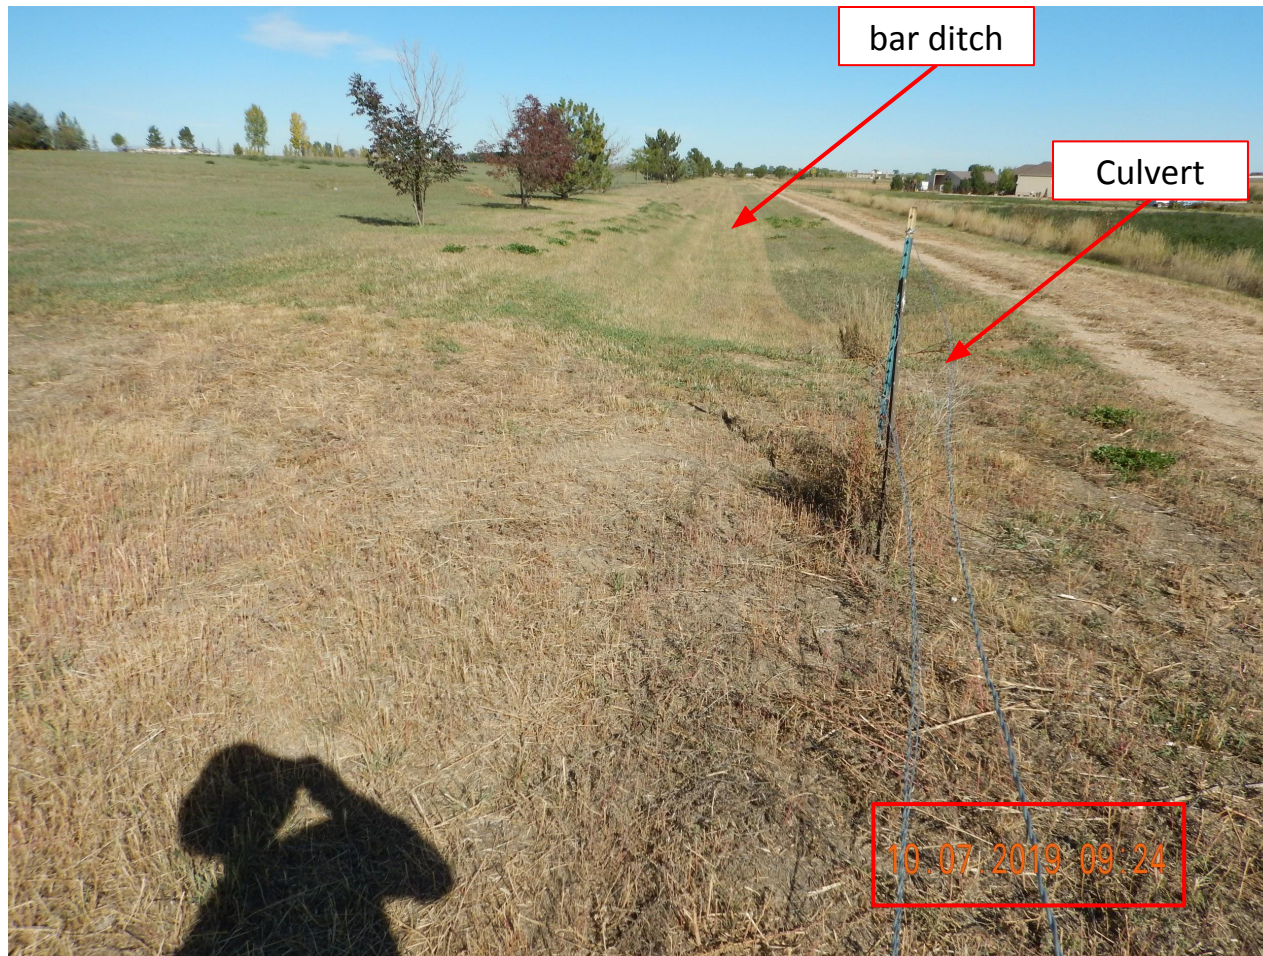
Photo 4. Photo taken on October 7, 2019 from the eastern tank battery location, facing North. Photo illustrates the Operator has failed to remove the culvert and put the bar ditch back in. Bar ditch plays an important role as this area is flooding irrigated.

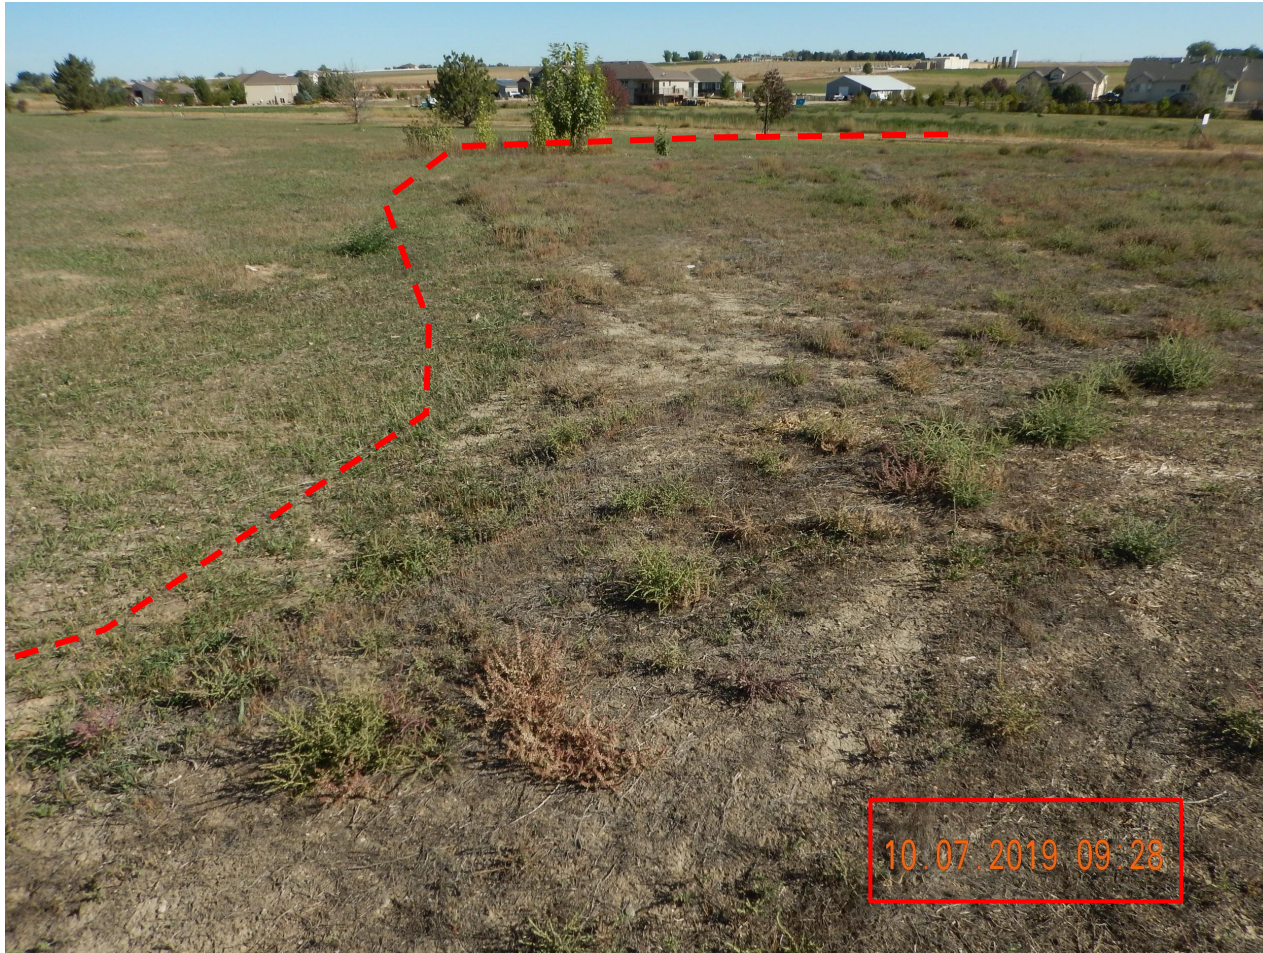
Photo 5. Photo taken on October 7, 2019 from the southwestern tank battery location, facing Northeast. Photo illustrates the Operator failed to properly contour the location to match the surrounding landscape to allow for successful flood irrigation. There appears to be a perimeter ditch along the outside and the location itself is elevated compared to the surrounding landscape. Location is to the right of the red-dashed line.

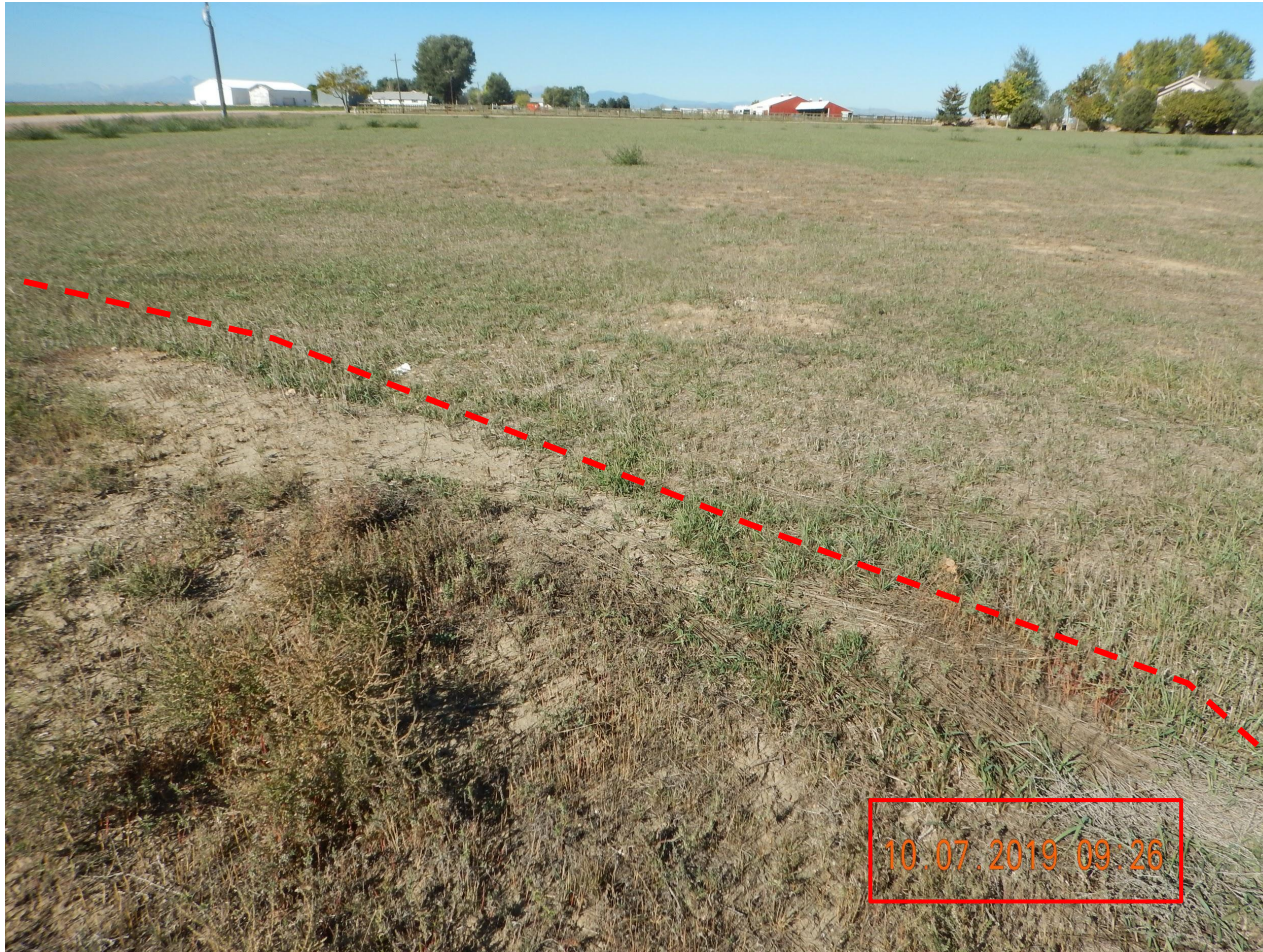
Photo 6. Photo taken on October 7, 2019 from the western tank battery location, facing West. Photo illustrates the reference area vegetation is mostly comprised of Smooth brome. Location is in the foreground of the photo, below the red-dashed line.

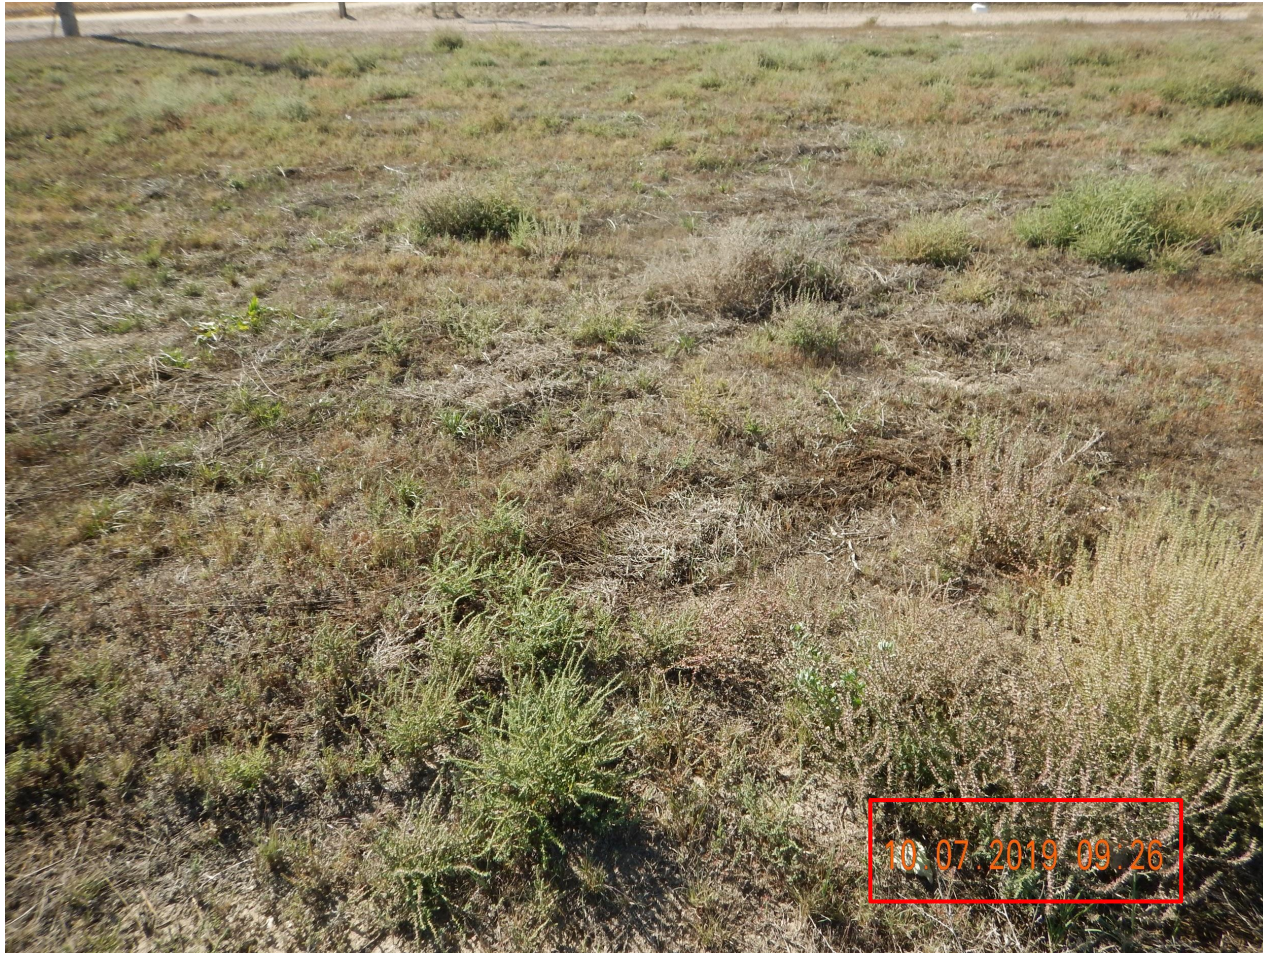
Photo 7. Photo taken on October 7, 2019 from the central tank battery location, facing South. Photo illustrates the location appears to have been mowed this season. Undesirable species (Kochia and Russian thistle) were observed. Note: Even though the Operator claims to use a seed mix approved by the Surface Owner, it is not reflective of reference area vegetation.

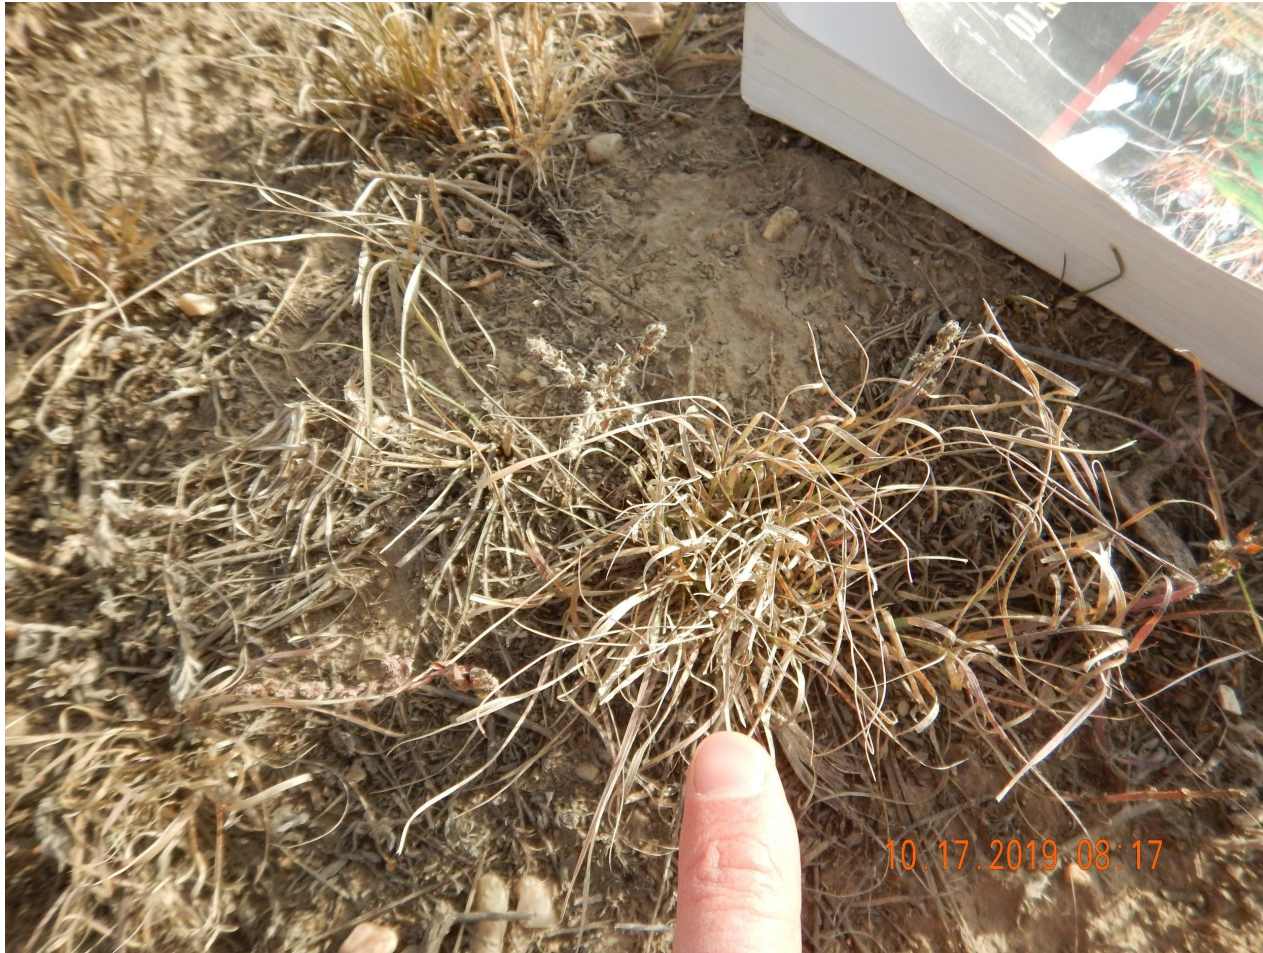
Photo 8. Photo taken on October 17, 2019 from the tank battery location. Photo illustrates a Blue grama (*Bouteloua gracilis*) grass species. Based on a qualitative assessment, this species was most commonly found grass species throughout the tank battery location. The next most abundant grass species were Western wheatgrass (*Pascopyrum smithii*) and Slender wheatgrass (*Elymus trachycaulus*). None of these grass species were a part of the Equestrian Grass Mix.

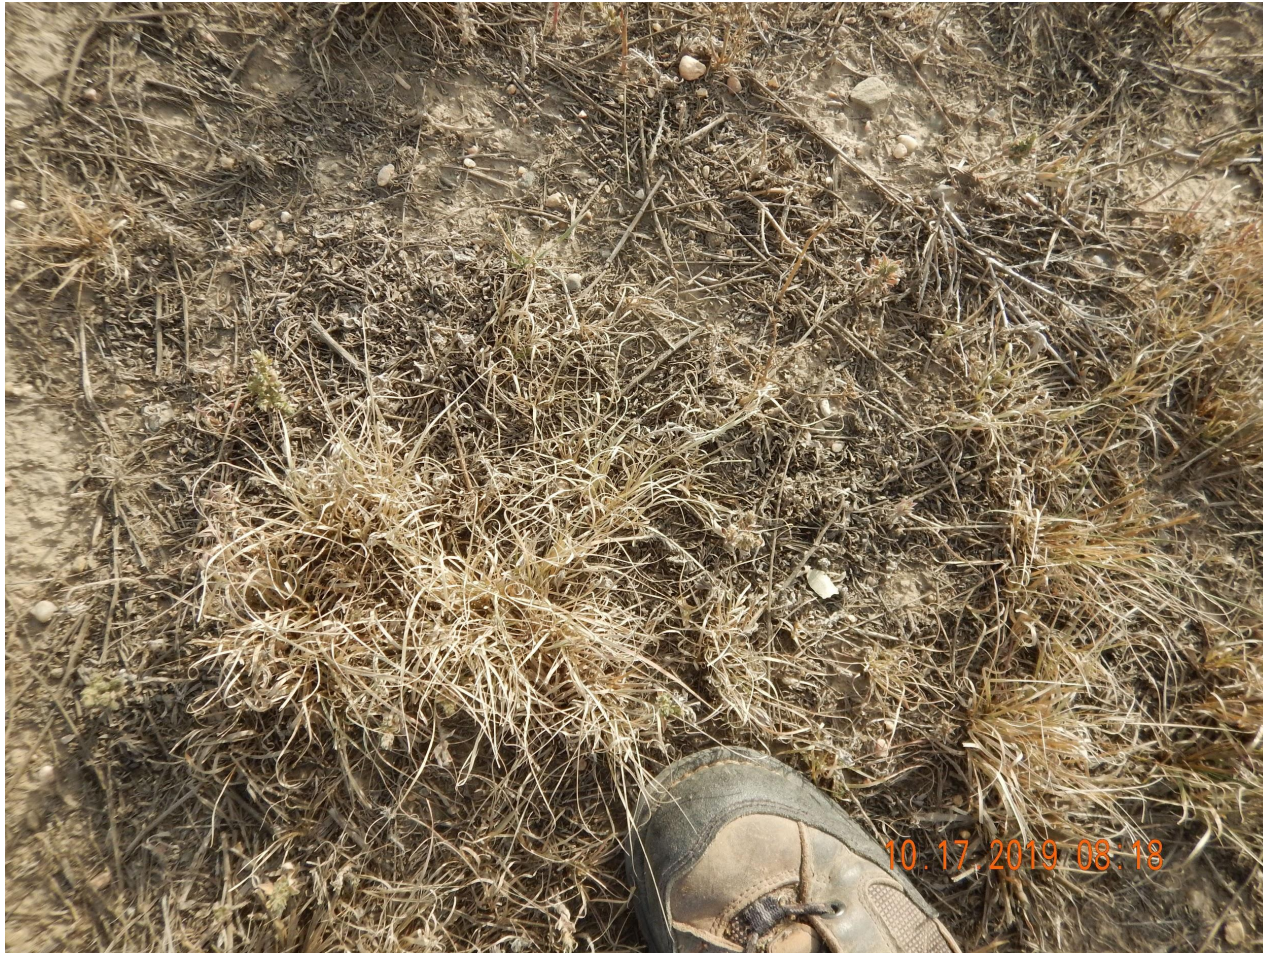
Photo 9. Photo taken on October 17, 2019 from the tank battery location illustrating more Blue grama (*Bouteloua gracilis*) grass species.

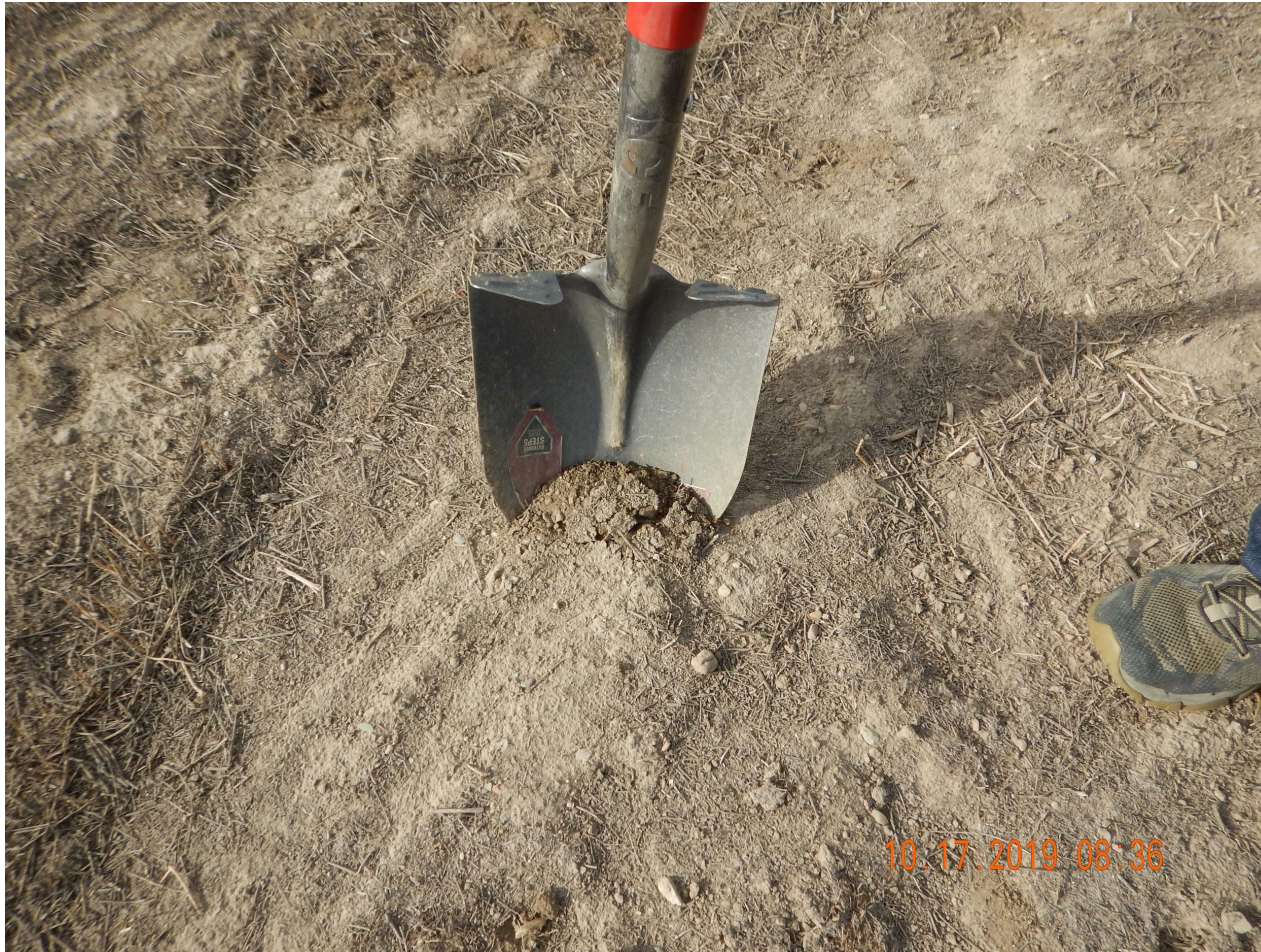
Photo 10. Photo taken on October 17, 2019 from the southeastern tank battery location illustrating compaction and a lack of vegetative growth. Photo illustrates COGCC staff could not penetrate the shovel more than a few inches. Operator will have to remove this material anyways as the Operator has failed to properly grade and recontour the location. COGCC staff also performed a compaction test in the reference area and did not observe the same compaction issue.

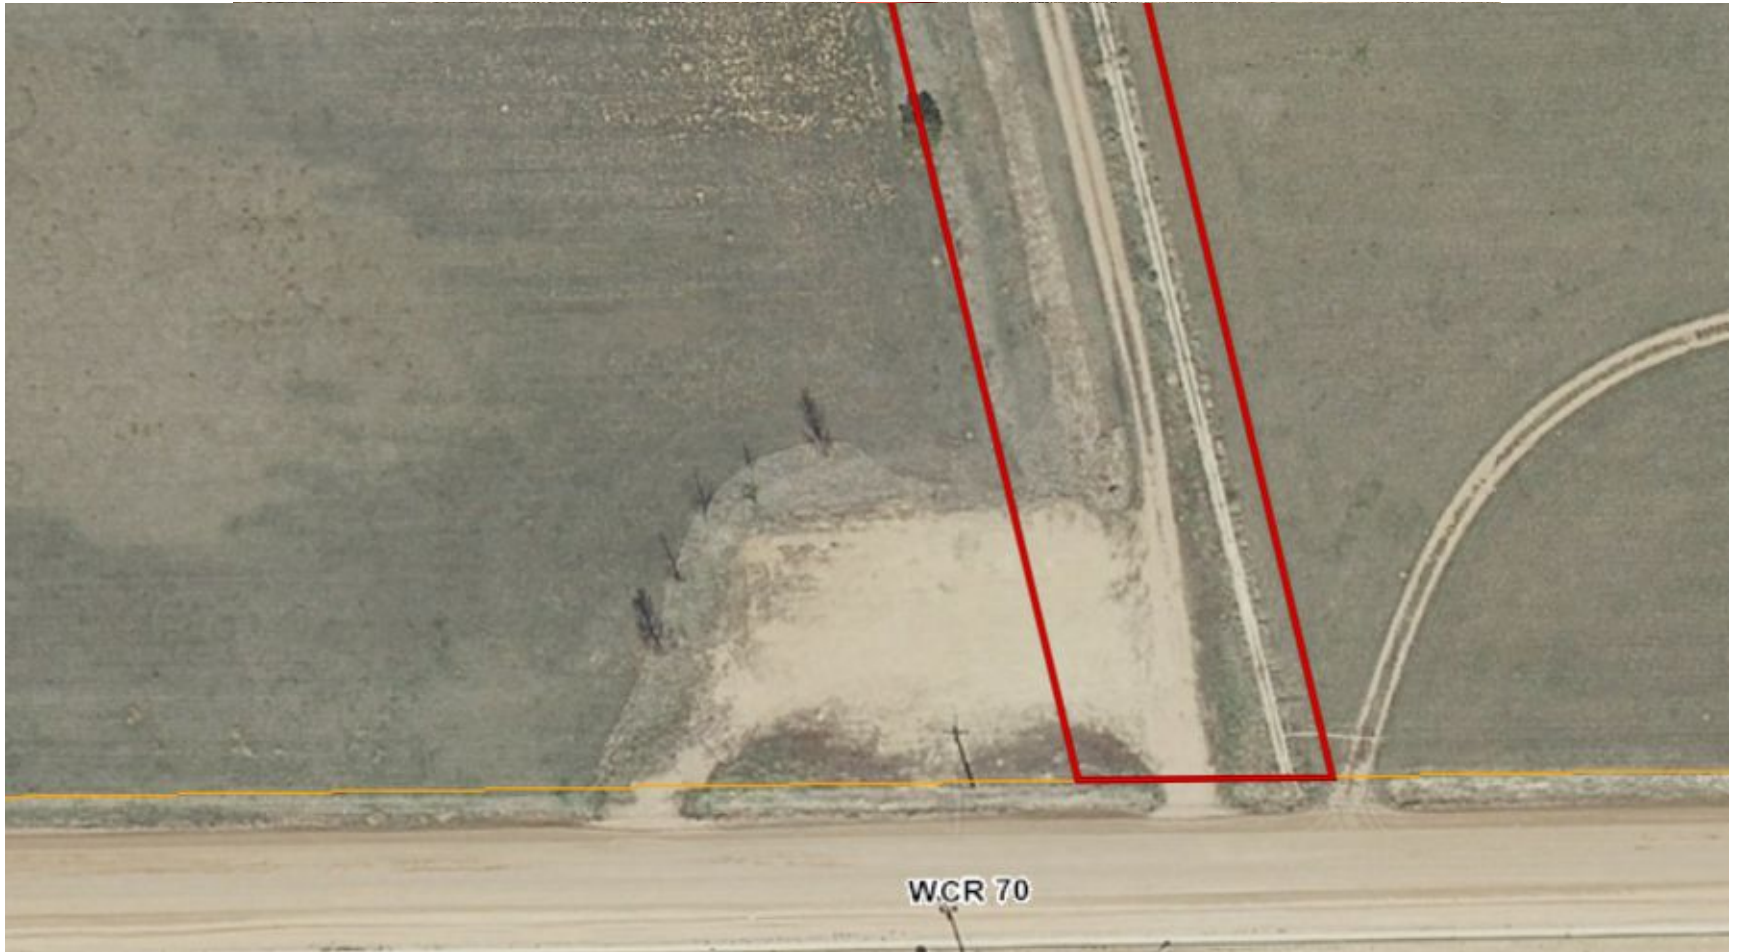
Photo 11. Photo taken from the Weld County Property Portal database. Please note the property where the culvert that remains (see Photo #3) is owned by the Cattail Creek HOA.
