Inspection Photos
Operator: Seeley Oil
Co.Location/API #: 083-06539
Date: 10-11-2019

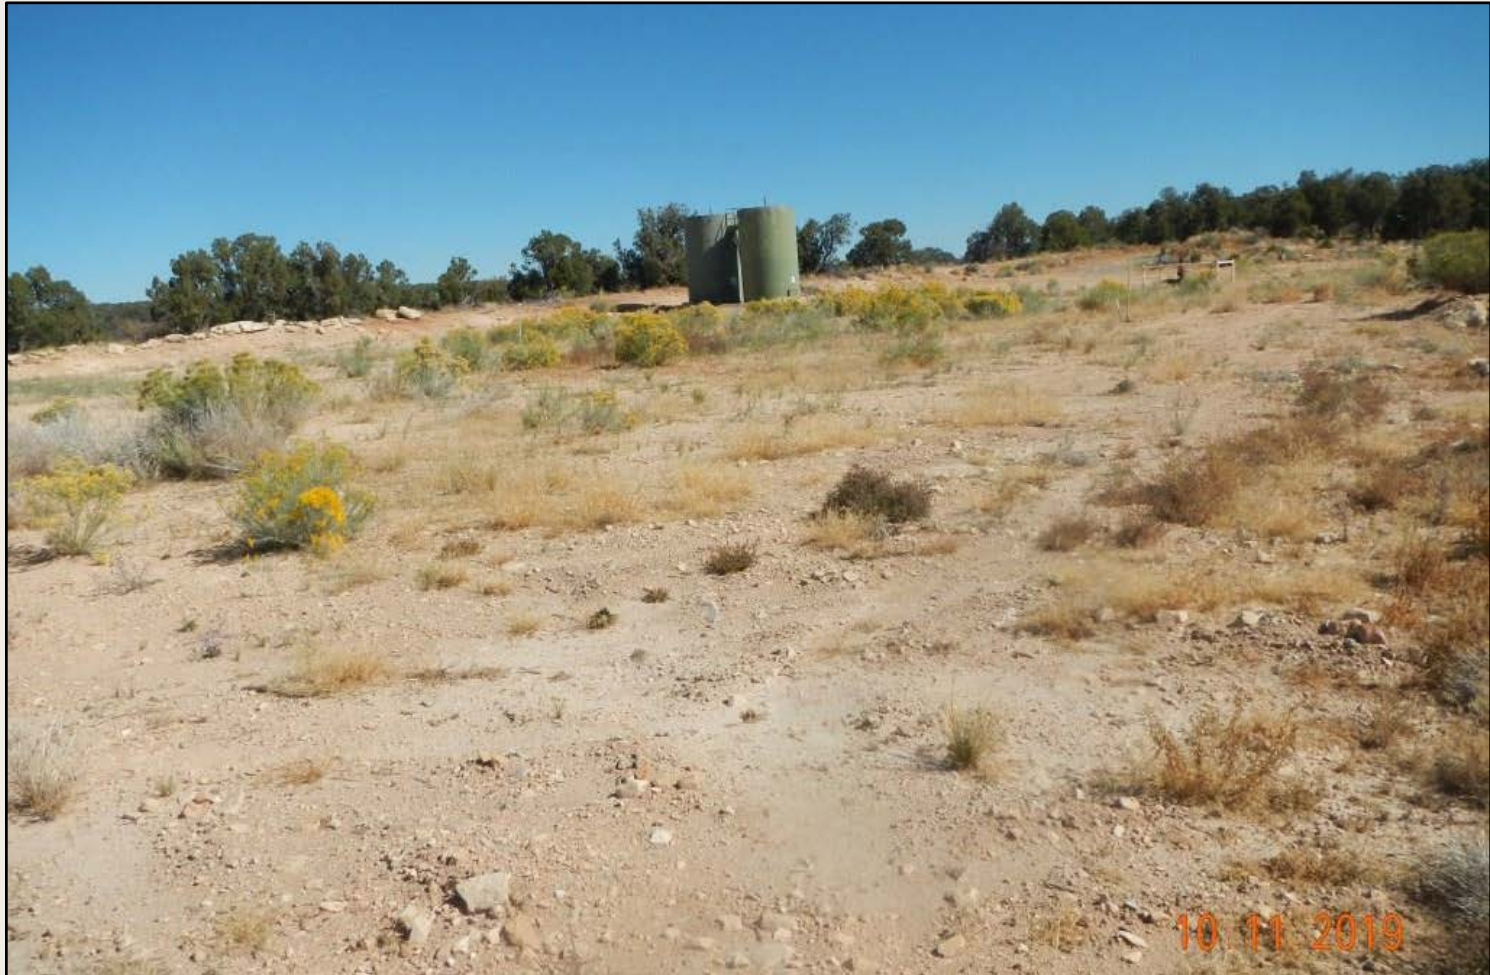
Photo 1. View of the project area from the southwestern edge facing center. The majority of the southern and western project area are not in use and need to be reclaimed.

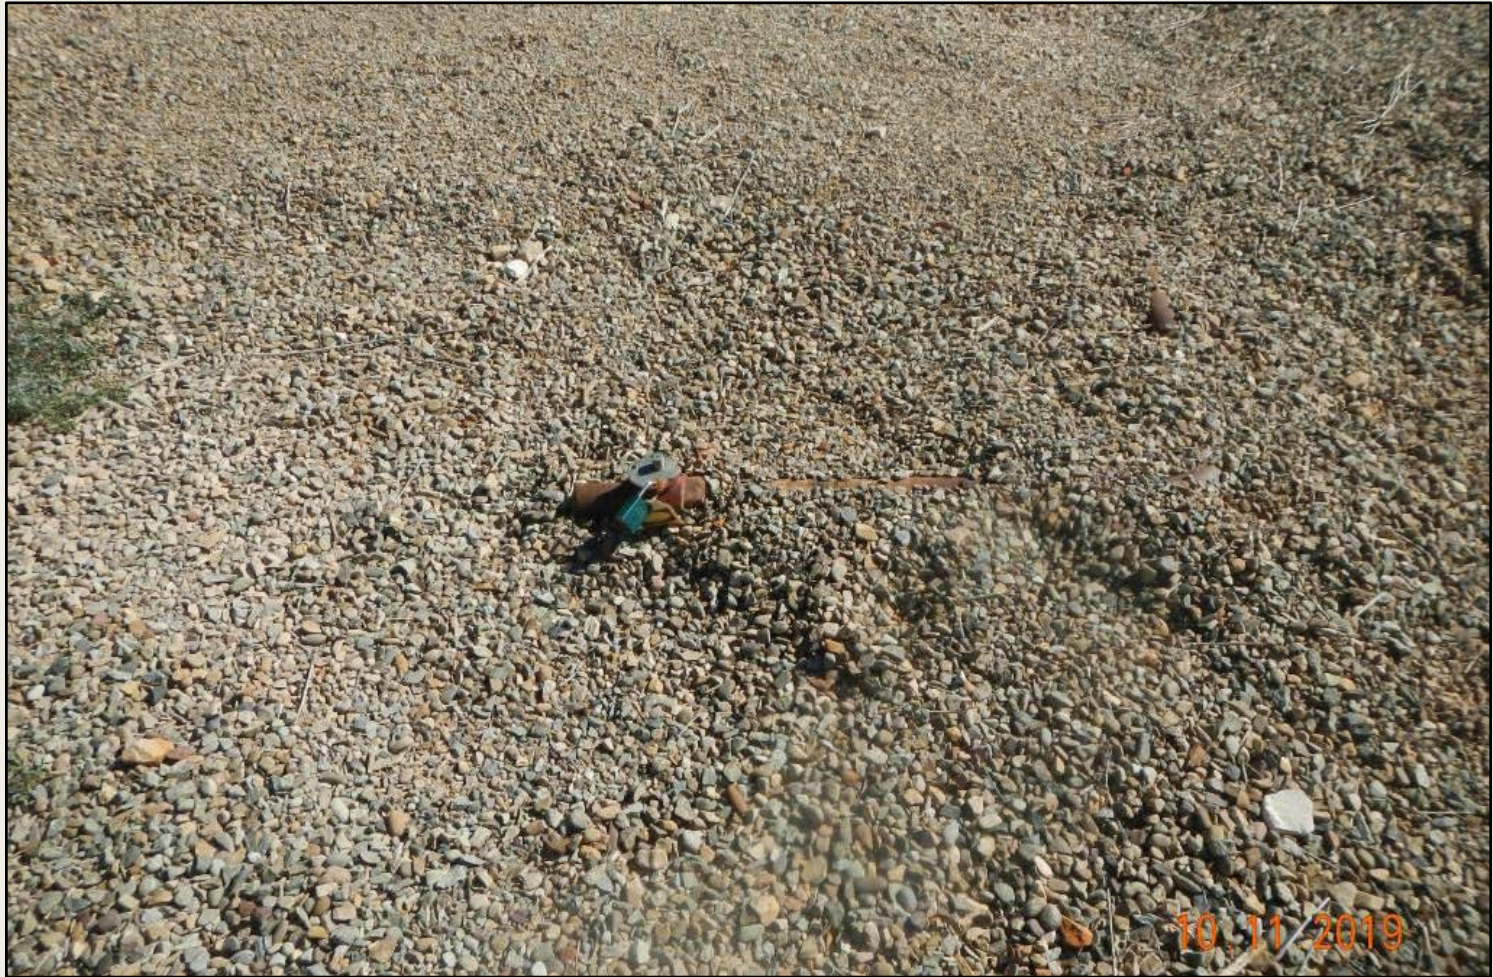
Photo 2. View of riser within the northwestern project area, needing removal.

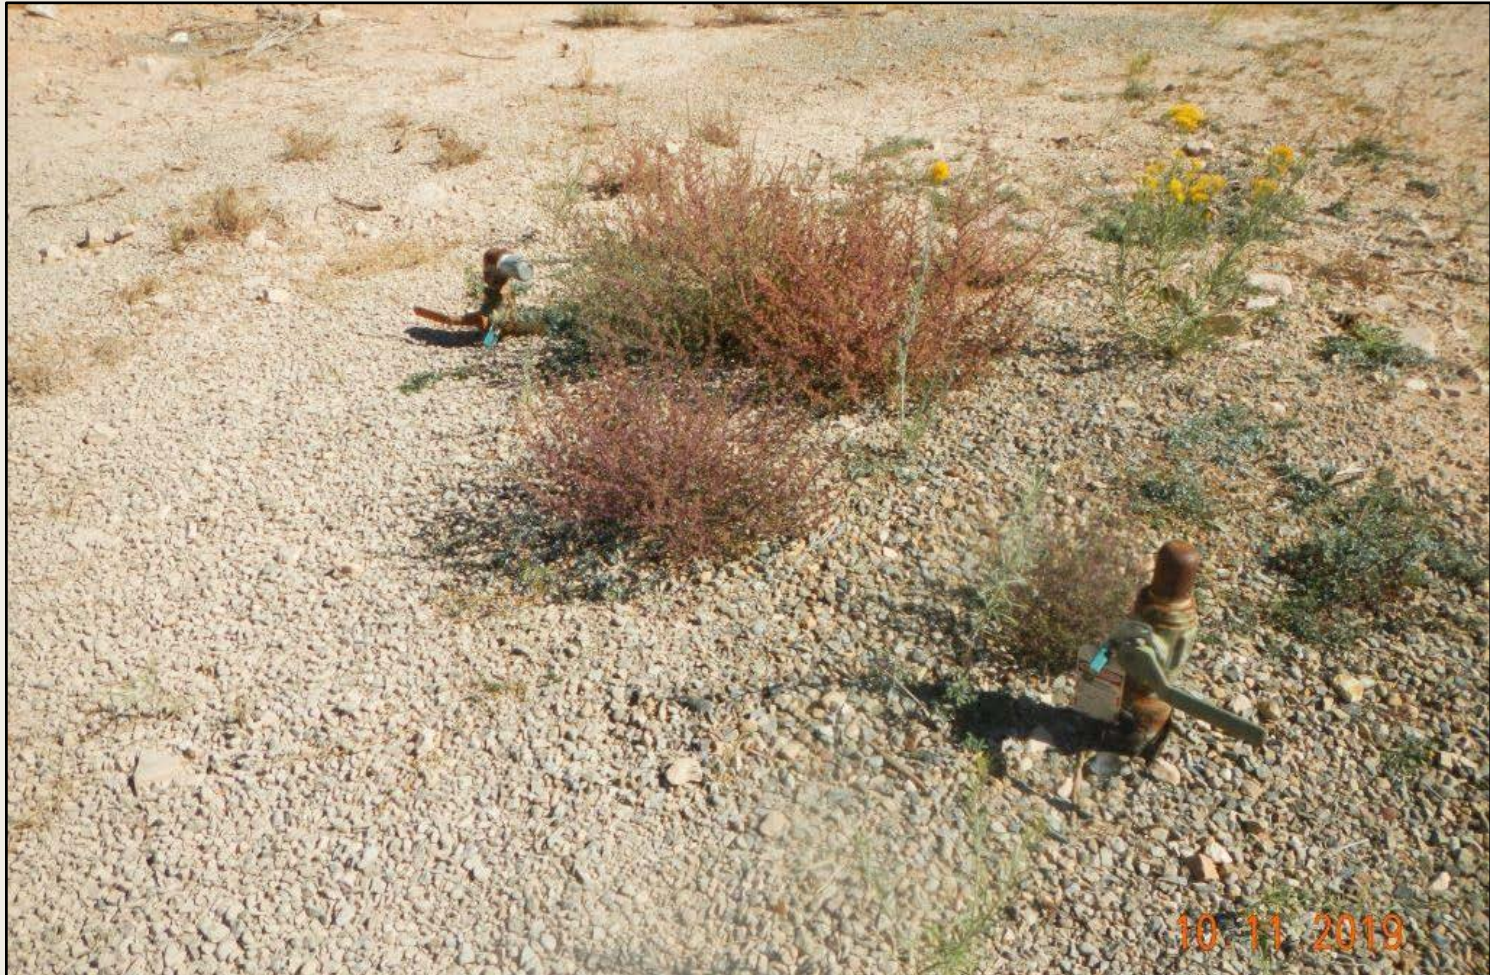
Photo 3. View of another riser within the western project area, needing removal.

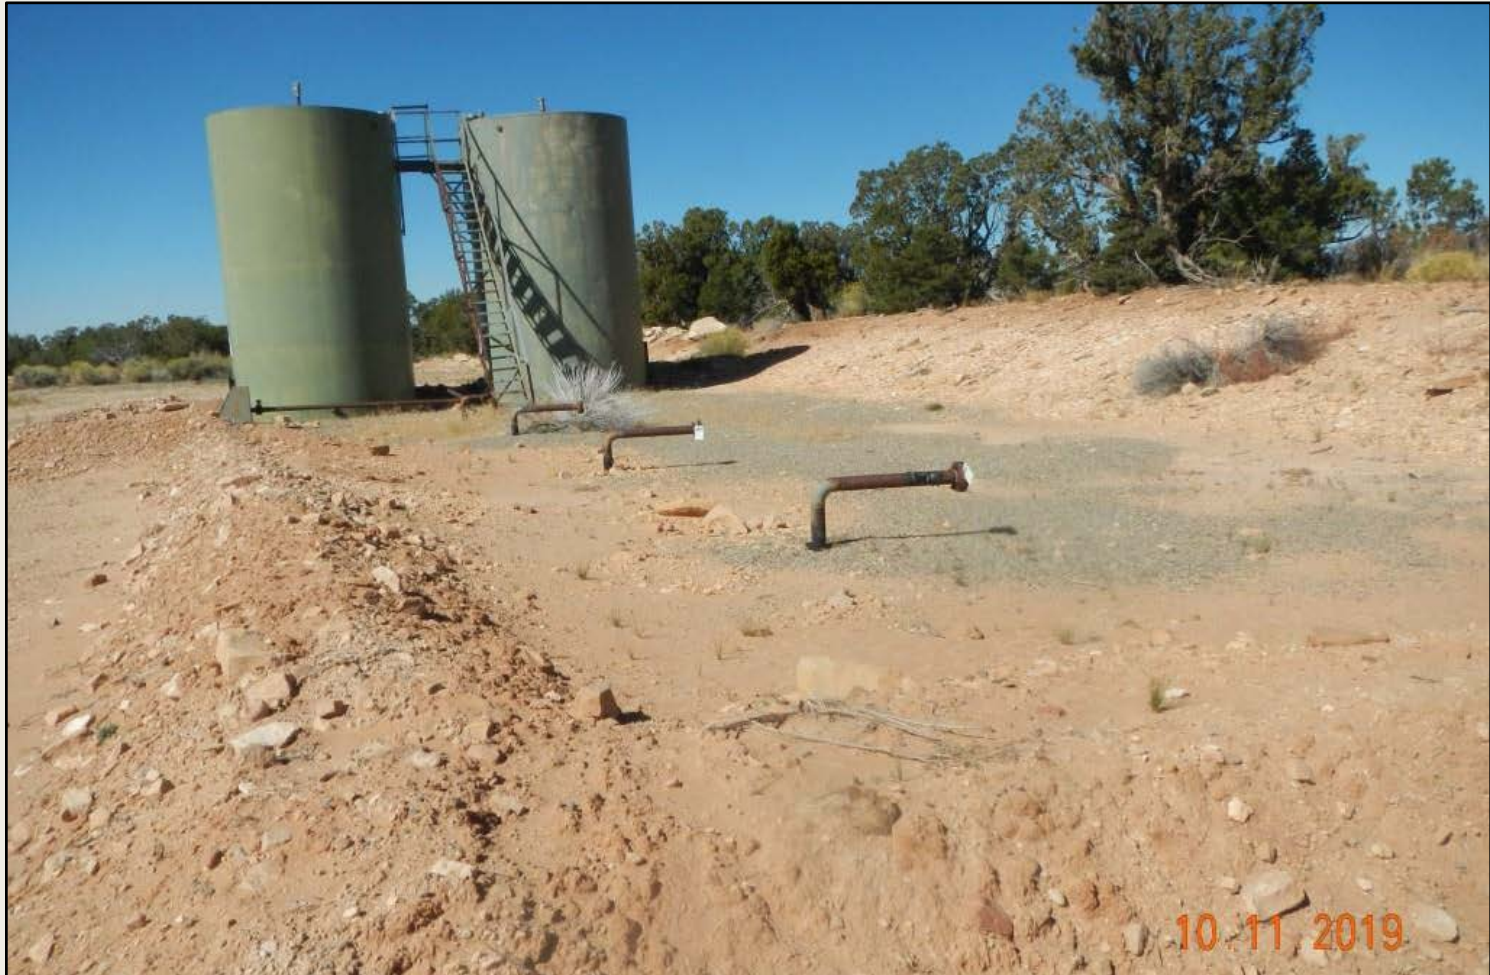
Photo 4. View of more risers, needing removal.

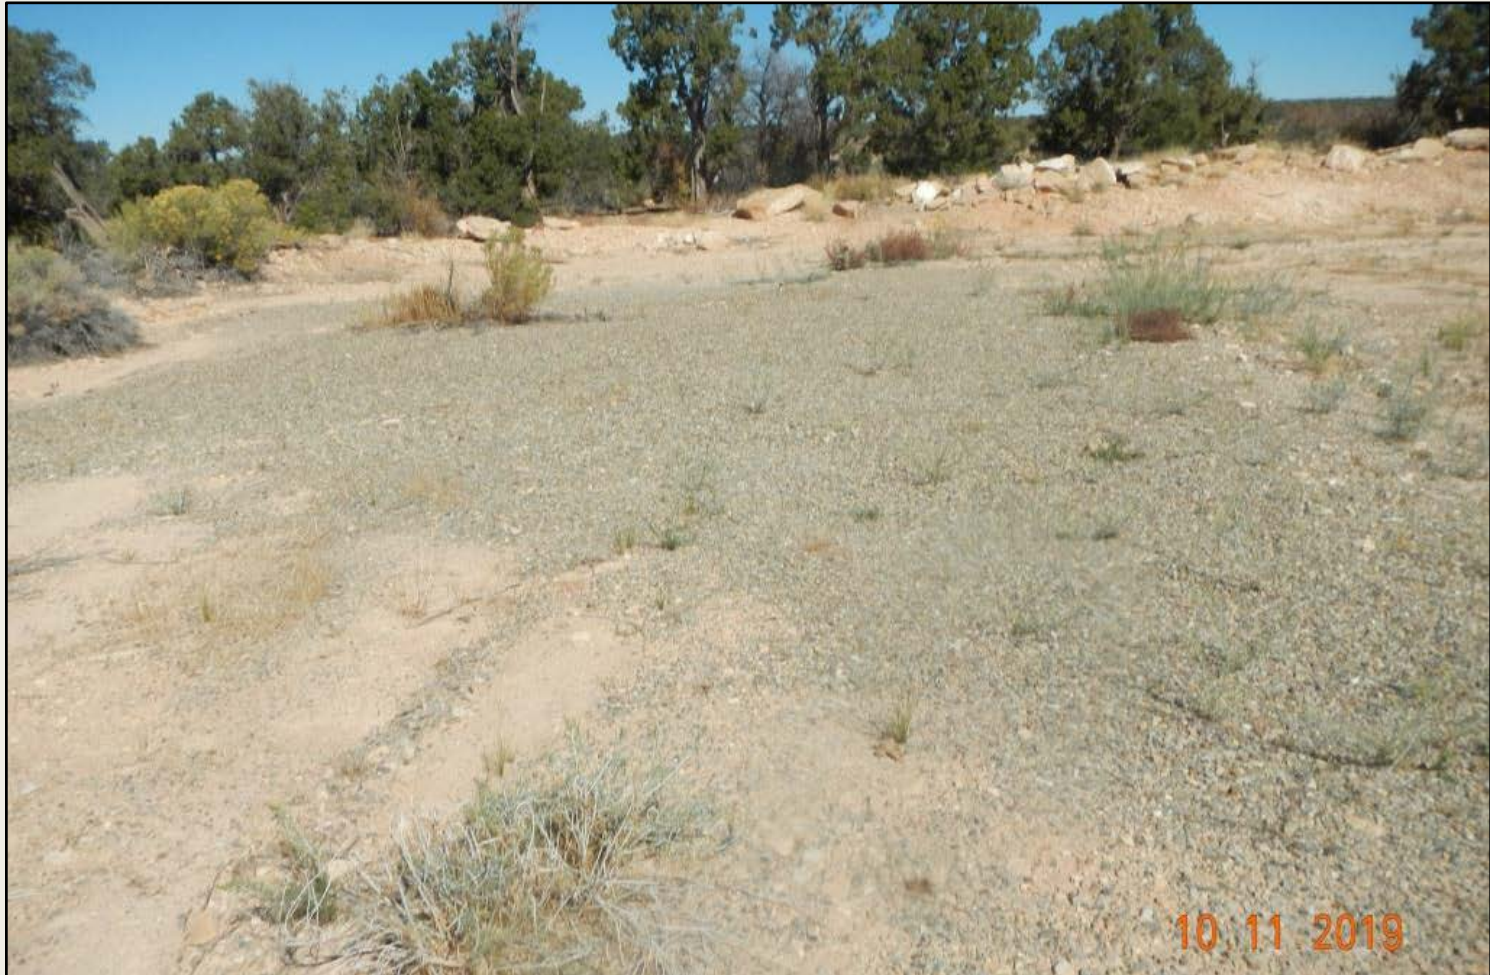
Photo 5. View of the western project area graveled and not in use, needing reclamation.

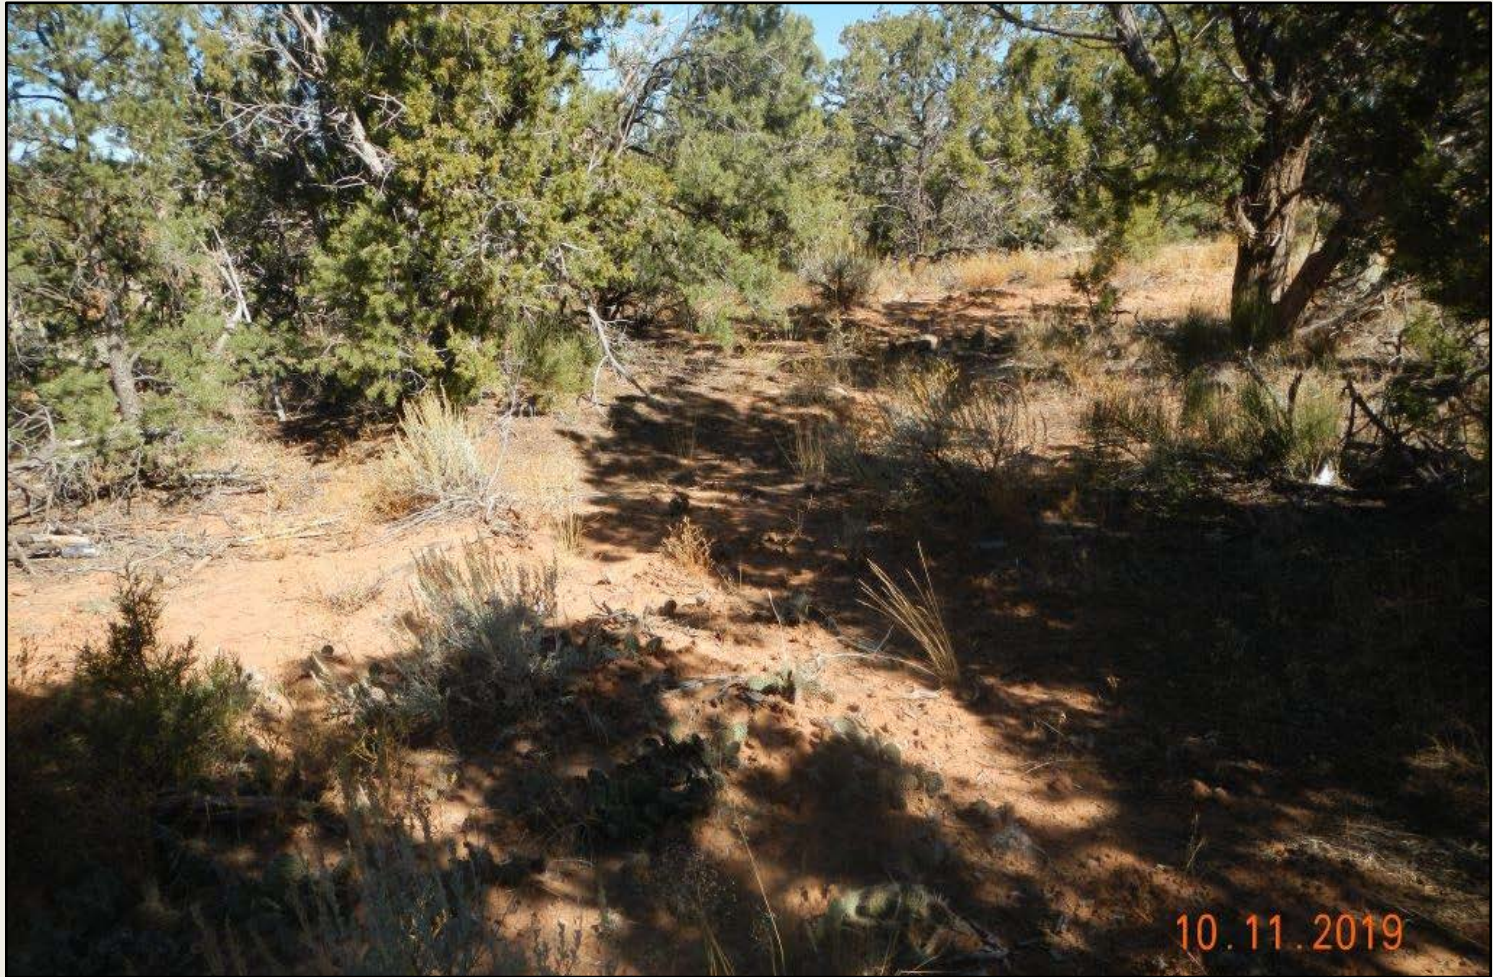
Photo 6. View of reference area vegetation comprised of pinyon juniper woodland.
