**Response to September 24, 2019 Inspection
Document Number: 679601640**

COGCC conducted an inspection of the Steve J Steve J 18 Pad (Location ID 333001) on September 24, 2019 (Document 679601640).

Name: Steve J 18 Pad

Location ID: 333001

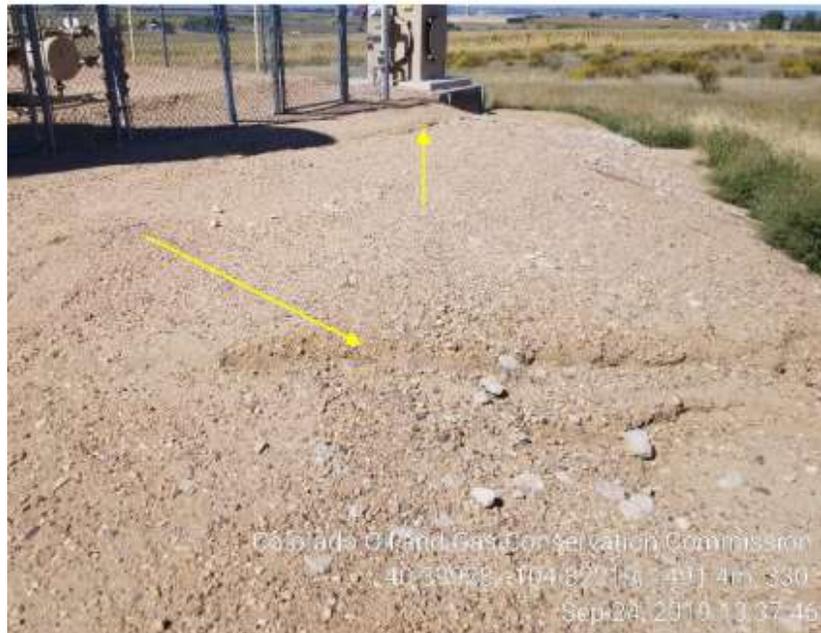
COGCC Stormwater comment: *Erosion to location. INSTALL OR REPAIR REQUIRED BMPs PER RULE 1002.F. (Corrective Action Date: October 24, 2019) See attached photo #11-13.*

COGCC Photo 11. Erosion

Stormwater Corrective Action: Install, repair, or replace required BMPs per Rule 1002.f. in accordance with good engineering practices.

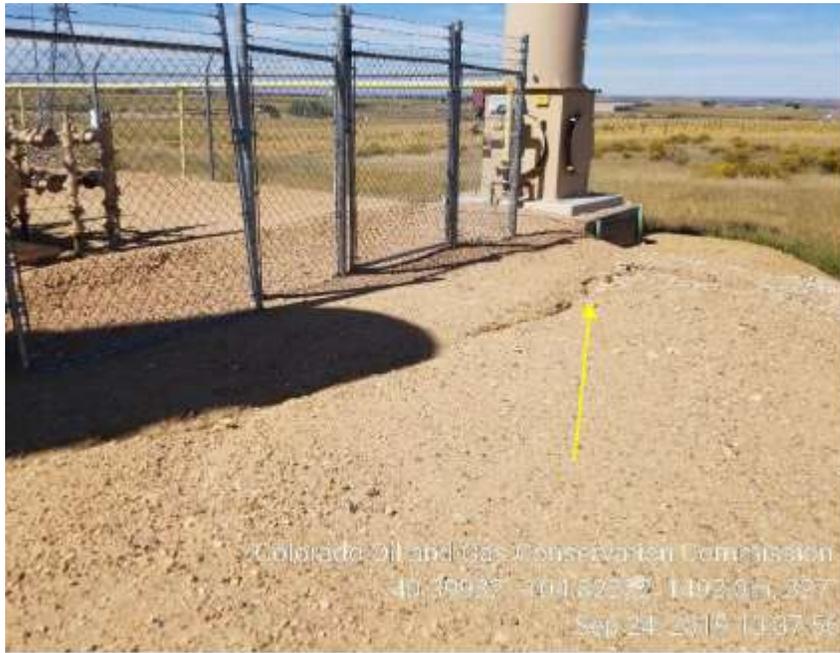
COGCC Photo 12. Erosion,

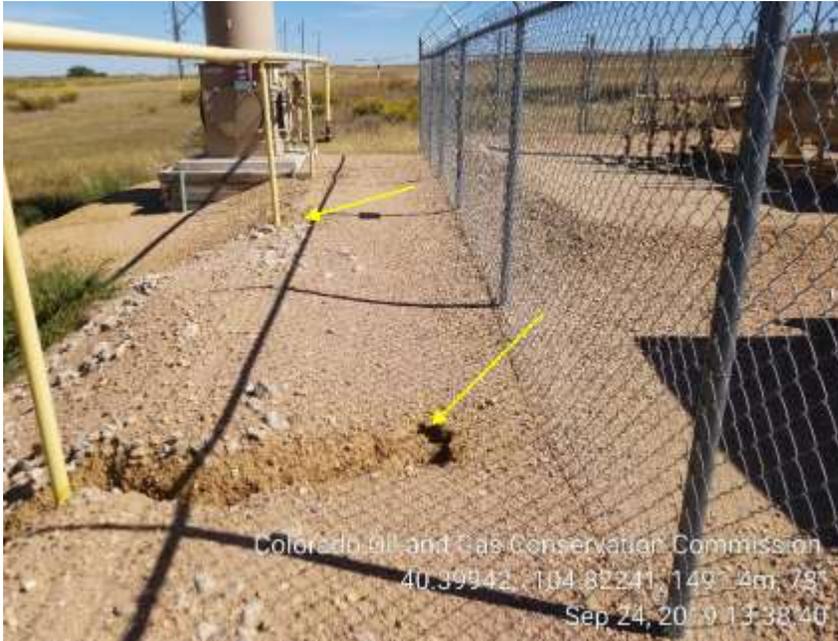
COGCC Photo 13. Erosion
