CB-3 CO2 Well Location Photos
API #05-083-06715 / Facility ID #436564
FIR #693900904 / CA #131546
FIRR #402218277

Response to CA #131546

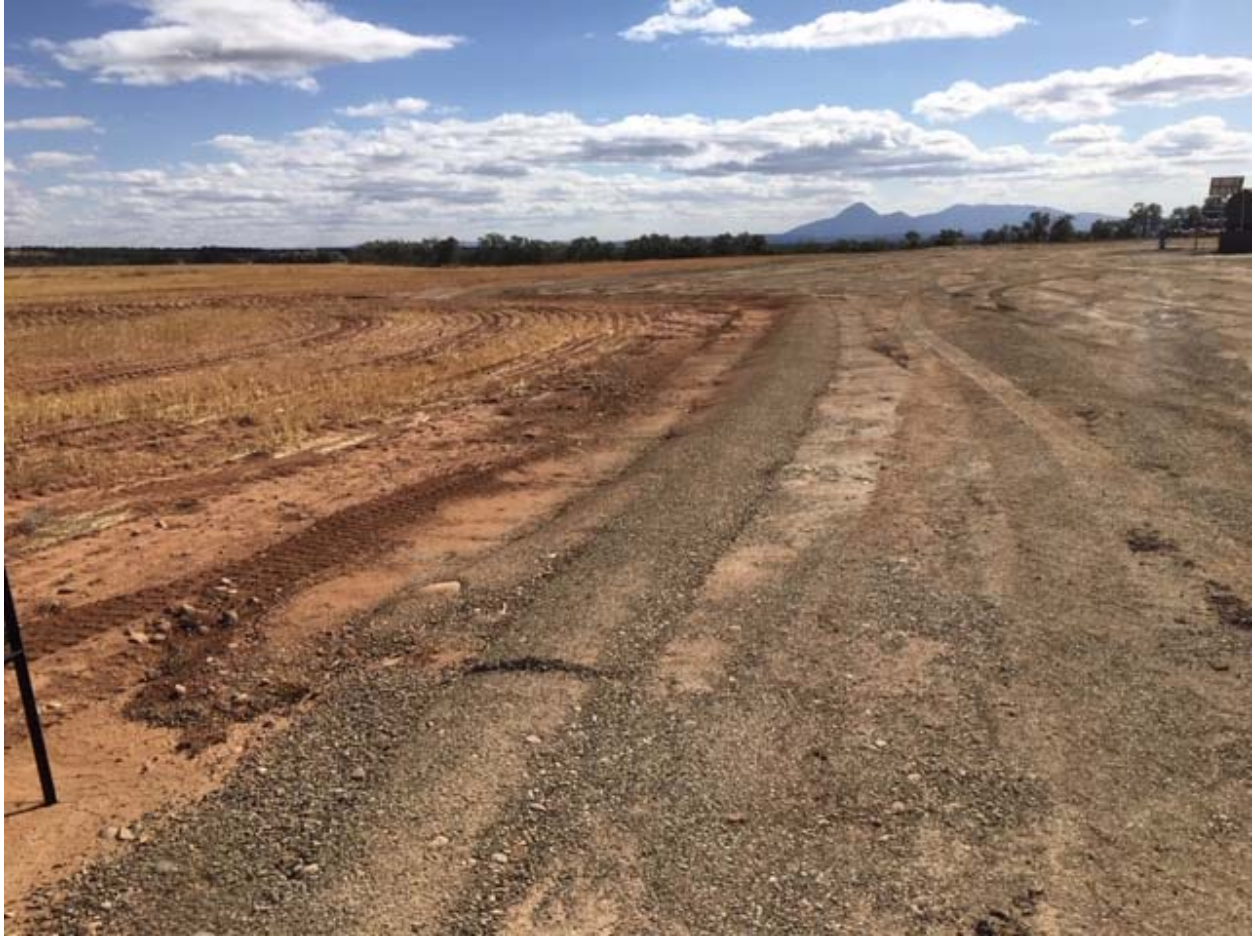
Gravel berm constructed on east side of access road at the CB-3 location.

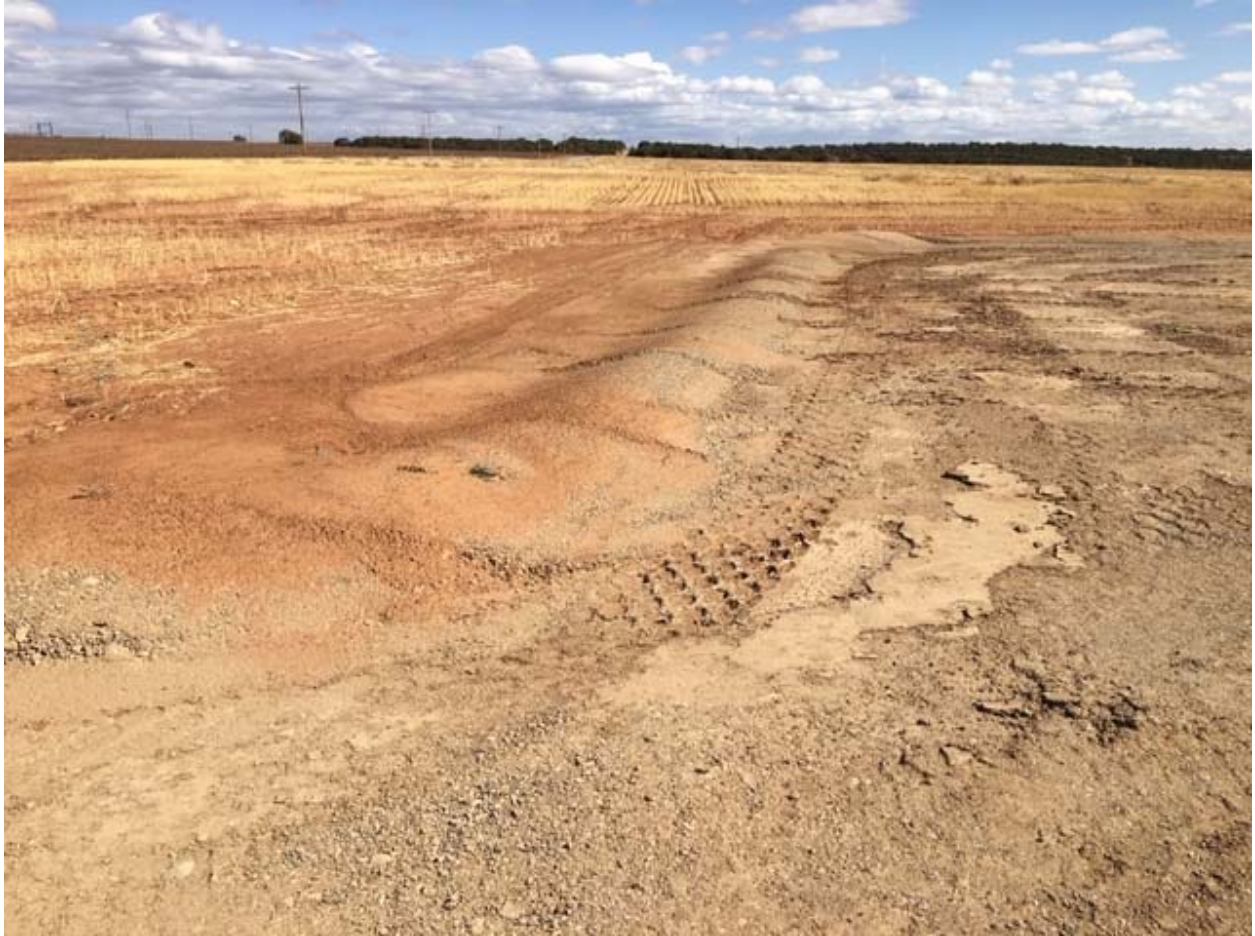
Gravel berm constructed on northeast side of well pad at the CB-3 location.

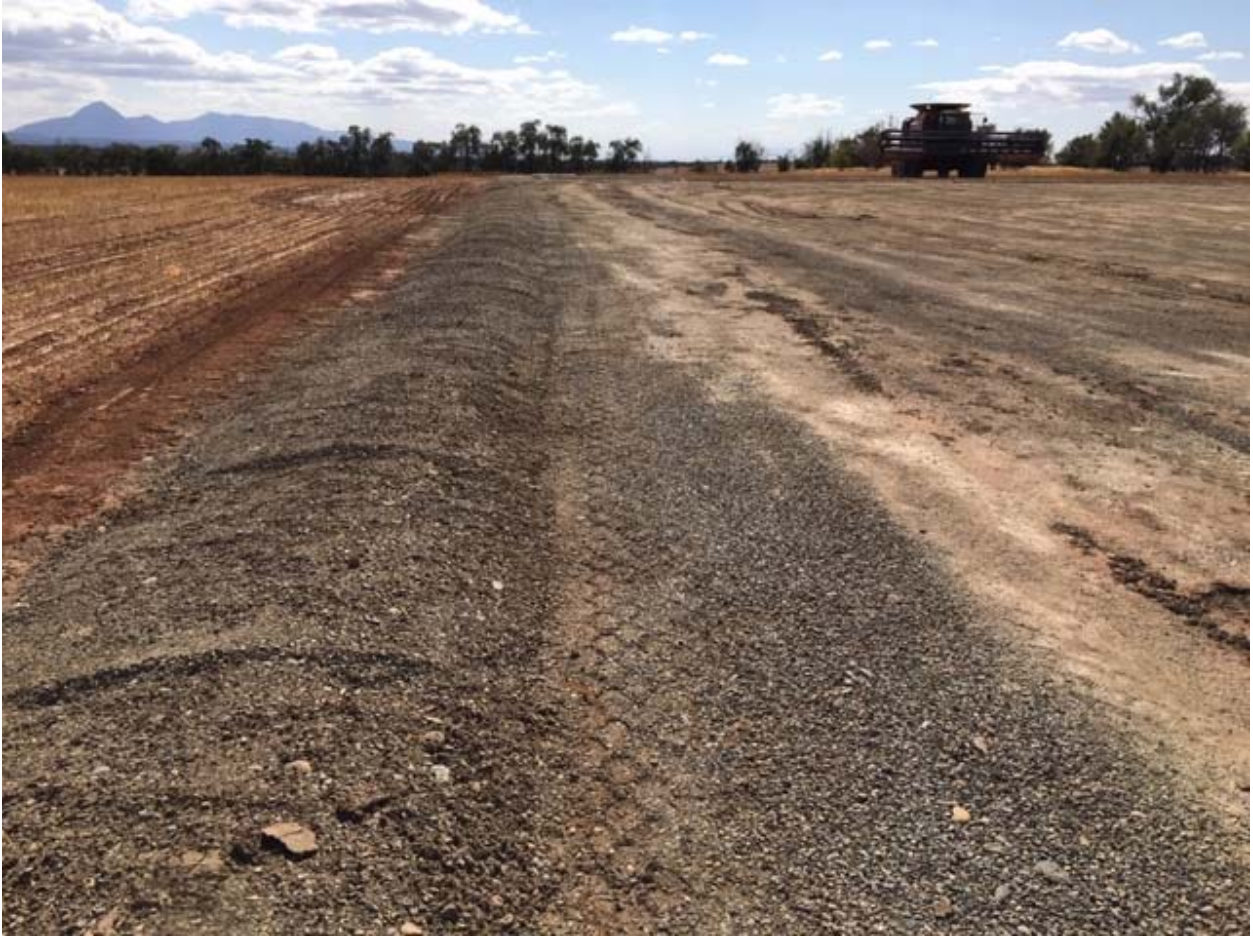
Gravel berm constructed on east side of well pad at the CB-3 location.

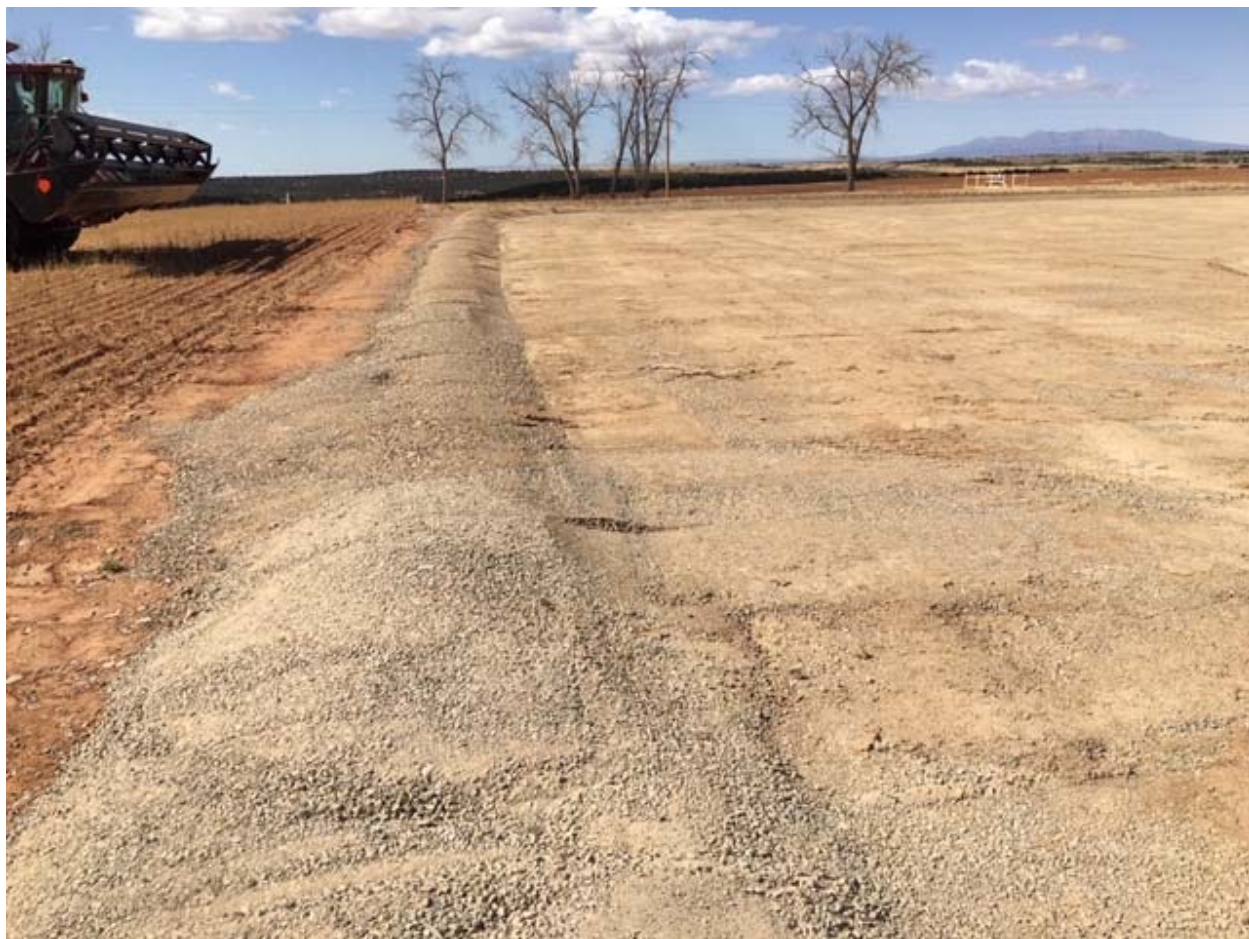
Gravel berm constructed on south side of well pad at the CB-3 location.

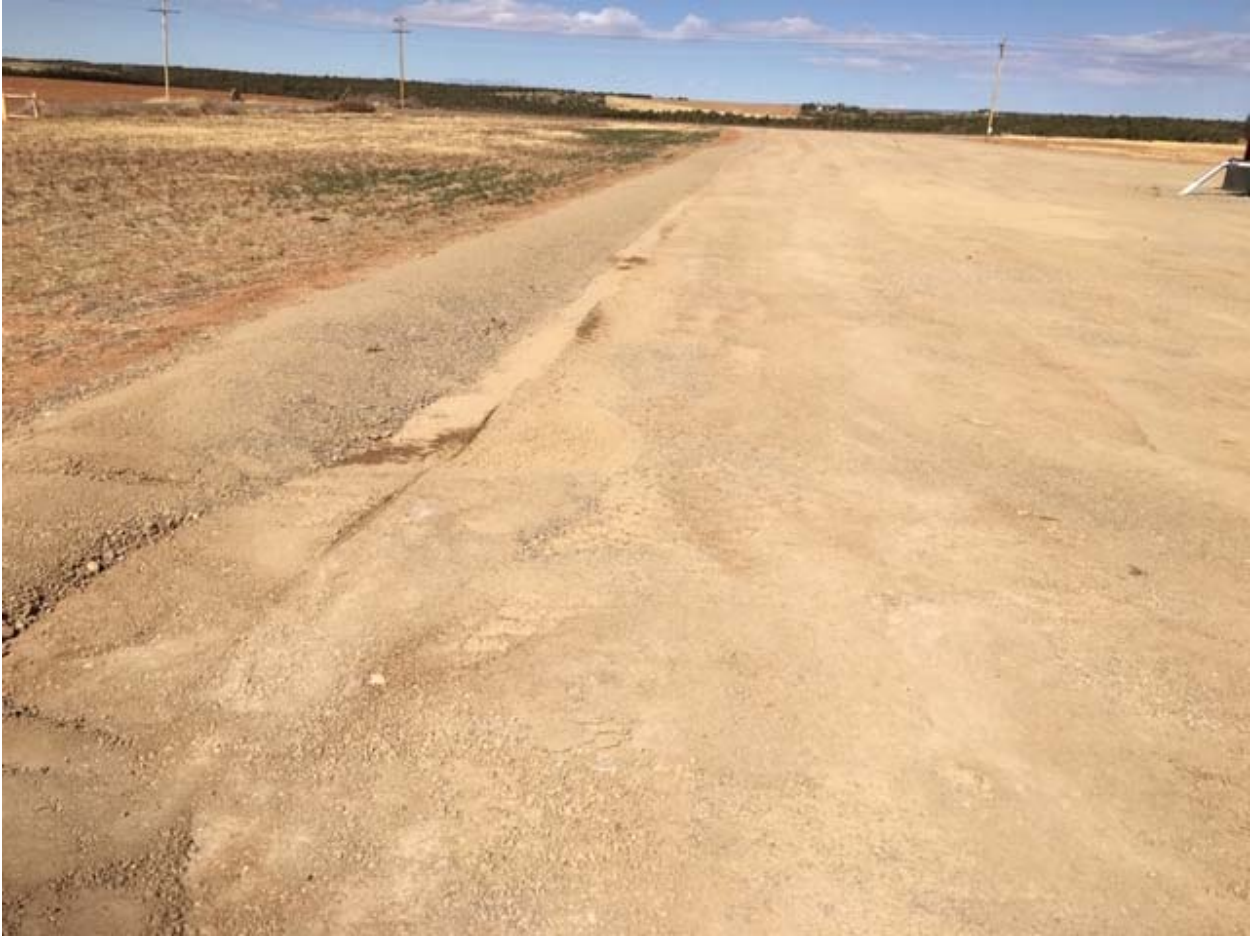
Gravel berm constructed on south half of west side of well pad at the CB-3 location.

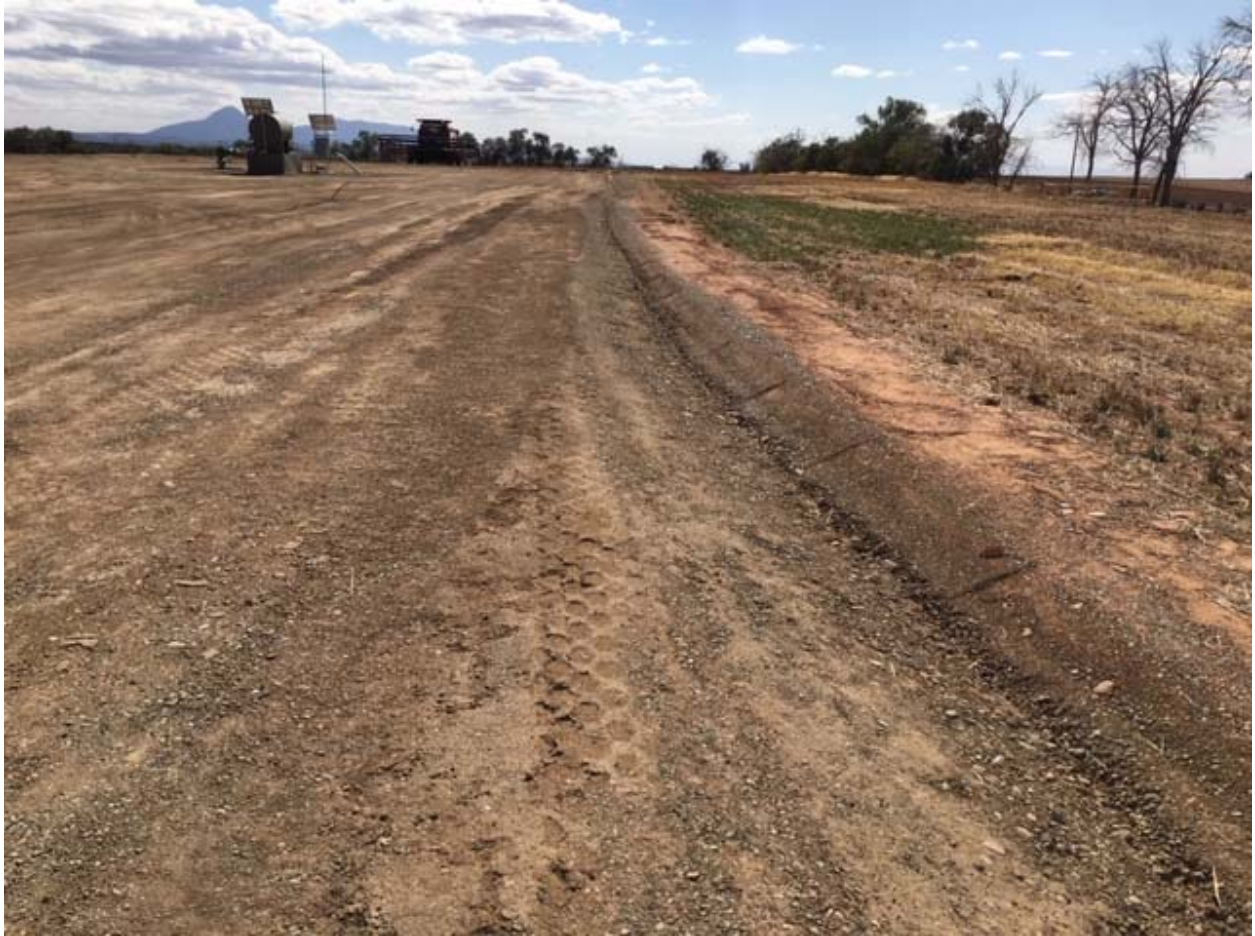
Drainage swale constructed on north half of west side of well pad at the CB-3 location.

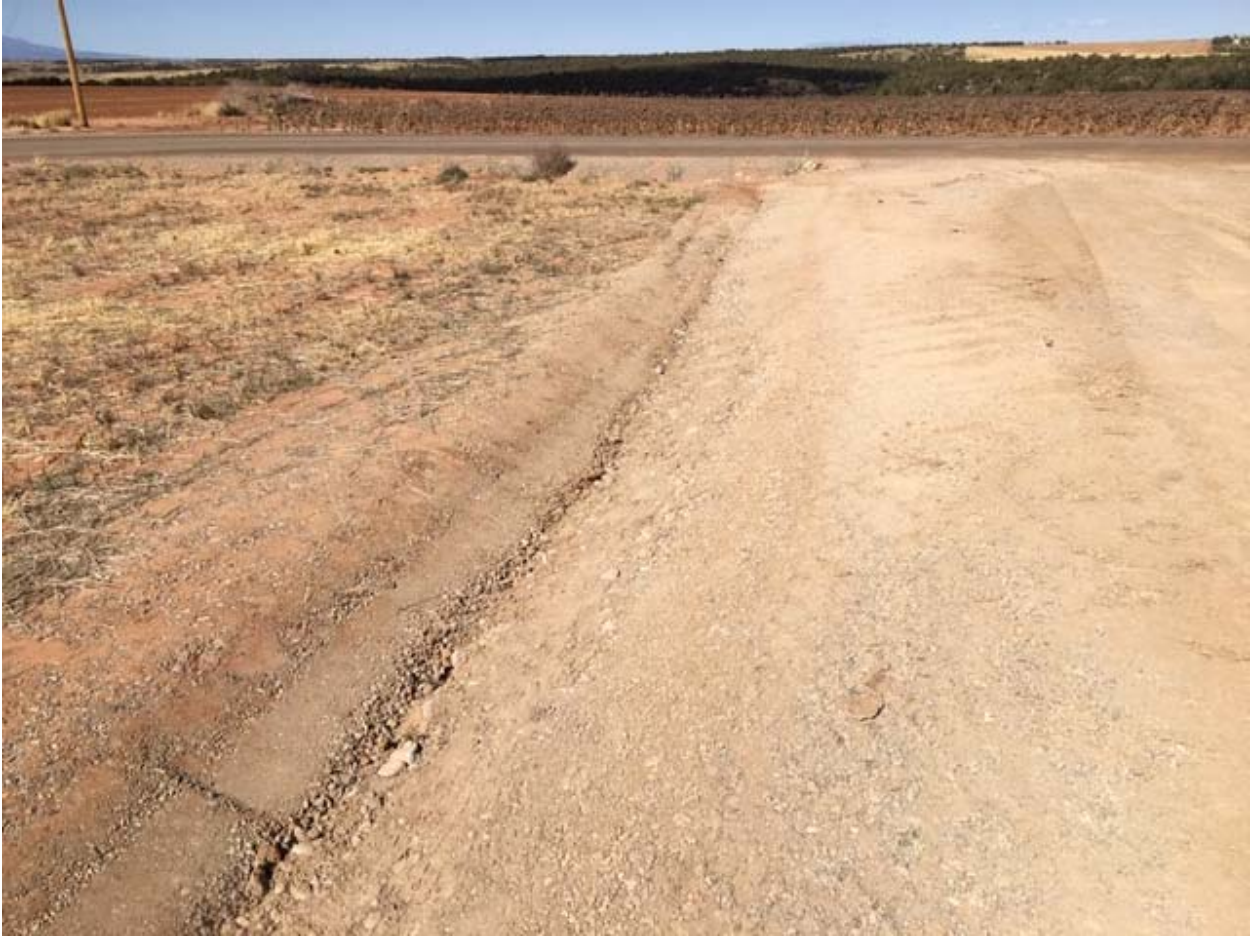
Drainage swale constructed on west side of access road at the CB-3 location.
