Inspection Photos
Location Name: KERI 33-18
API#: 05-071-06469
INSP. #: 695101571

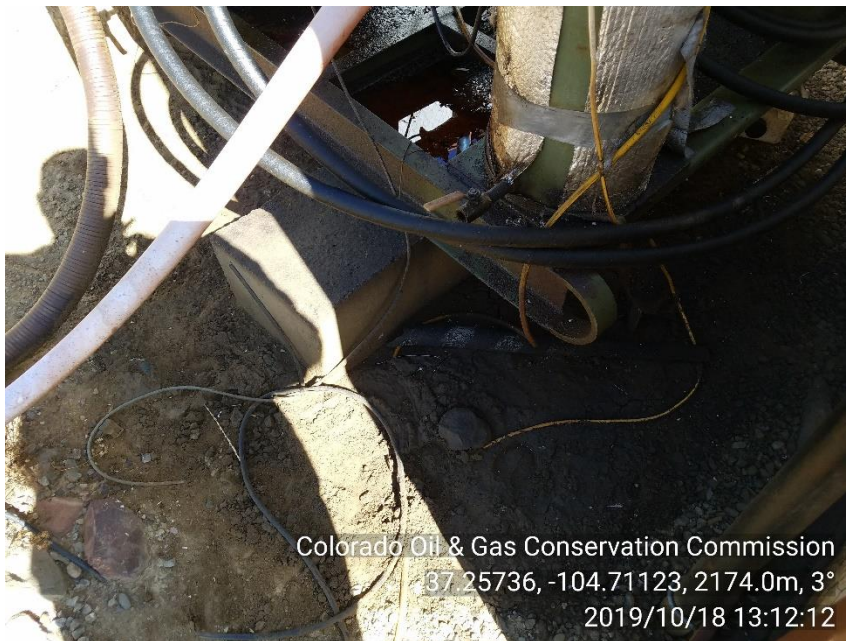
PHOTO 3: AREA OF IMPACTED SOIL AROUND AND UNDER ENGINE SKID. Properly treat or dispose of oily waste in accordance with 907.e. CA DATE 11-18-19

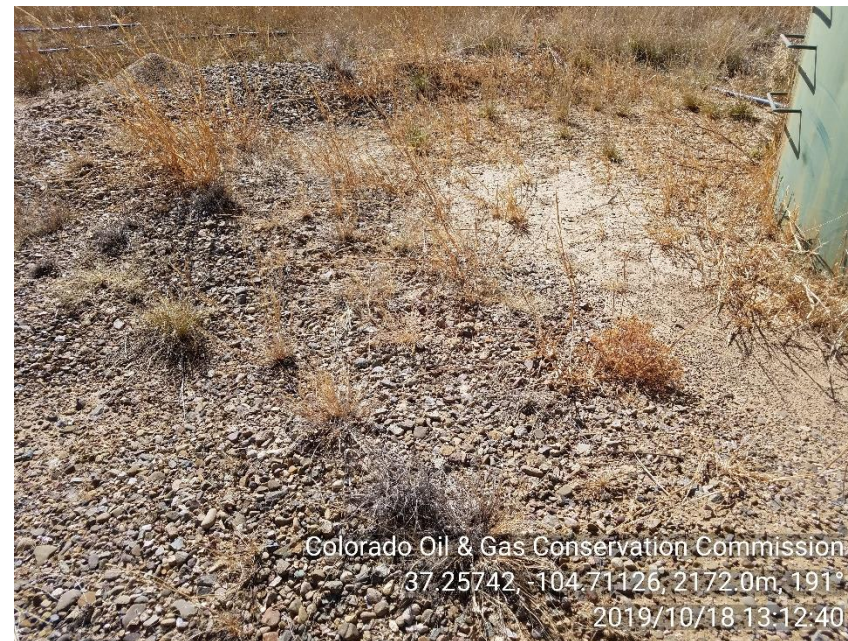
PHOTO 4: CONTAINMENT BURMS AROUND PRODUCED WATER TANK IS IN ADEQUATE FOR PROPER CONTAINMENT. Repair or install berms or other secondary containment devices per Rule 906.d.(1). CA DATE 11-18-19
