Inspection Photos
Operator Name: Caerus
Location ID: 323864

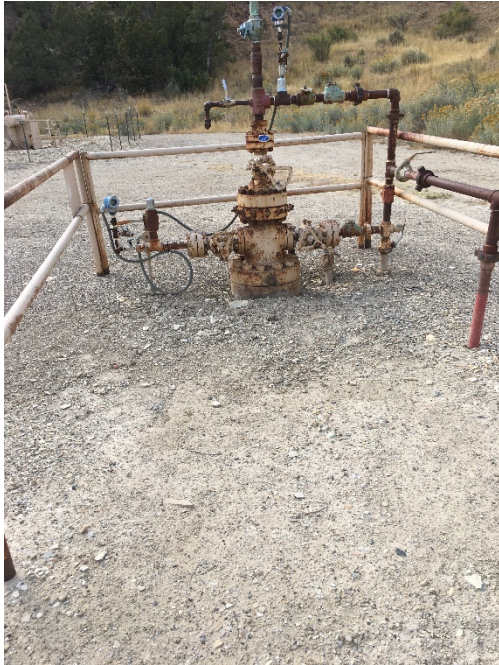
Flowlines removed

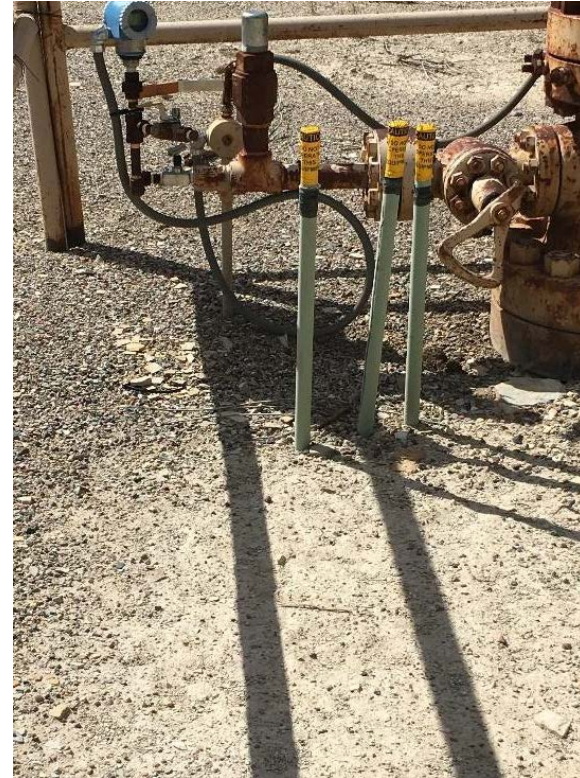
**3 flowlines Tagged documented in inspection
693200408**

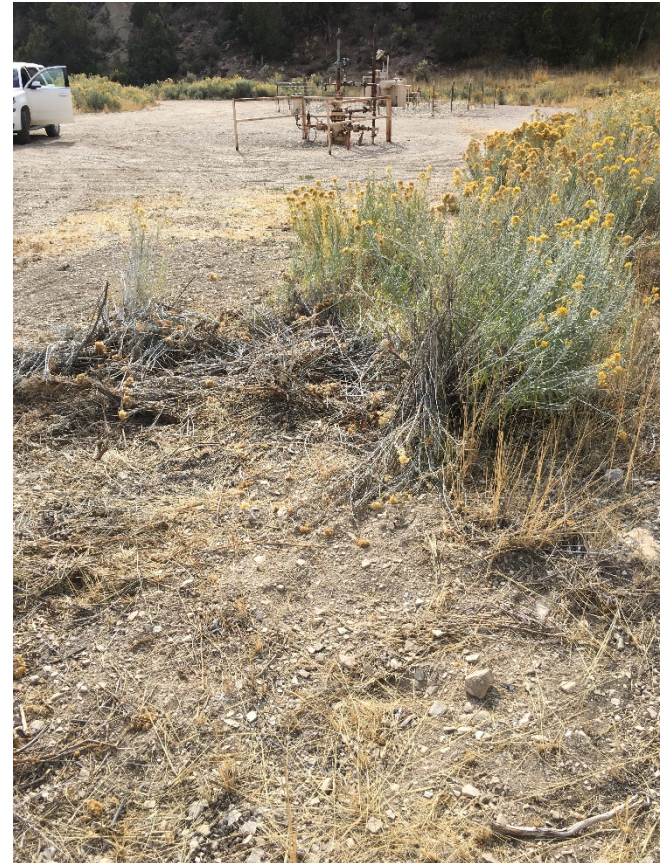
3 flowlines 1" removed

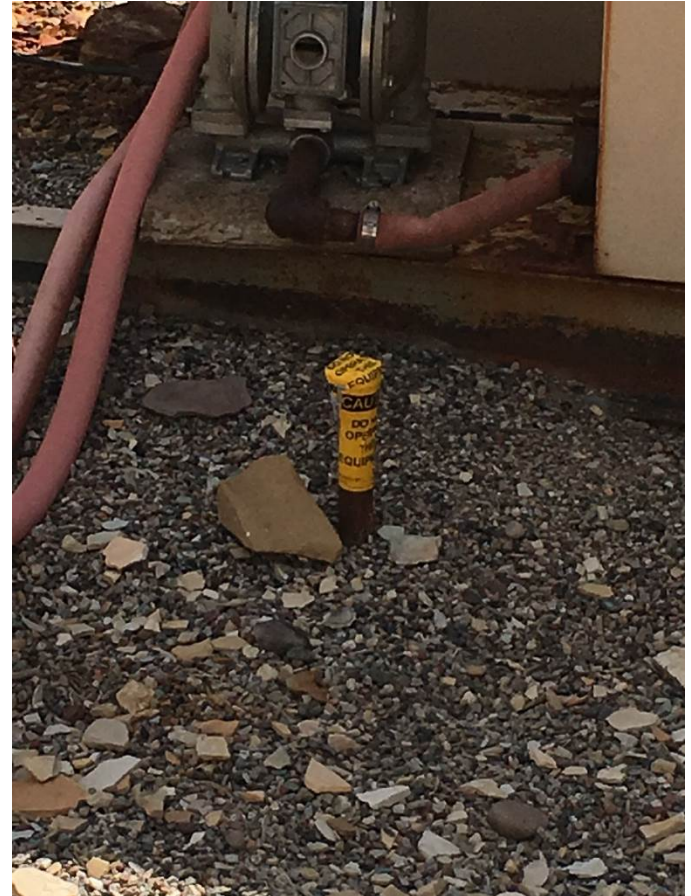
flowline marked and documented on inspection
693200408
