CAERUS PICEANCE LLC
FEDERAL-68S97W 14SENE (OH14)
Location # 334360

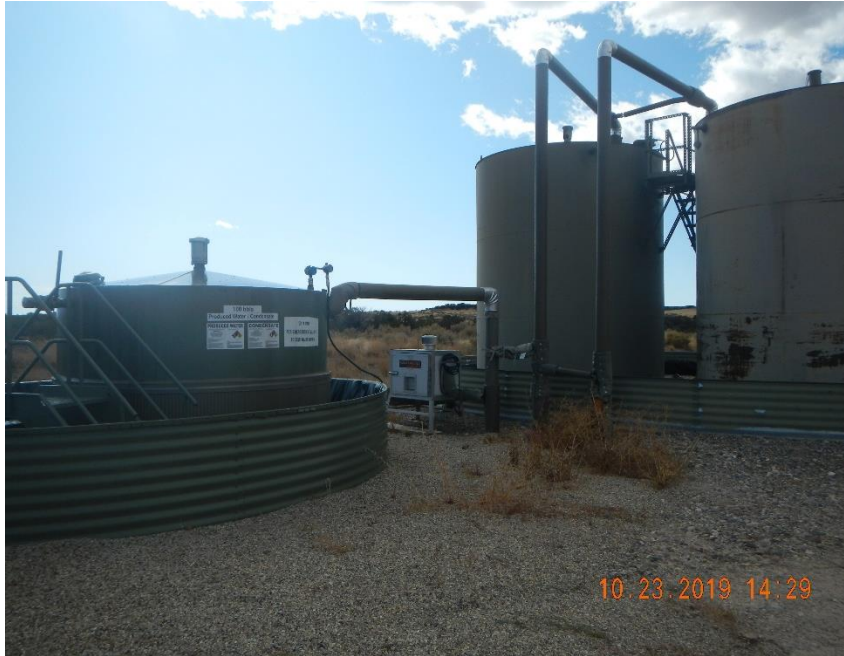
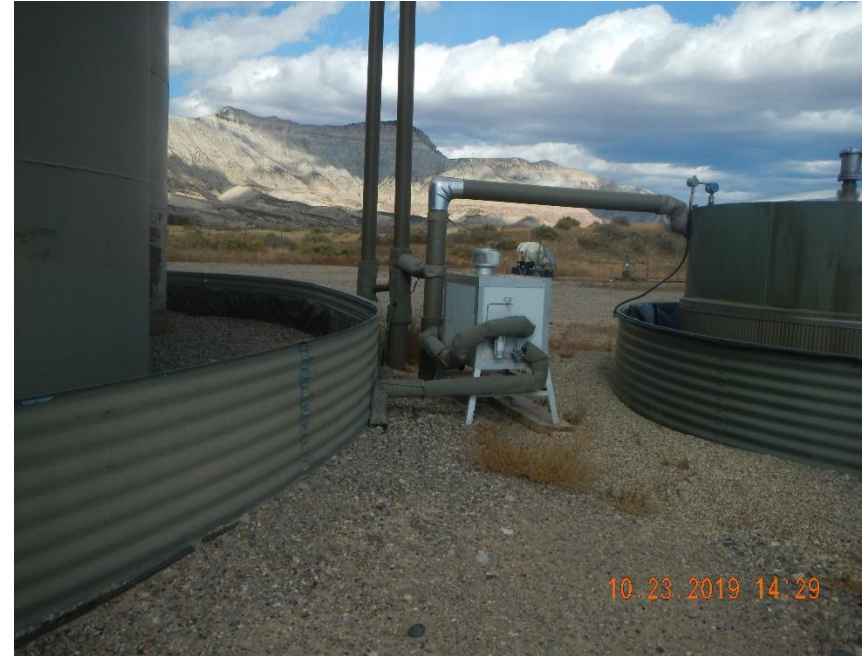
Dead weed debris around tanks and heat unit.

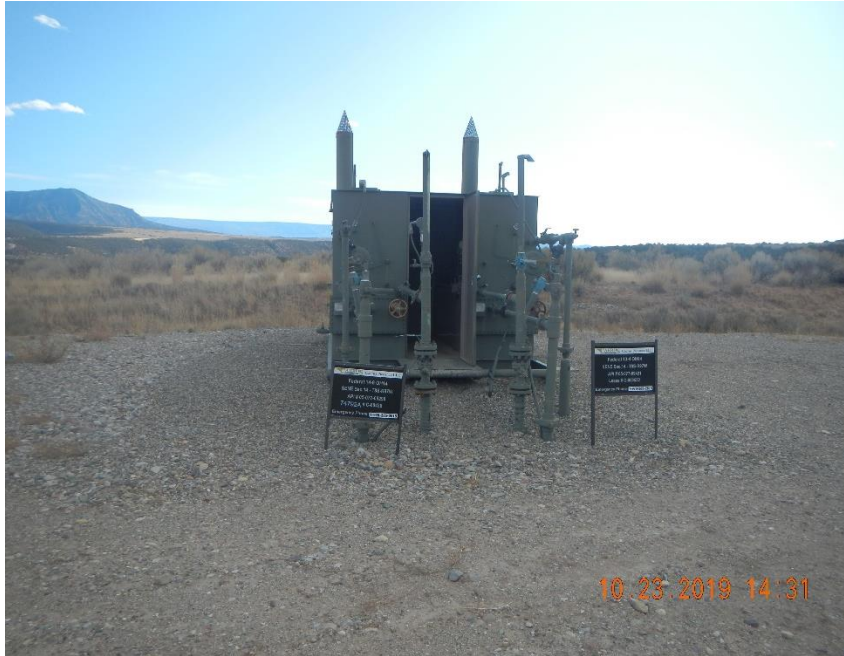
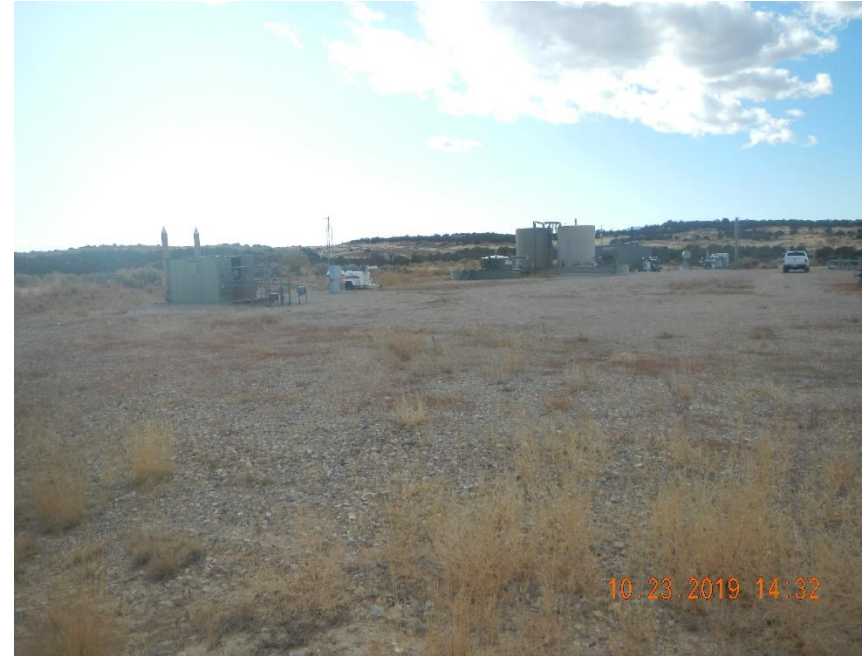
Dead weed debris

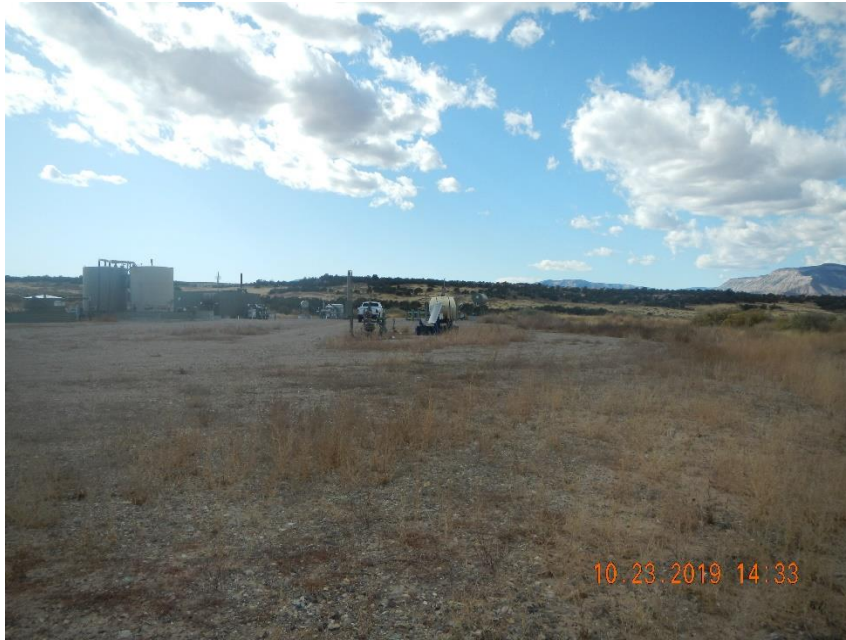
Dead weed debris

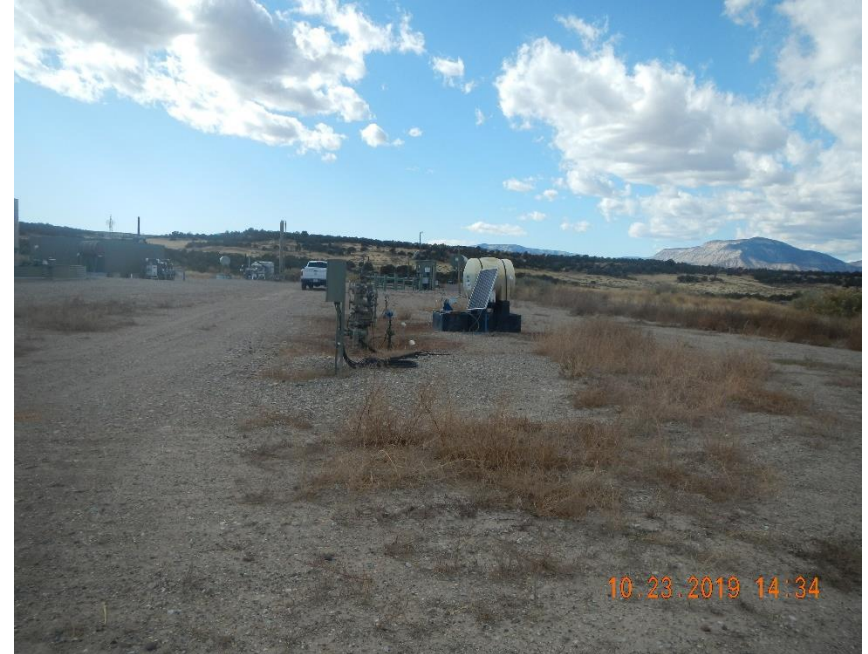
Dead weed debris

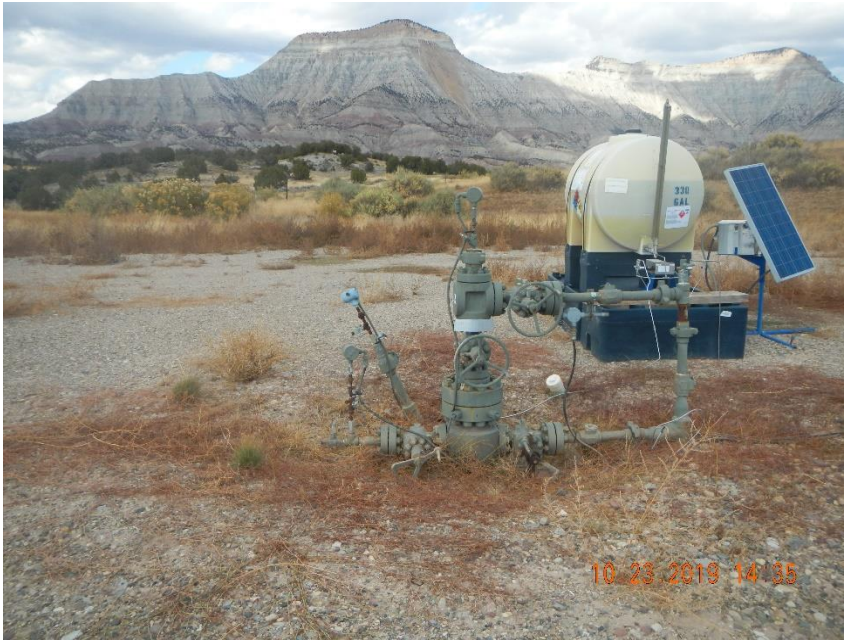
Dead weed debris

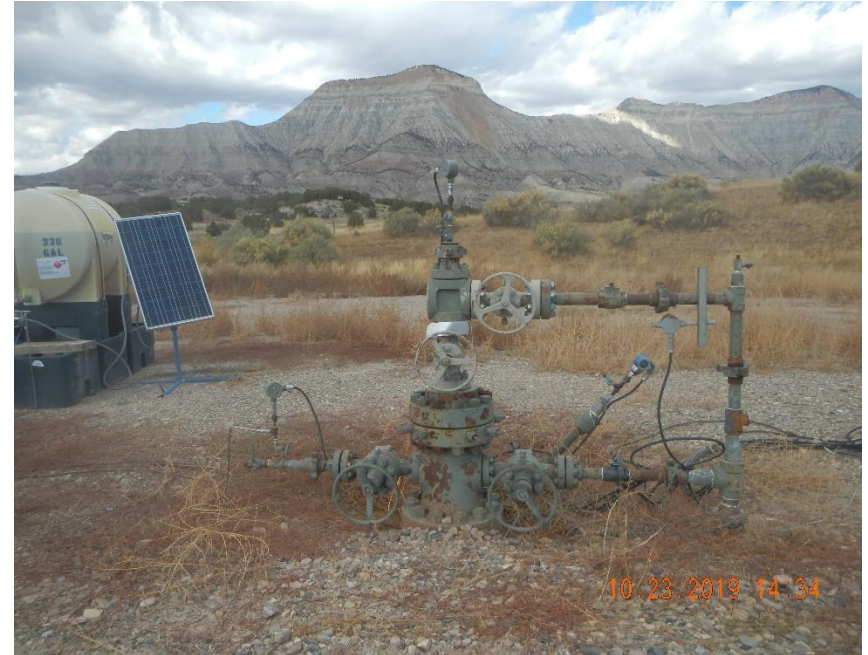
Dead weed debris

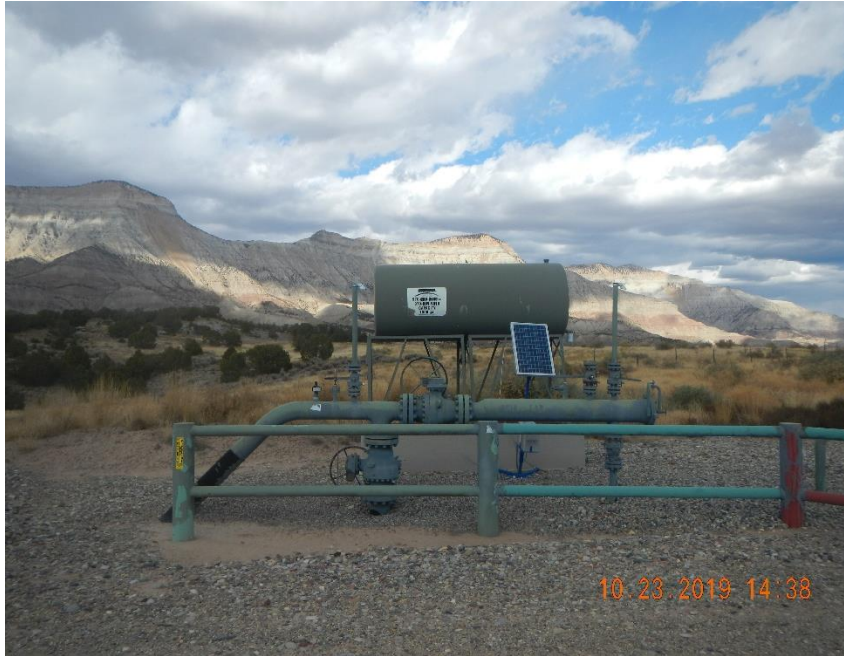
Operator name and numbers blacked out.

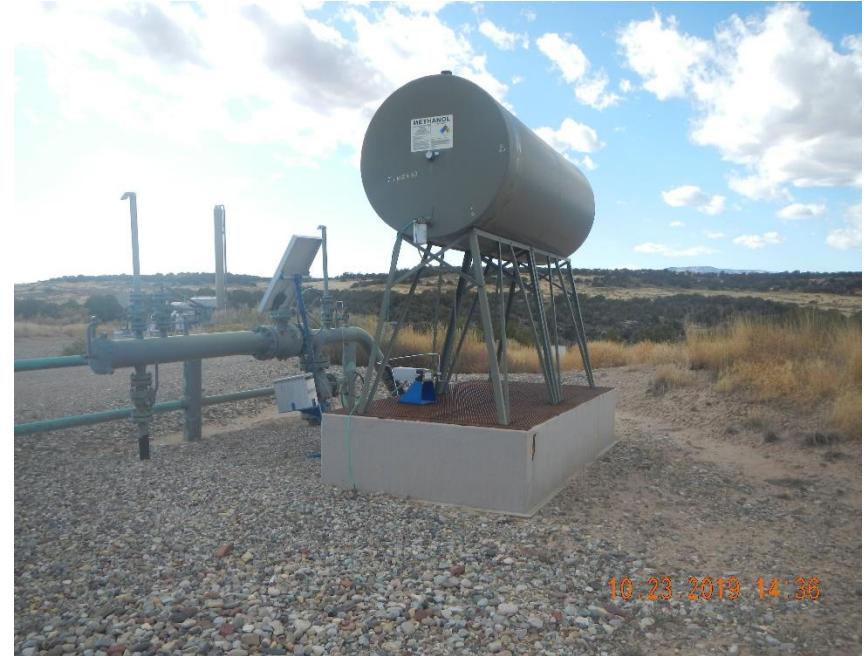
Damaged fiberglass secondary containment

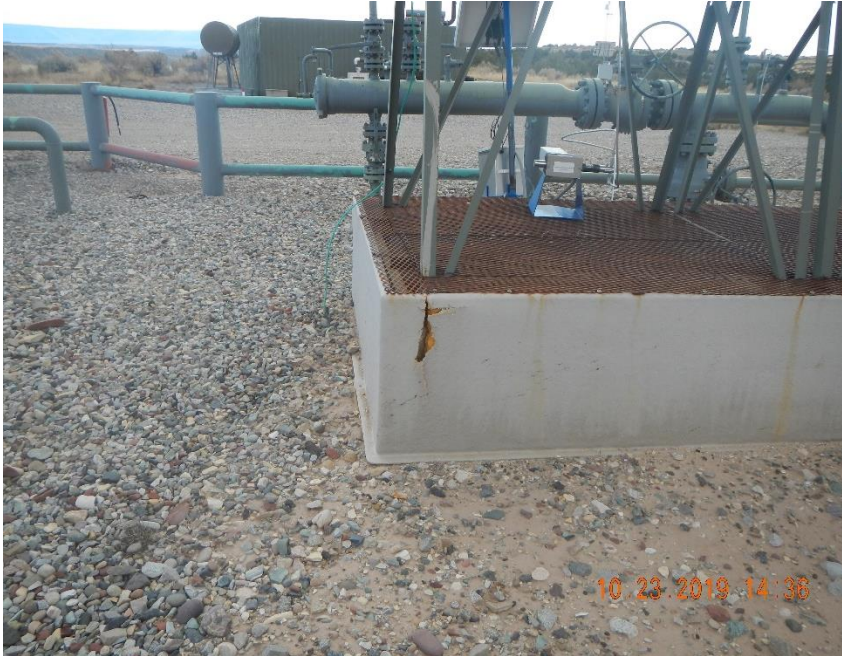
Damaged fiberglass secondary containment

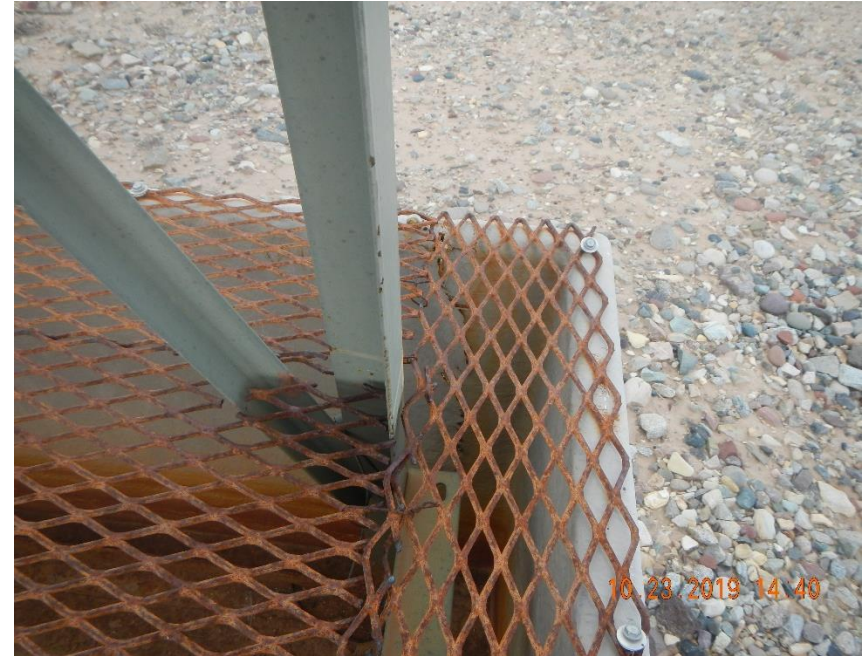
Damaged fiberglass secondary containment

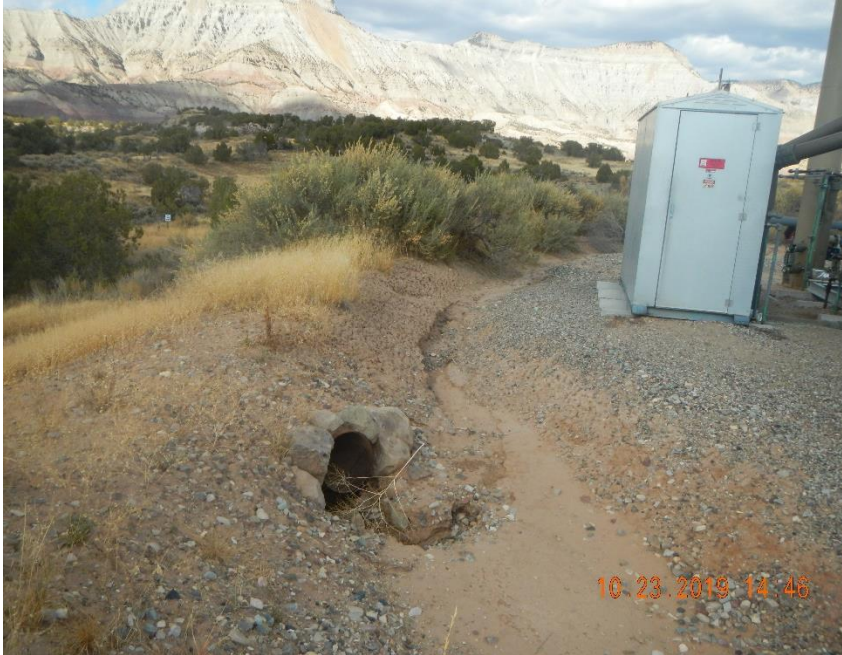
Washed out around drainage pipe.

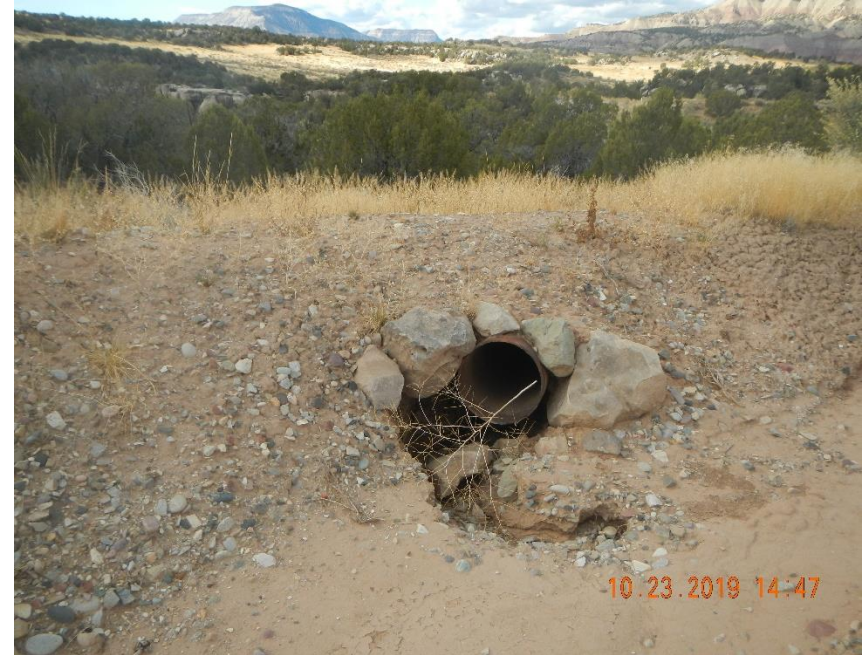
Washed out around drainage pipe.

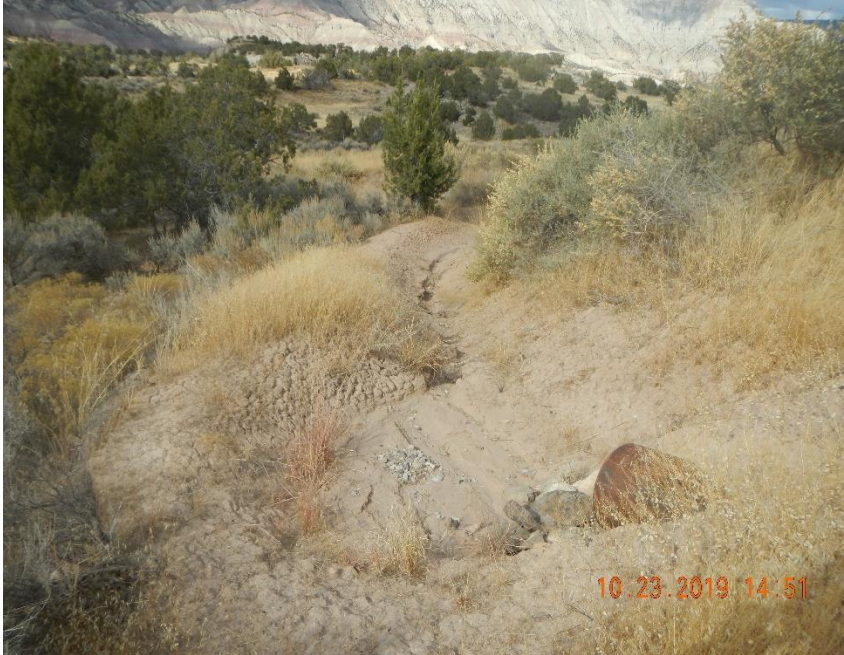
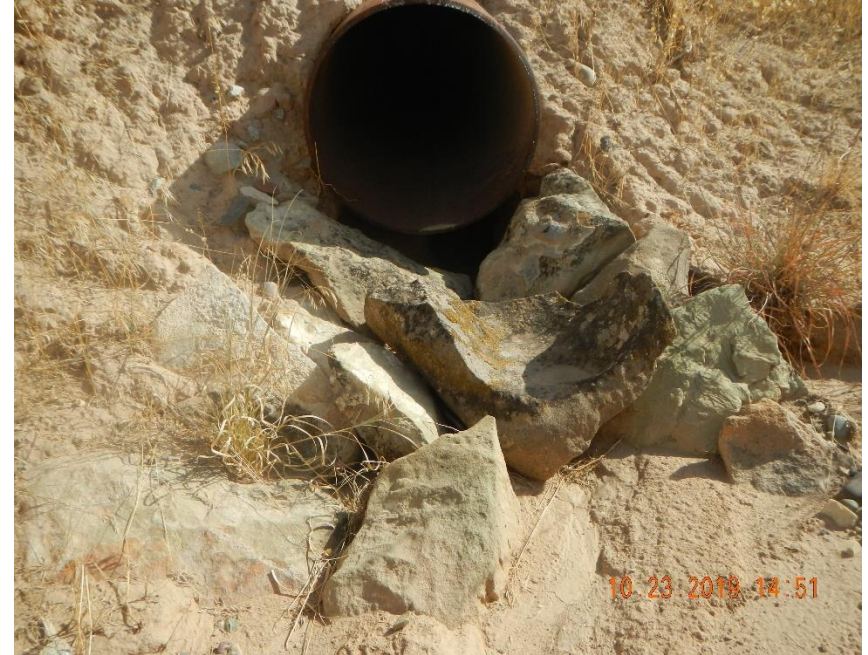
Washed out around drainage pipe.

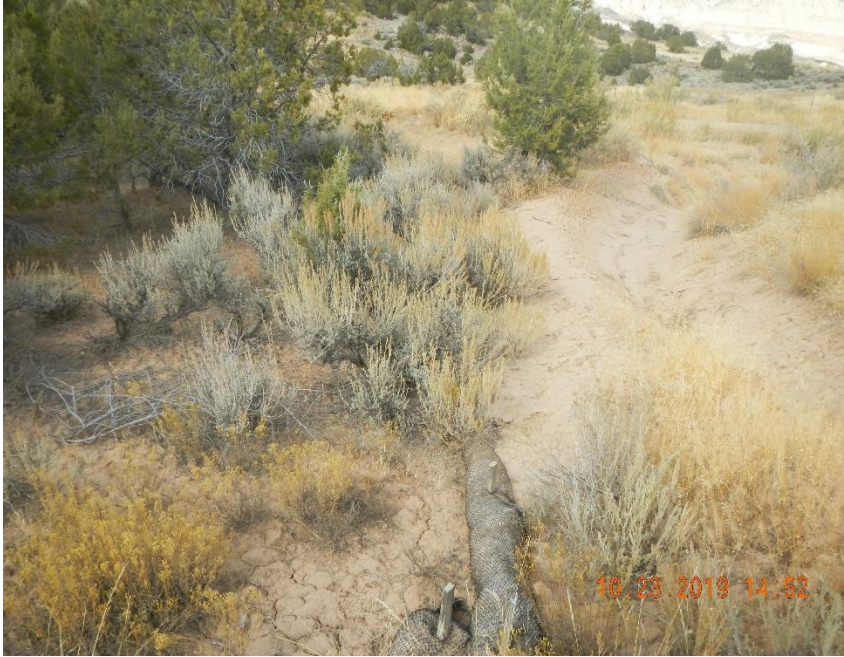
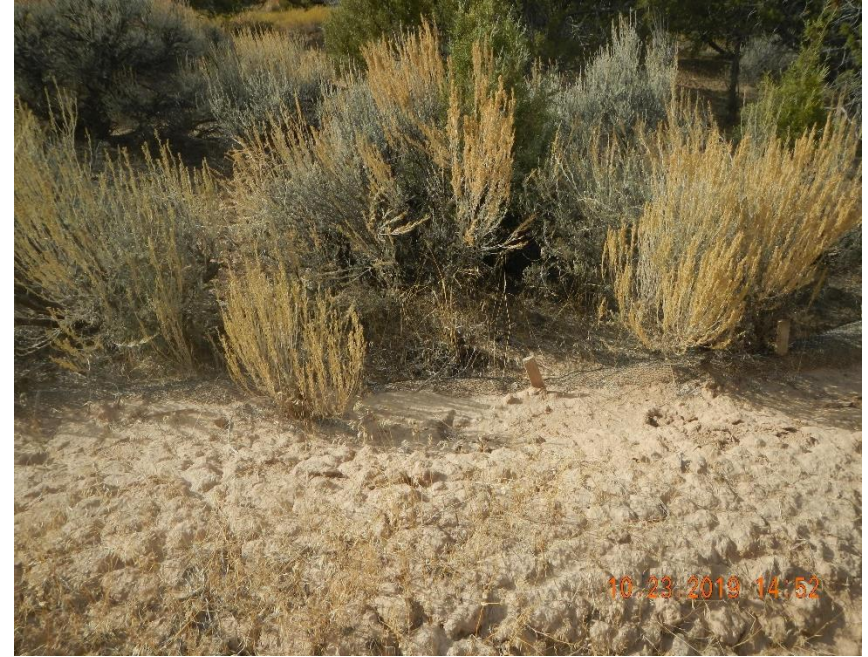
Unmaintained waddles along ditch.
