Eric Clubine 2
API: 05-103-05066
Inspection: 679705820

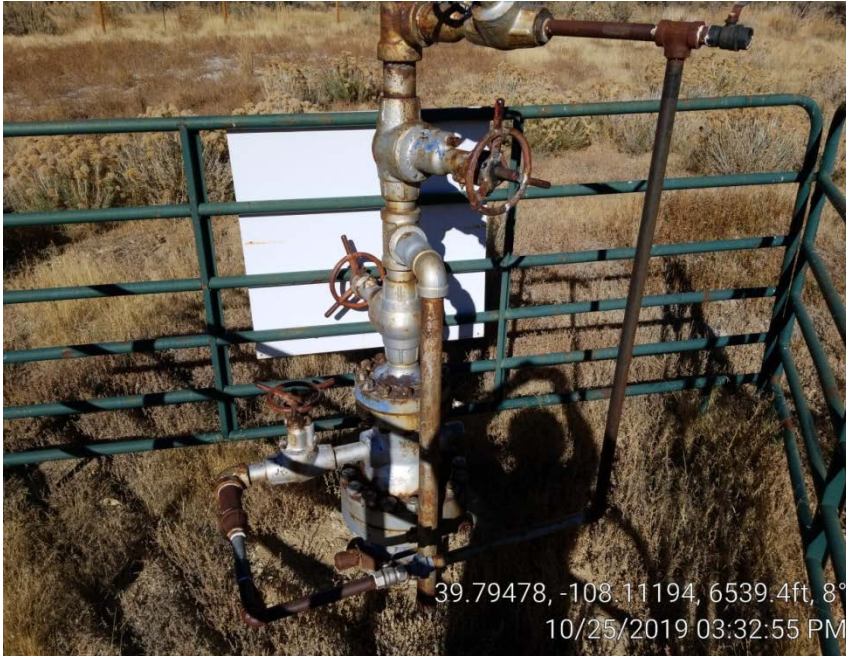
Photo 2. Well head.

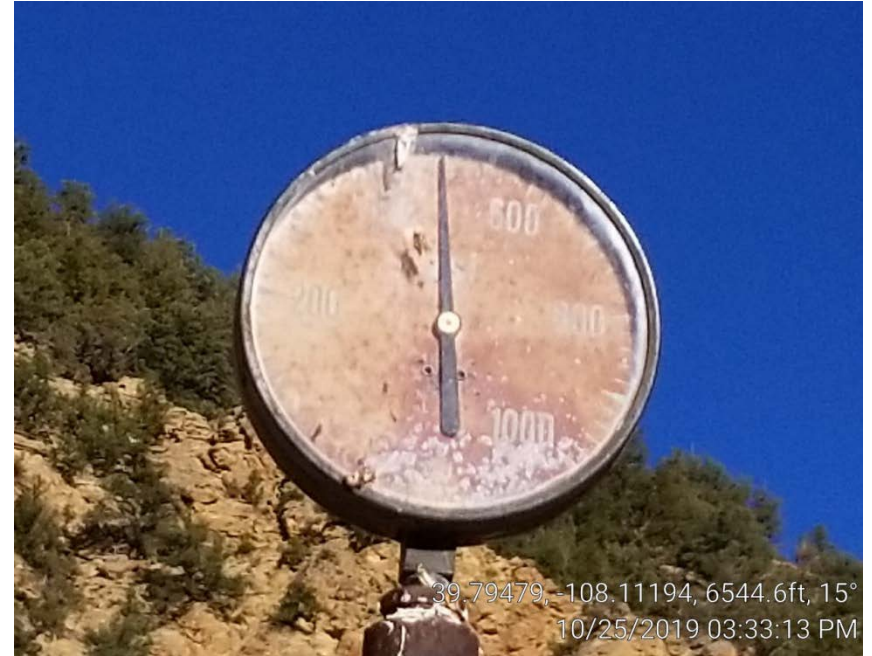
Photo 3. Well head gage.

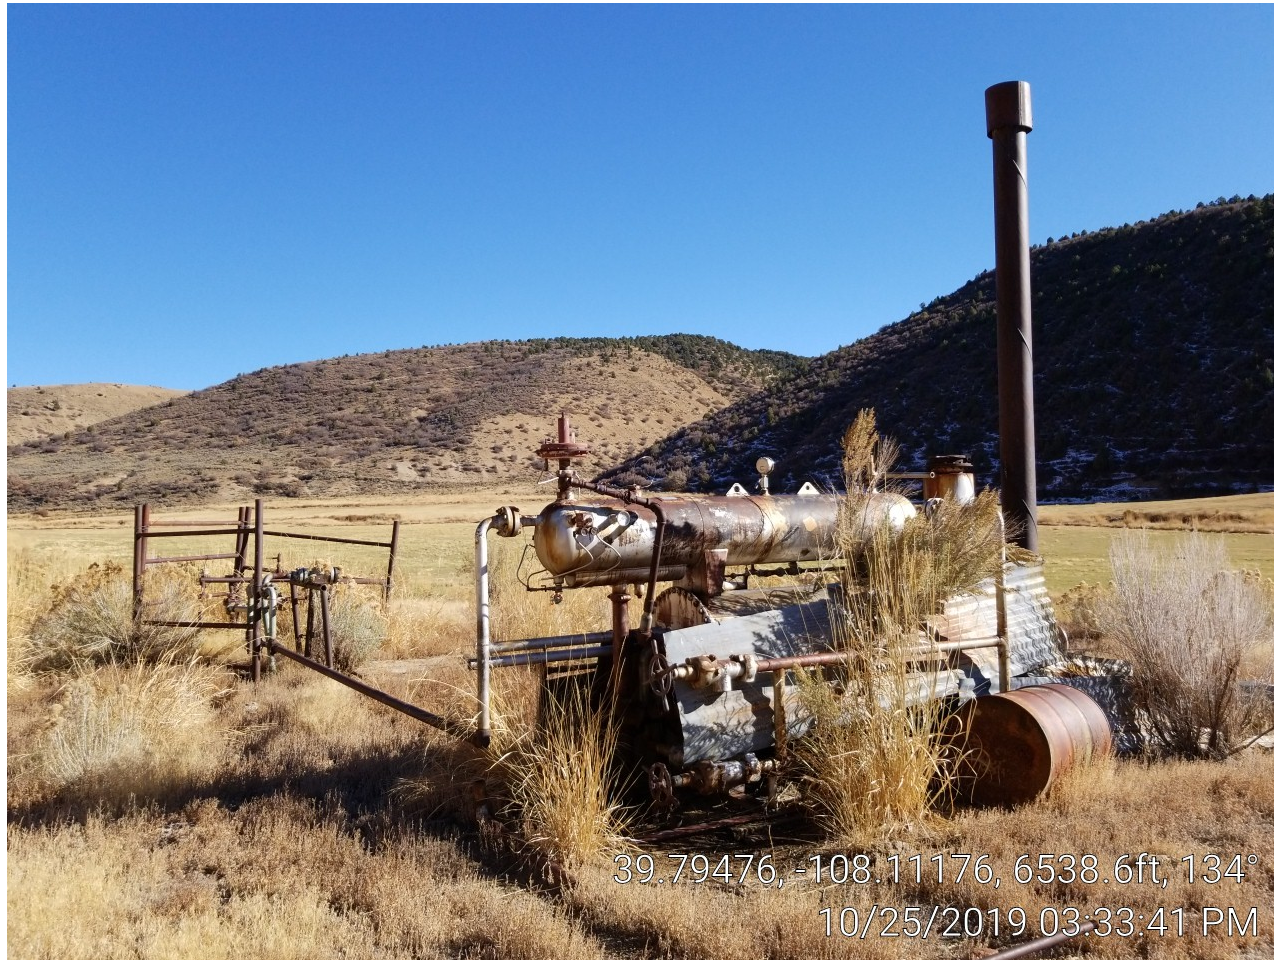
Photo 4. Separator & flowline.

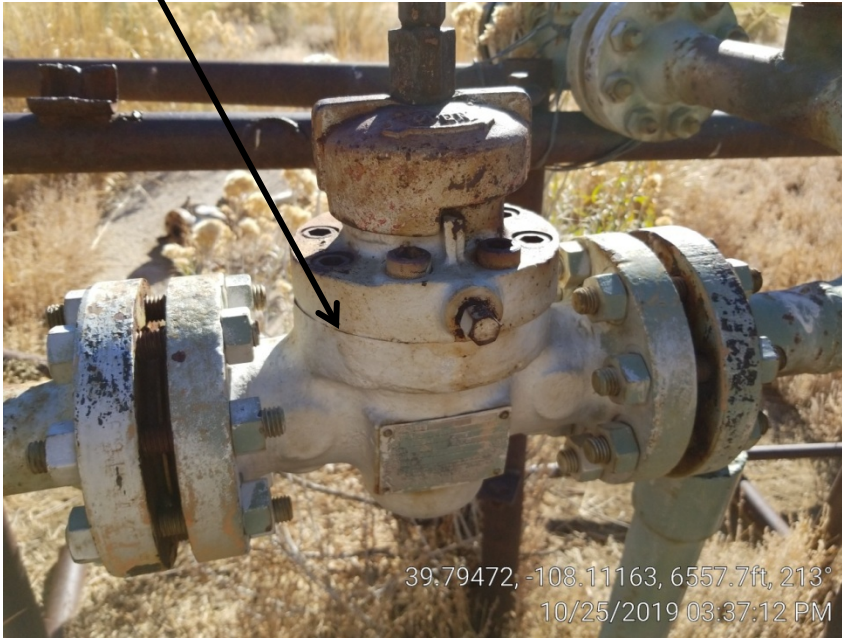
Gas leaking

Photo 5. Flowline junction.

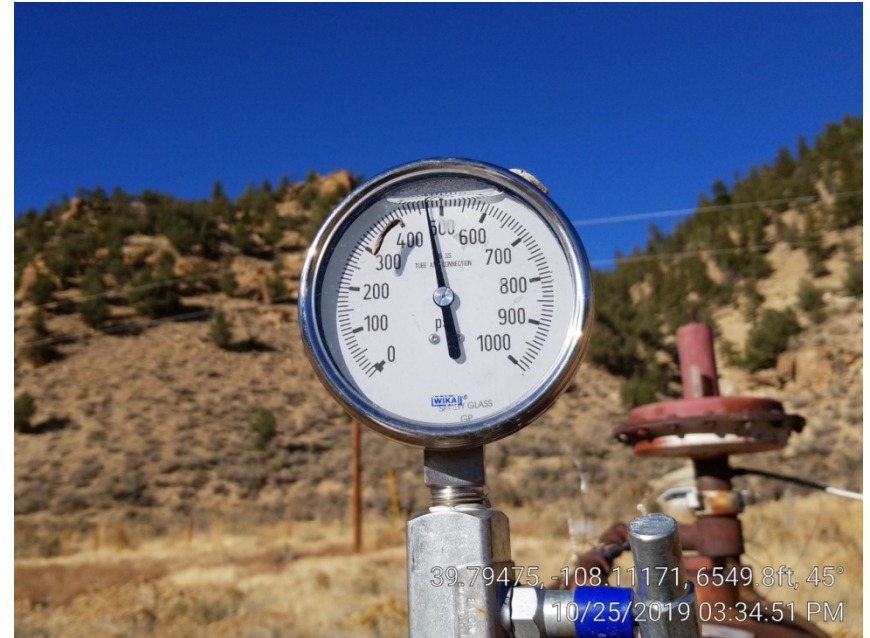
Photo 6. Gage at separator.

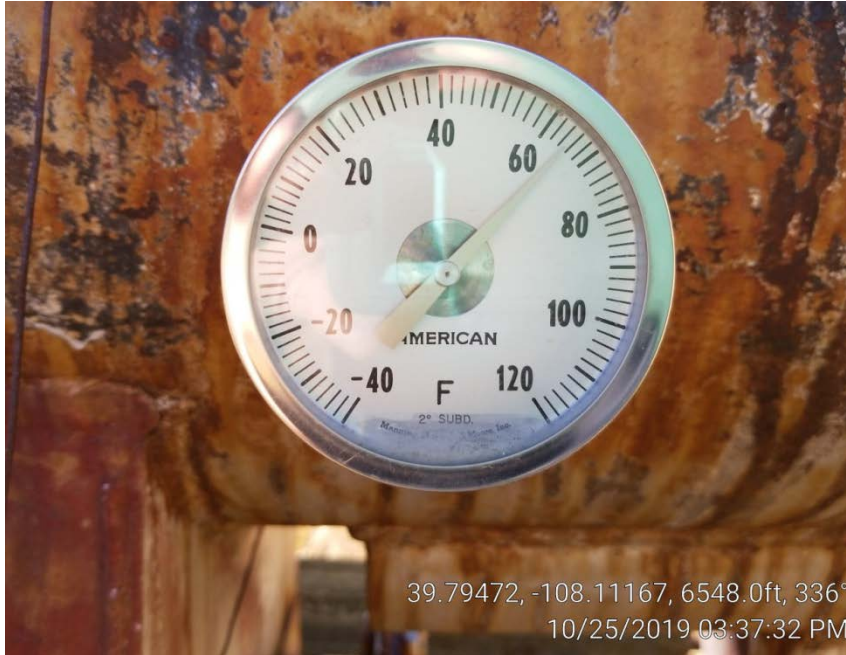
Photo 7. Gage at separator.

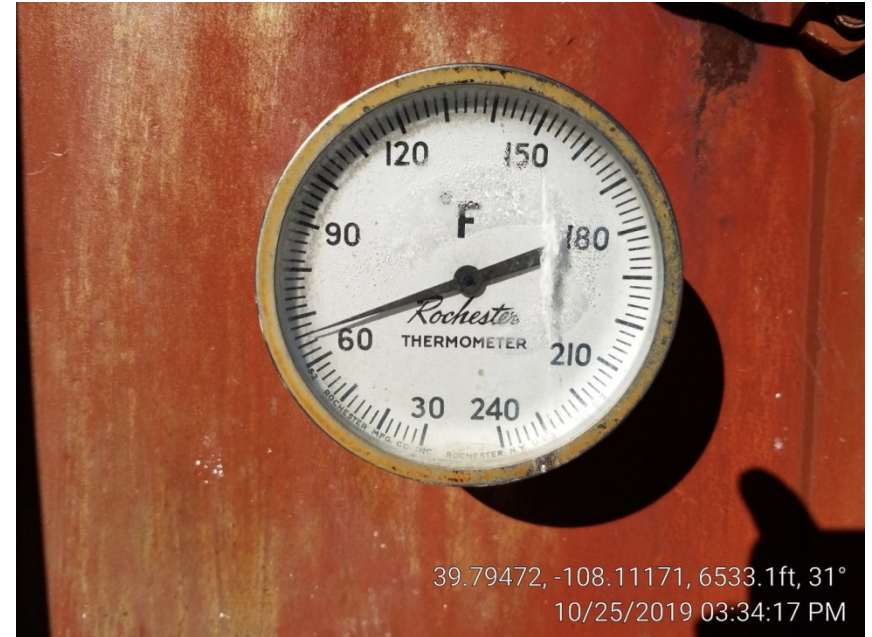
Photo 8. Gage at separator.

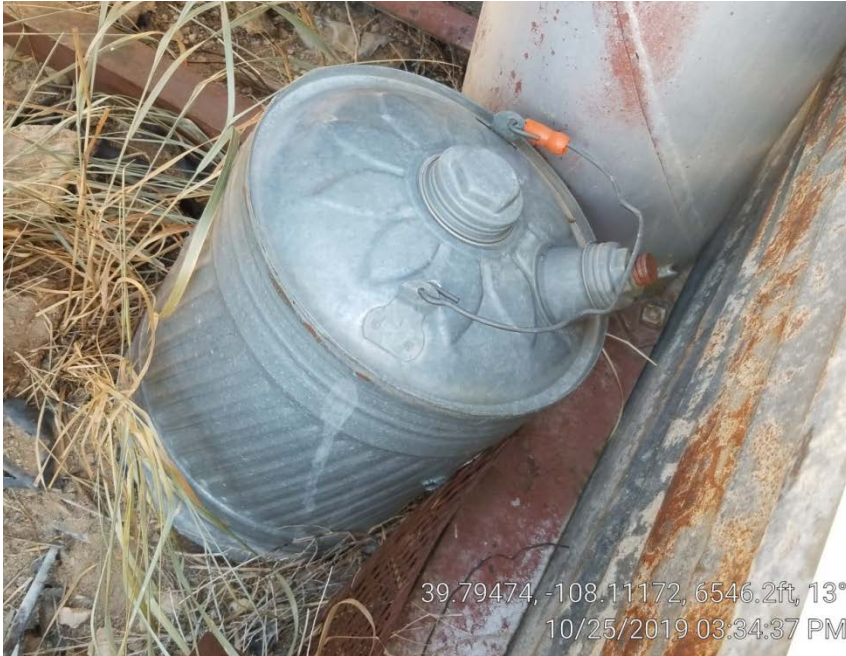
Photo 9. Container at separator.

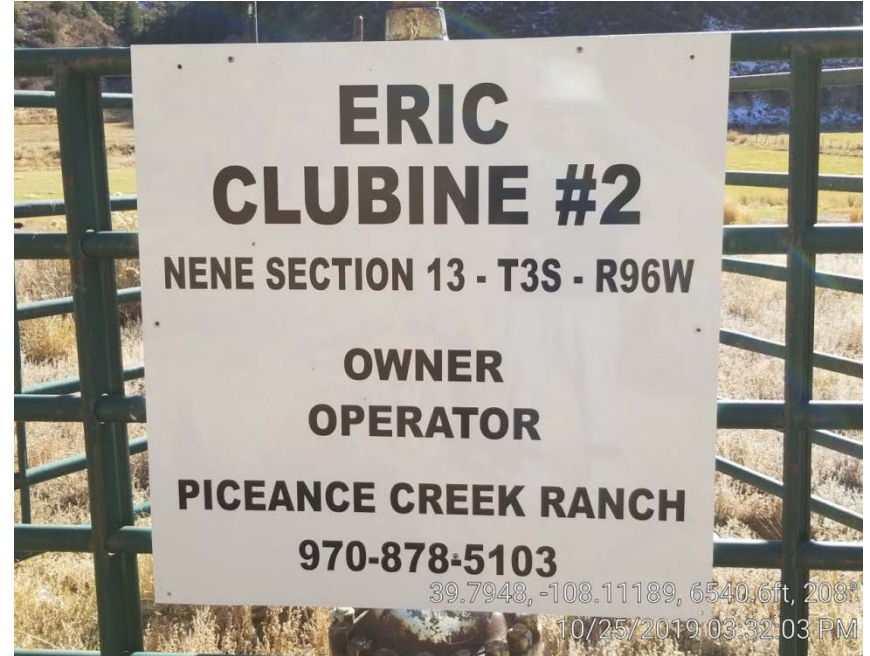
Photo 10. Well head sign.
