**Inspection Photos**  
**Location Name: Zorro #32-4**  
**Location ID: 309483**

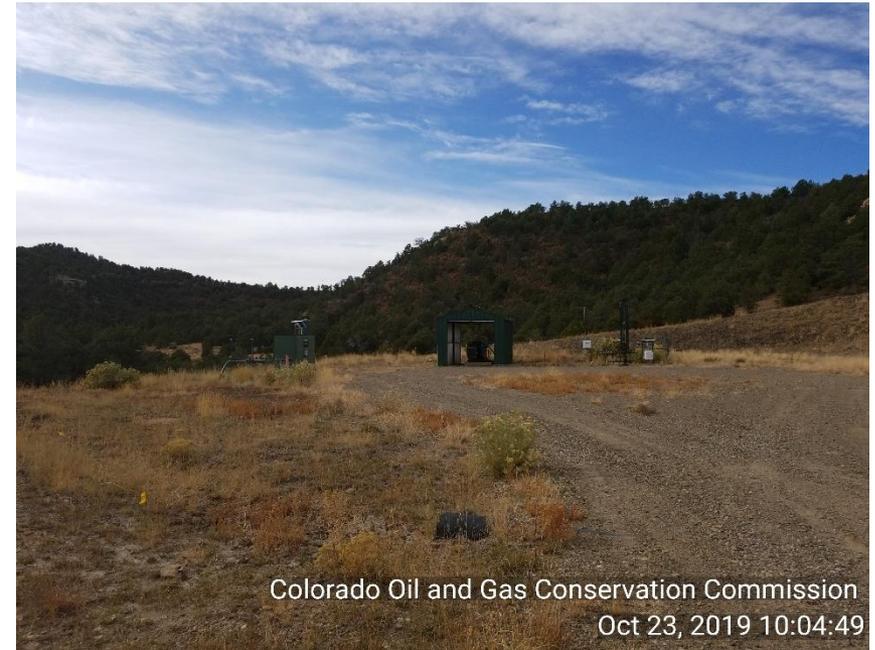
**Photo 2 loc pic Weeds on location and around pit**

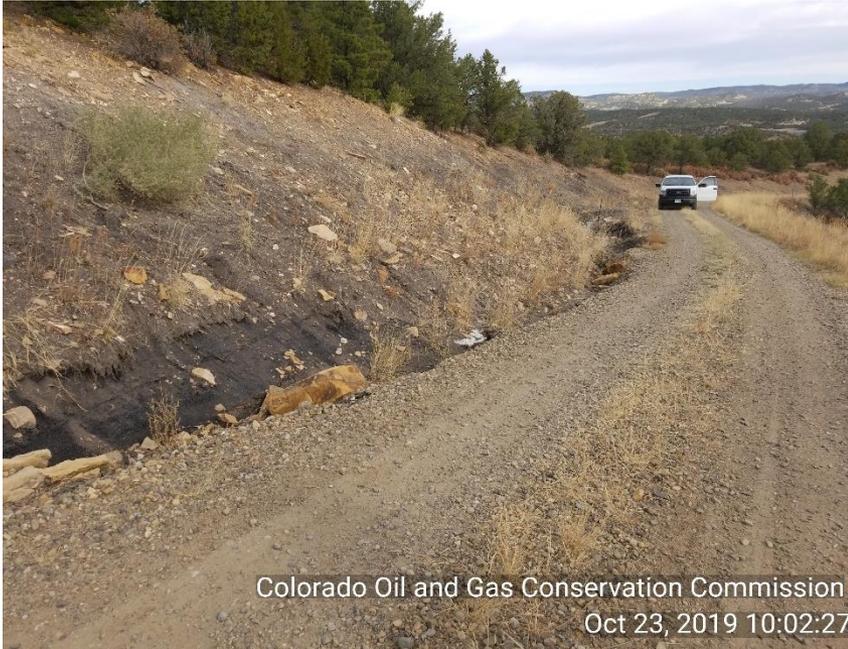
**Photo 3 BMP's not in place to control erosion on access road to location. Ditch is approx. 3ft wide in places.**

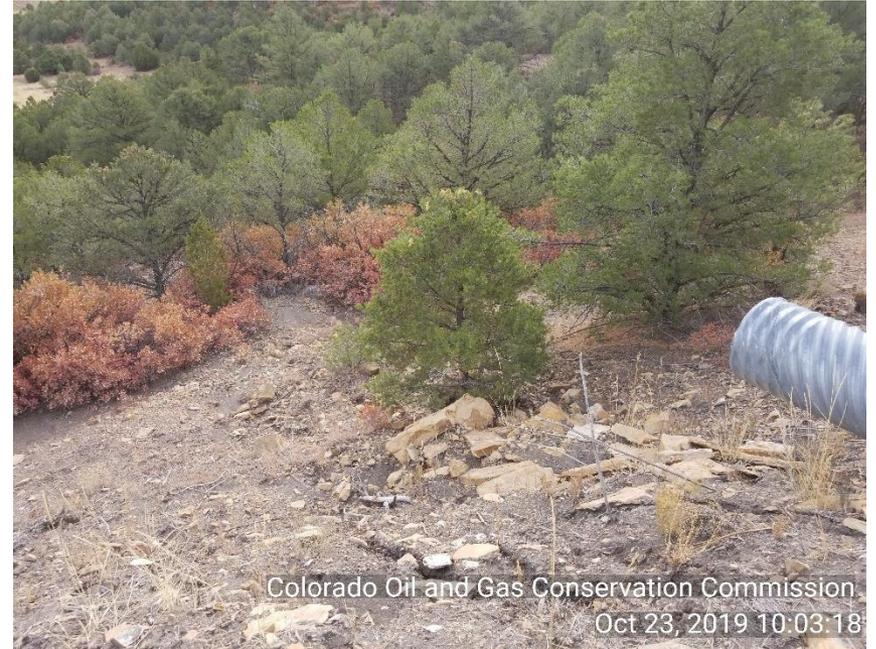
**Photo 4 Sediment from Pic 3 erosion BMP issues not controlled and being carried off rightaway.**

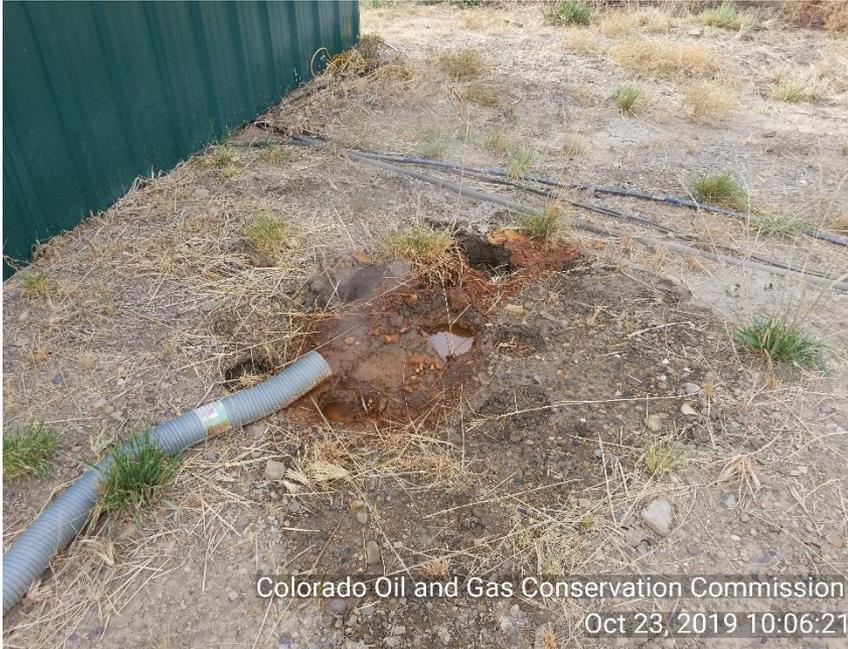
**Photo 5 Stained soil from HYD motor exhaust pipe.**

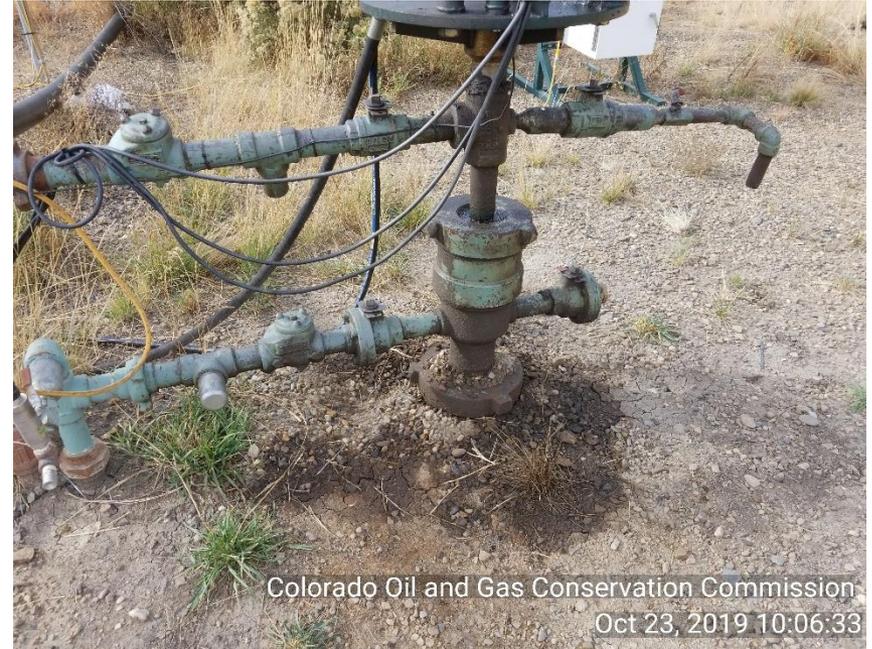
**Photo 6 Mechanical issues and stained soil around well head**
