Inspection Photos
Location Name: Abeyta #17-1
API: 05-067-05064

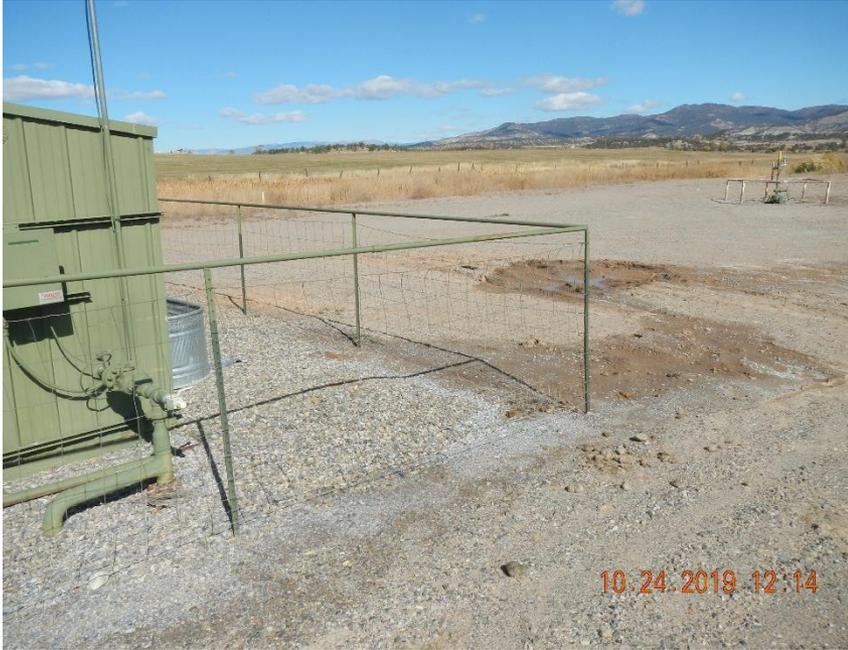
Damp area on location from separator to low spot on location.

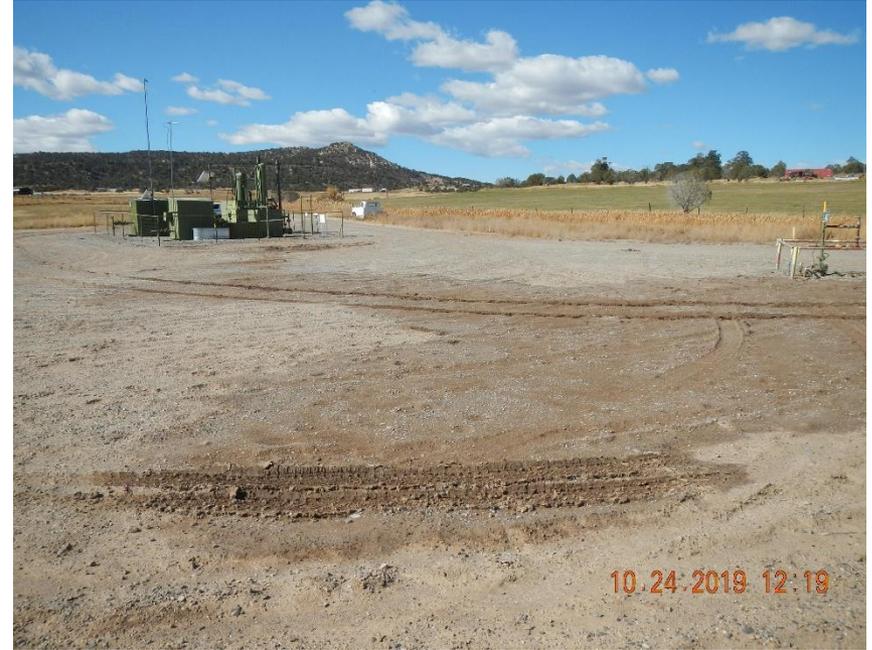
Low lying area on location with wet soil.

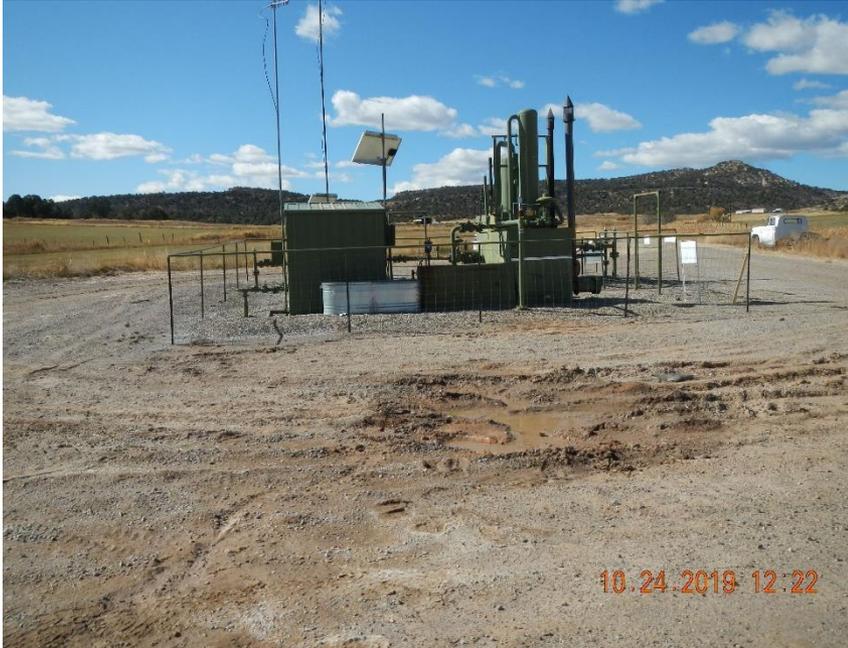
Standing water along flow path of release.

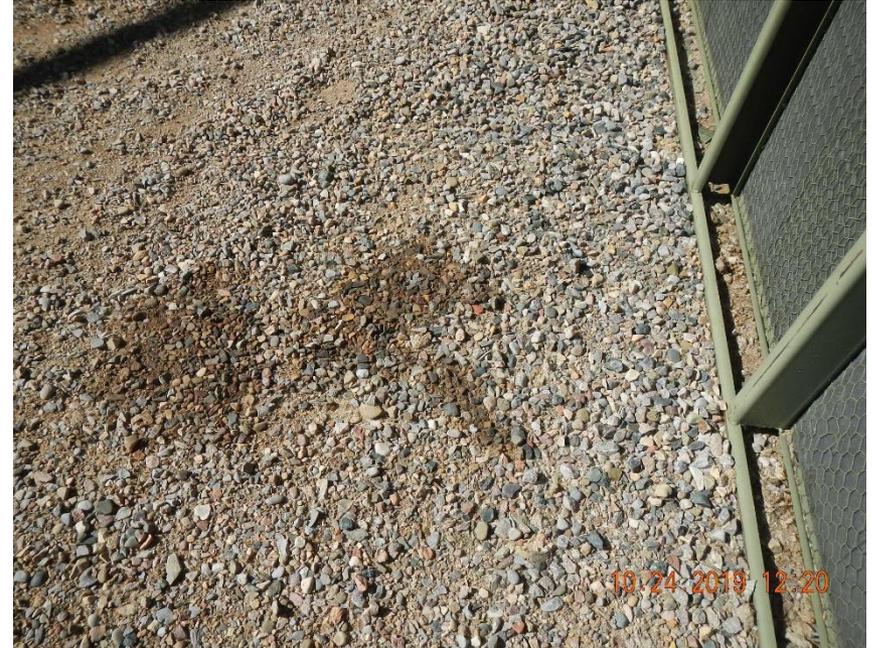
Stained soil and gravel within sound walls for pump jack.

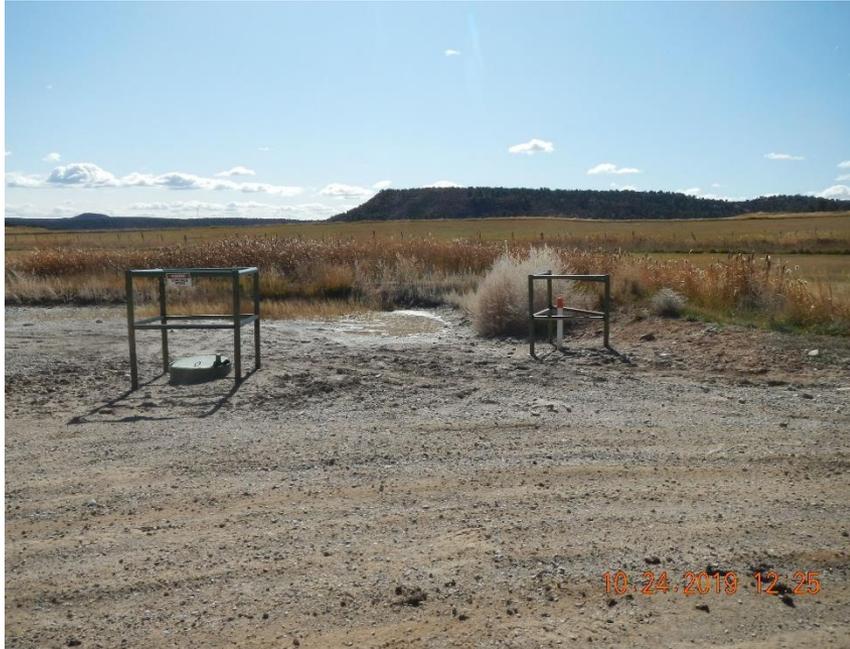
Standing water on location.

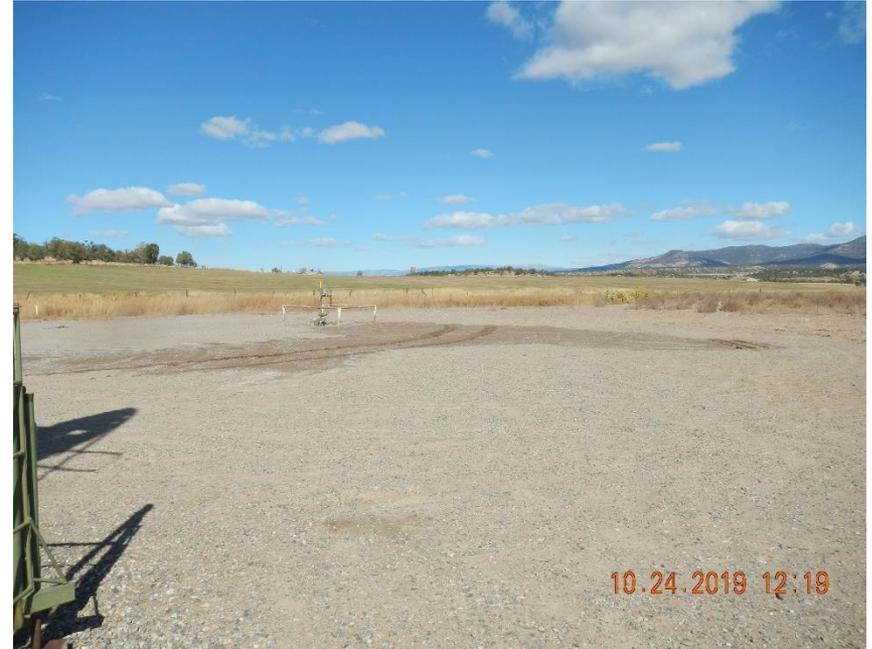
Low lying area near well head where release terminated.
