**Inspection Photos**  
**Location Name: Allison Unit #116S**  
**API: 05-067-09289**

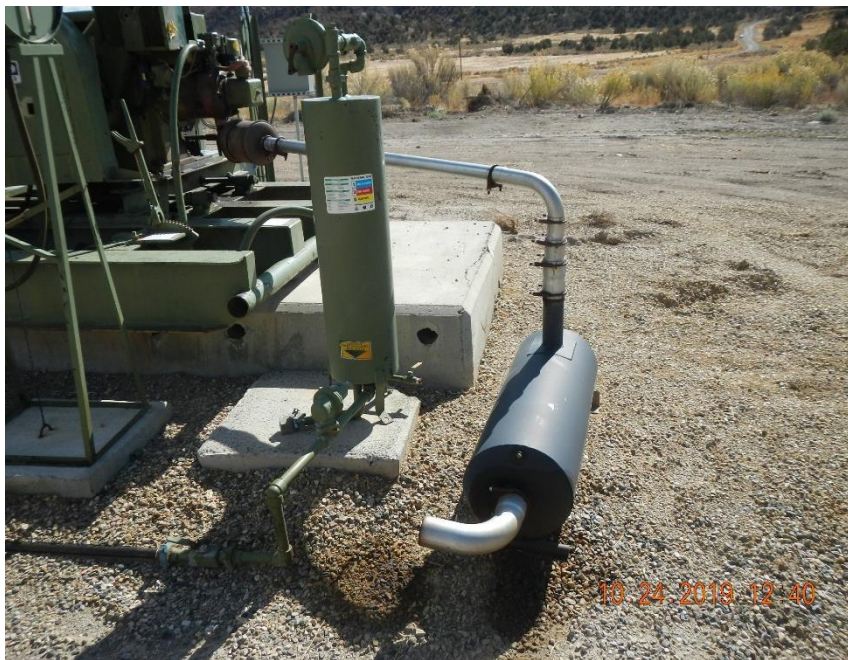
**Stained gravel at exhaust outlet for prime mover.**

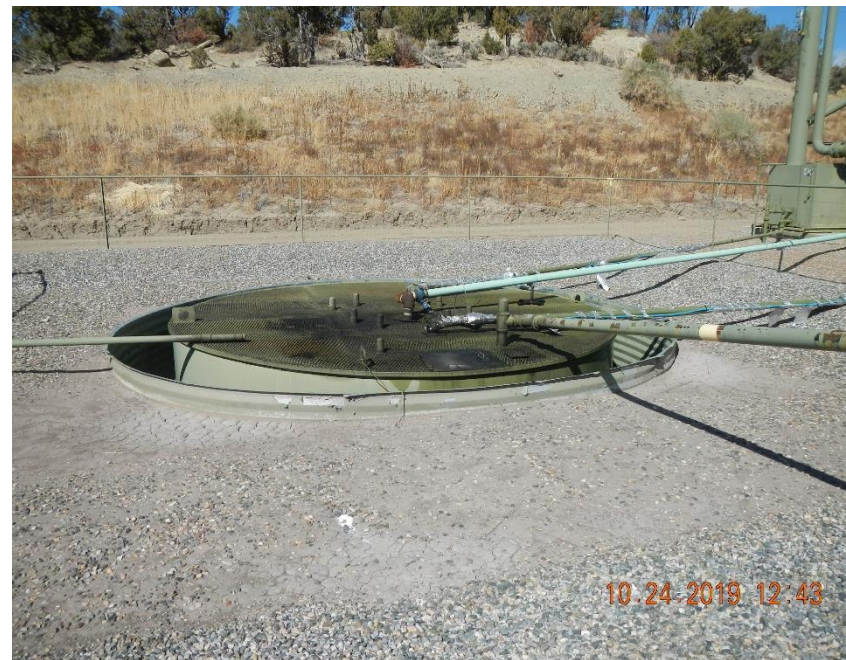
**Open topped below grade tank is not labeled.**

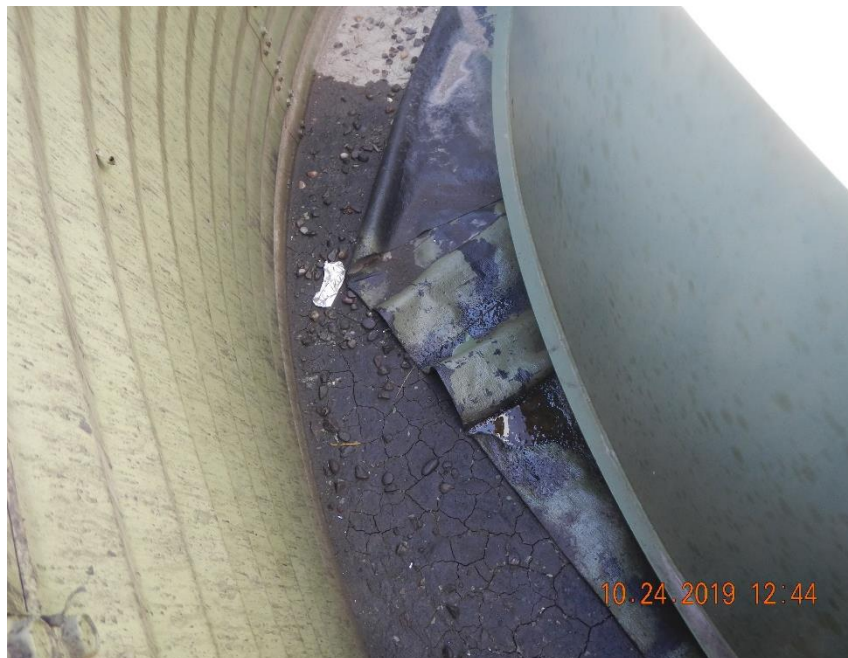
**Soil within cellar for below grade tank is wet and stained.**

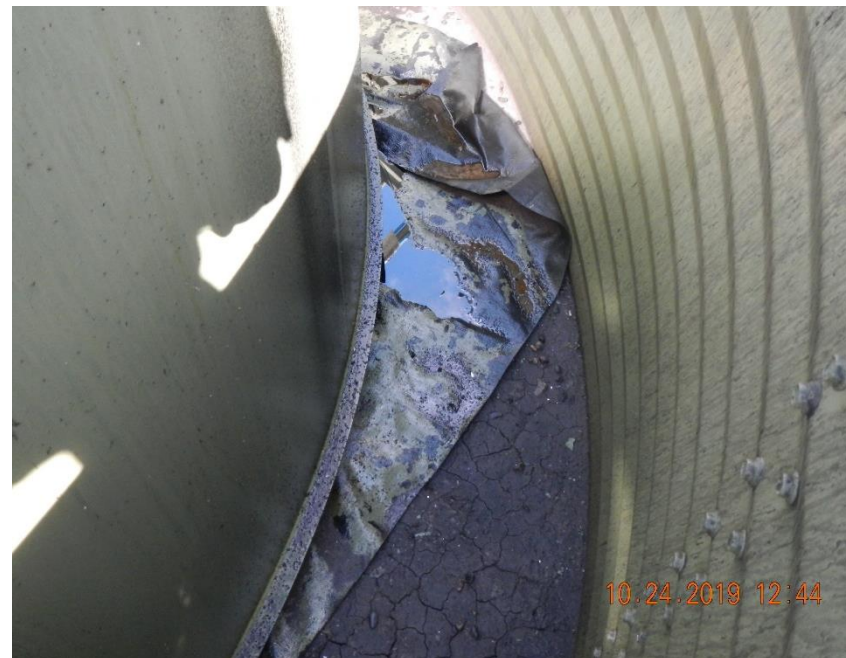
**Fluids and stained soil present within cellar for below grade tank.**

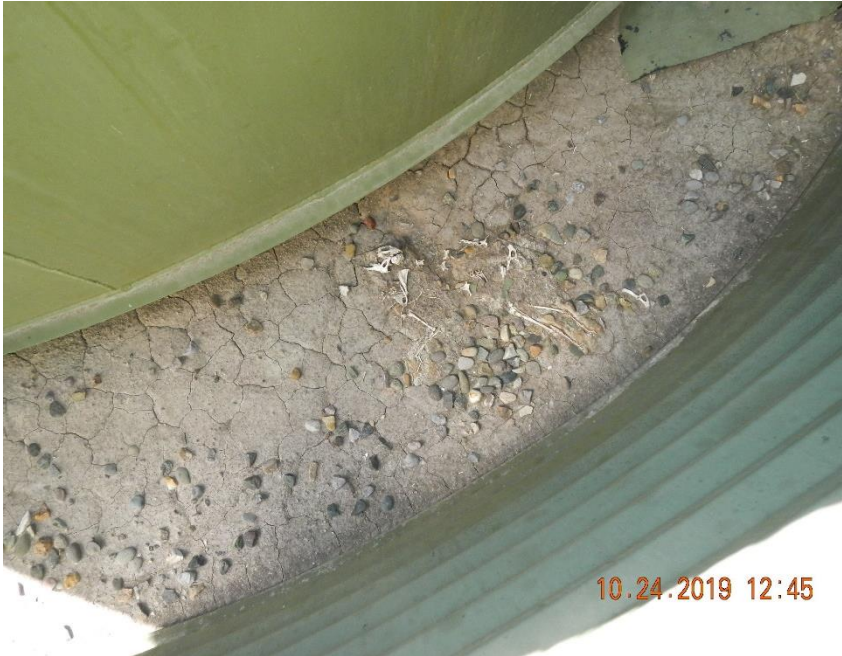
**Skeletal remains within cellar for below grade tank.**

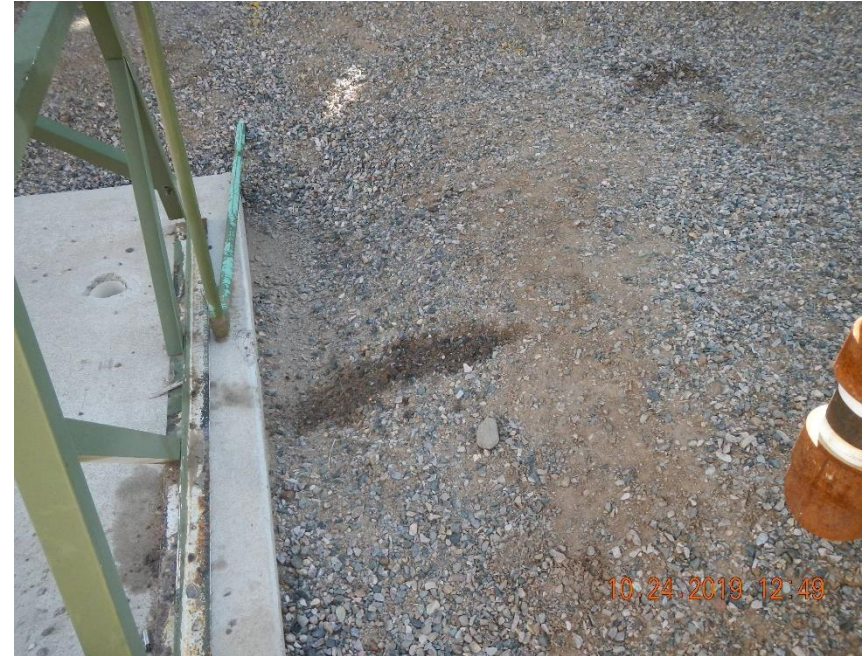
**Stained gravel beneath valve on lube oil container.**
