Inspection Photos
Location Name: Fuqua 18-15
Location 324766

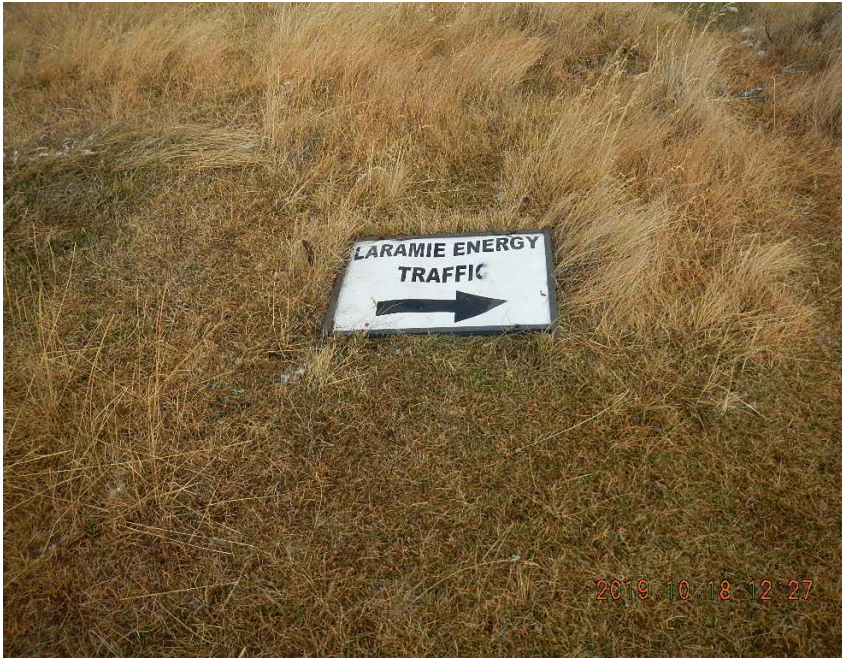
Direction sign to Location 324766.

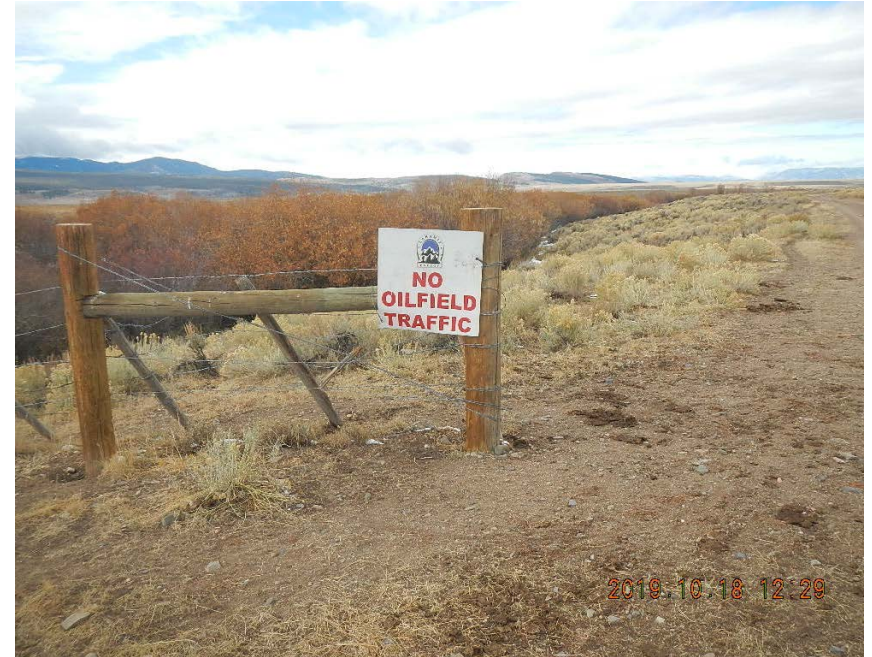
Direction sign to Location 324766.

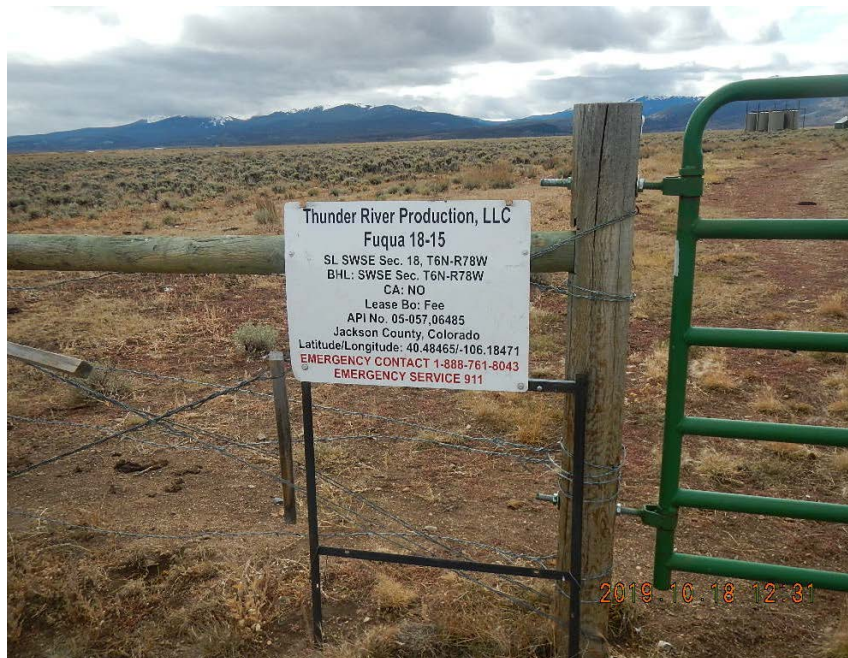
Location Sign.

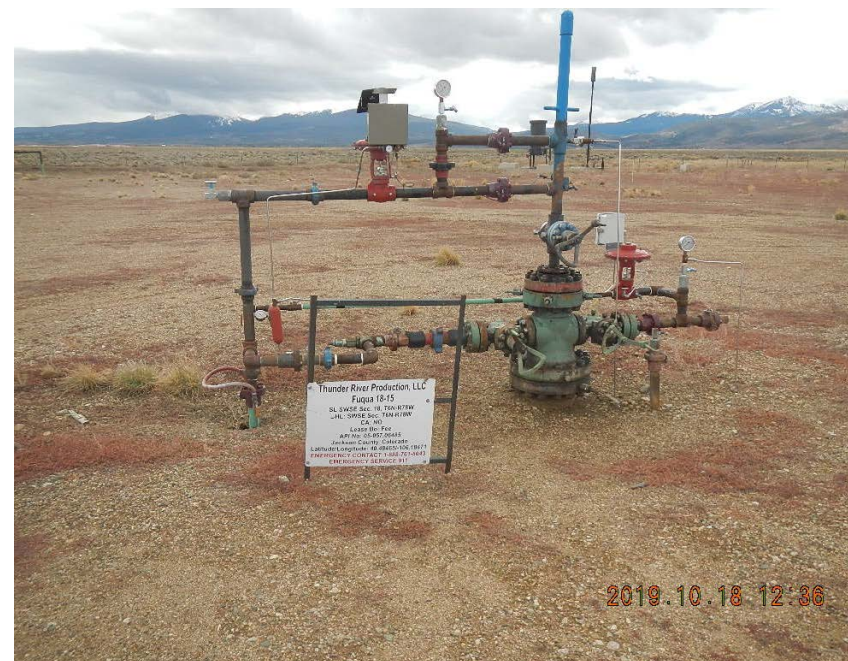
Wellhead Sign.

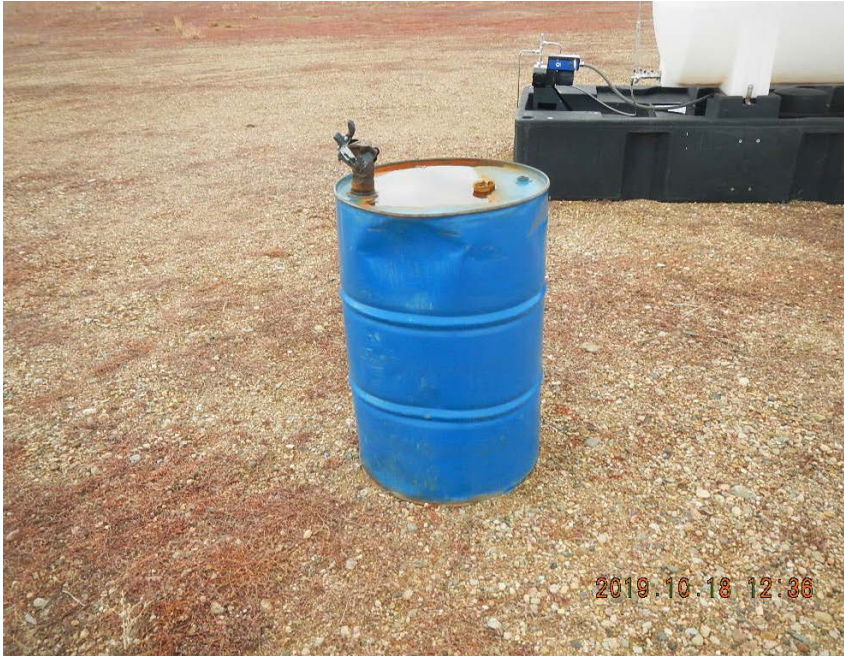
Unmarked drum.

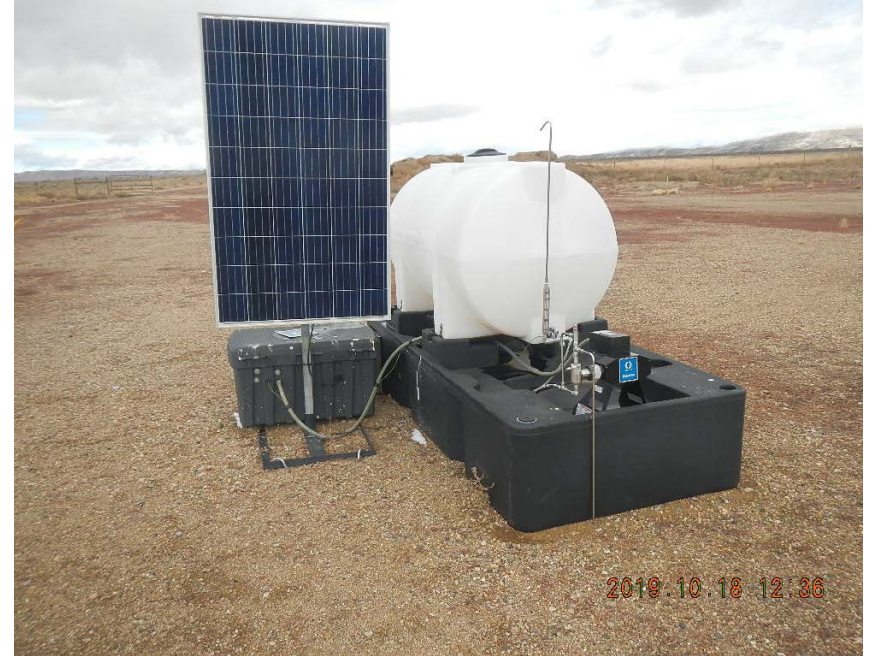
Unmarked chemical storage unit.

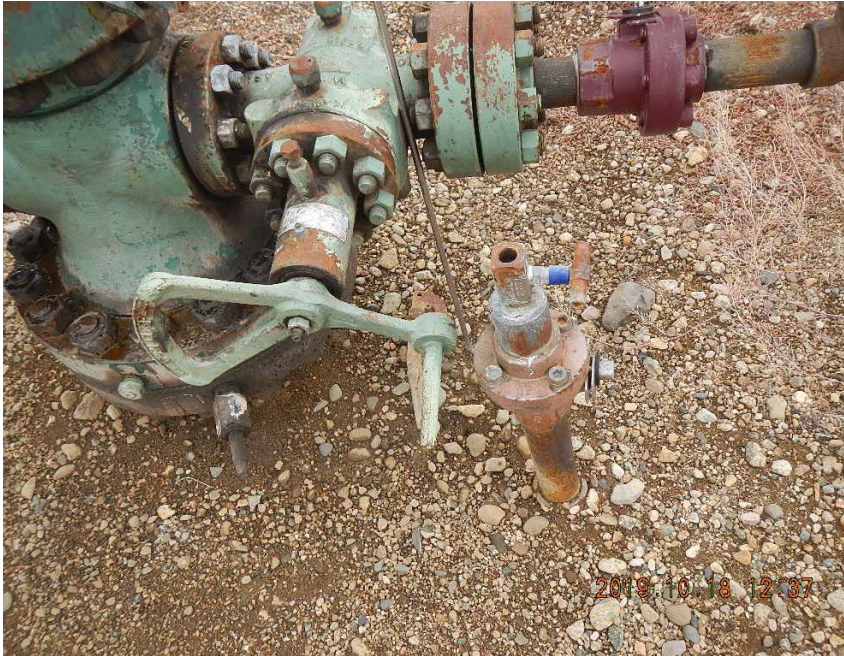
Unmarked and not cap riser.

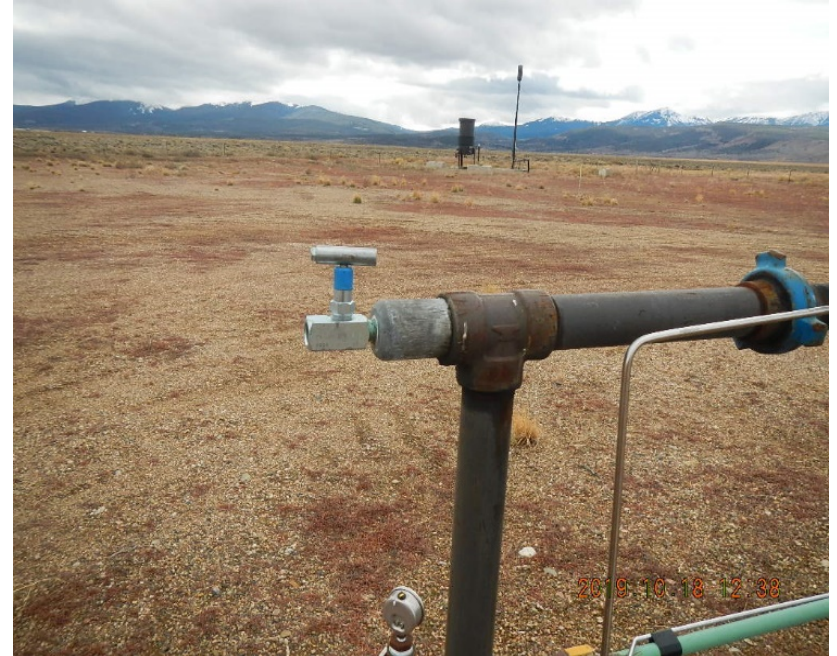
Needle valve not capped.

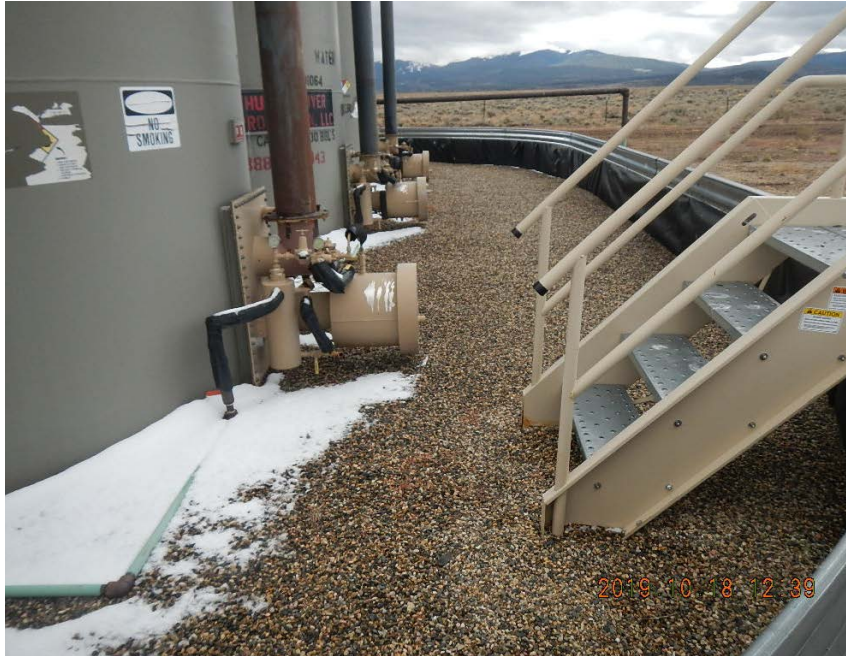
Tank battery.

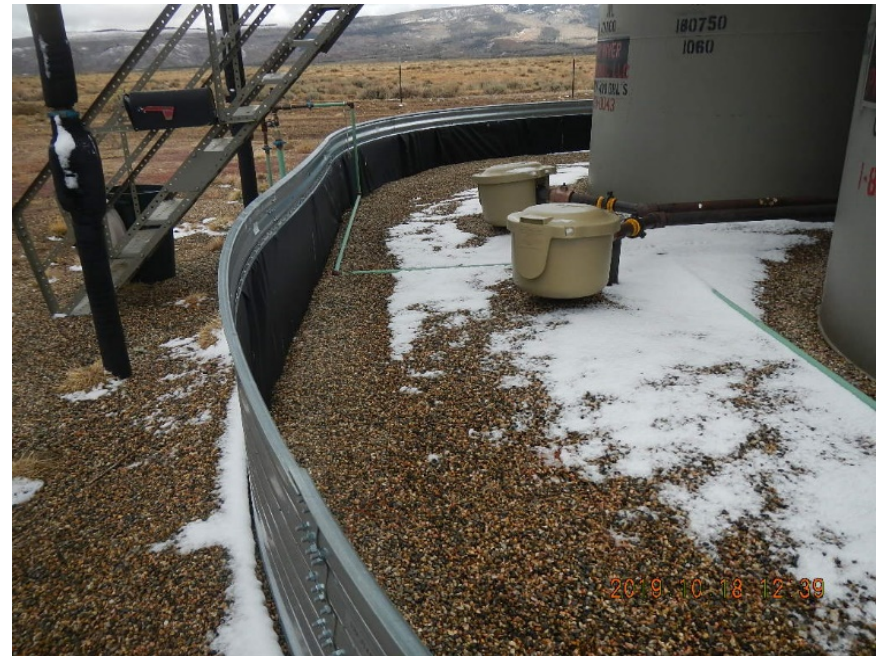
Tank battery.

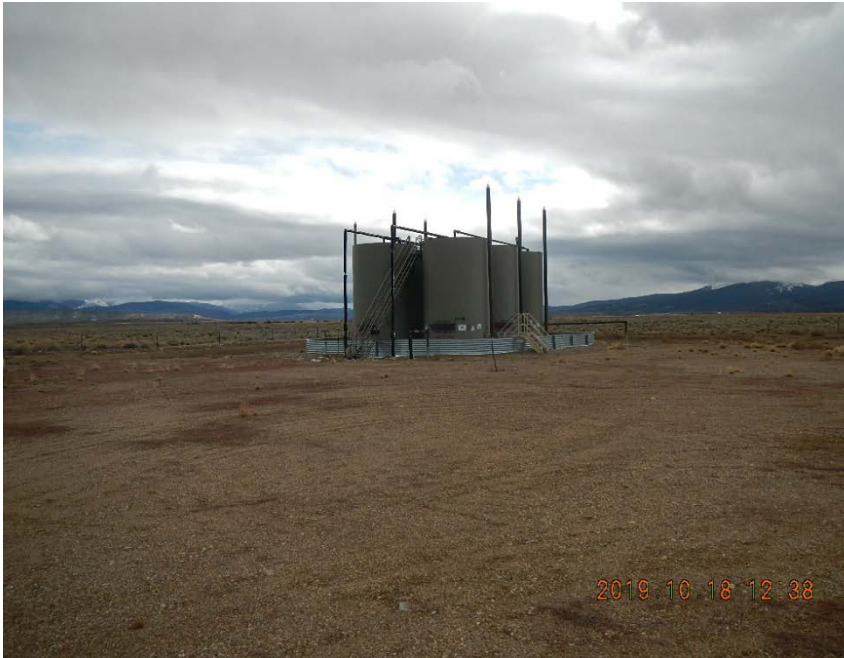
View of tank battery.

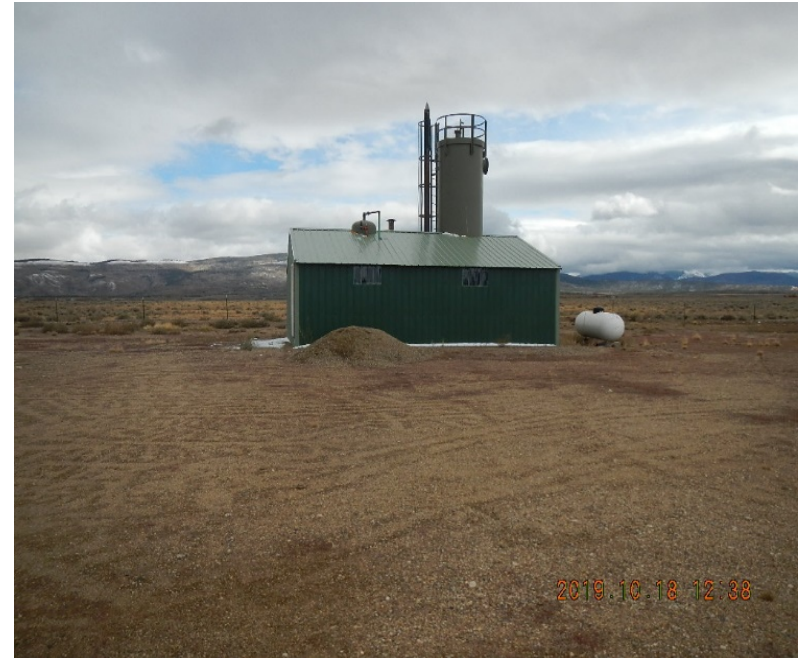
Separator enclosure.

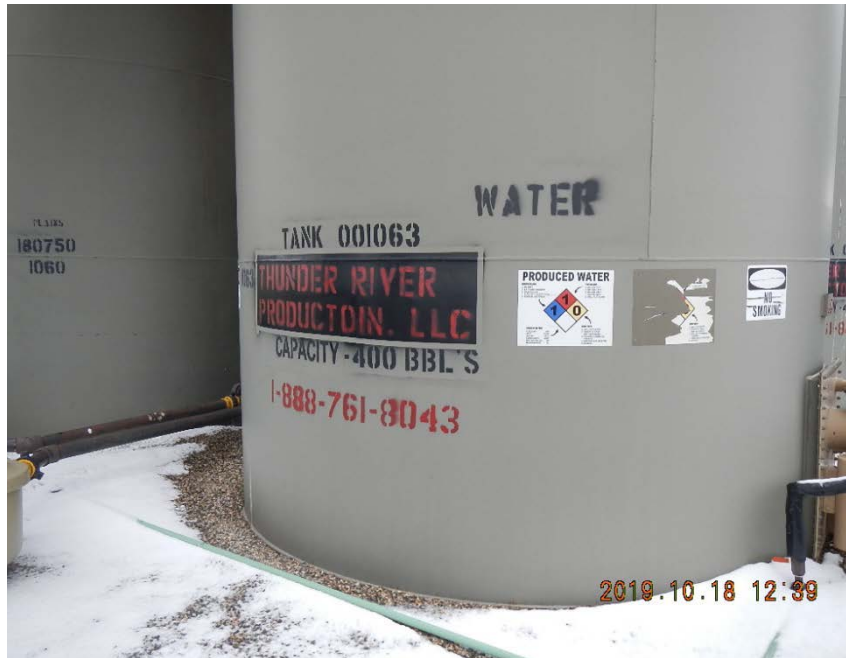
Produced water tank.

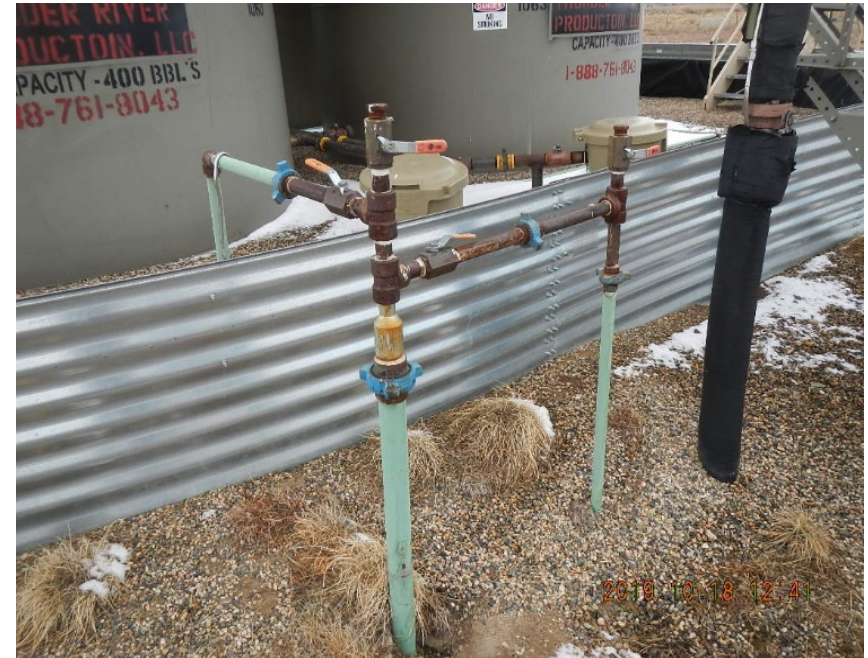
Capped risers.

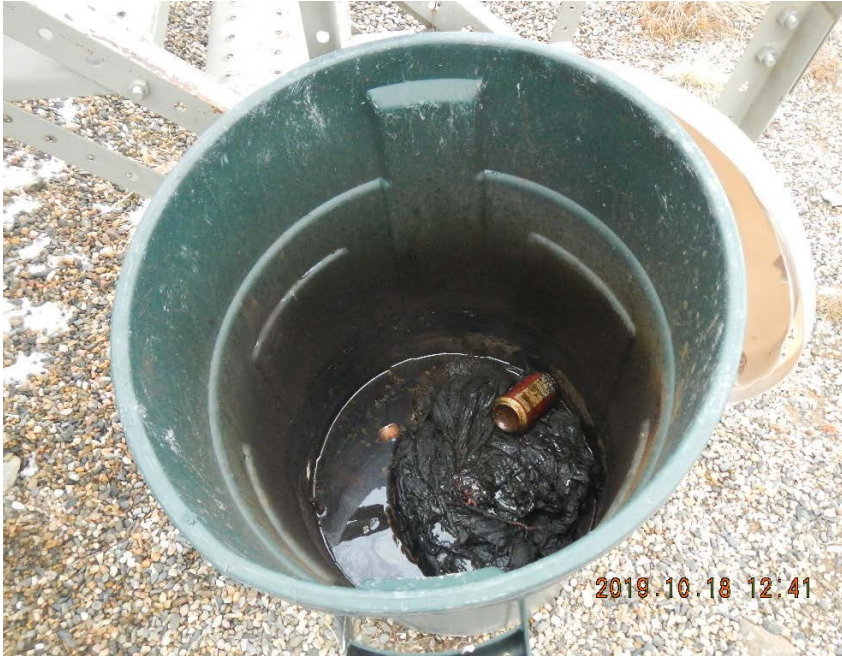
Trash can with oily rag and trash.

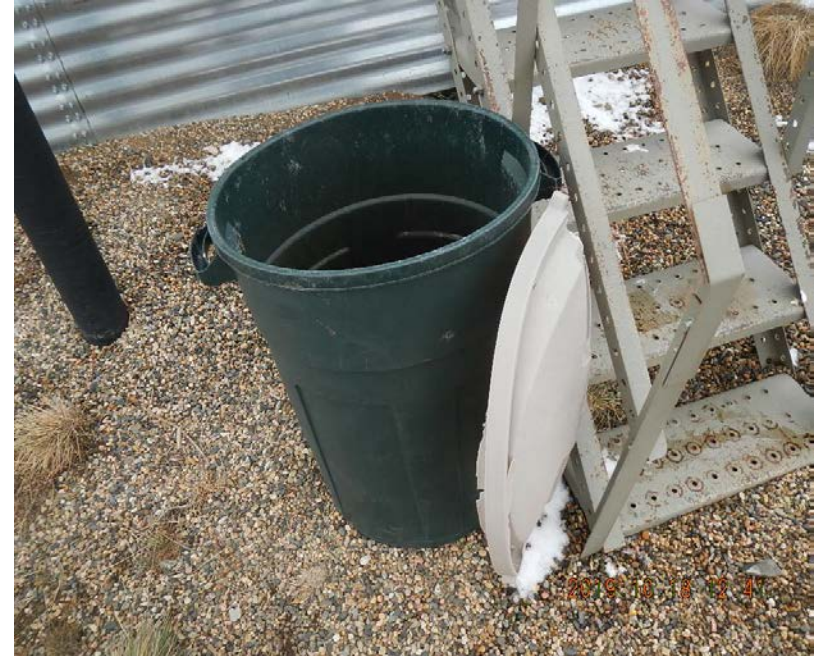
Trash can with oily rag and trash.

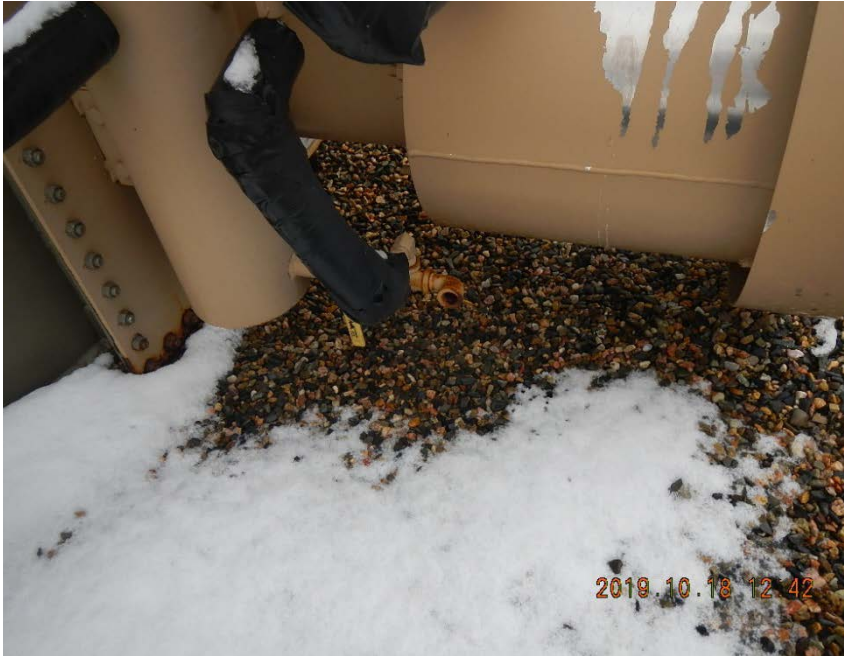
Drain valve at in-tank heater.

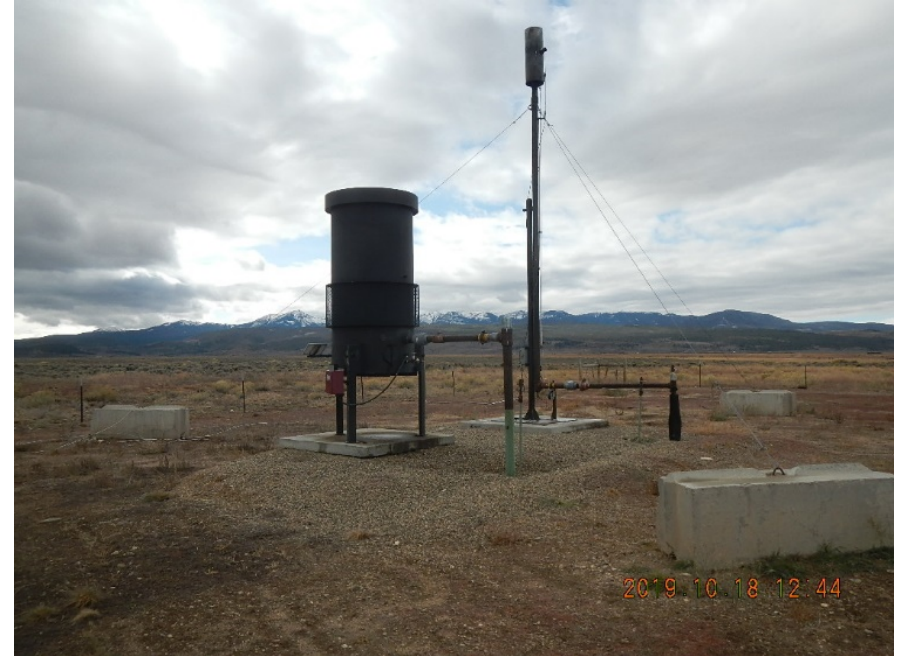
ECU and flare.

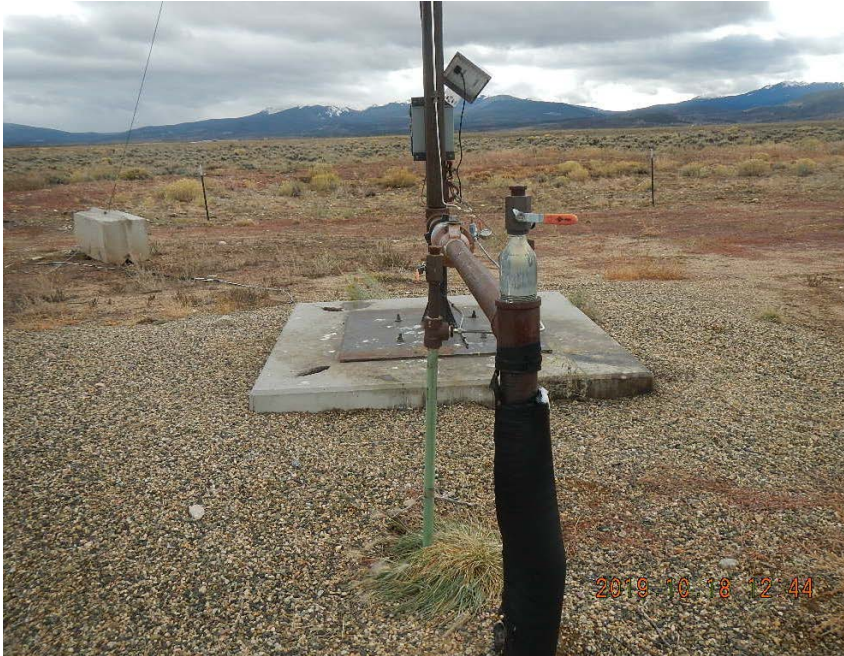
Capped riser.

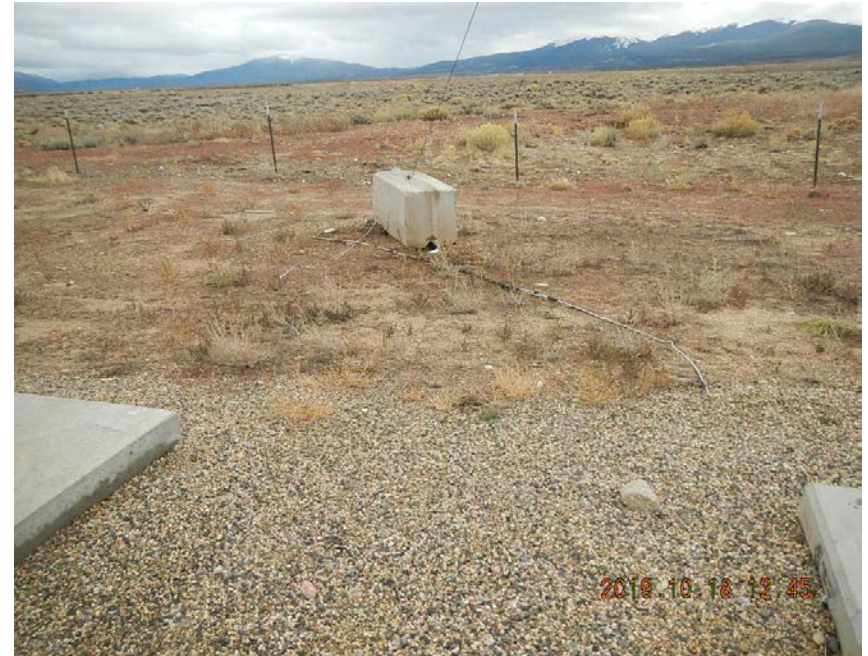
Stainless steel line is considered trash and debris.

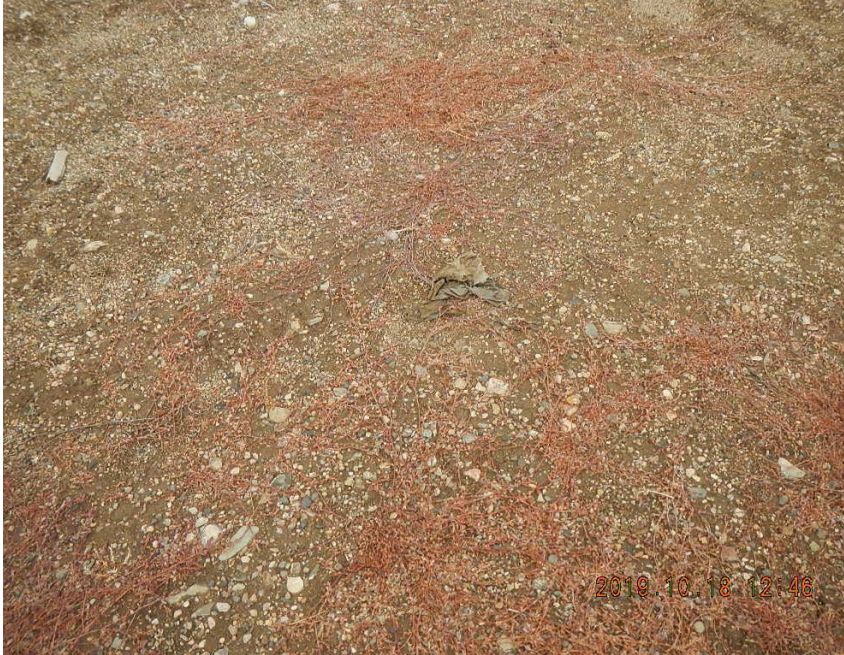
Trash and debris (rag).

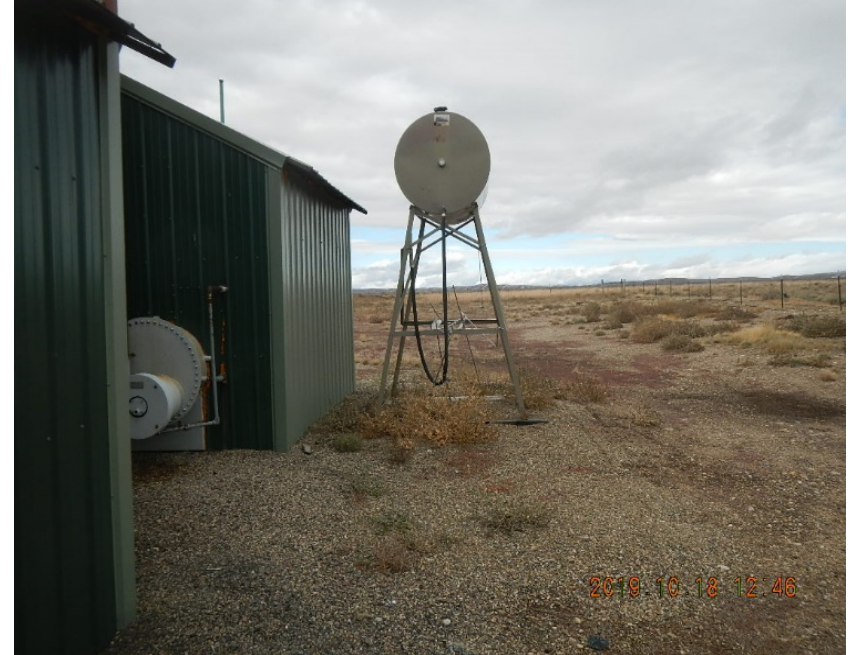
Unlabeled AST

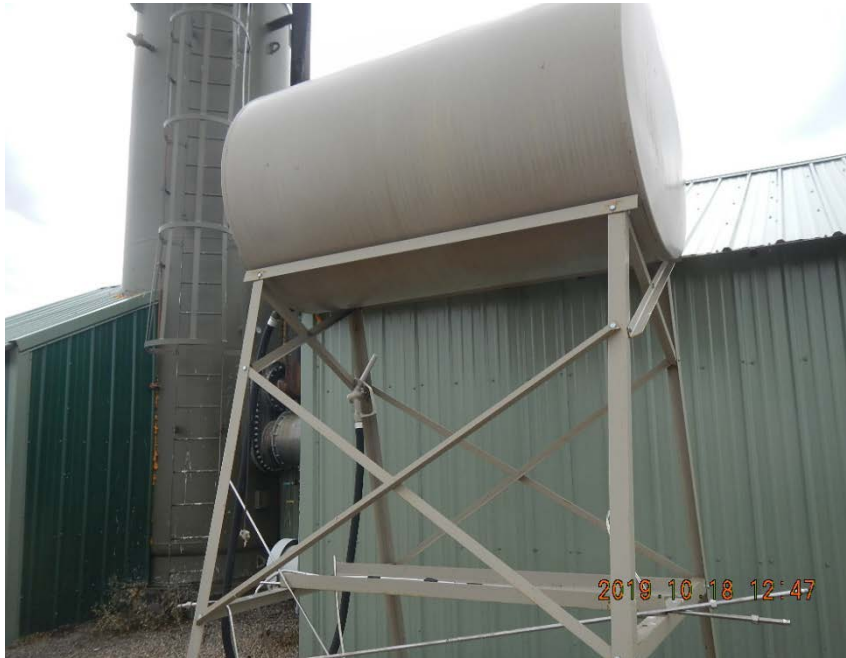
Unlabeled AST

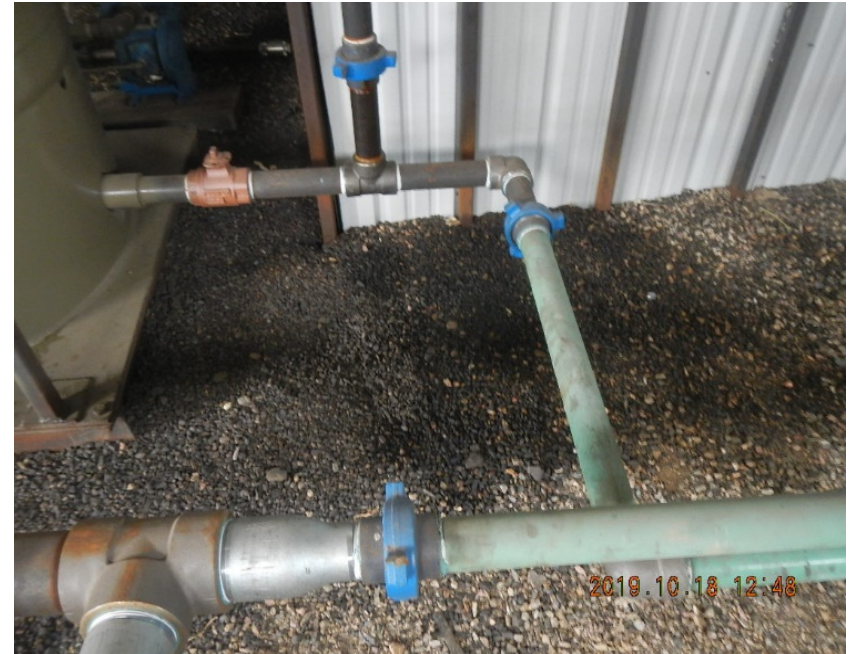
Oily staining in separator enclosure.

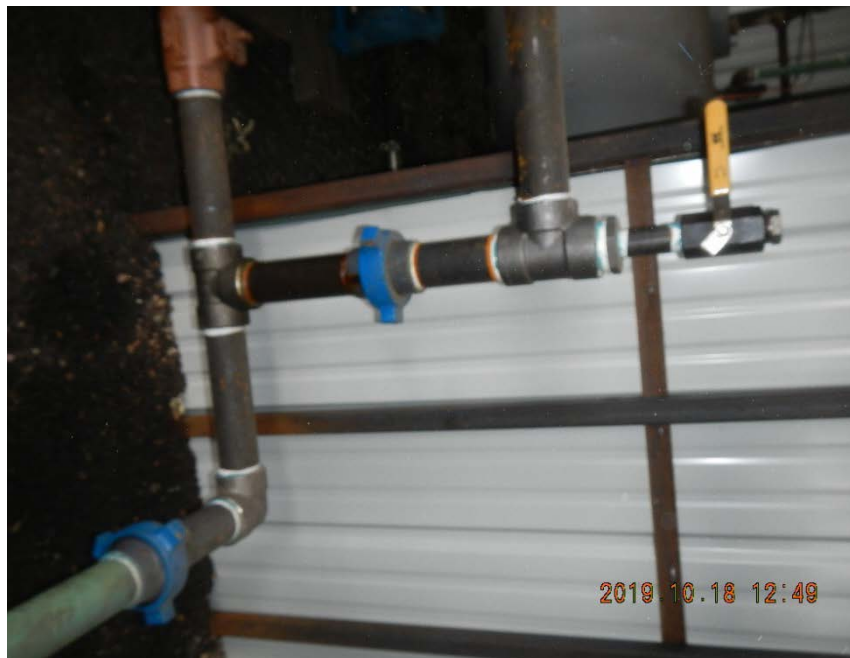
Blue hammer union weeping fluids.

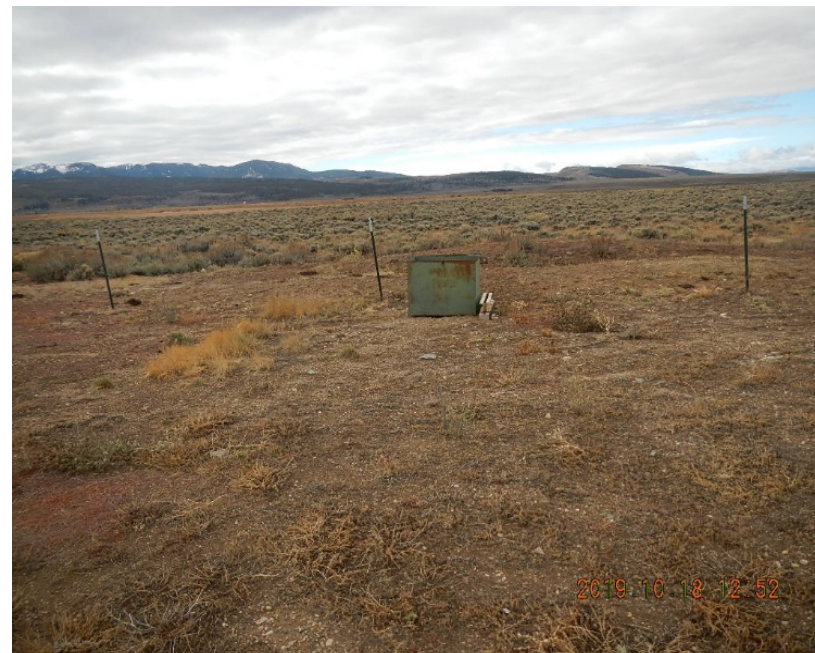
Metal container in NW corner of Location with trash and debris.

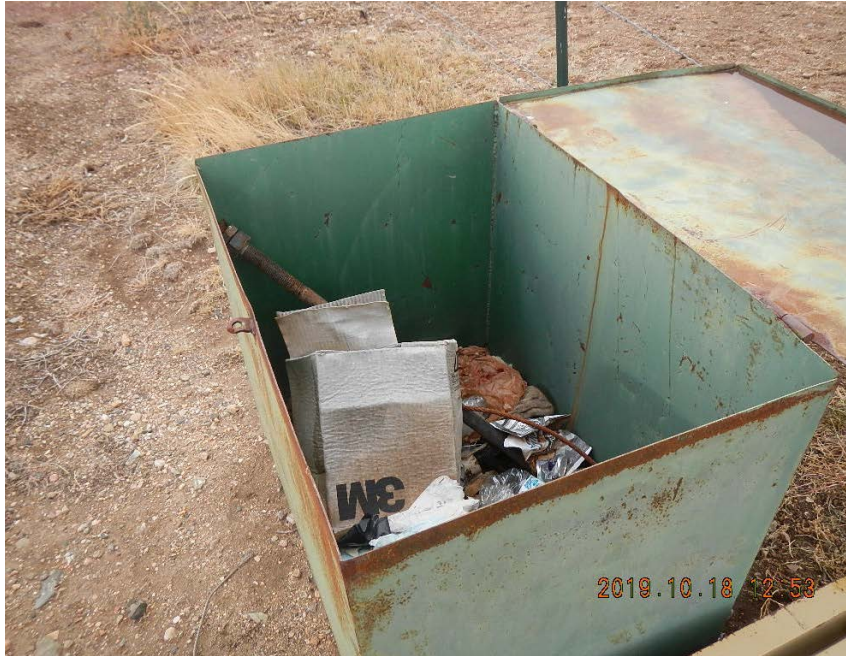
Metal container in NW corner of Location with trash and debris.

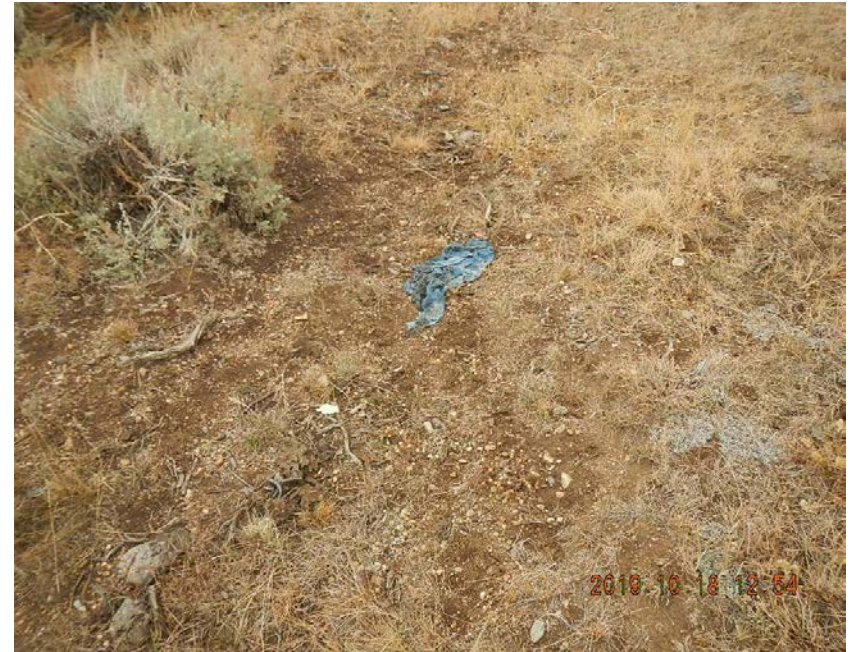
Trash (rag).
