Inspection Photos

API: 05-071-06339

Operator: TIMBER CREEK OPERATING LLC

Inspection Date: 10/30/2019

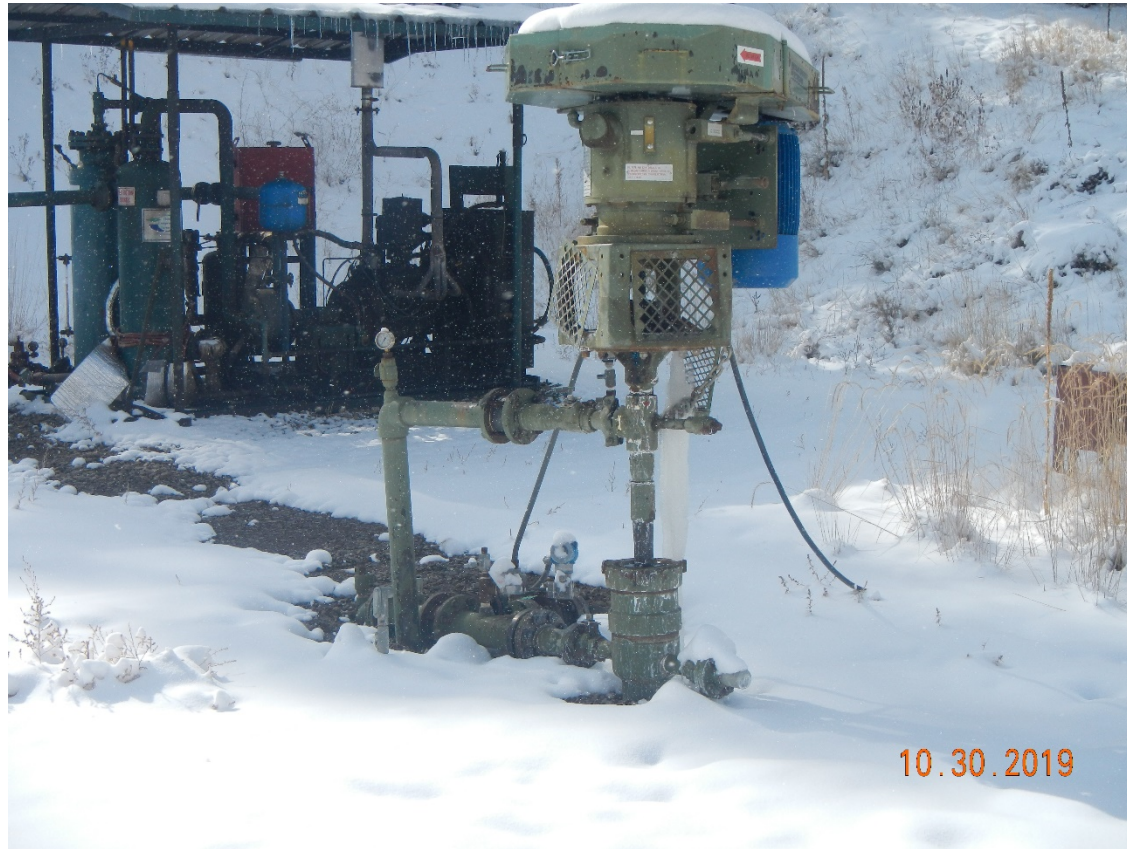
Photo 1. There is water leaking from the well head. There is ice buildup around the wellhead and water dripping. Corrective action was not properly performed.
