Inspection Photos

API: 05-071-06300

Operator: TIMBER CREEK OPERATING LLC

Inspection Date: 10/30/2019

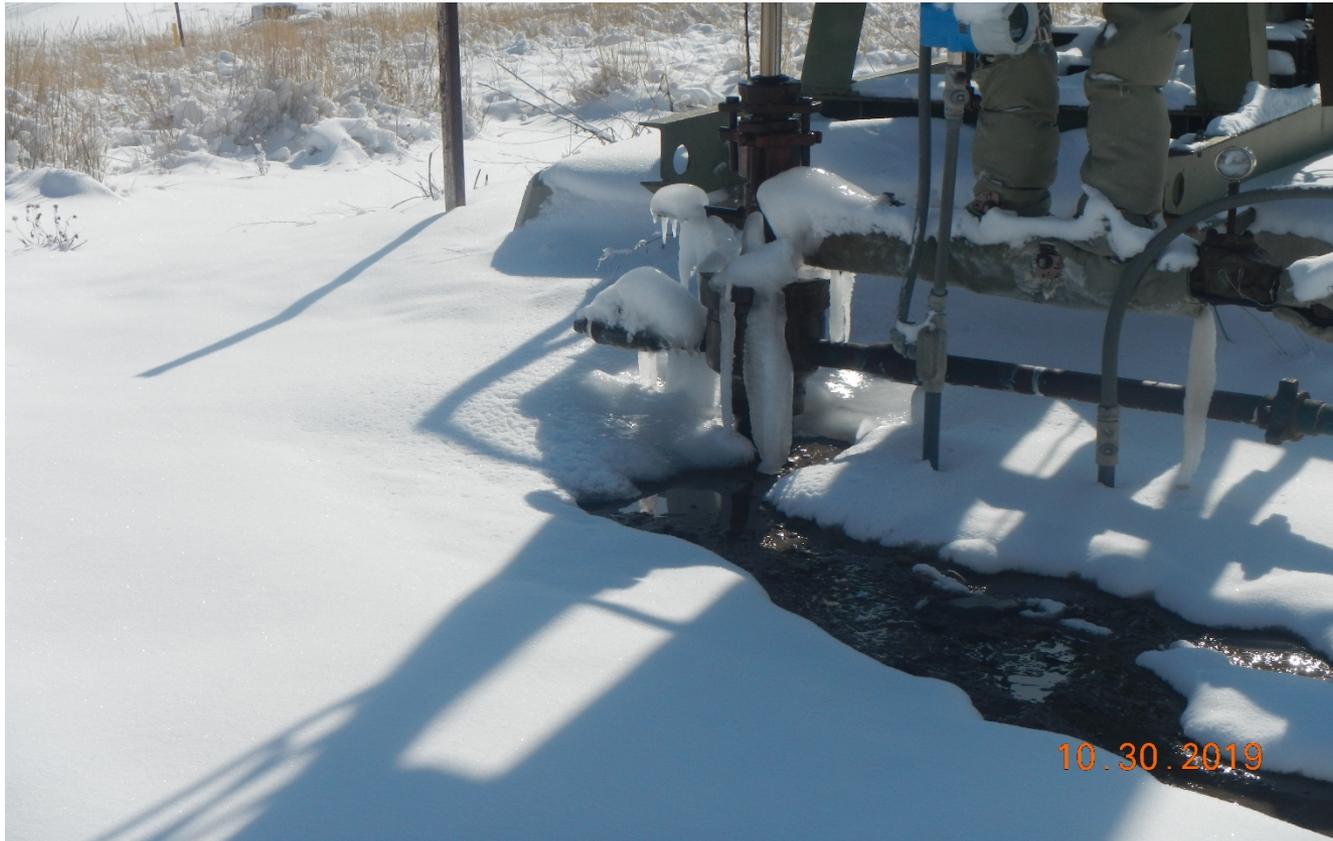
Photo 1. There is water leaking from the well head. There is ice buildup around the wellhead and water dripping.

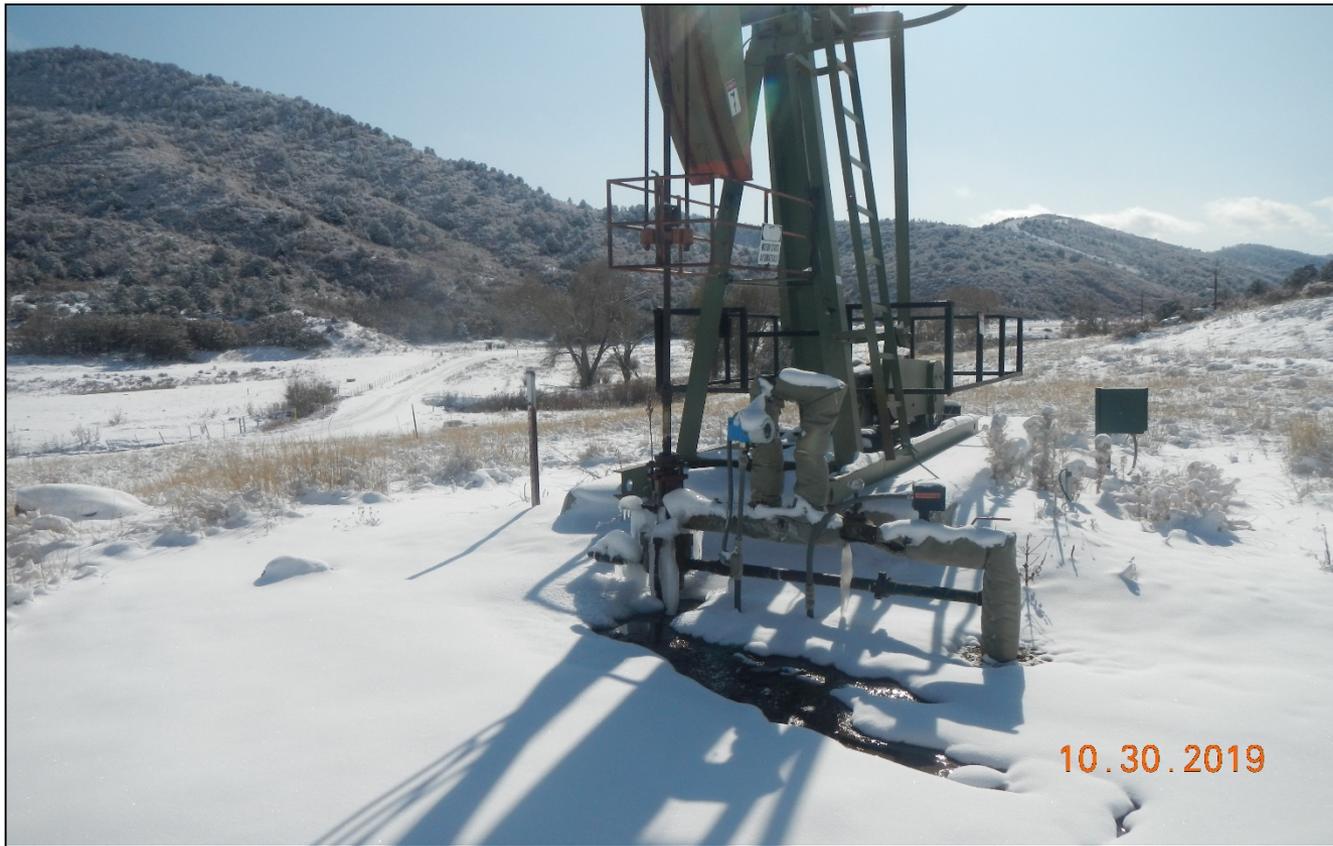
Photo 2. Facing toward the wellhead.

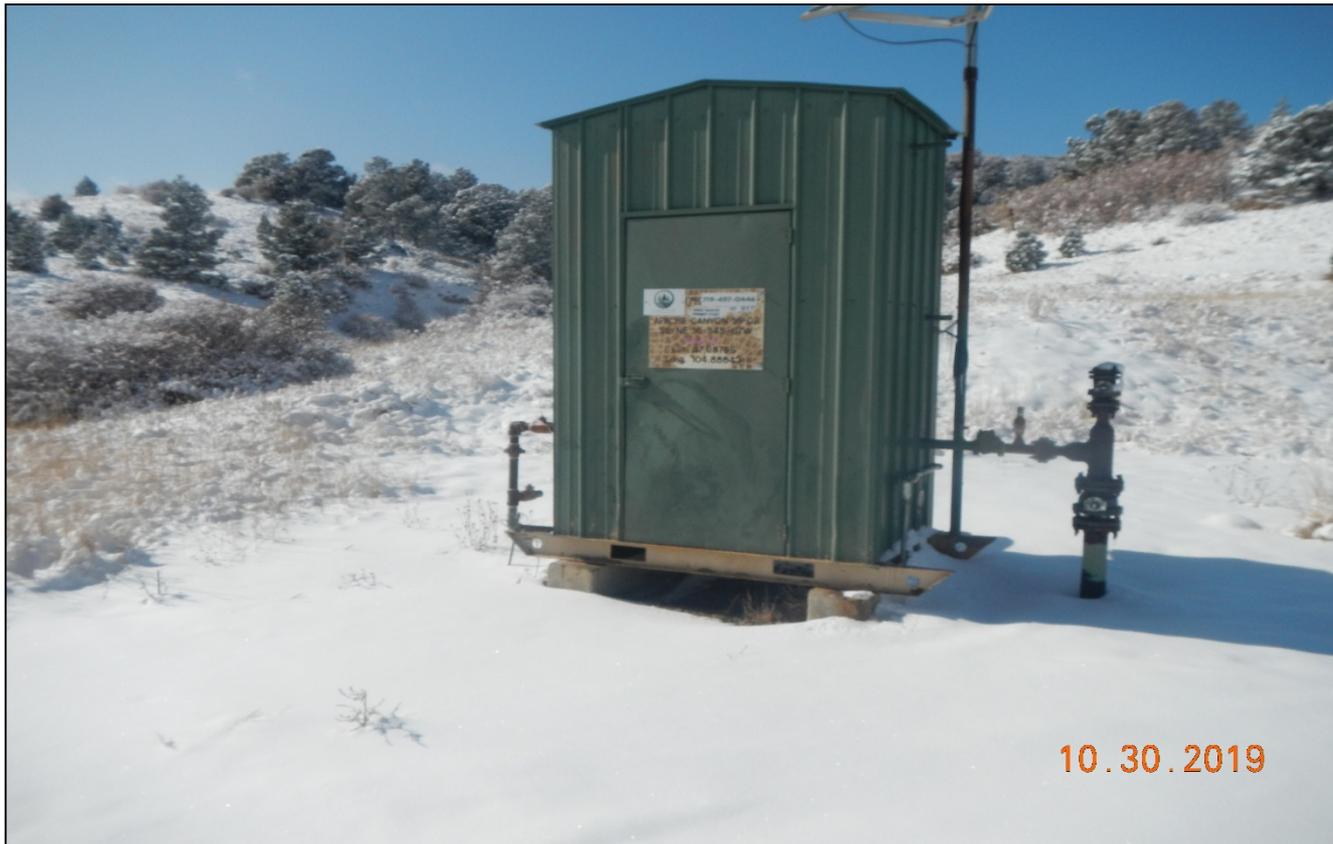
Photo 3. Well sign is posted.
