Inspection Photos

Operator: Benson Montin Greer
Location/API #: 067-05805 Date:
10-24-2019

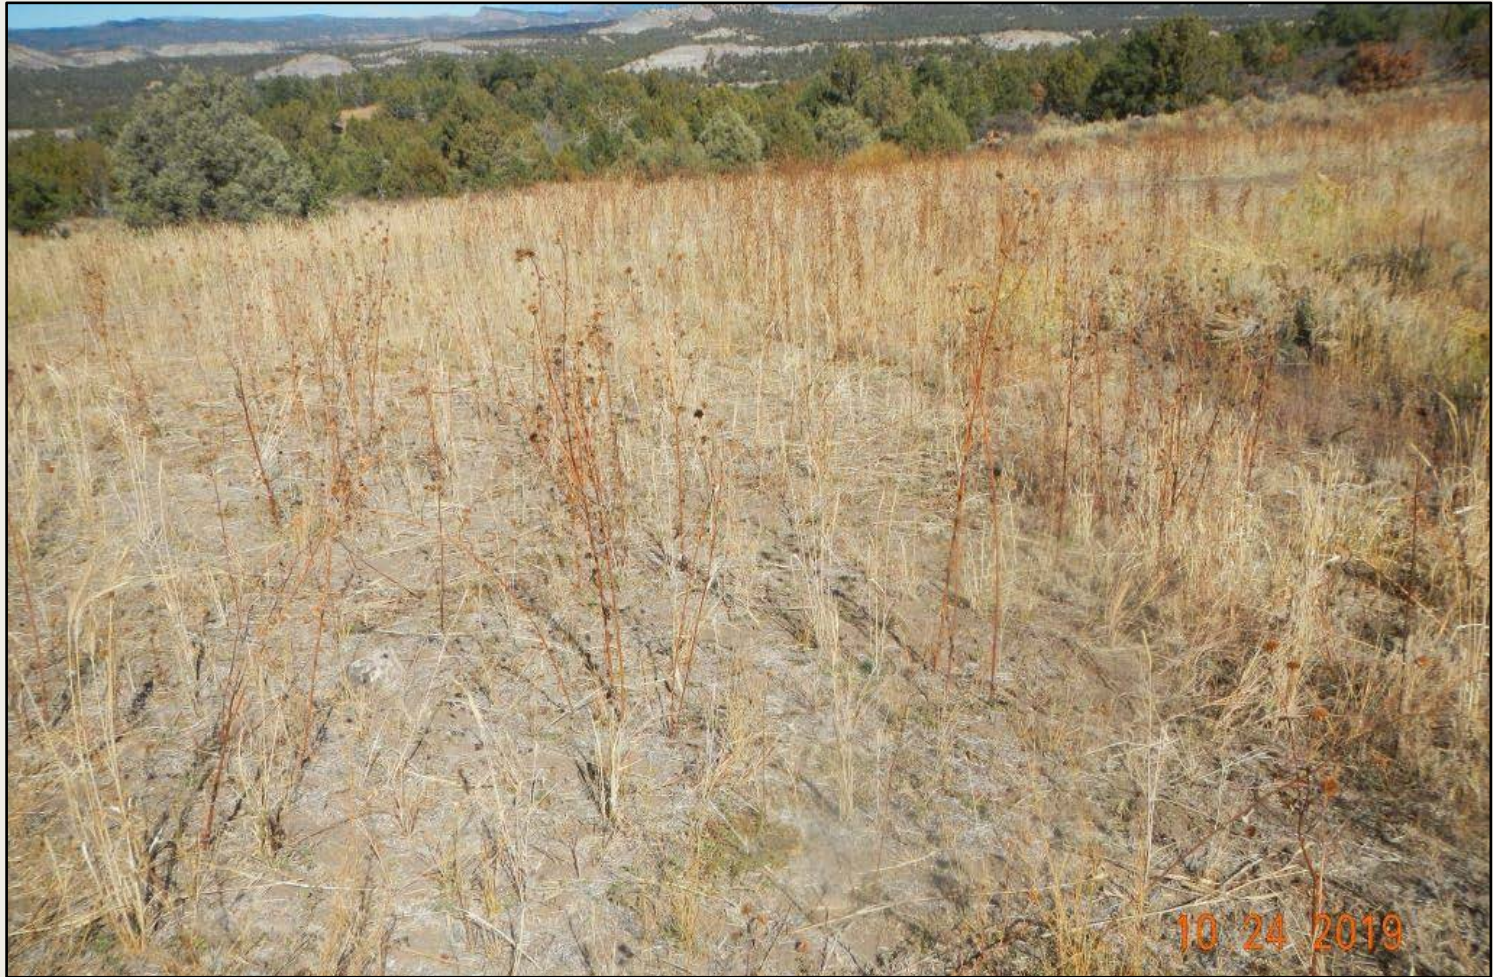
Photo 1. View of the project area from the well entrance facing center.

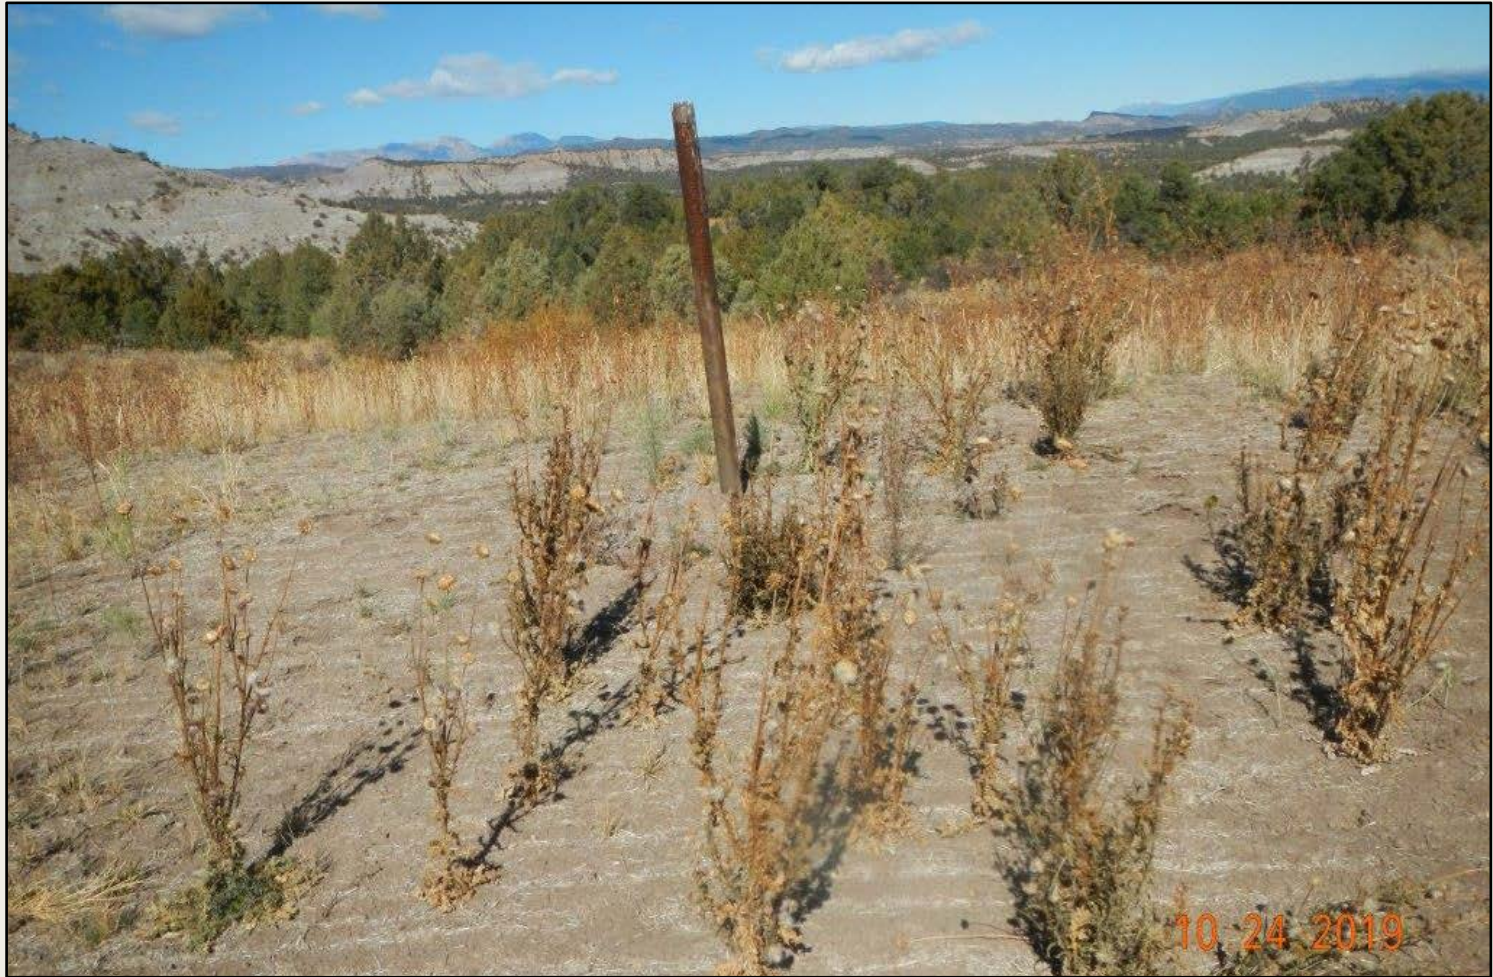
Photo 2. View of the plugged well marker facing northeastward. Area is infested with musk thistles, and revegetation is sparse in this area.

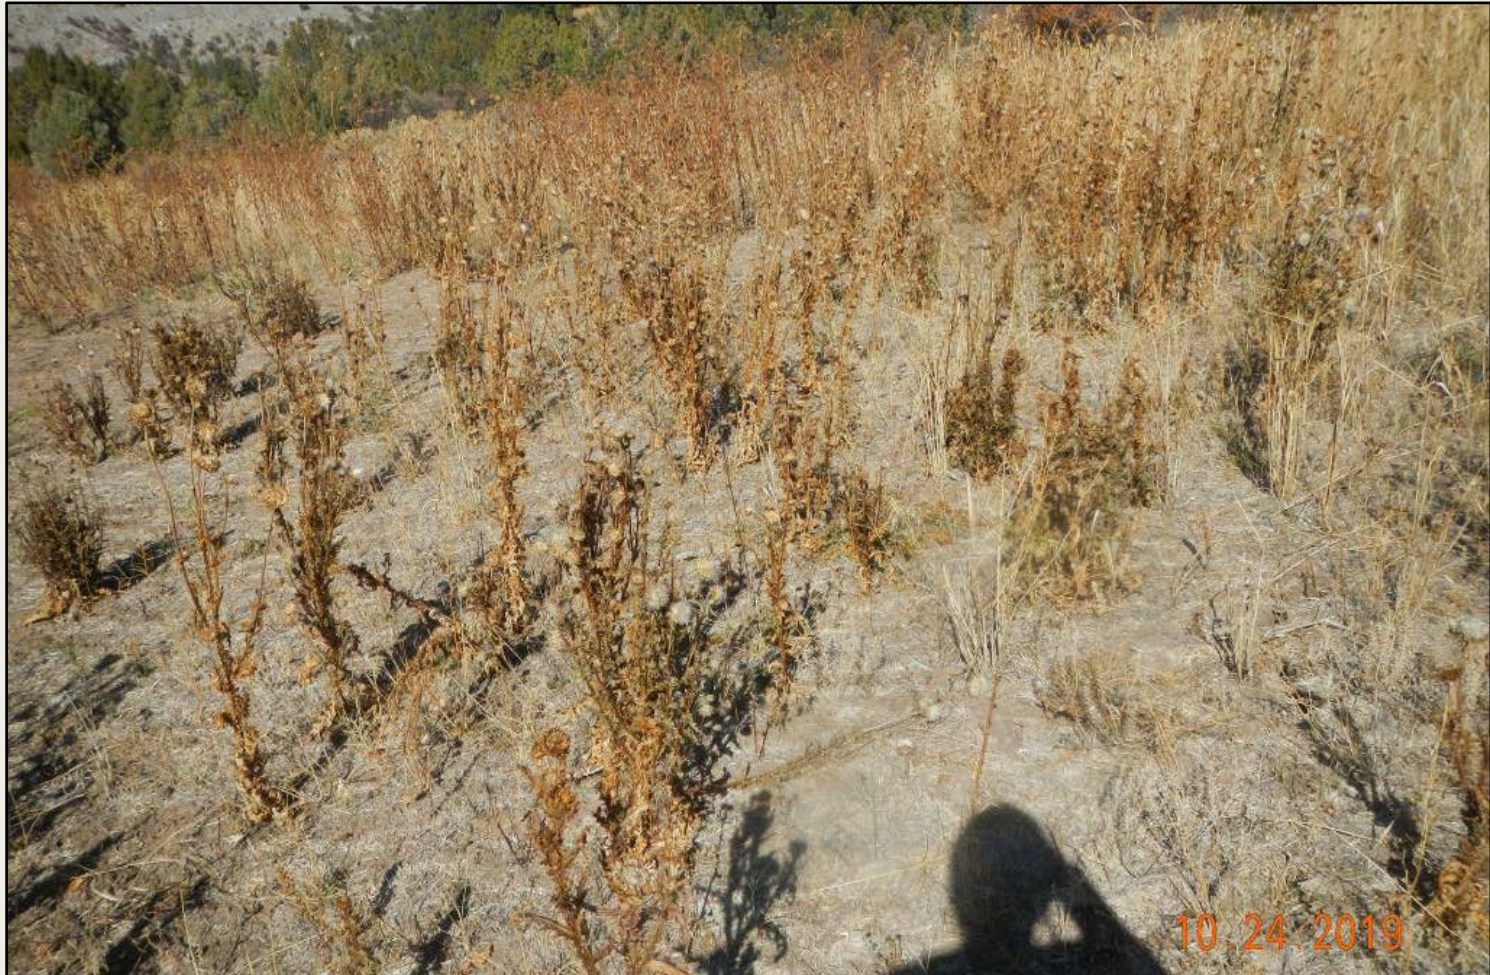
Photo 3. View of musk thistle infestation within the project area.

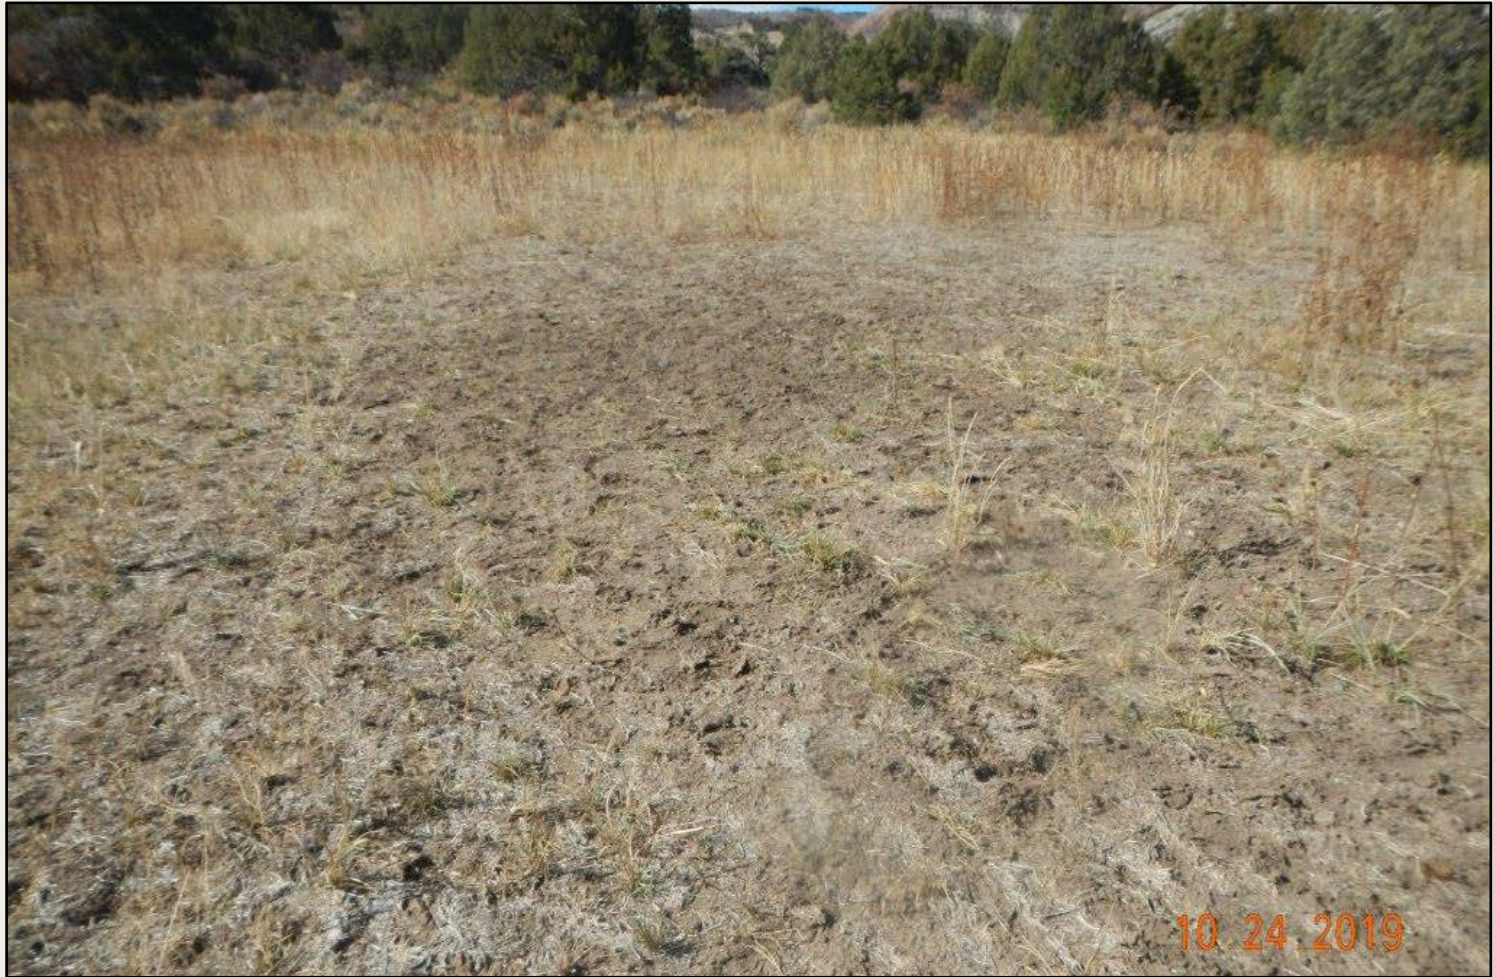
Photo 4. View of area north of wellhead with poor revegetation.

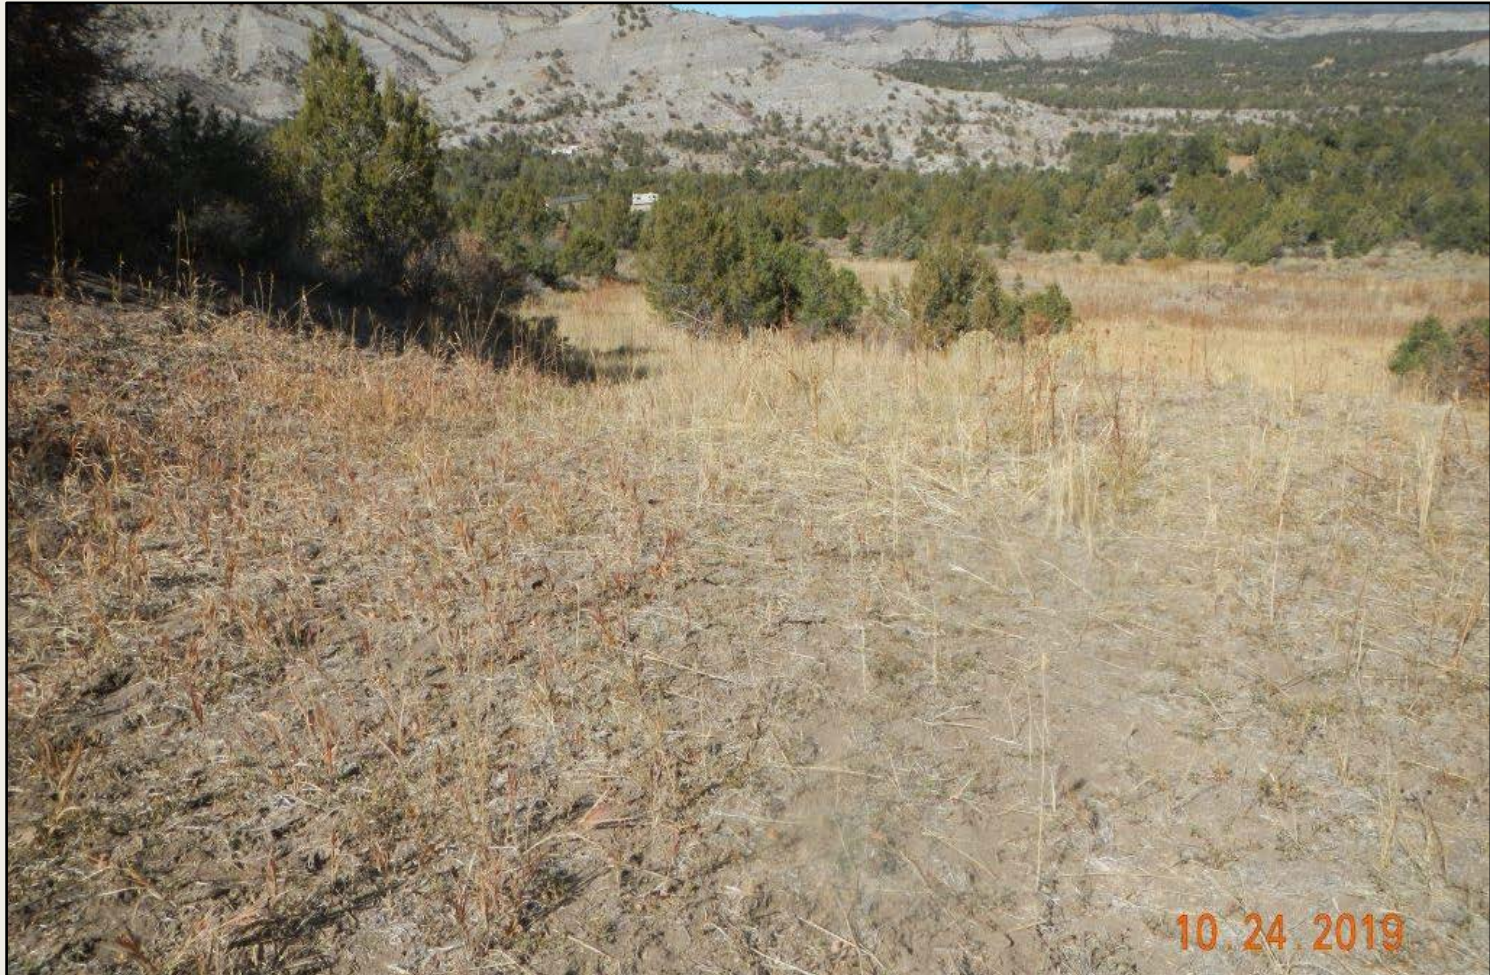
Photo 5. View of reclamation along access road, appears to be progressing in early revegetation condition, with perennial grasses such as smooth brome and western wheatgrass.

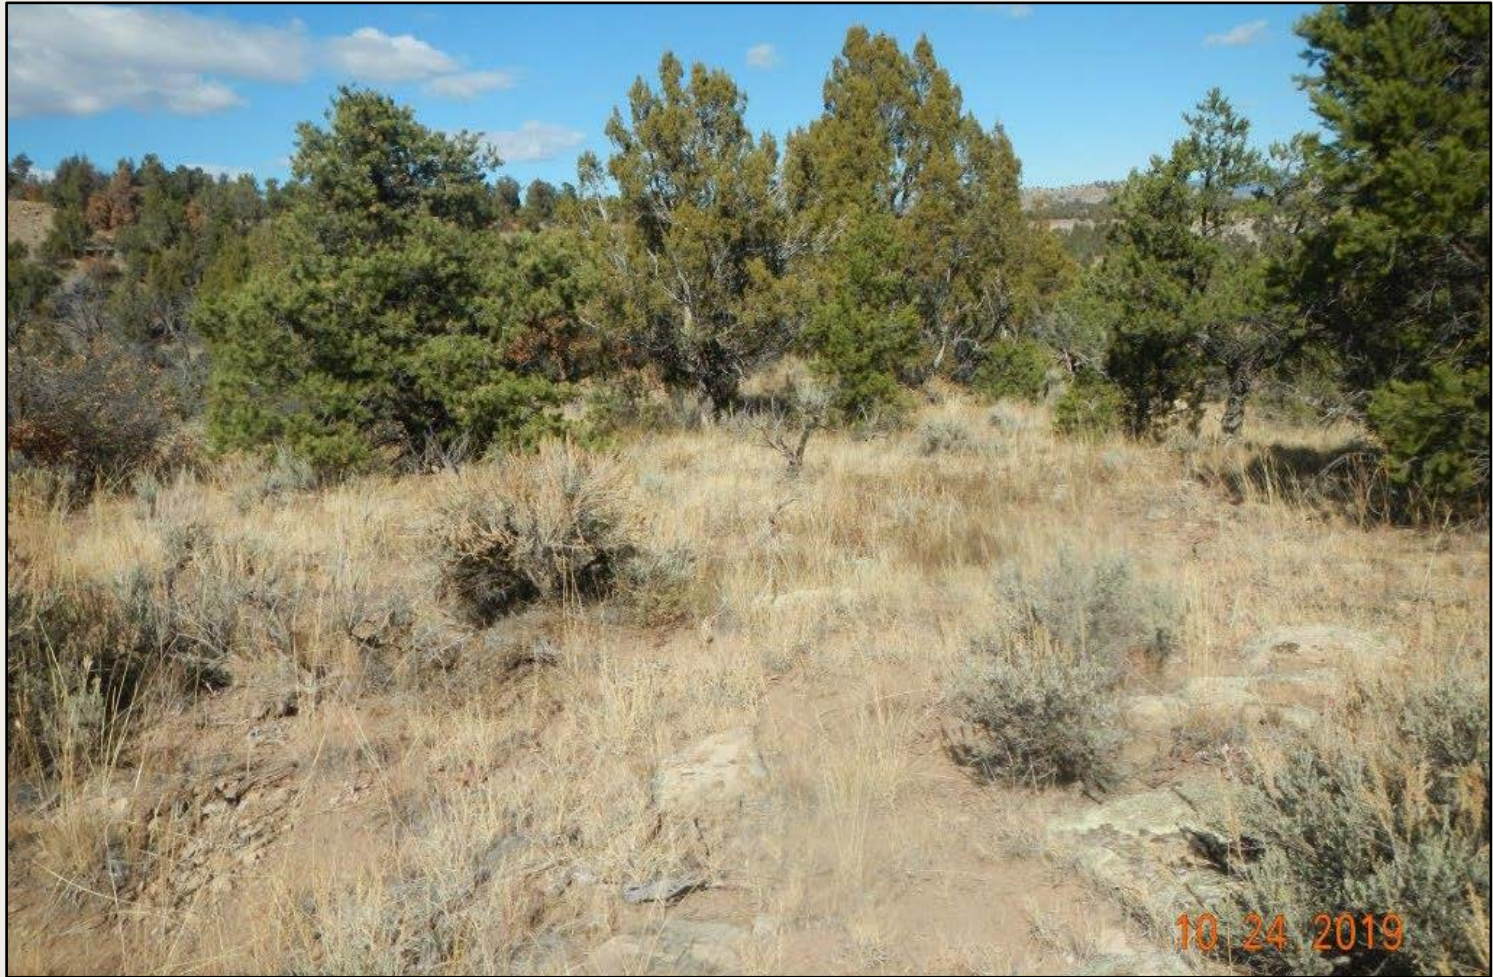
Photo 6. View of reference are vegetation comprised of mixed pinyon juniper woodland, and sagebrush shrubland with native grasses such as James galleta and forbs such as perky Sue.
