Inspection Photos
Location Name: Lamb 33-24
Location ID: 310021

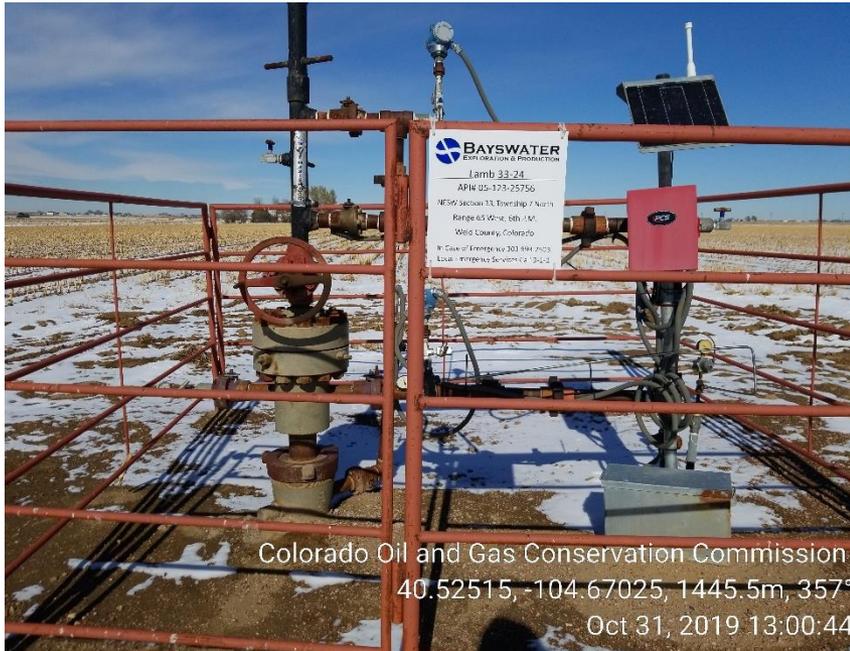
Photo 1: Wellhead

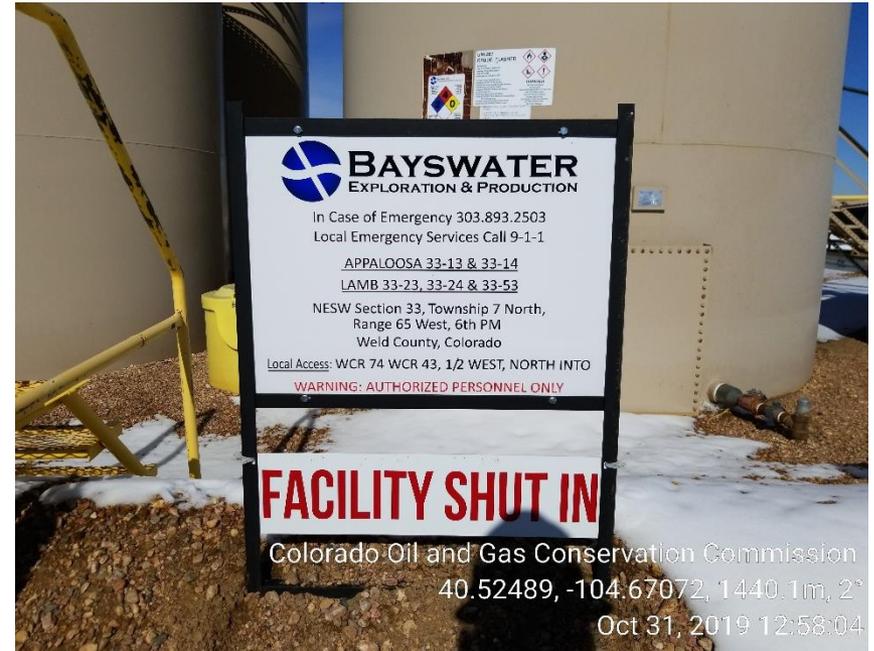
Photo 2: Tank Battery Sign

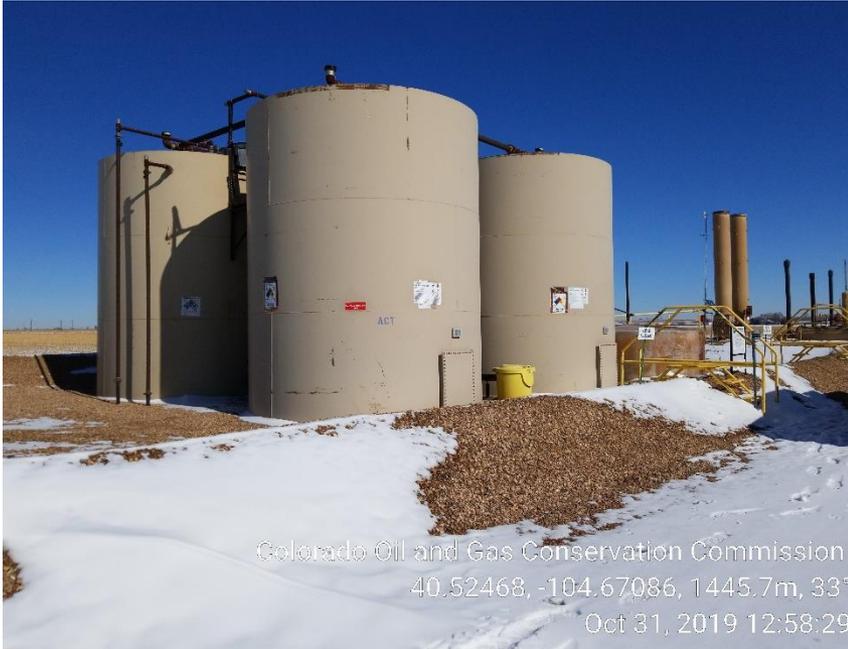
Photo 3: Tank Battery

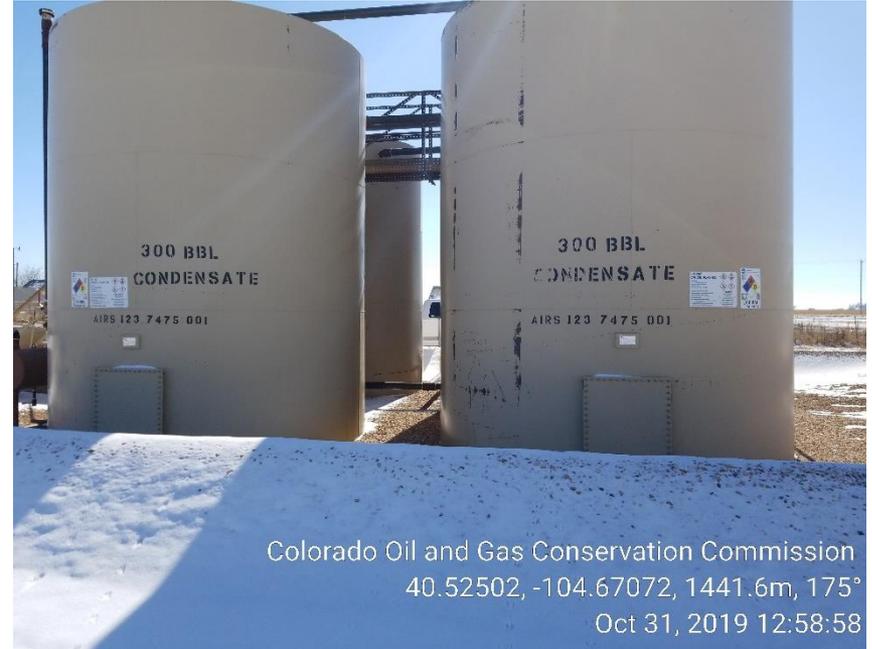
Photo 4: NFPA placarding added to North tanks

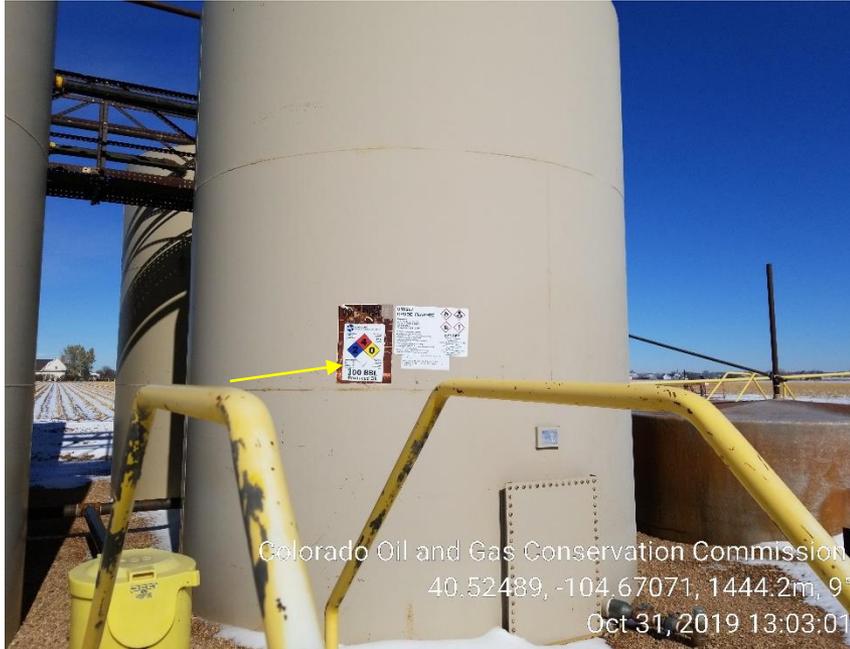
Photo 5: Labeling added to south tank

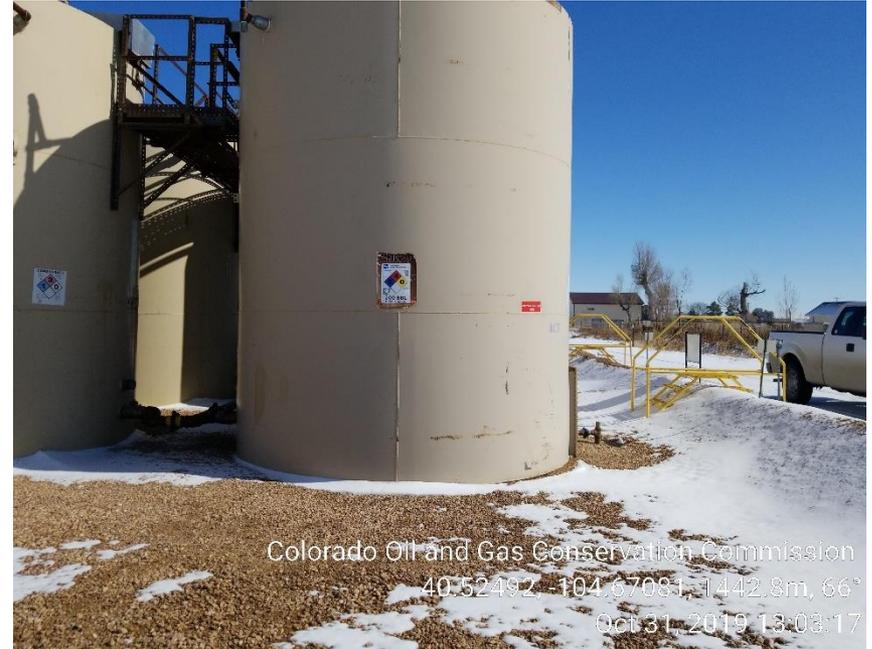
Photo 6: Labeling added to south tank

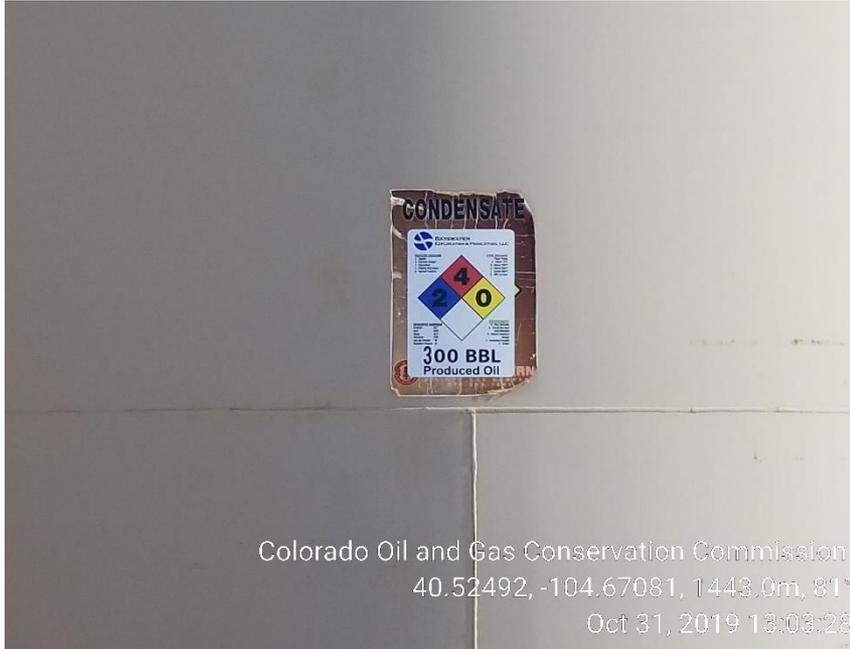
Photo 7: Close up of labeling on south tanks

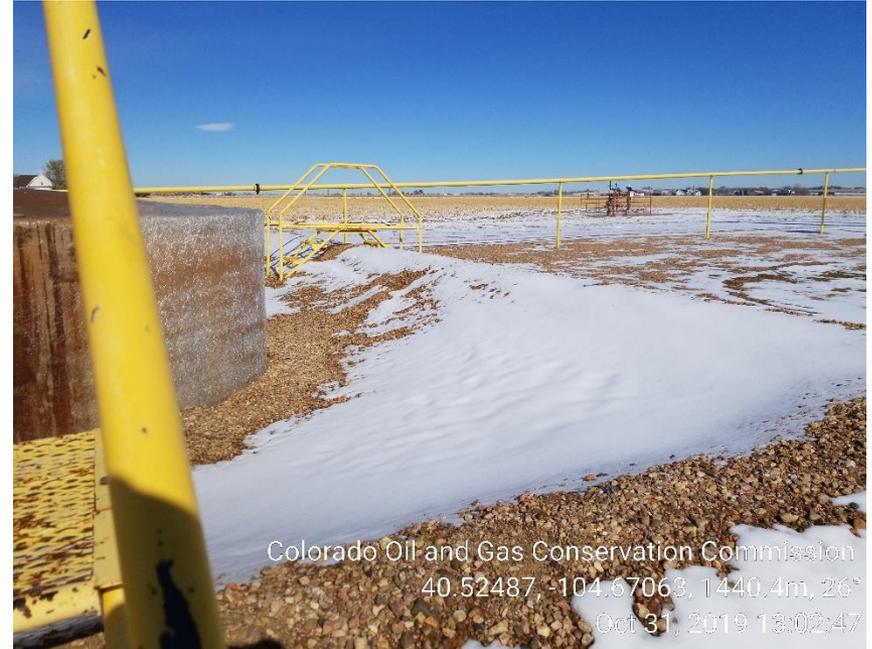
Photo 8: Hole repaired in berm wall

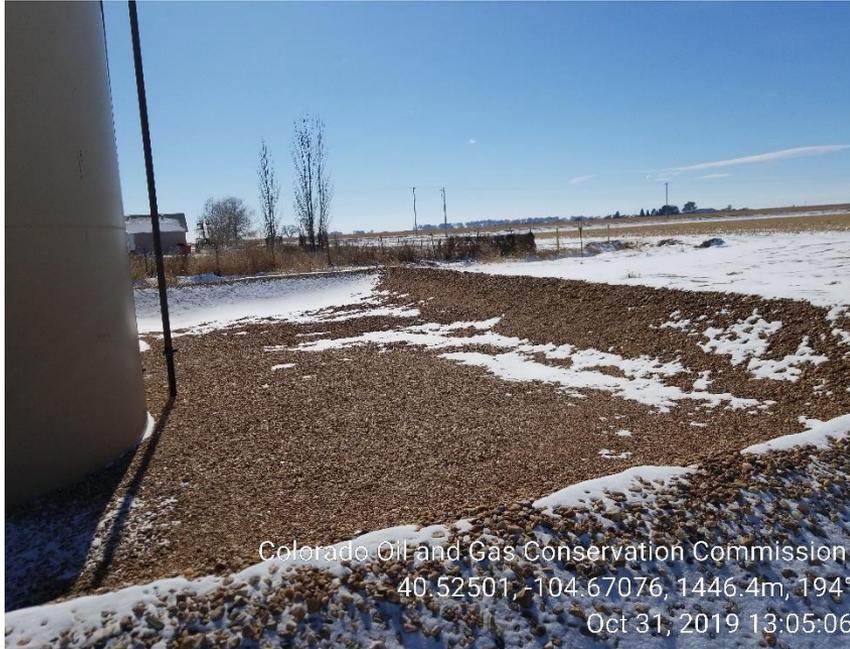
Photo 9: Hole repaired in berm wall

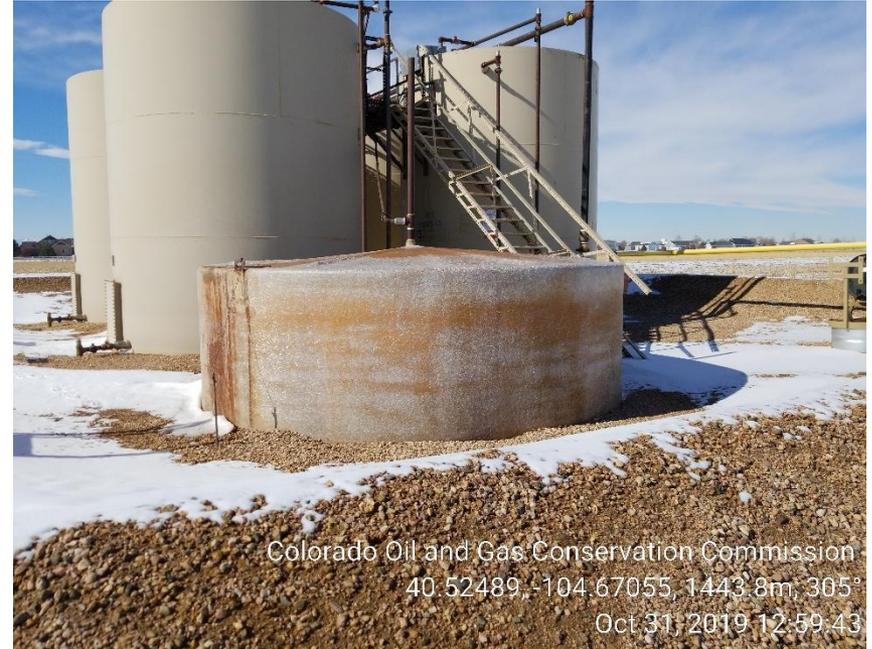
Photo 10: No Labeling/Placard on H2O tank

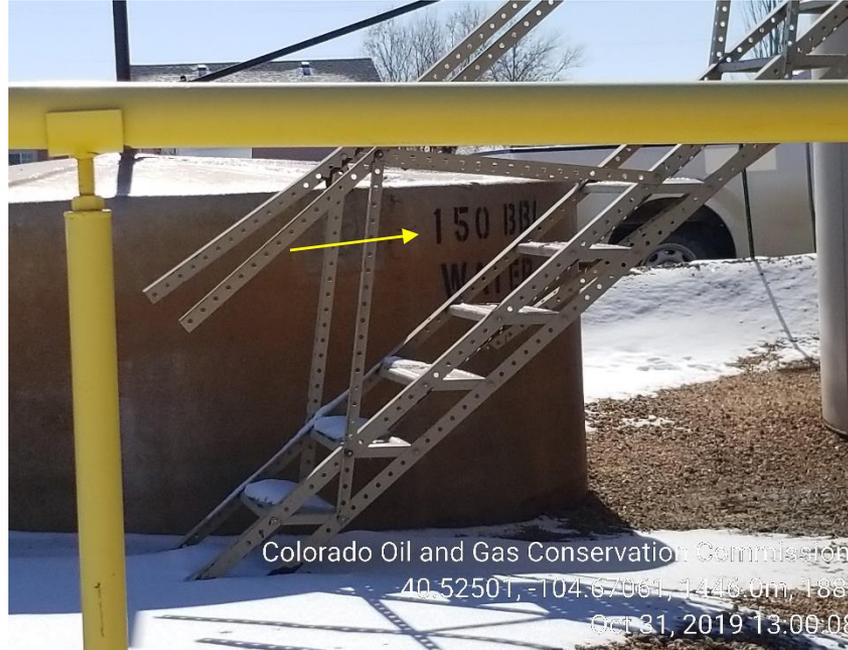
Photo 11: BBLs on wrong side of tank.
