## Inspection Photos

Location Name: N Parachute EF12A-19 L19595 Pad & L19-595 Dumpline release

Location ID: #335635 & Spill/Release ID: #466606

Inspection Date: October 31, 2019

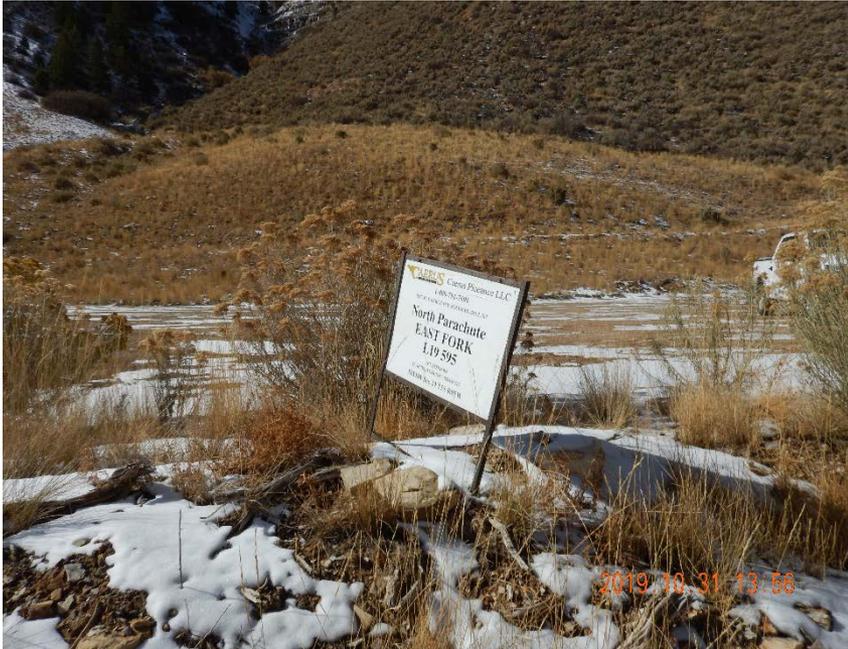
Photo #1 – Pad sign.

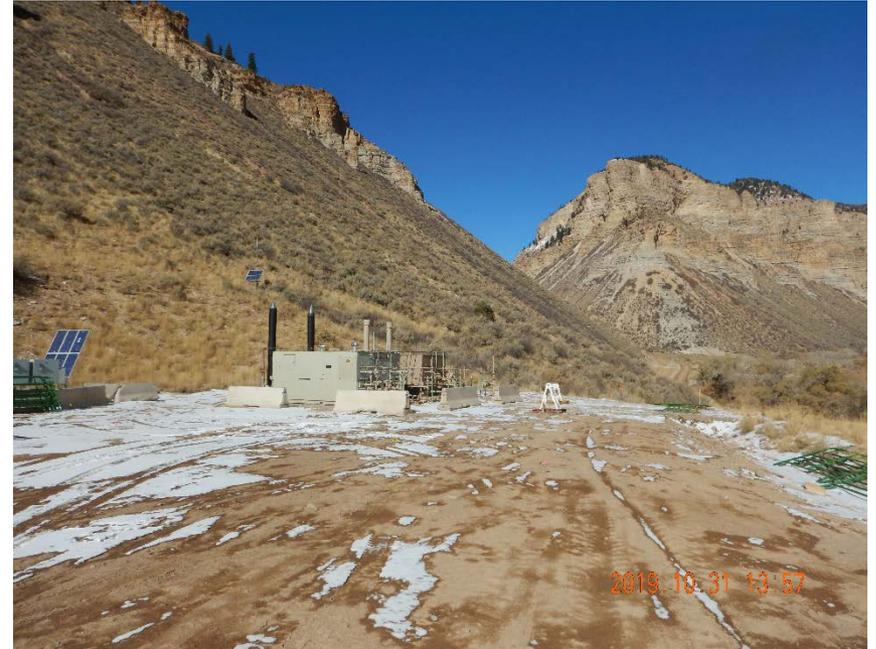
Photo #2 – Overview of north end of pad.

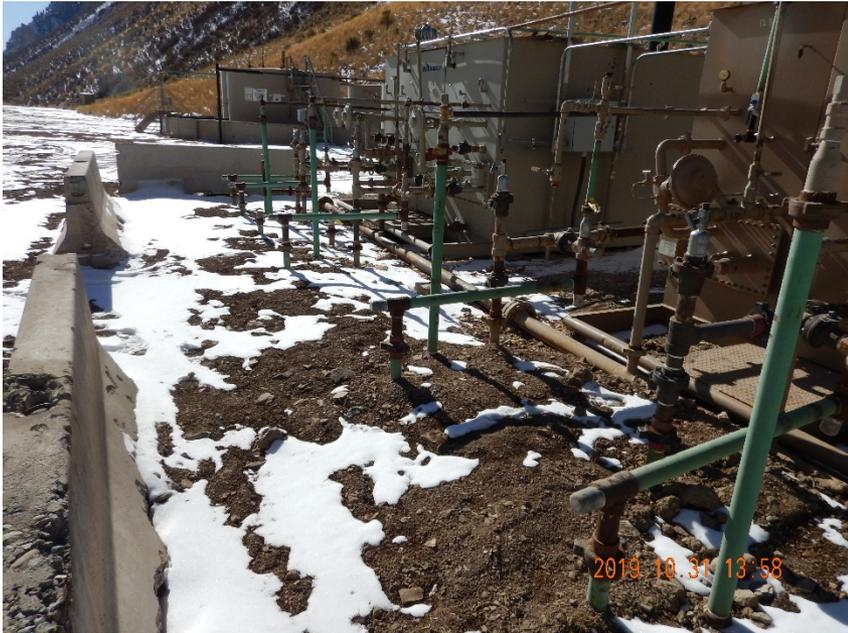
**Photo #3 – Backfilled excavation area, located east of separators.**

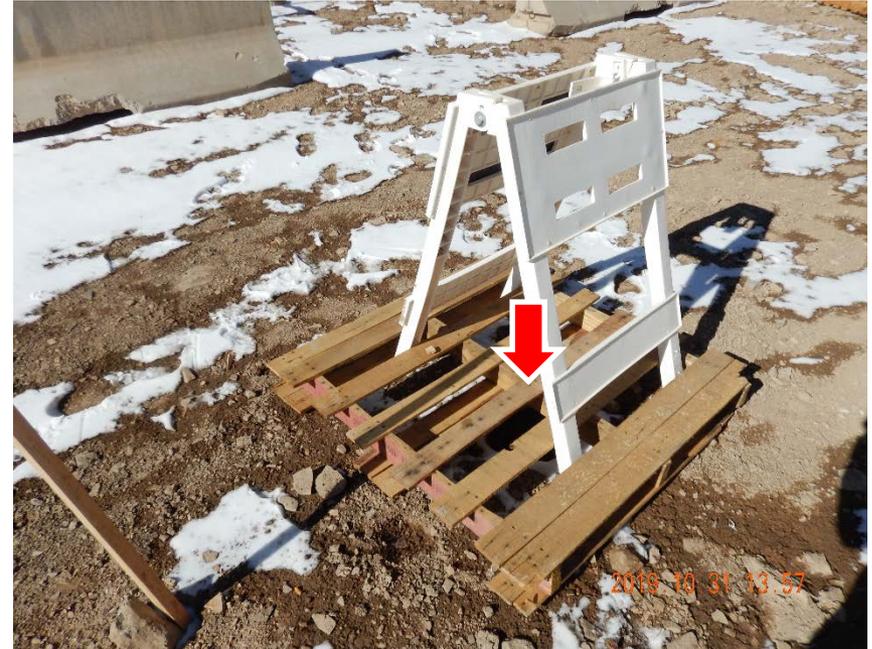
**Photo #4 – View of covered pothole east of former excavation area.**

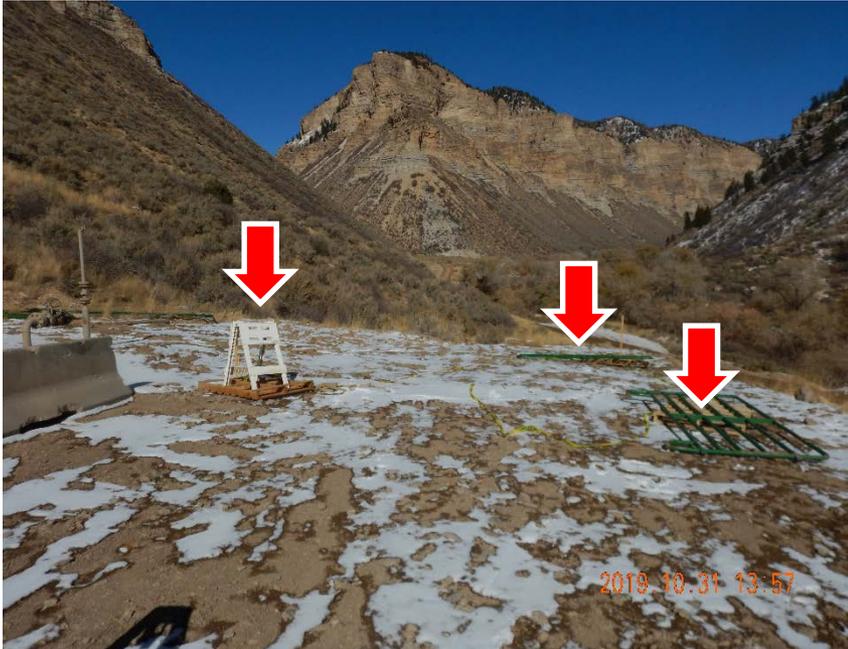
Photo #5 – Additional covered potholes located northeast of former excavation area.

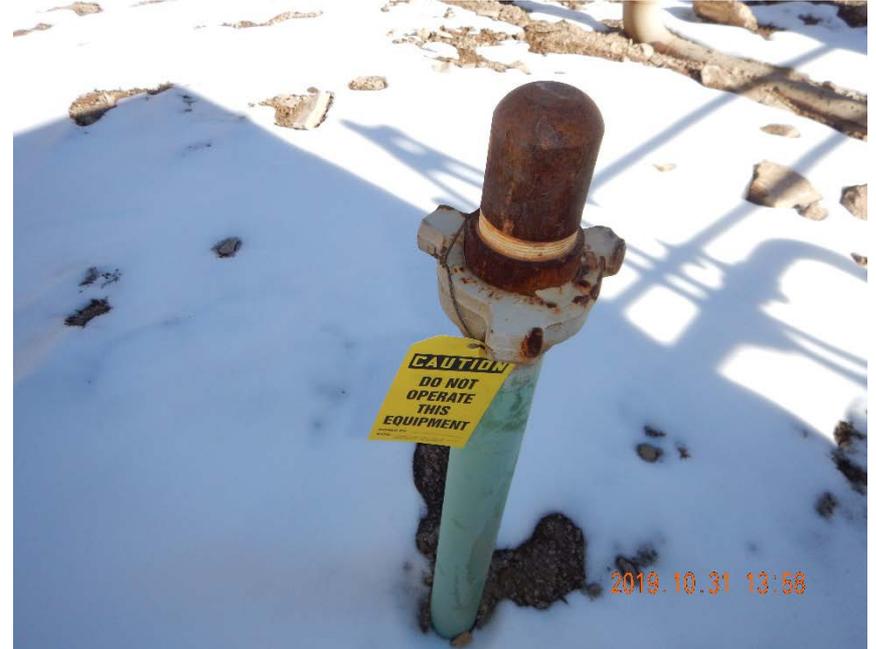
Photo #6 – Flowline riser north of separators has been tagged out.

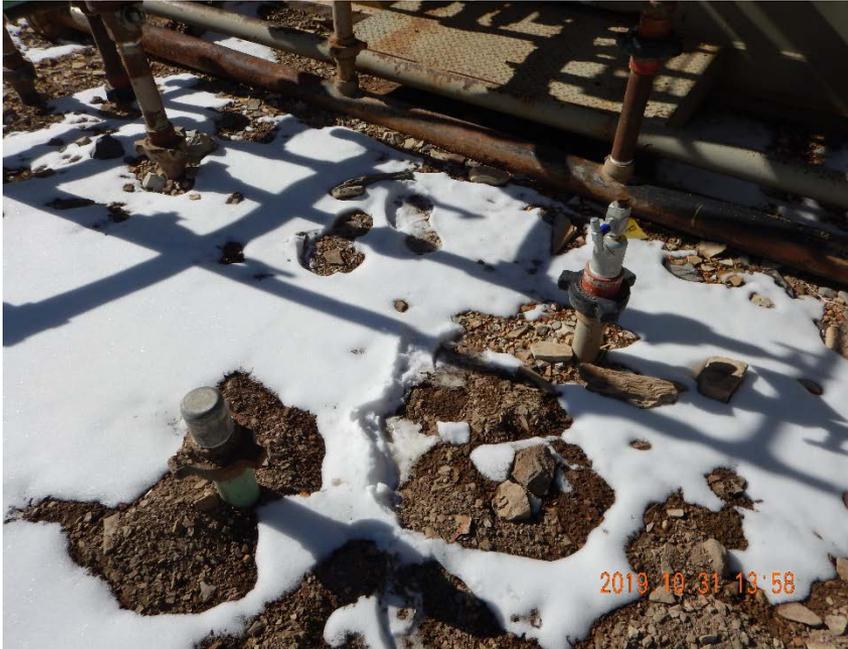
**Photo #7 – Flowline risers east of separators. Flowline riser with 1" valve has been tagged out.**

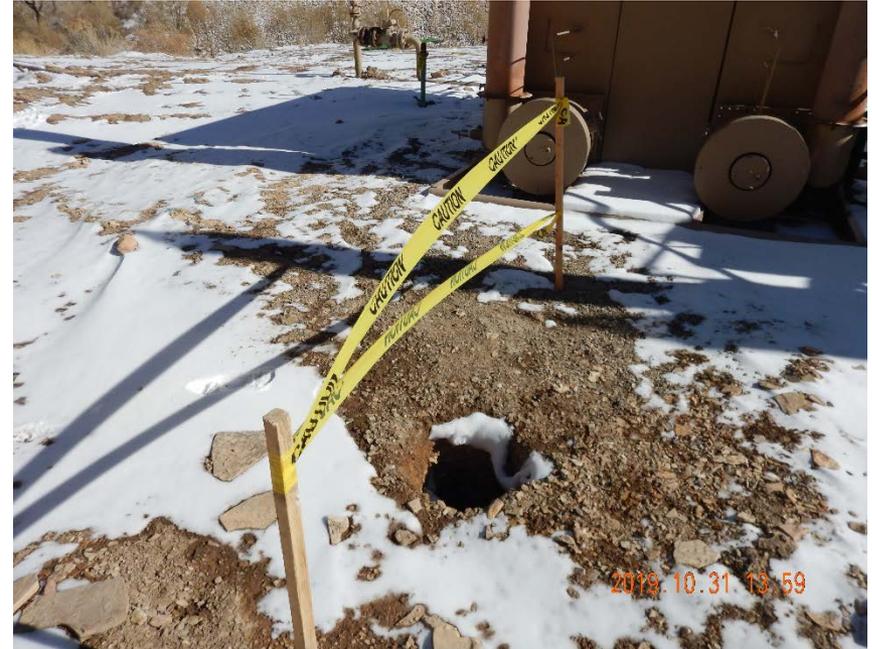
**Photo #8 – Uncovered pothole located west of separators.**

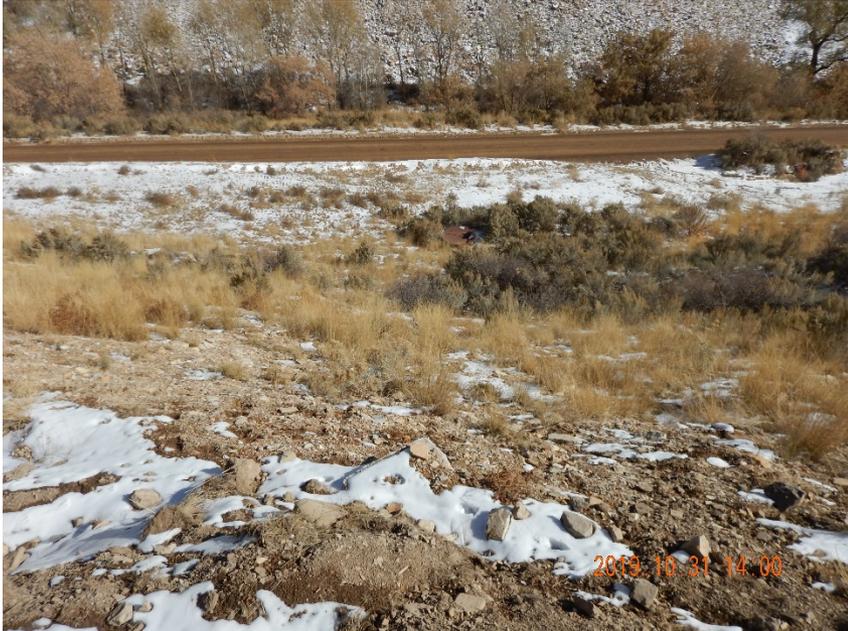
**Photo #9 – Downhill area east of backfilled excavation. No hydrocarbon stains or odors were observed in this area on inspection date.**

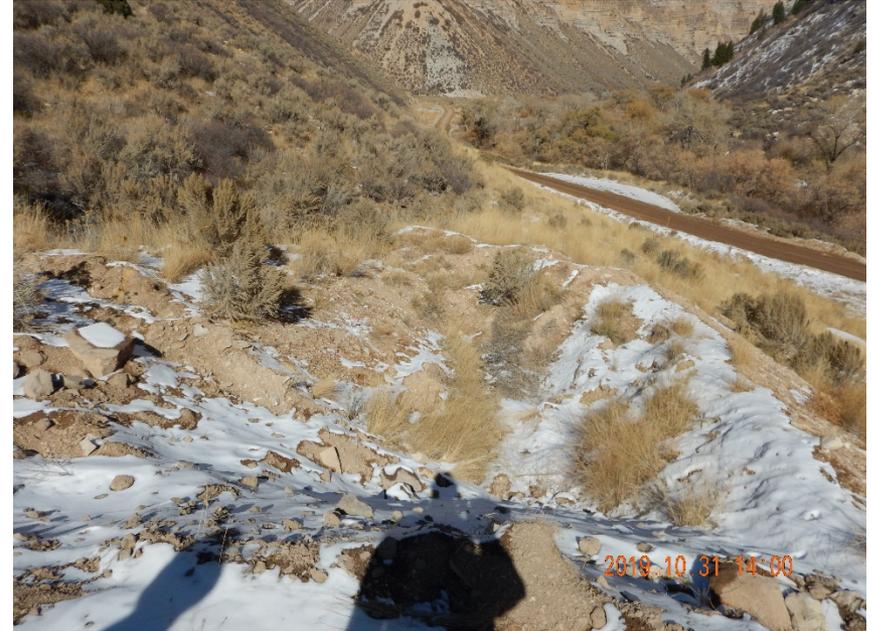
**Photo #10 – Sediment trap located north of backfilled excavation. No hydrocarbon stains or odors were observed in this area on inspection date.**
