Construction and Stormwater Inspection

November 4, 2019

Operator: EDGE ENERGY II LLC- #10671

Inspection Photos
Location Name: Deporter /29-A Pad
Location ID: 456286

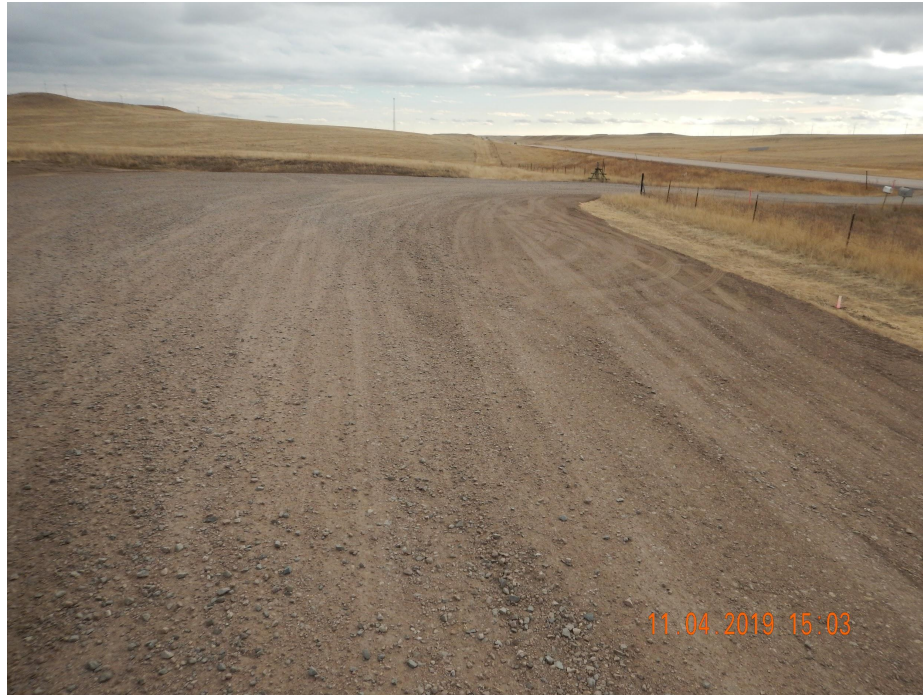
Photo 1. Photo taken from the entrance of location off HWY 85, facing South. Photo illustrates Operator has constructed and gravelled an access road.

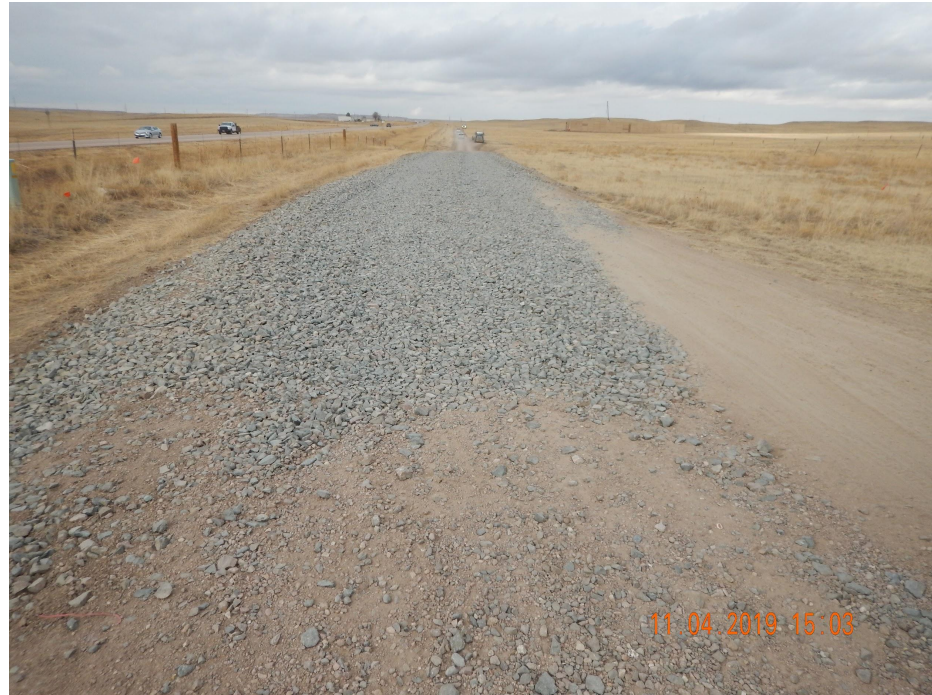
Photo 2. Photo taken from the entrance of location off HWY 85, facing North. Photo illustrates Operator has installed a vehicle tracking device BMP.

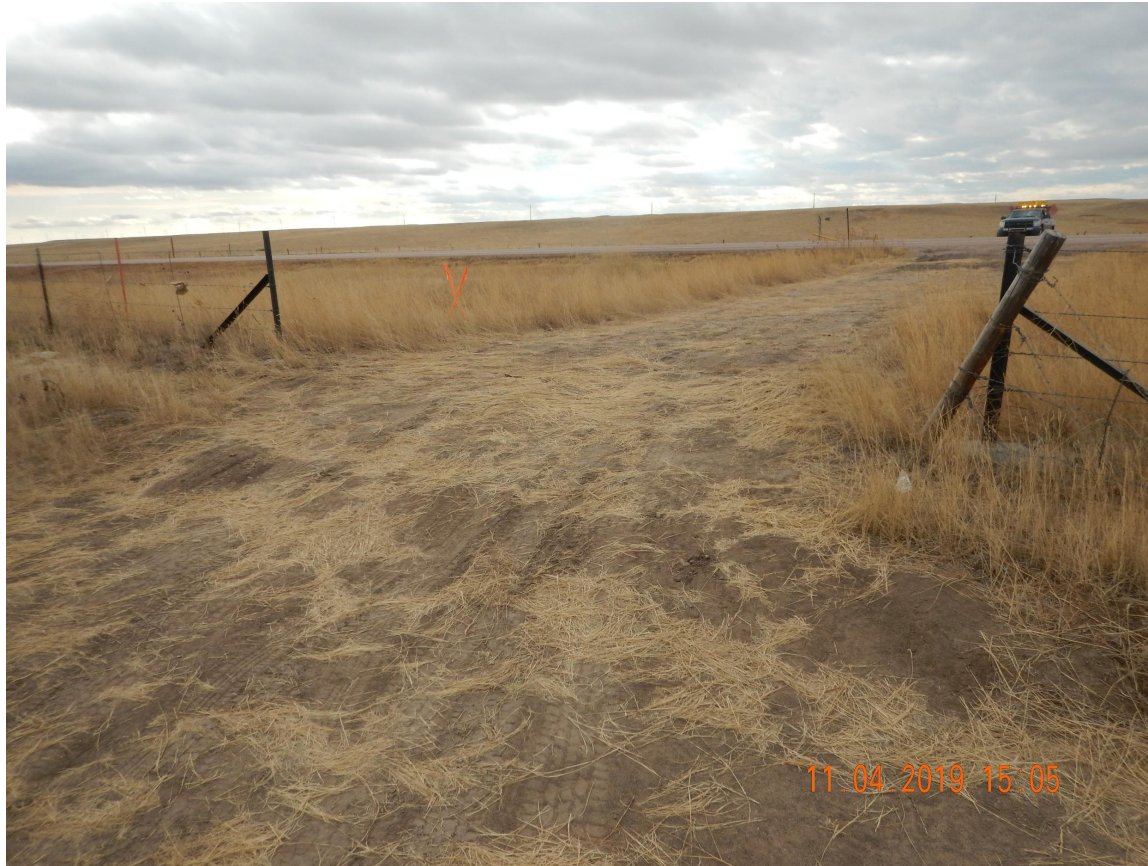
Photo 3. Photo taken along the access road, facing West toward HWY 85. It appears vehicle traffic is using this as an access point which should be prohibited.

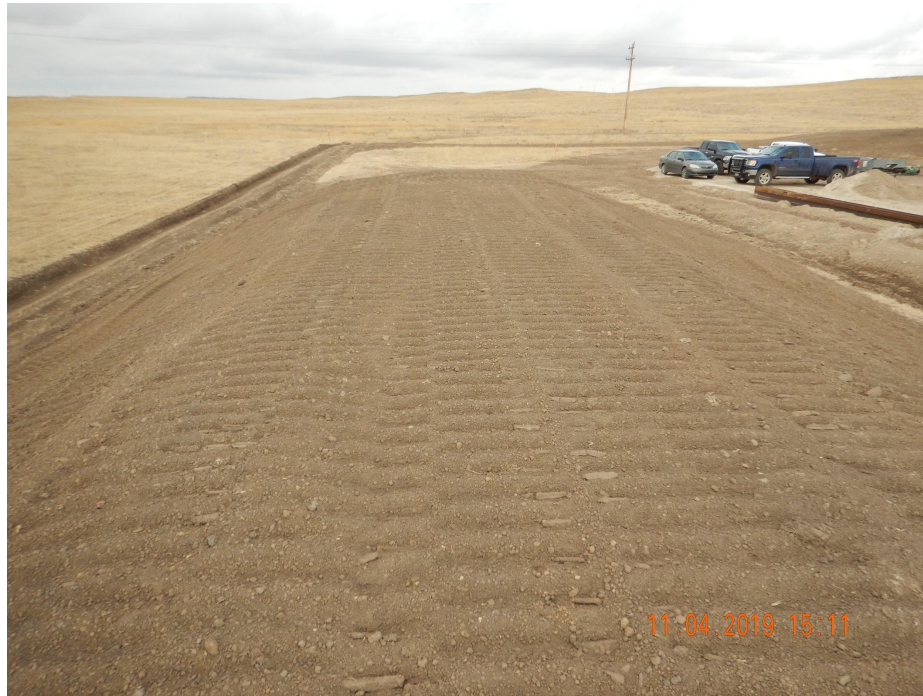
Photo 4. Photo taken from the western location, facing North. Photo illustrates the topsoil stockpile which has been temporarily stabilized with equipment tracking.

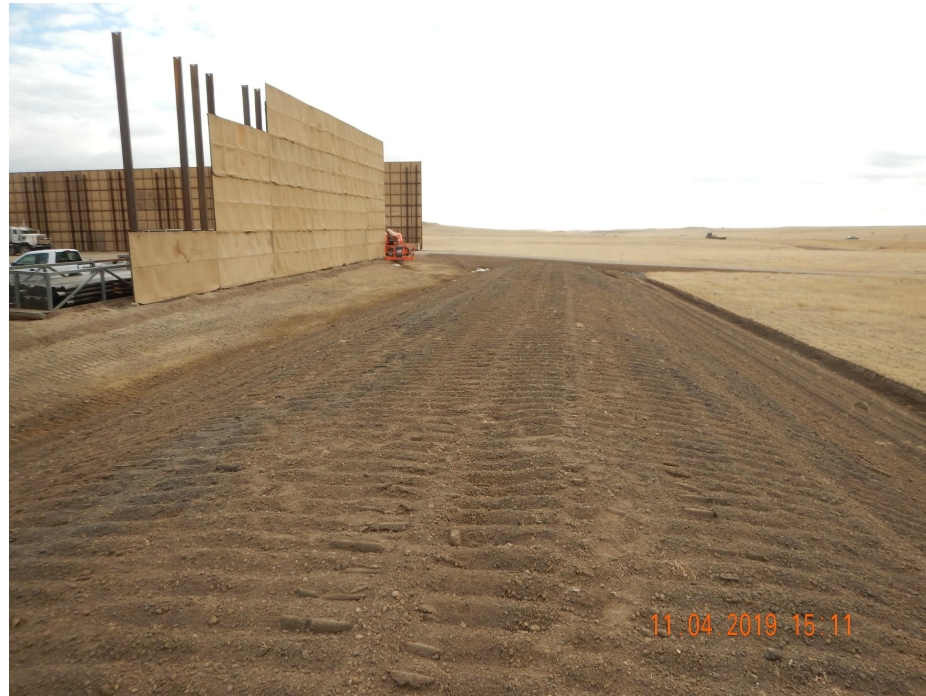
Photo 5. Photo taken from the western location, facing South. See comments under Photo 4.

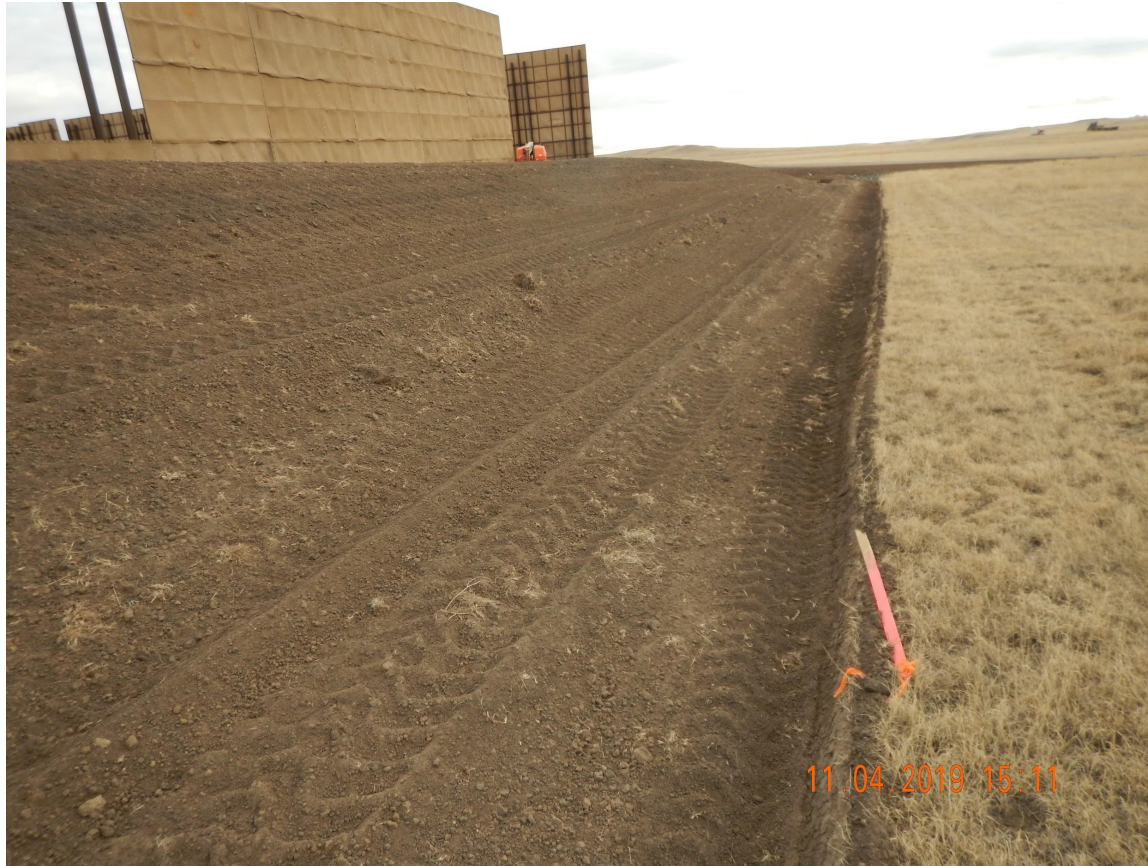
Photo 6. Photo taken from the western perimeter of location, facing South. Photo illustrates a shallow ditch BMP along the western location. This ditch BMP would not be considered installed to a sufficient depth.

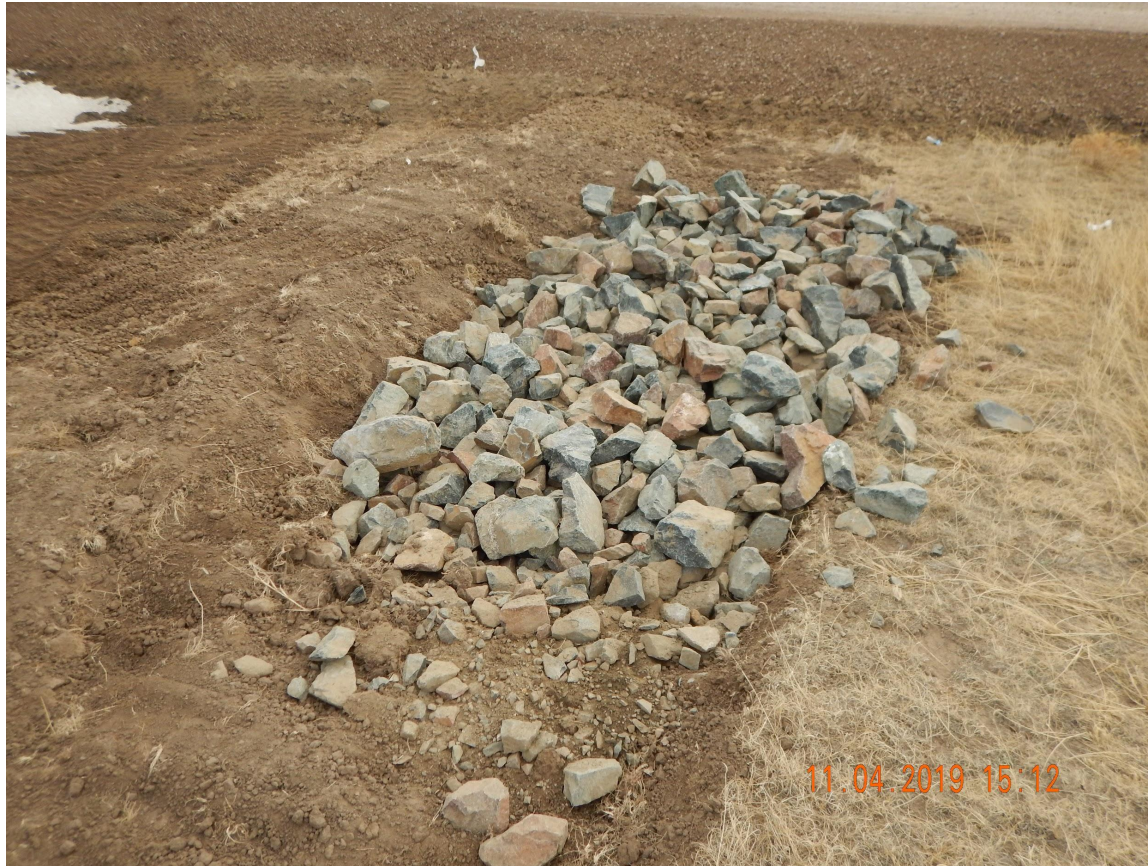
Photo 7. Photo taken from the southwestern perimeter of location (north of the access road), facing South. Photo illustrates an ~3'x6' area of riprap at the end point of the ditch. This would not be considered a sediment trap.

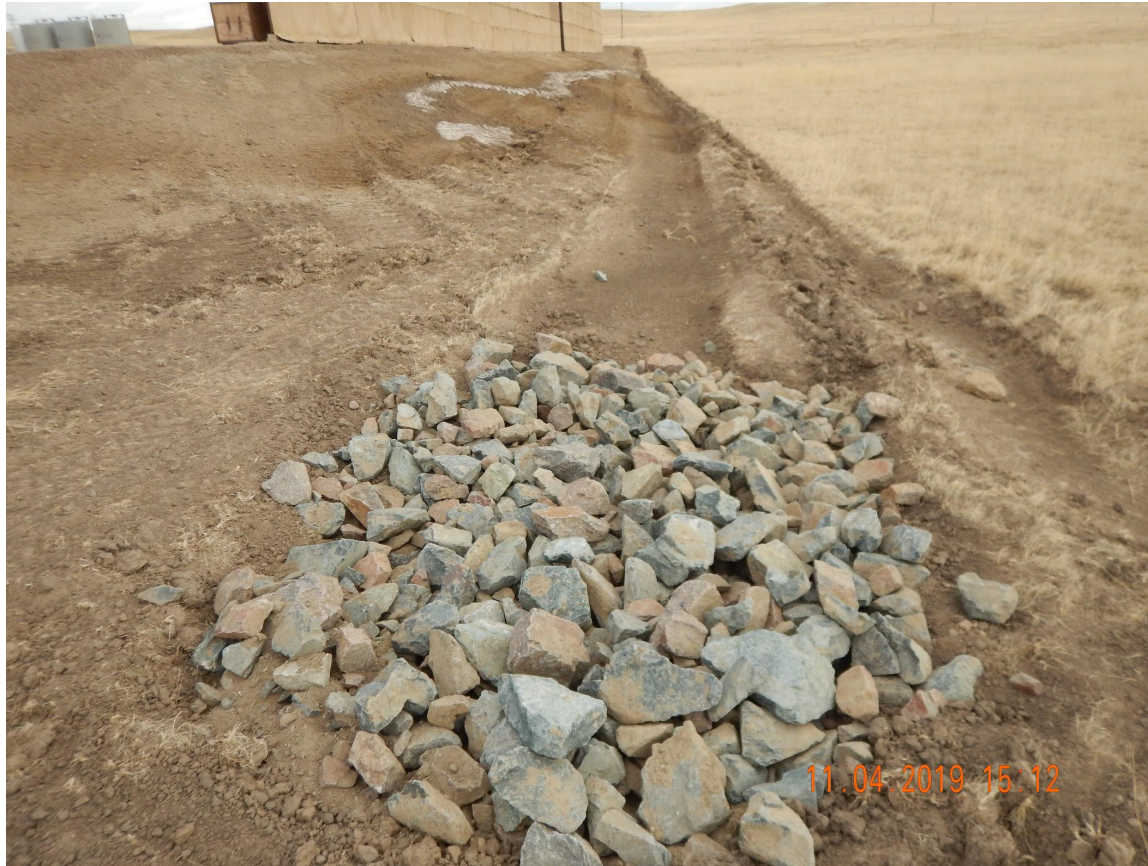
Photo 8. Photo taken from the southwestern perimeter of location (south of the access road), facing East. See comments under Photo 7.

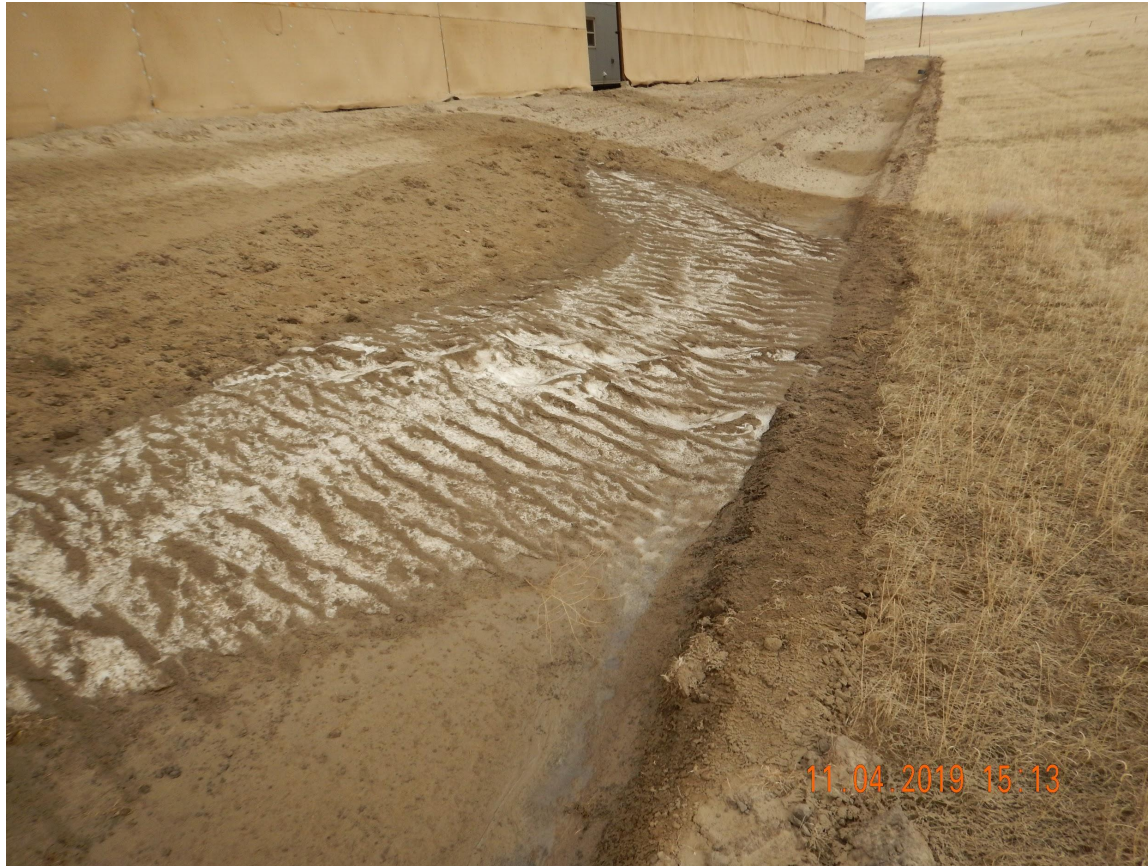
Photo 9. Photo taken from the southern perimeter of location, facing East. Photo illustrates sediment accumulation within the shallow ditch BMP. Also, Operator shall stabilized the unconsolidated fill material along the southern location as this is susceptible to wind and water erosion.

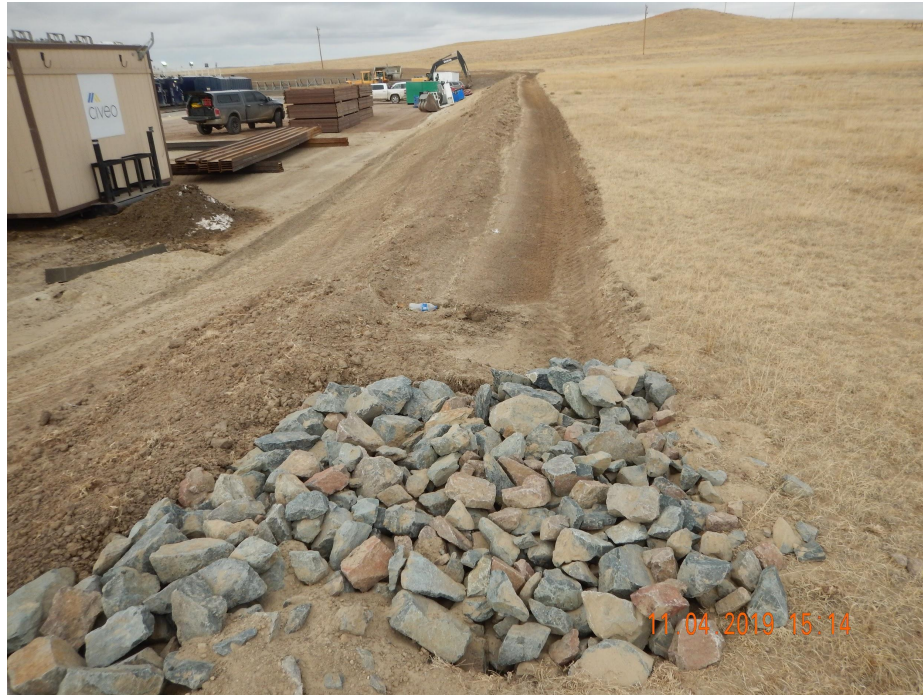
Photo 10. Photo taken from the southeastern perimeter of location, facing North. See comments under Photo 7.

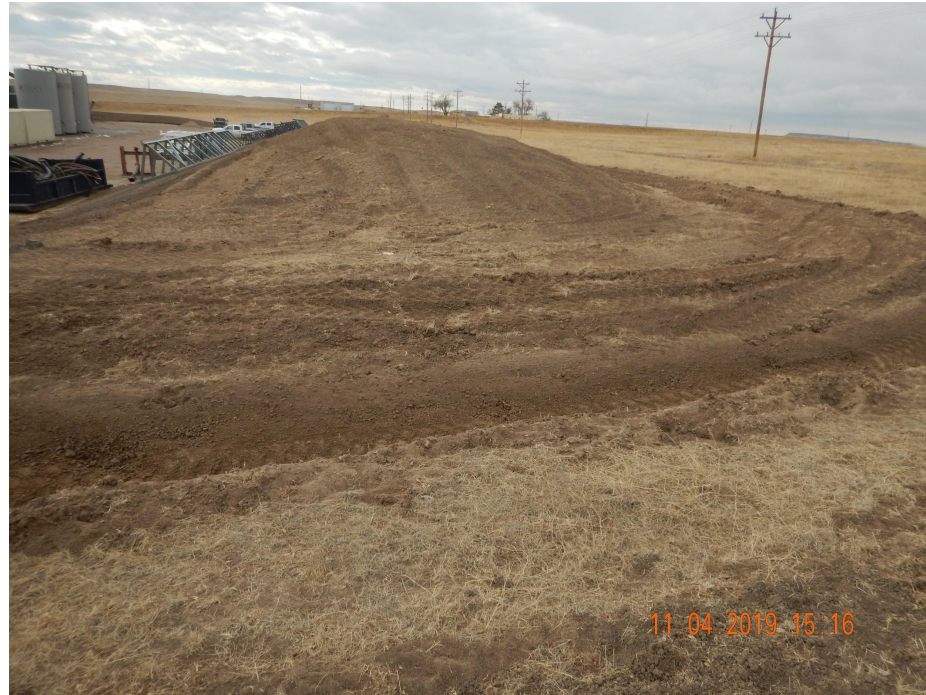
Photo 11. Photo taken from the northeastern perimeter of location, facing West. Photo illustrates the second topsoil stockpile which has been temporarily stabilized with equipment tracking.

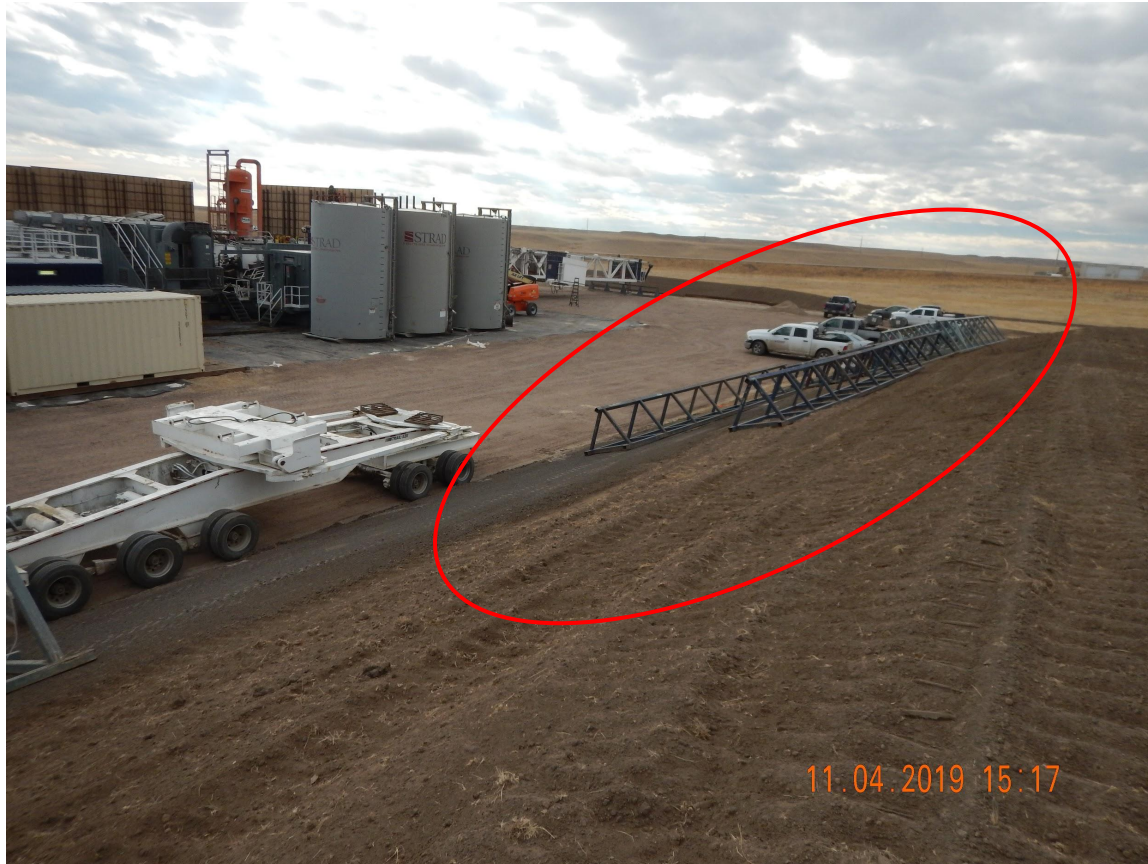
Photo 12. Photo taken from the northern topsoil stockpile, facing West. Photo illustrates equipment being stored on the topsoil stockpile which should be prohibited.
