Inspection Photos
Location Name: Ocoma 31-27
API ID: 123-17806

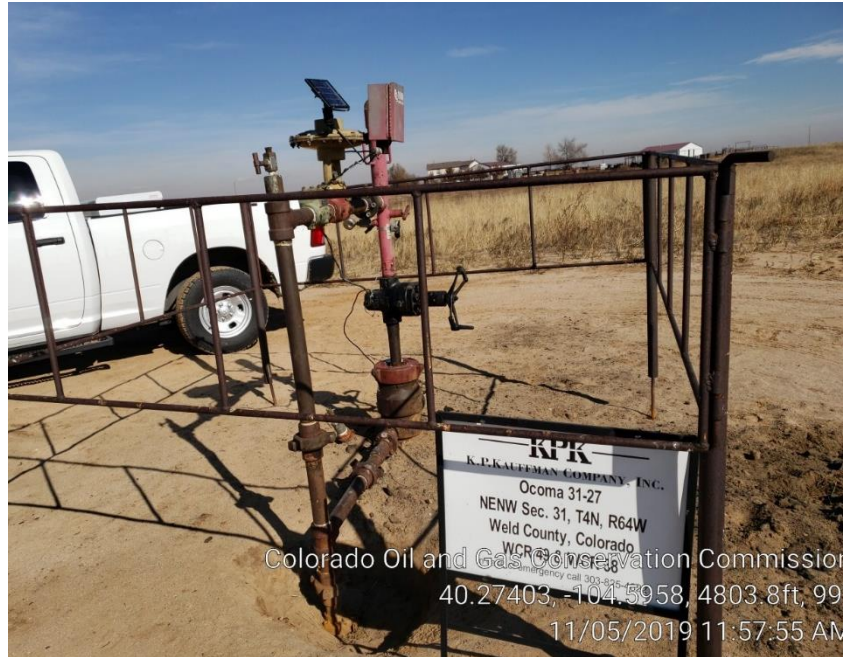
Photo #1 Wellhead & Sign

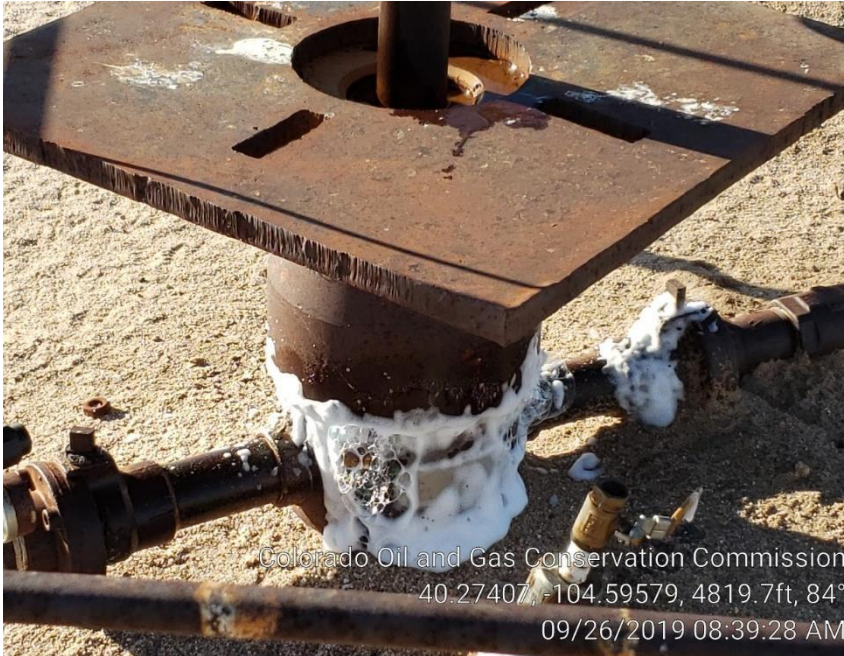
Photo #2 Active leak at the casing collar. On 9/26/19

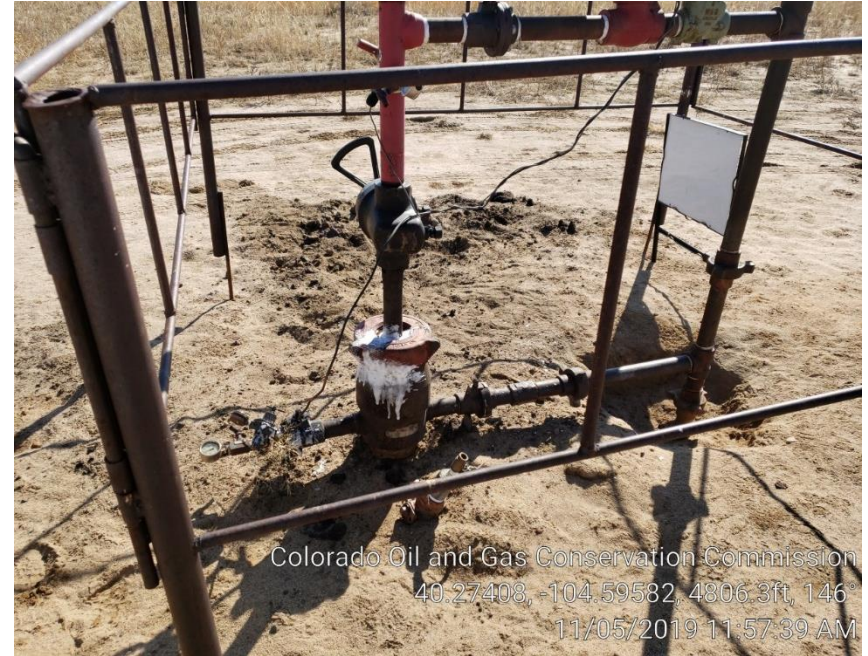
Photo #3 No Active leak at the casing collar. On 11/5/19

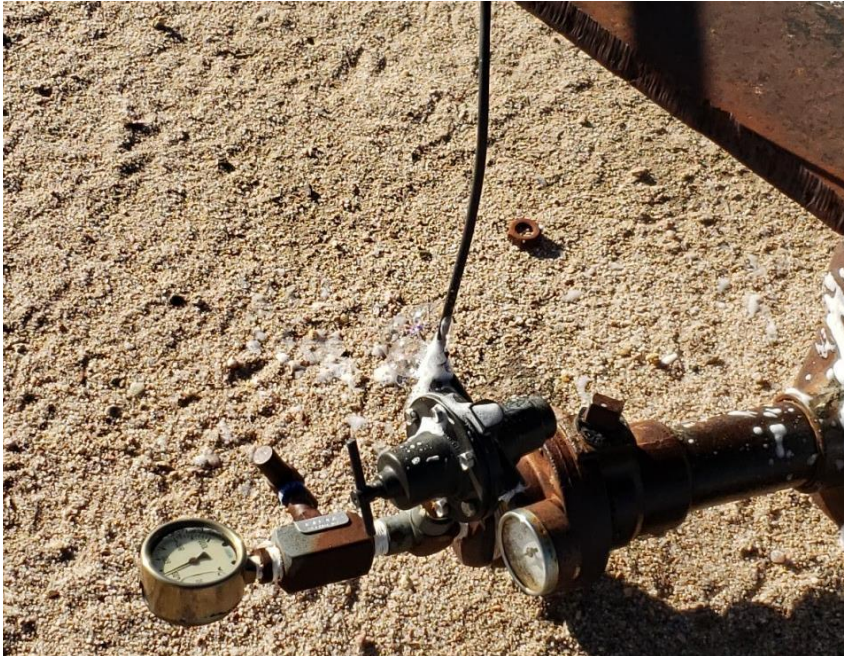
**Photo #4 Active leak at the Meco regulator stainless fitting.
On 9/26/19**

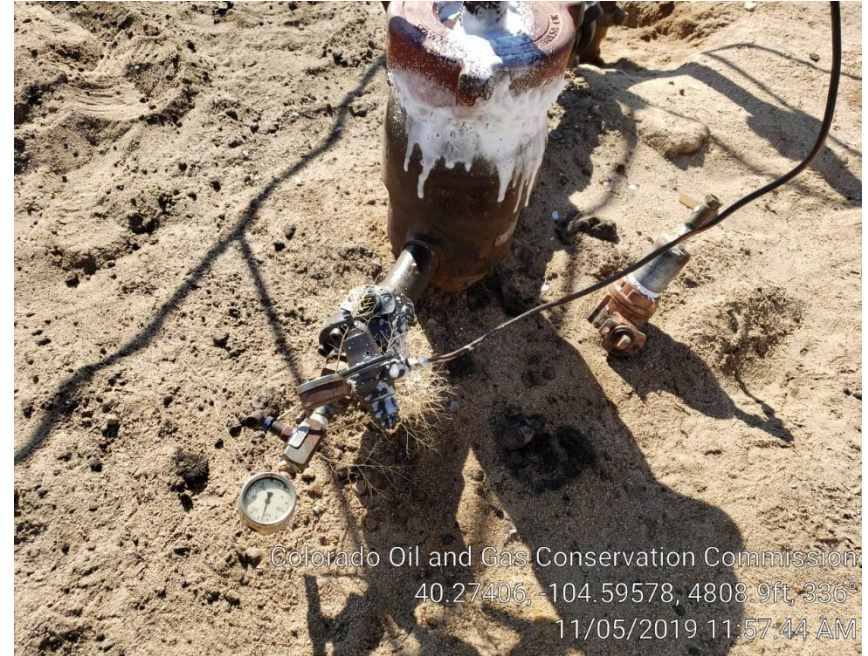
**Photo #5 No Active leak at the Meco regulator stainless
fitting. On 11/5/19**
