MARALEX RESOURCES, INC.– 53255
API# 05-077-08216 LIPAN WASH UNIT #3-15-2-2
Inspection Date : 11/4/2019

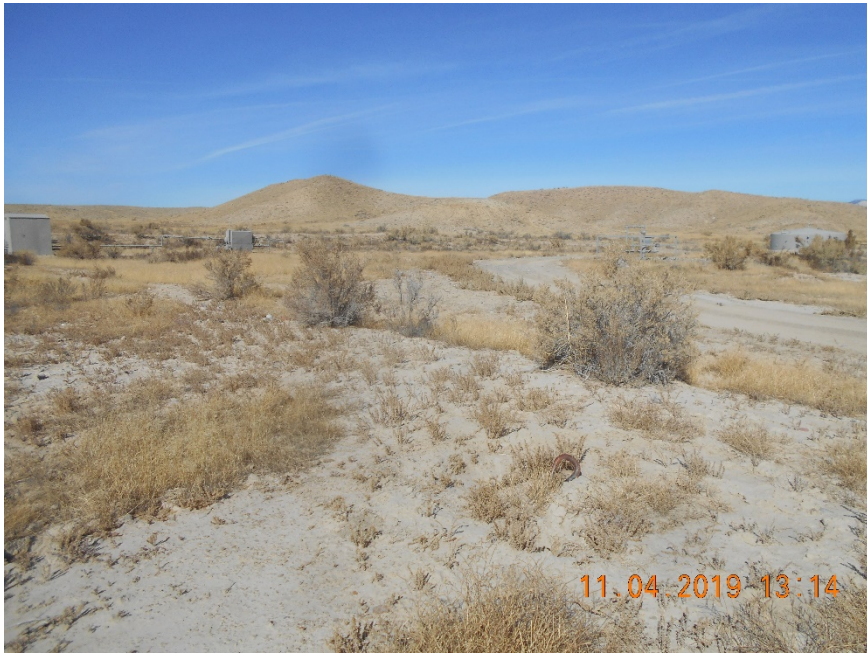
Overview of location looking. SE anchor looking N.

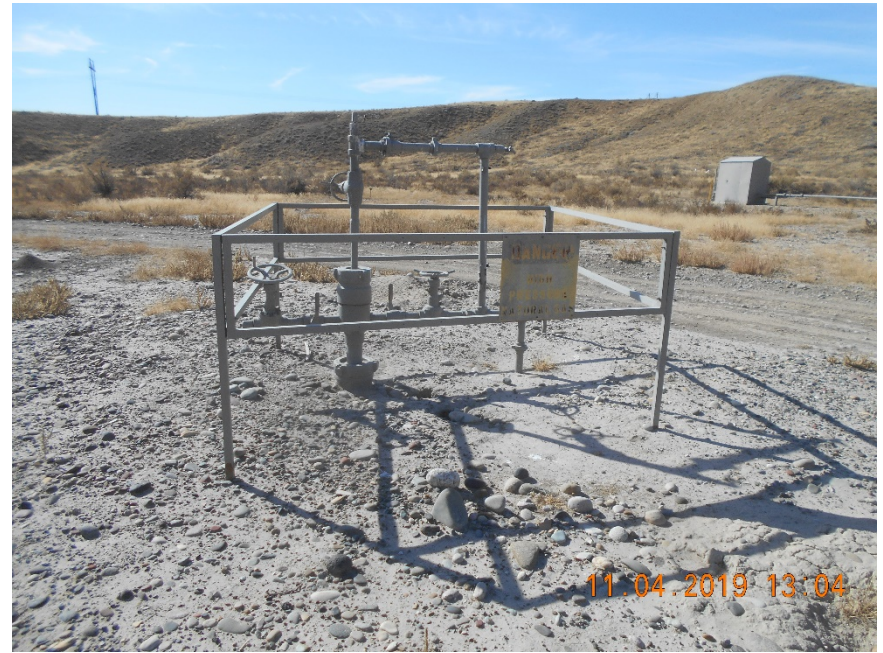
Wellhead with fence.

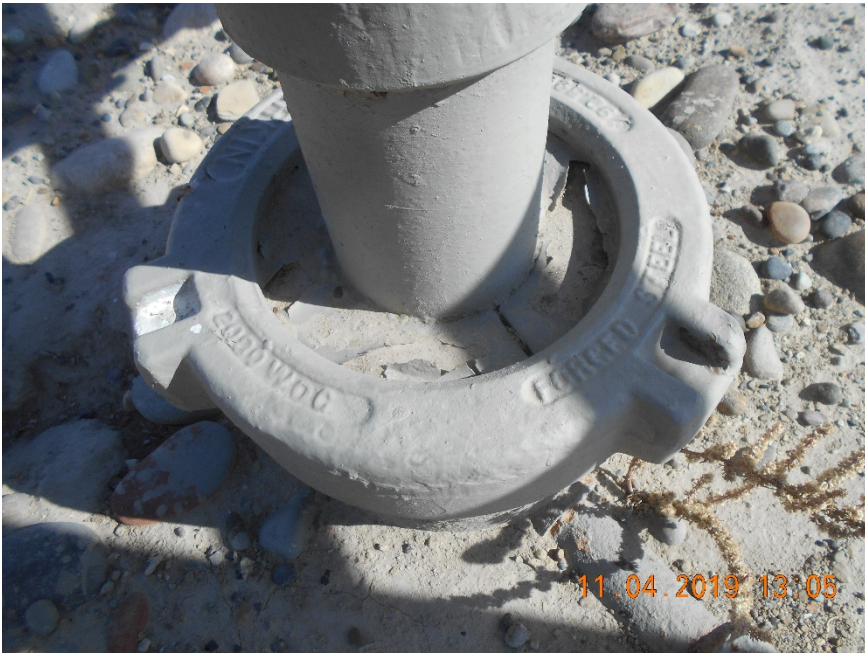
Audible leak at Surface casing / Production casing seal.

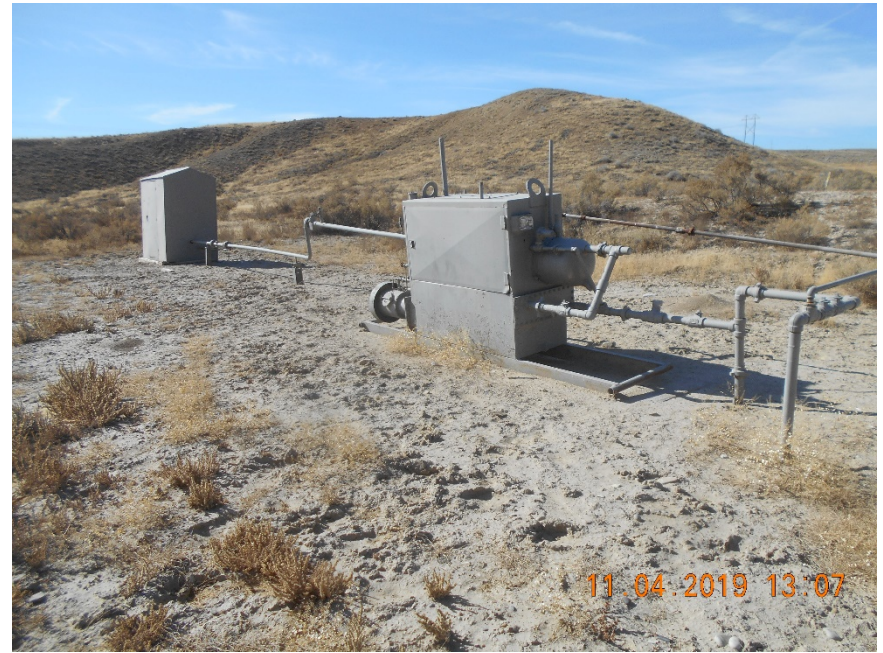
Separator and Meter housing looking SW

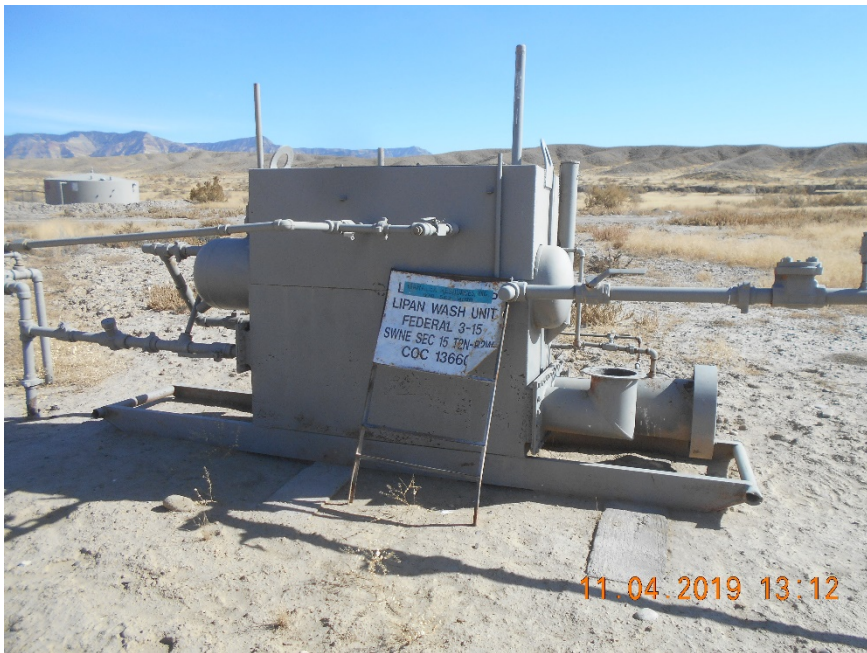
Separator with sign. Sign not visible from location entrance.

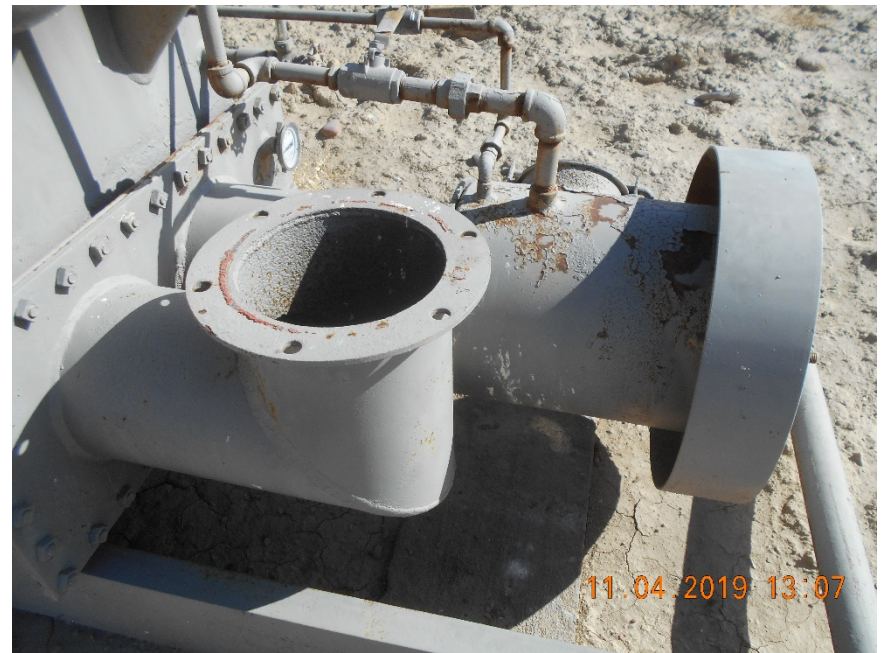
**Open ended burner flue on separator
with no bird/wildlife screen.**

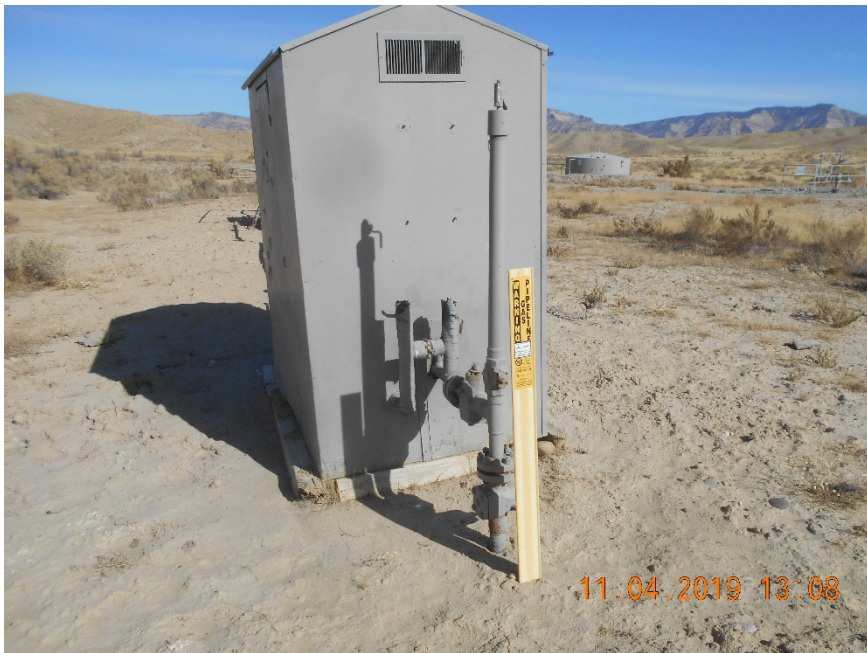
Meter housing with sales line riser.

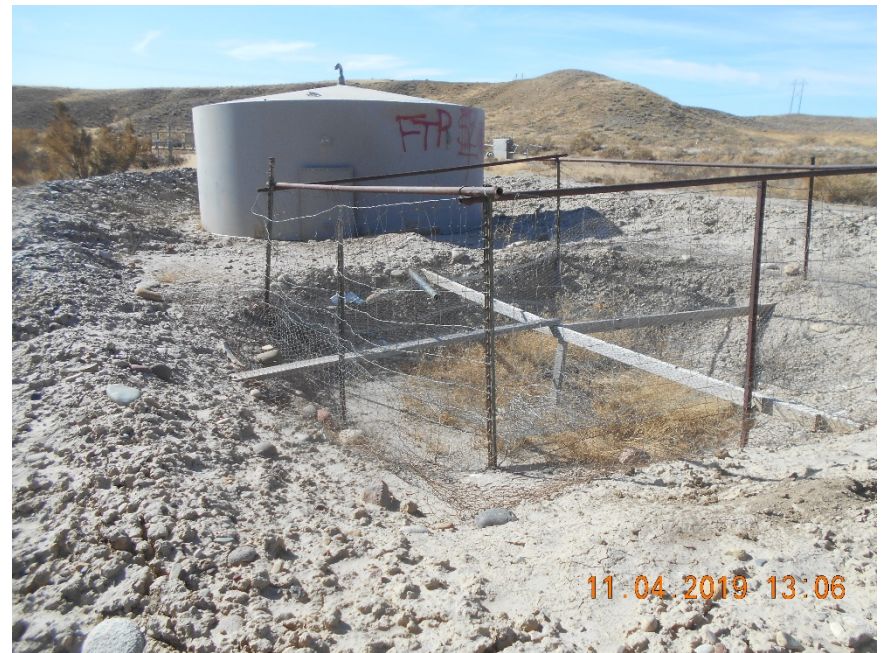
**Produced water tank and blowdown pit
with fence and netting.**

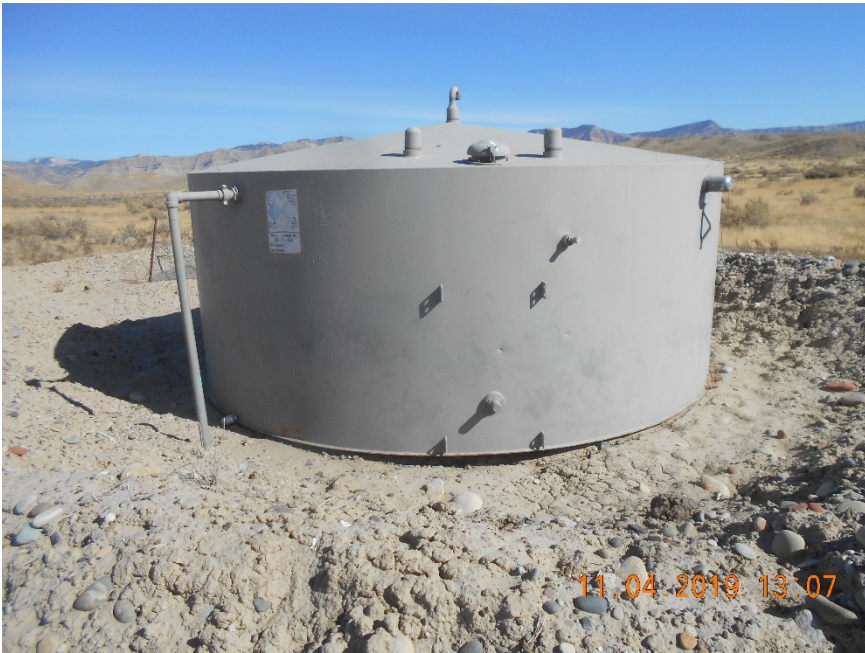
Produce water tank with fade and peeling labels.

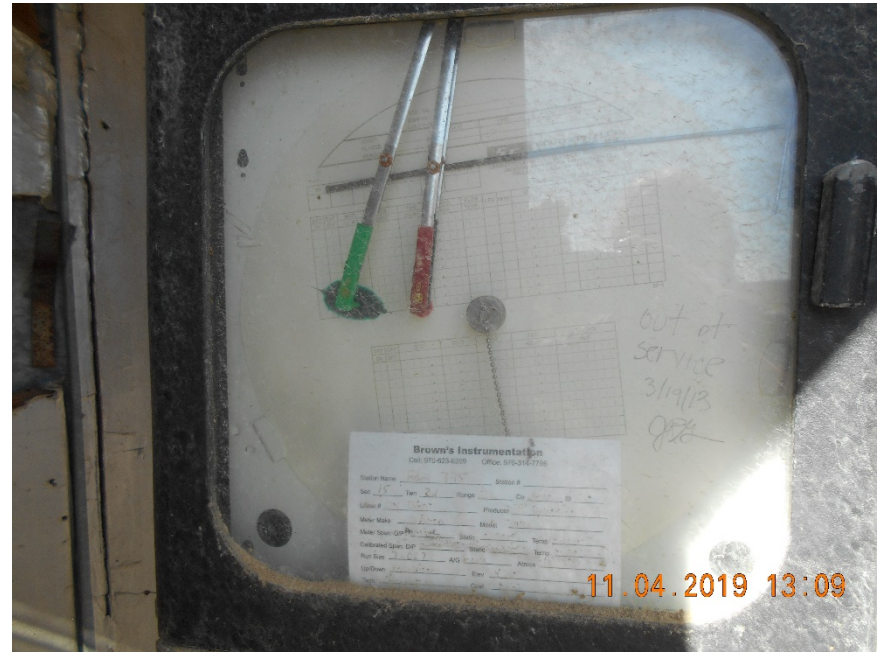
**Meter with Out of Service label
Dated 3/19/13**
