Inspection Photos
Location Name: Espinosa #1
API: 05-067-05781

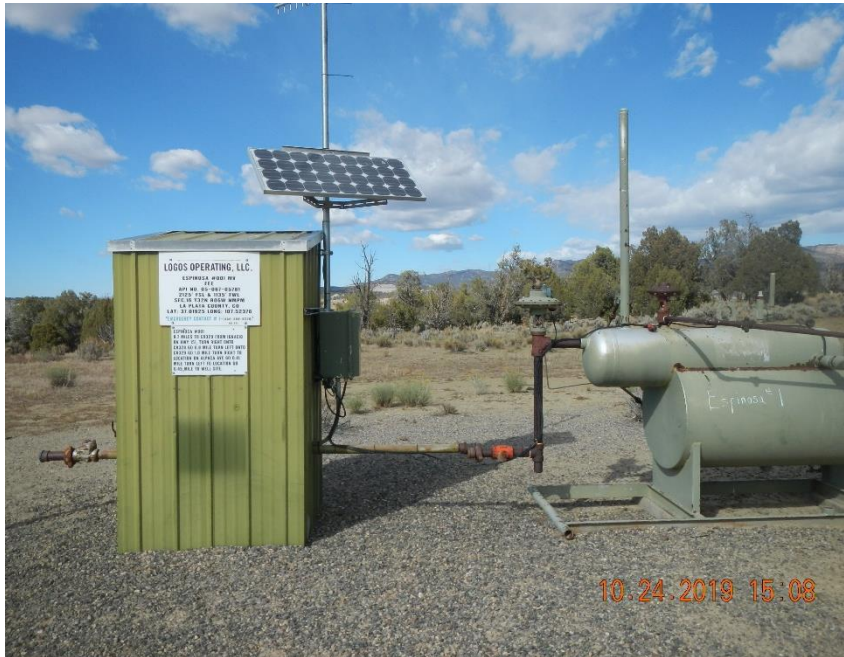
Logos Operating LLC Espinosa #1 observed to be temporarily abandoned during this inspection.

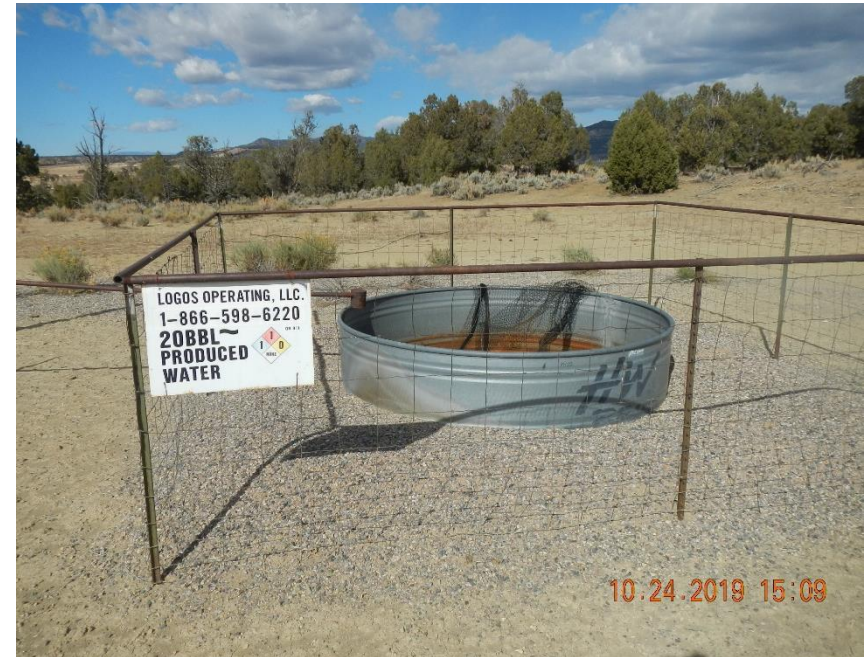
Netting on produced water vessel has fallen into tank.

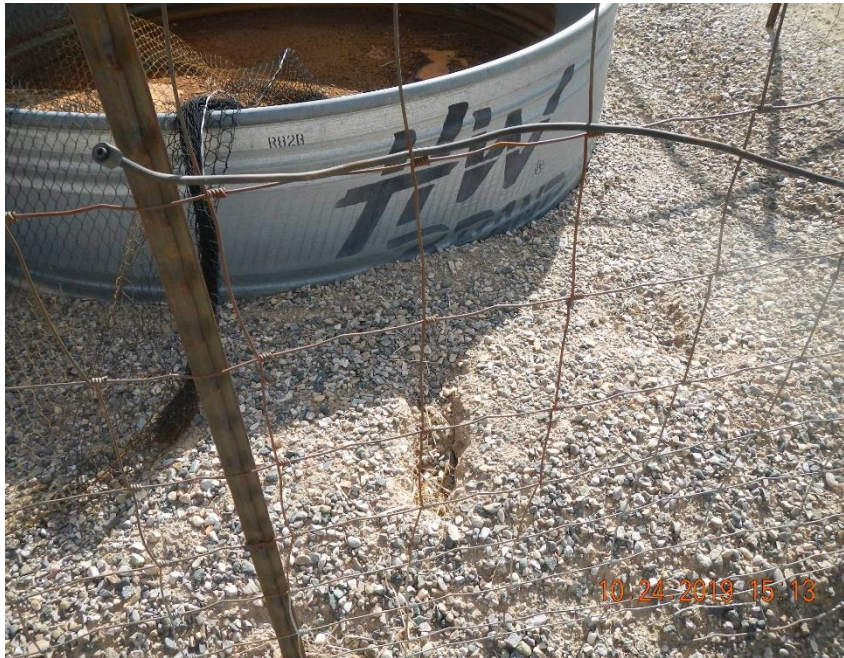
Secondary containment for produced water vessel has animal burrows in it and appears to be insufficient capacity.

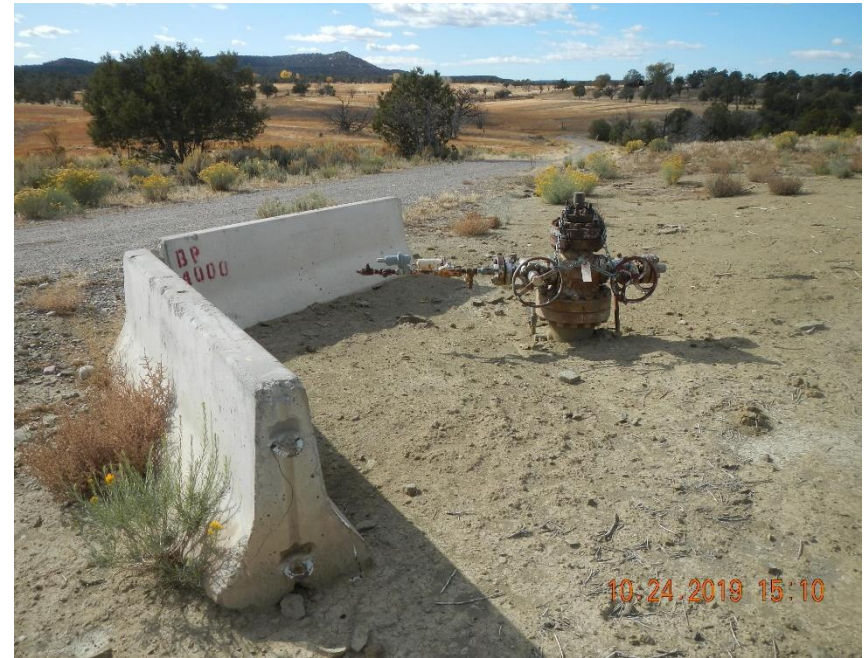
Espinosa #1 well head.
