Inspection Photos  
Operator: Kinder Morgan  
Location/API #: 033-06081  
Date: 10-29-2019

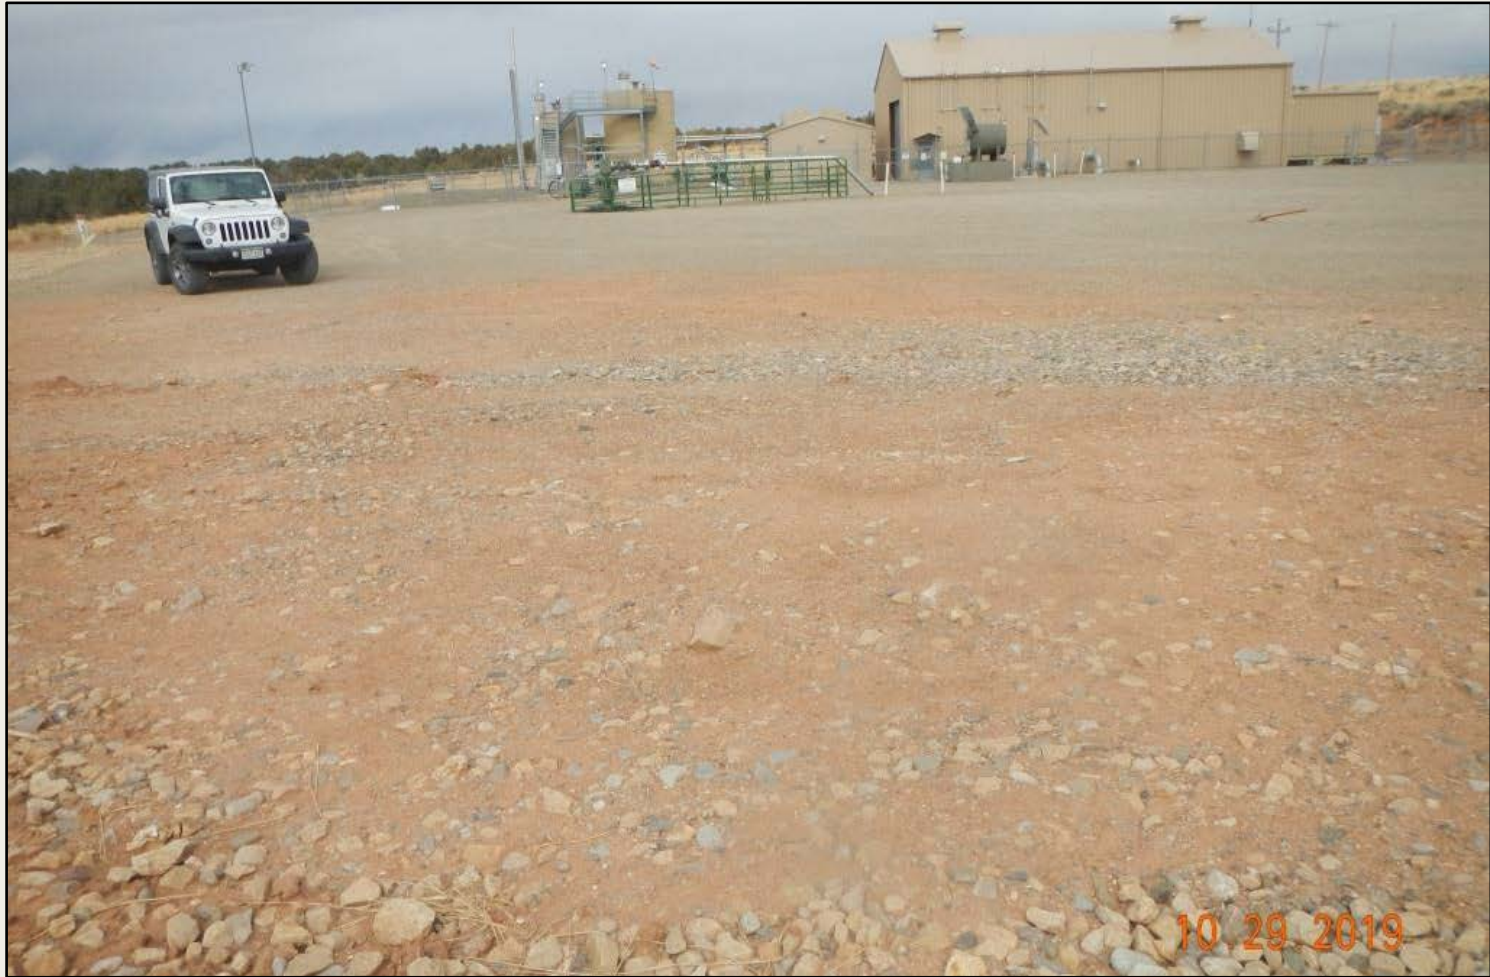
Photo 1. View of the project area from the southwestern corner facing center.

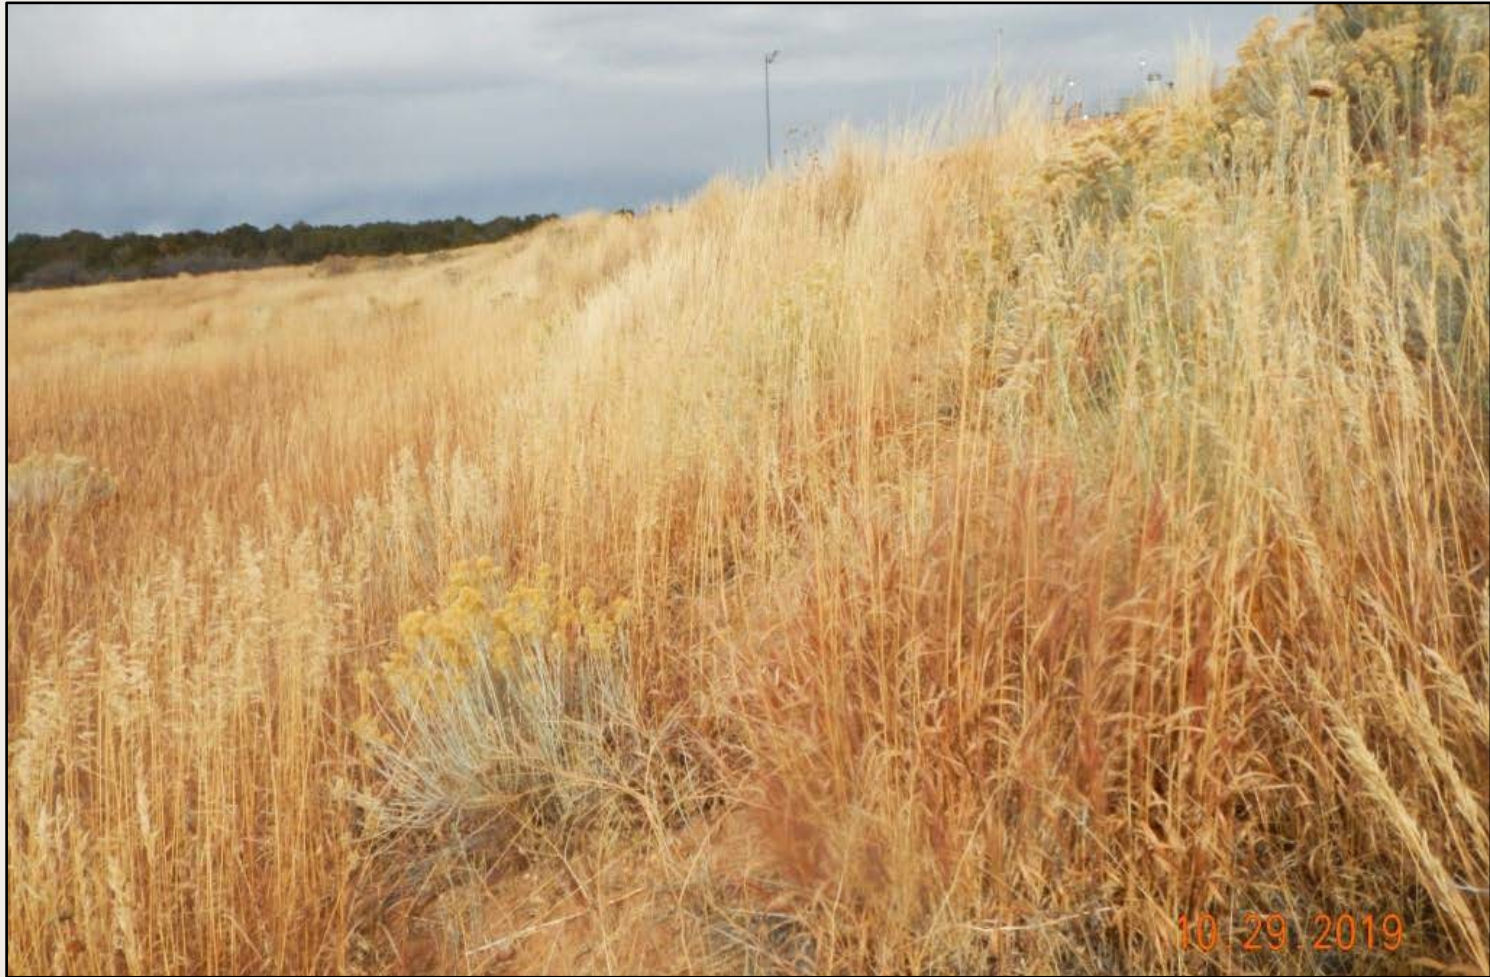
Photo 2. View of the western fill slope from the southwestern corner facing northward. Revegetation is progressing within the interim reclamation areas, largely with a mixture of wheatgrasses and smooth brome, as well as rubber rabbitbrush shrubs.

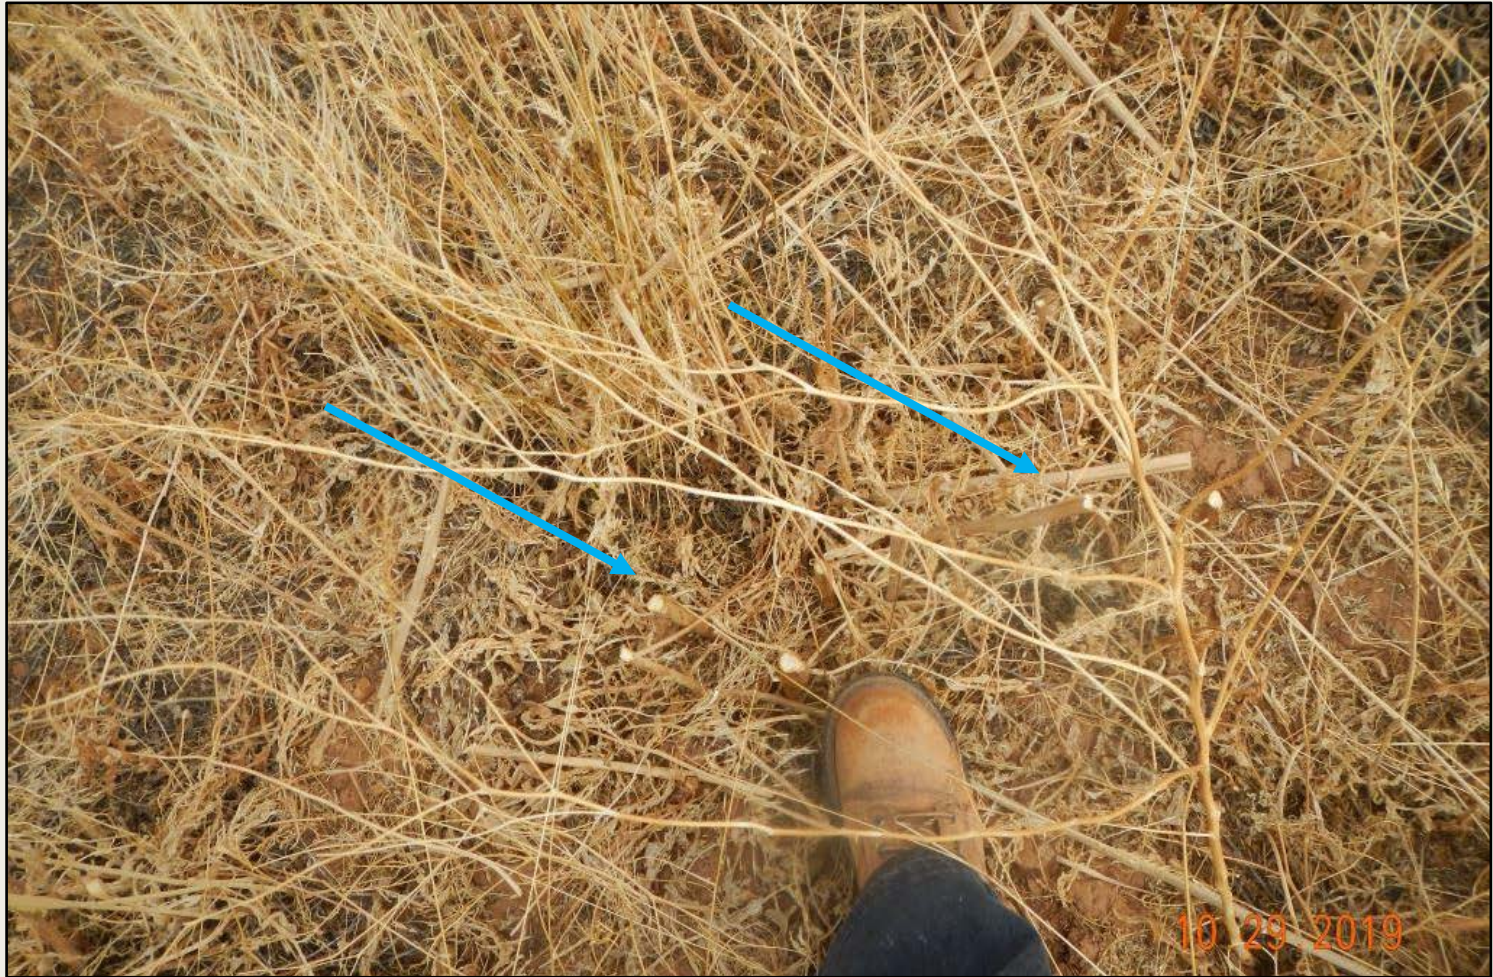
Photo 3. View of musk thistles that appear to have been cut and removed as a treatment measure.

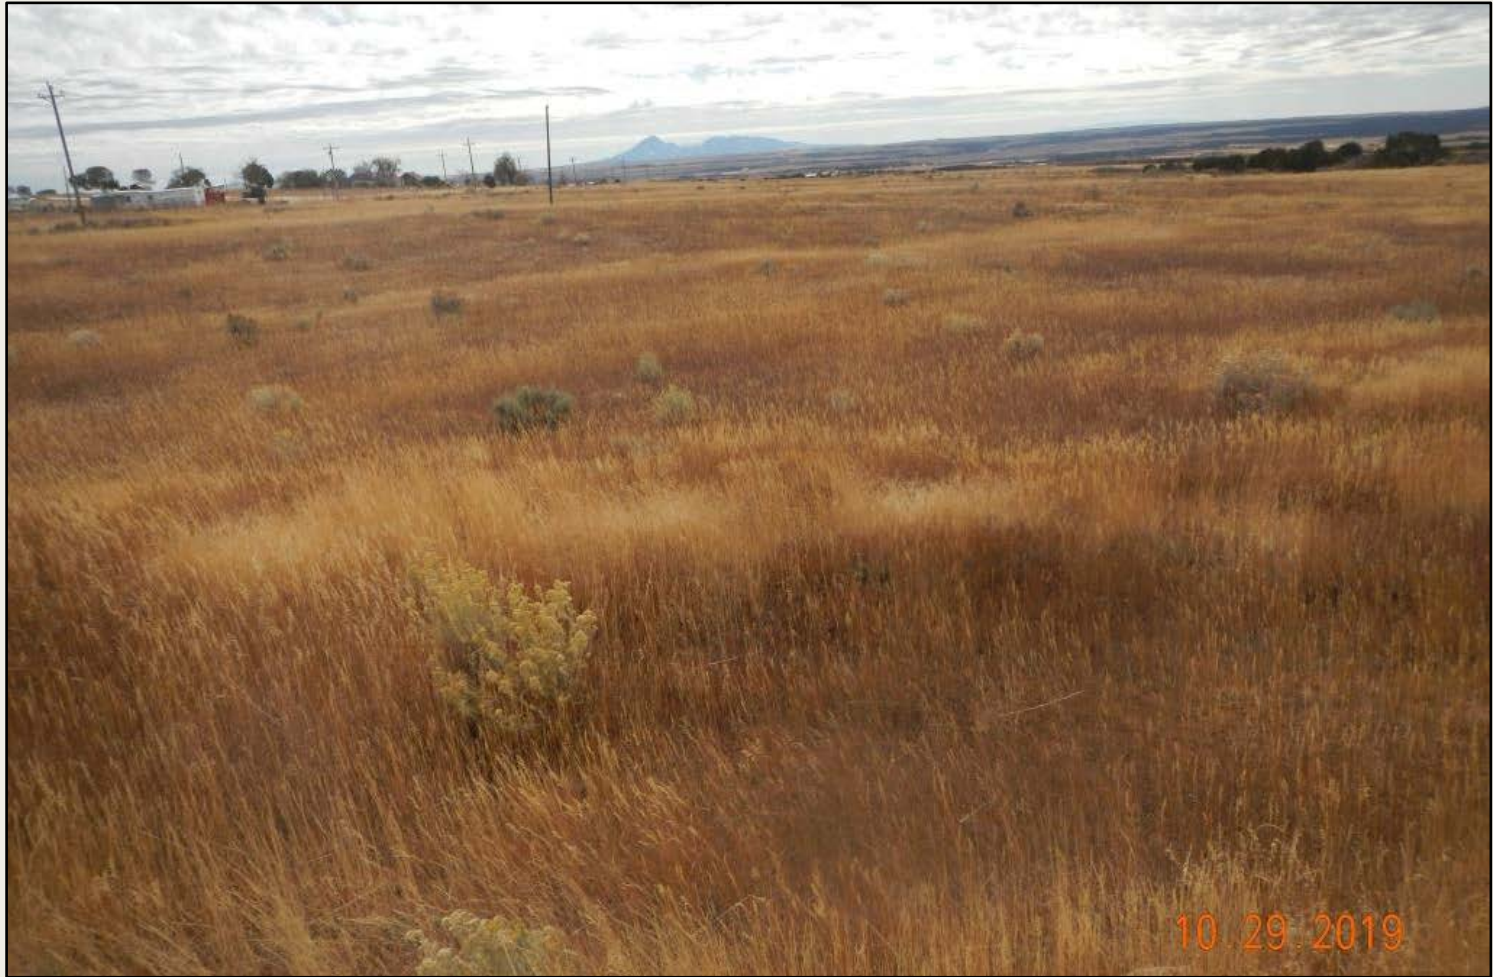
Photo 4. View of reference area vegetation northwest of the project area, comprised of grass field, dominated with smooth brome.
