Inspection Photos
Operator: Kinder Morgan
Location/API #: 033-06183
Date: 10-29-2019

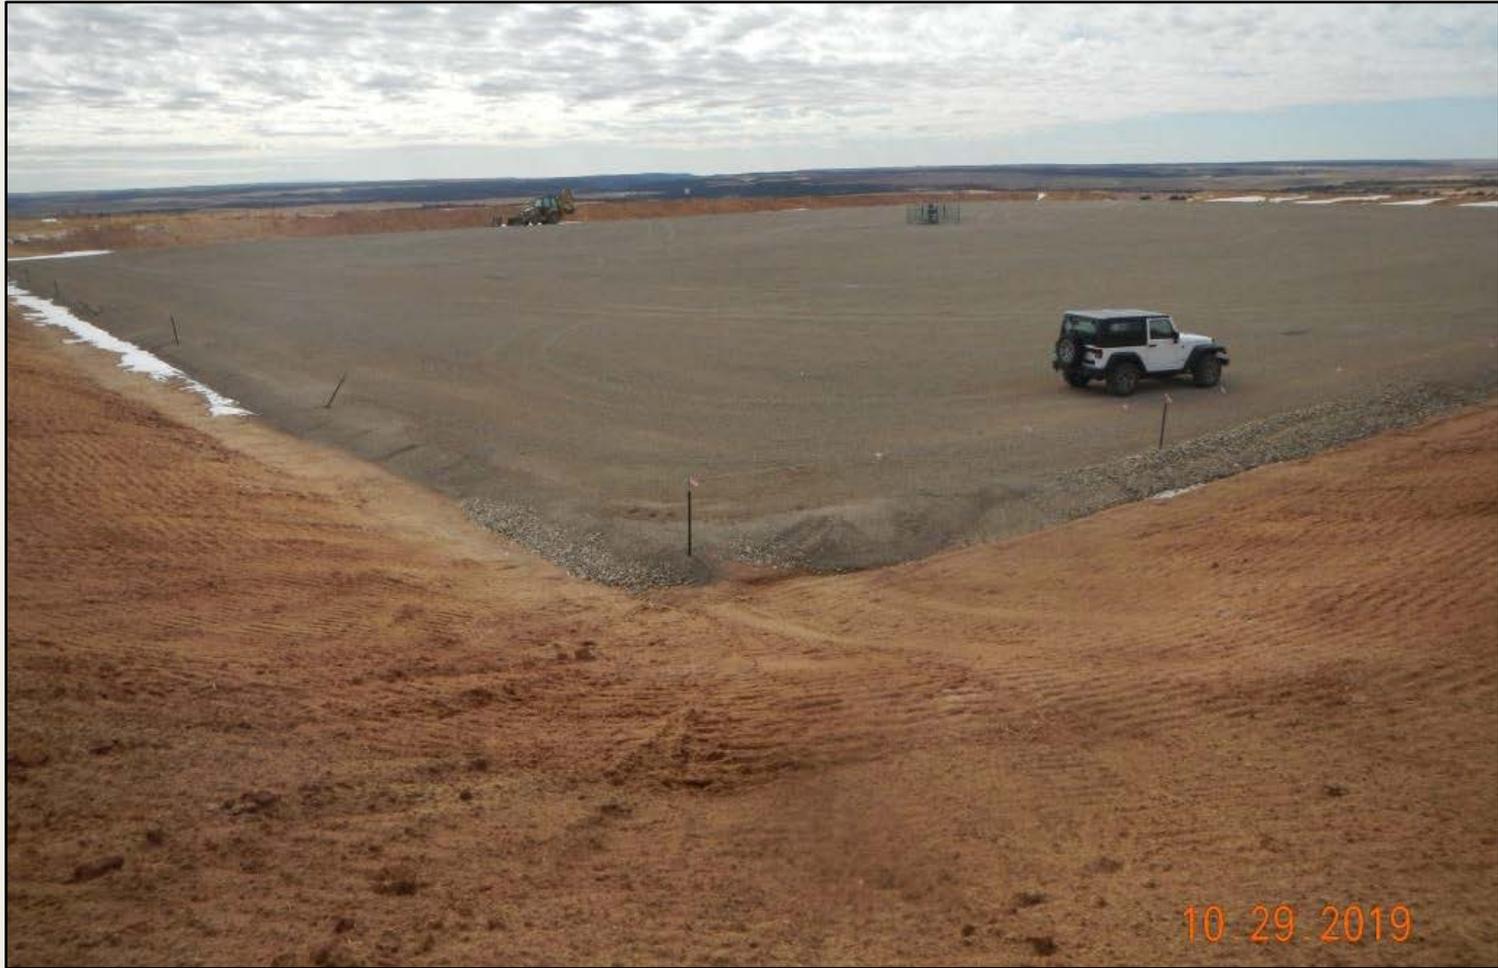
Photo 1. View of the project area from the northwestern corner facing center.

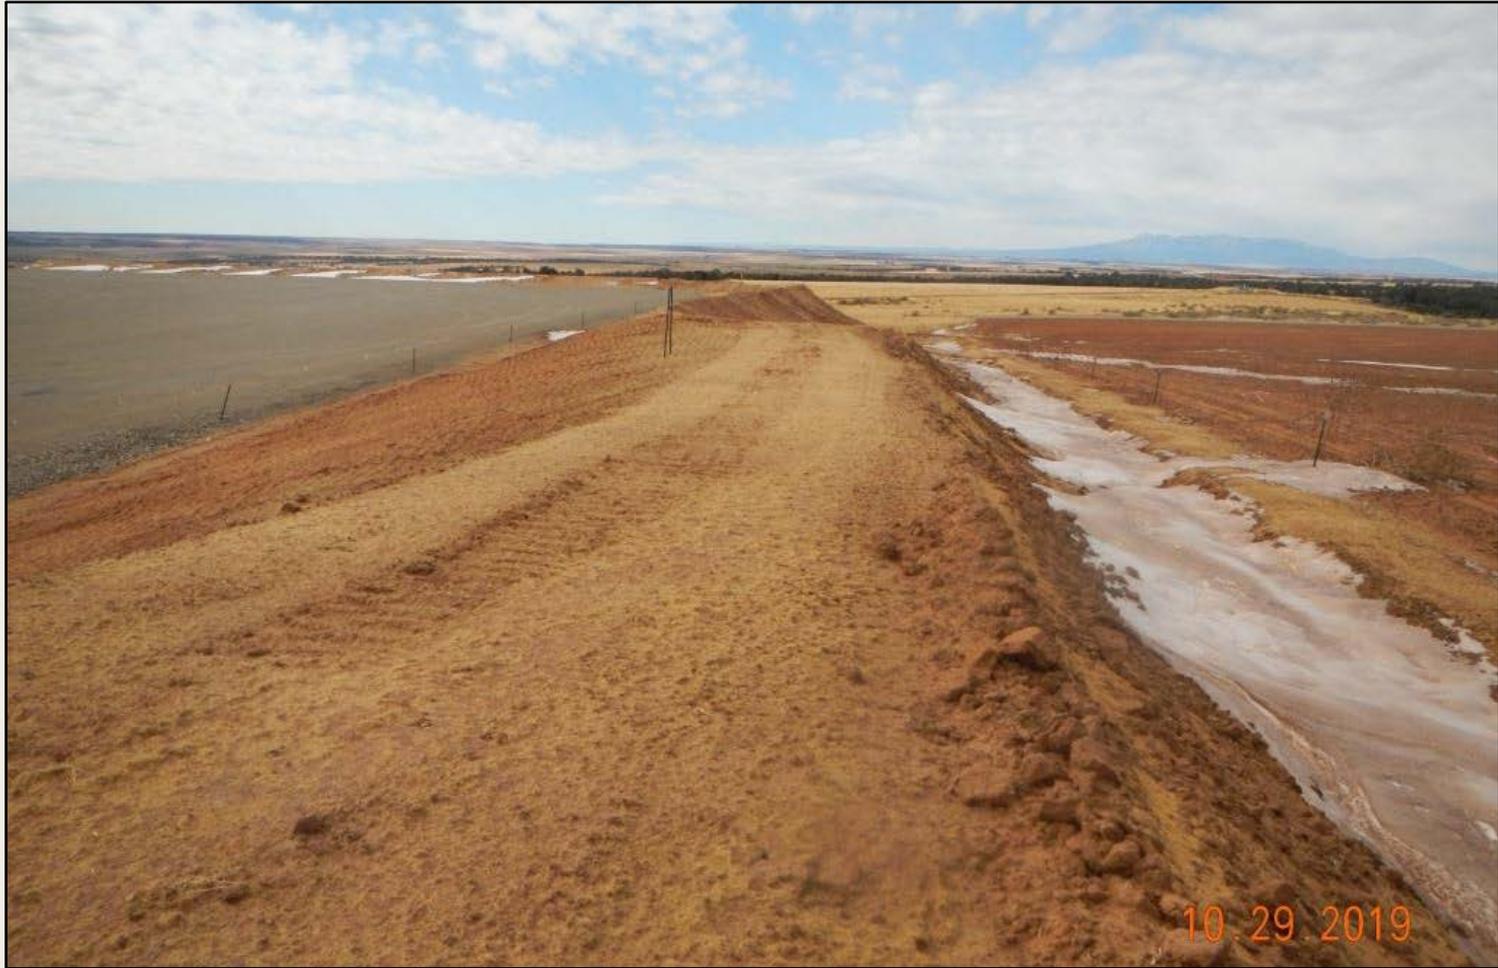
Photo 2. View of the northern fill slope from the northeastern corner facing westward. Disturbed soils are tracked and hydromulched. Drainage swales are berms are placed around the well pad perimeter.

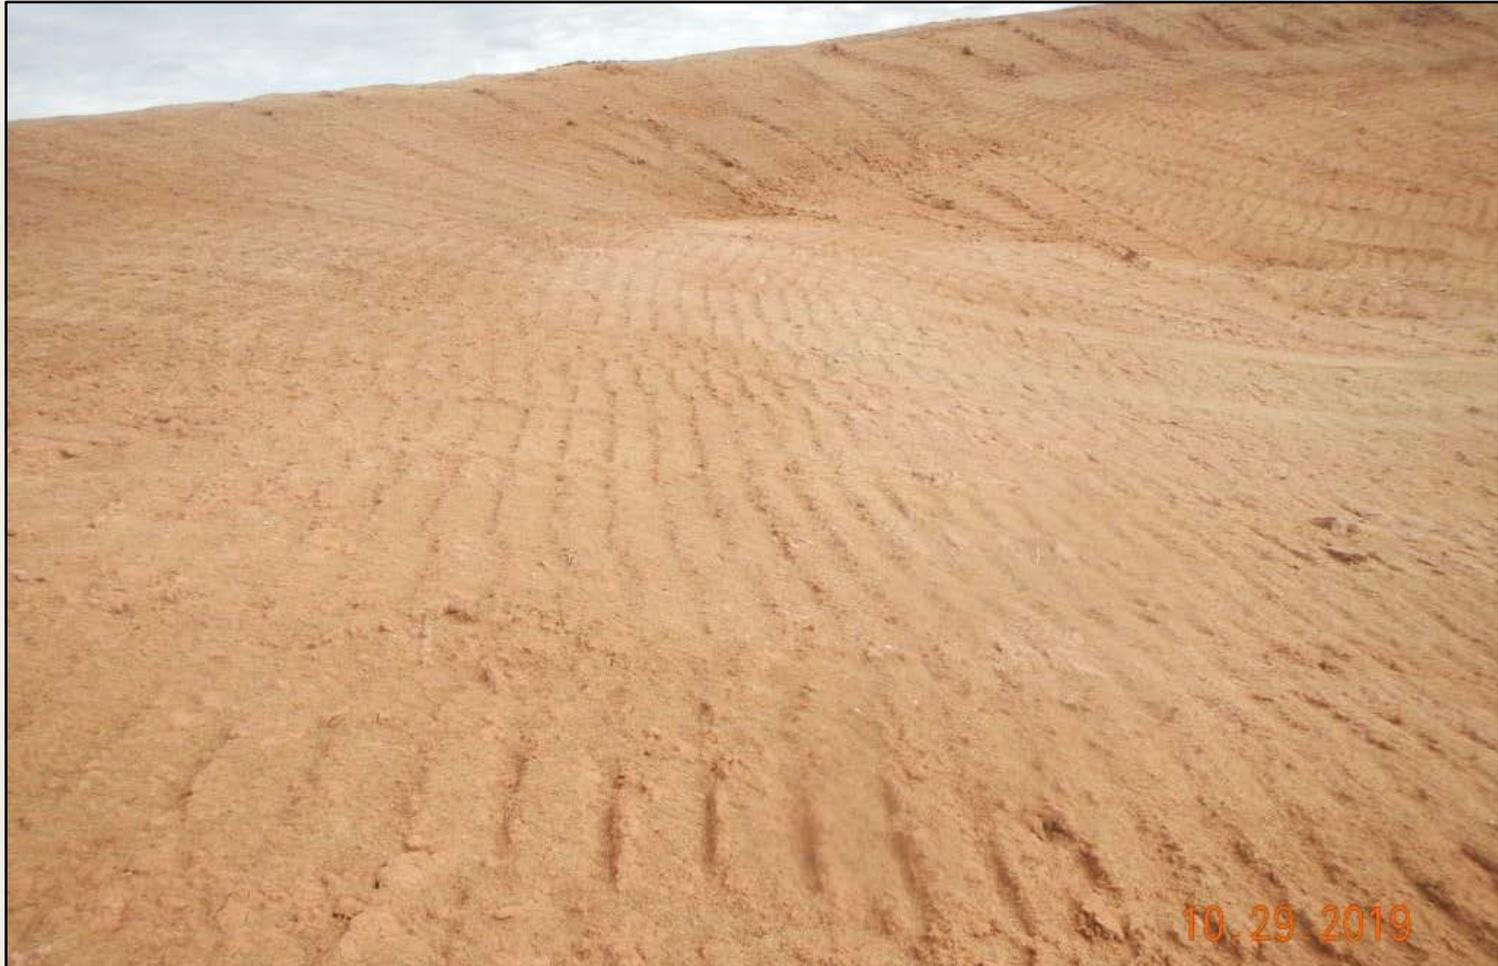
Photo 3. View of the tracking on slopes within the southeastern project area.

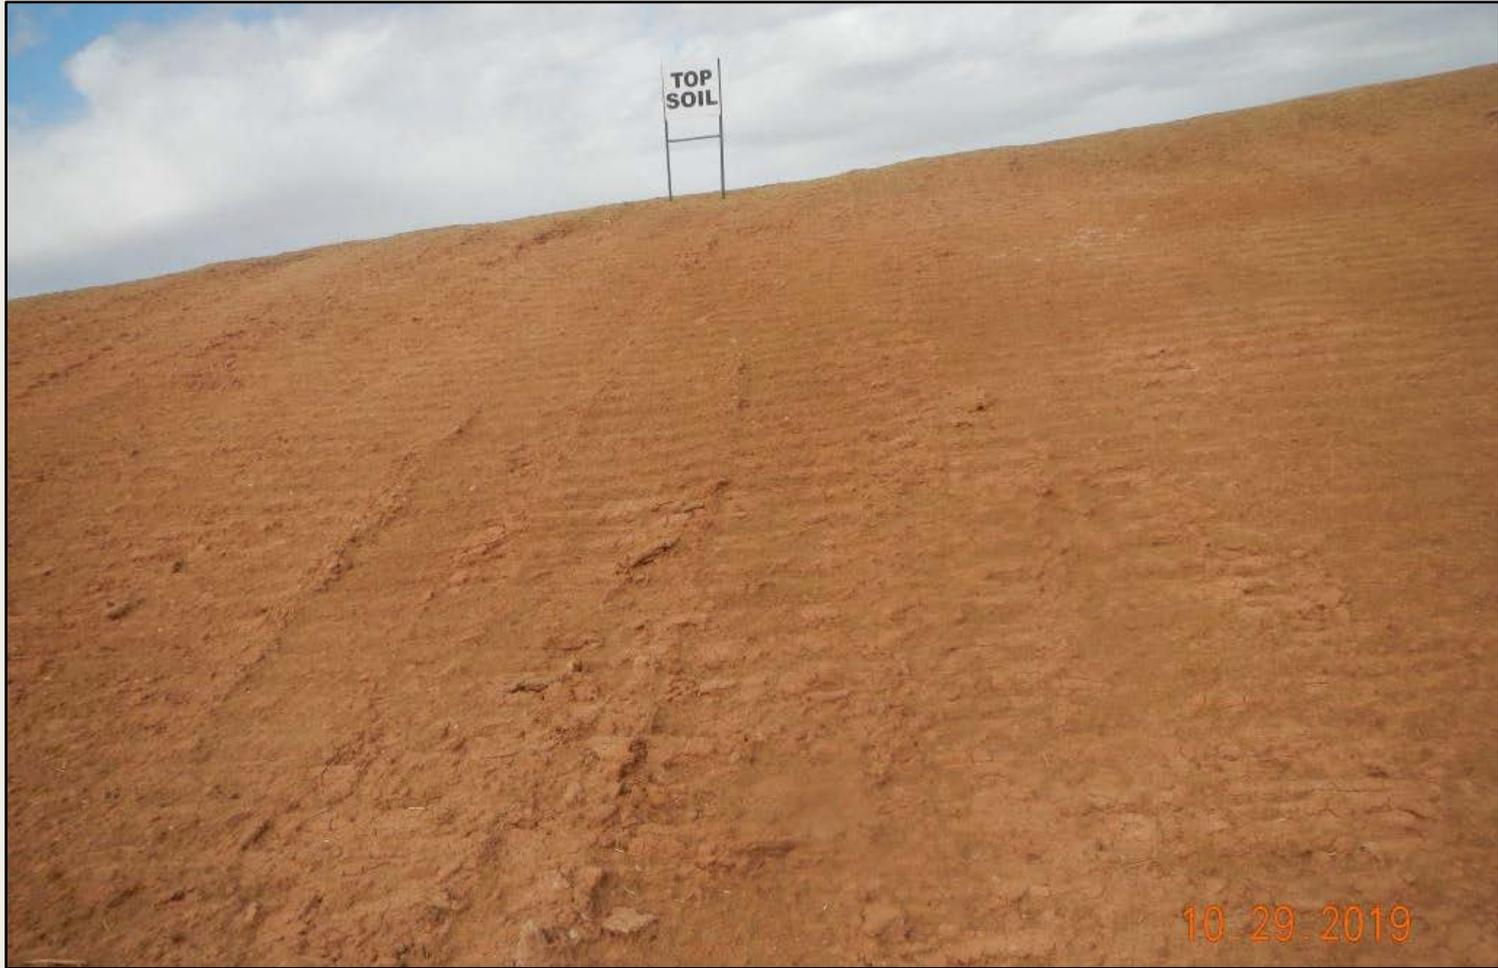
Photo 4. View of topsoil signage and stockpiling within the eastern project area.

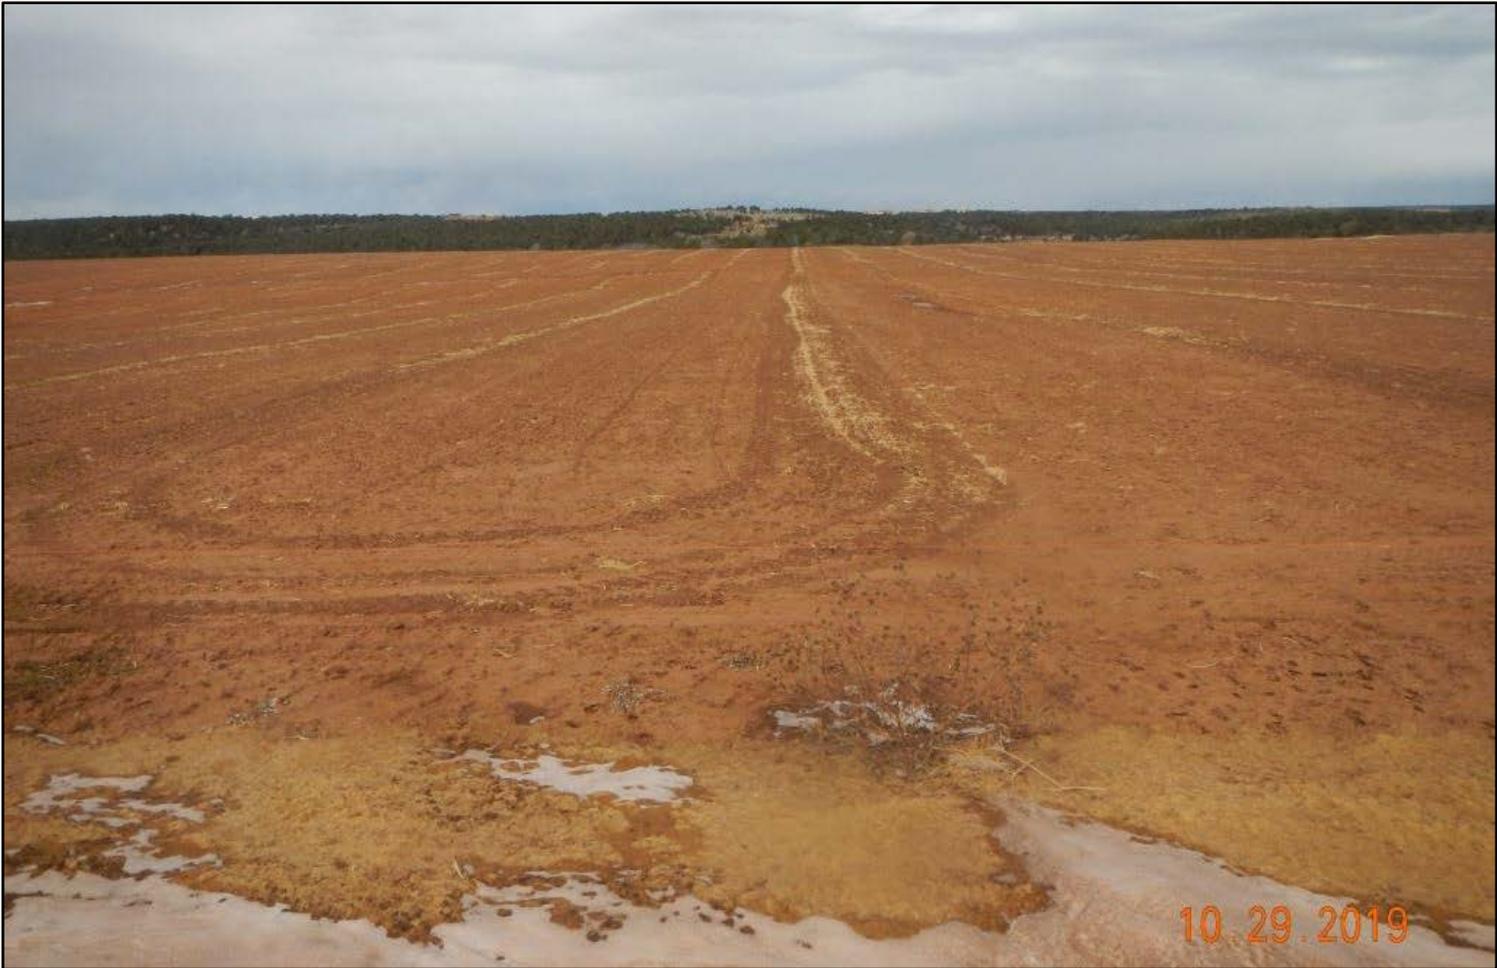
Photo 5. View of reference area in background, comprised of a cultivated field that is not supporting crop at this time.
