Inspection Photos
Operator: Catamount Energy
Location/API #: 007-06098
Date: 11-1-2019

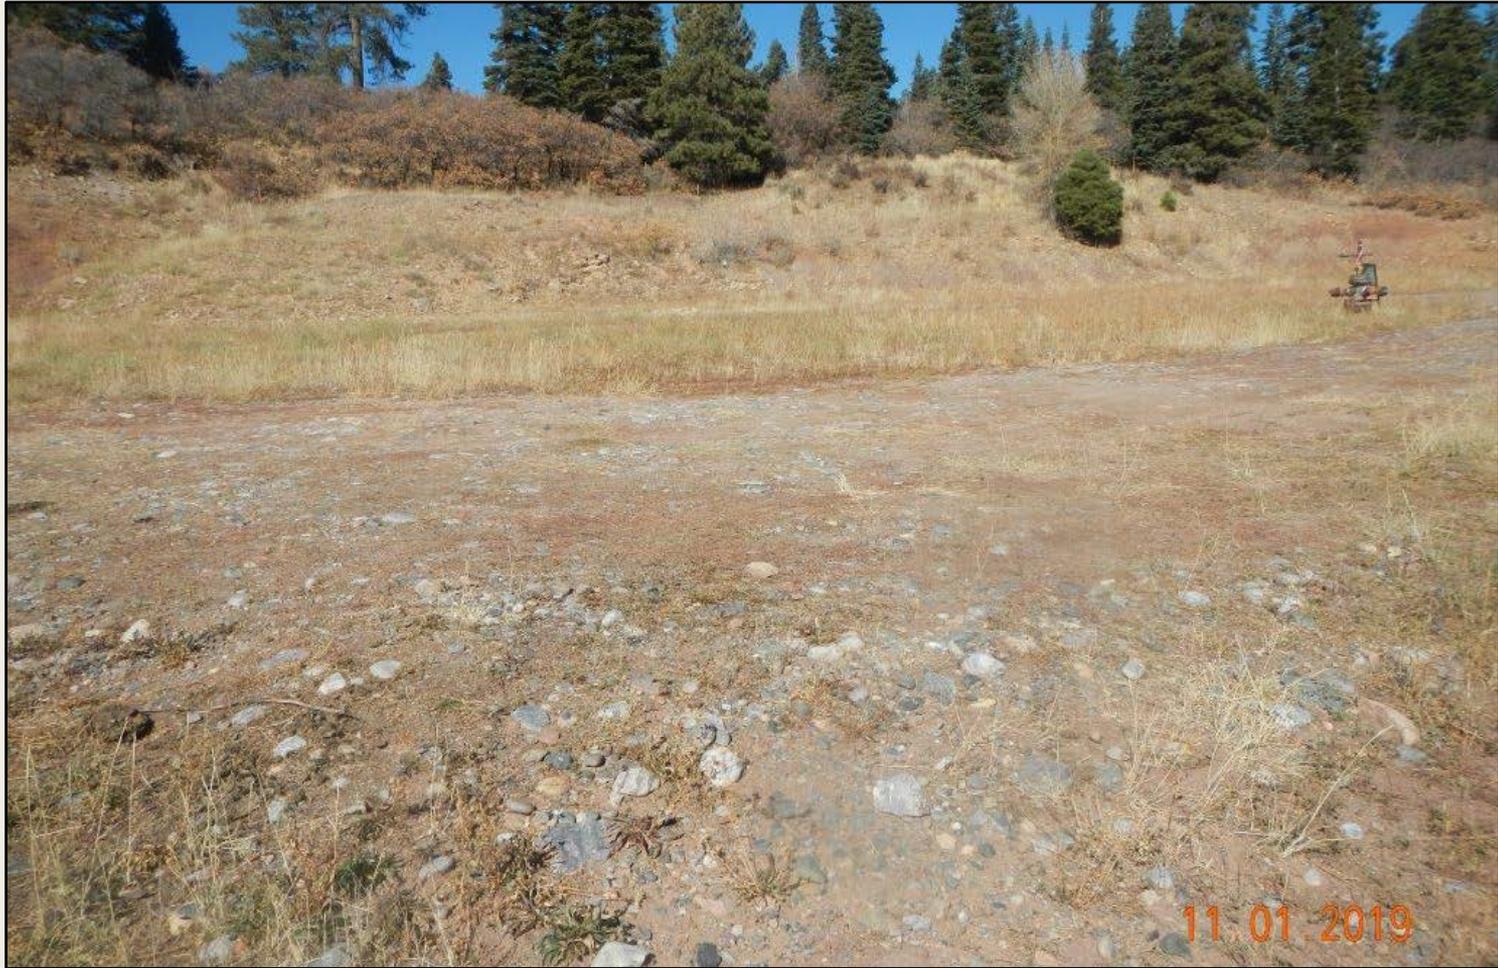
Photo 1. View of the project area from the southwestern corner facing center.

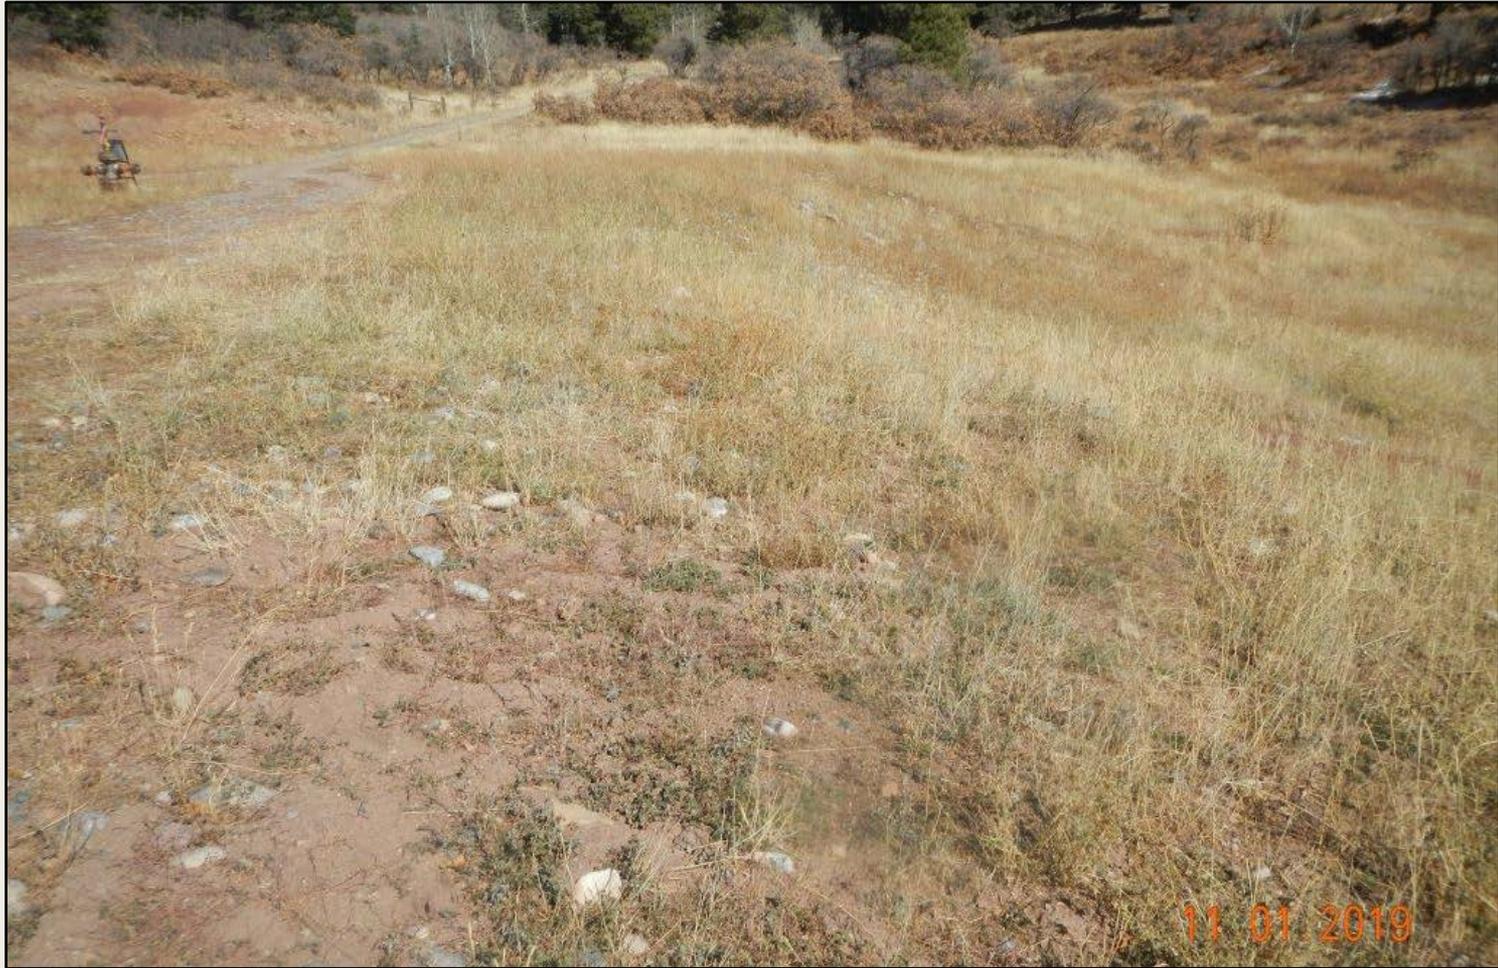
Photo 2. View of the southeastern fill-slope from the southwestern corner facing northeastward. Revegetation is progressing on fill slopes with perennial grasses such as western wheatgrass and smooth brome, as well as forbs such as Arizona gumweed.

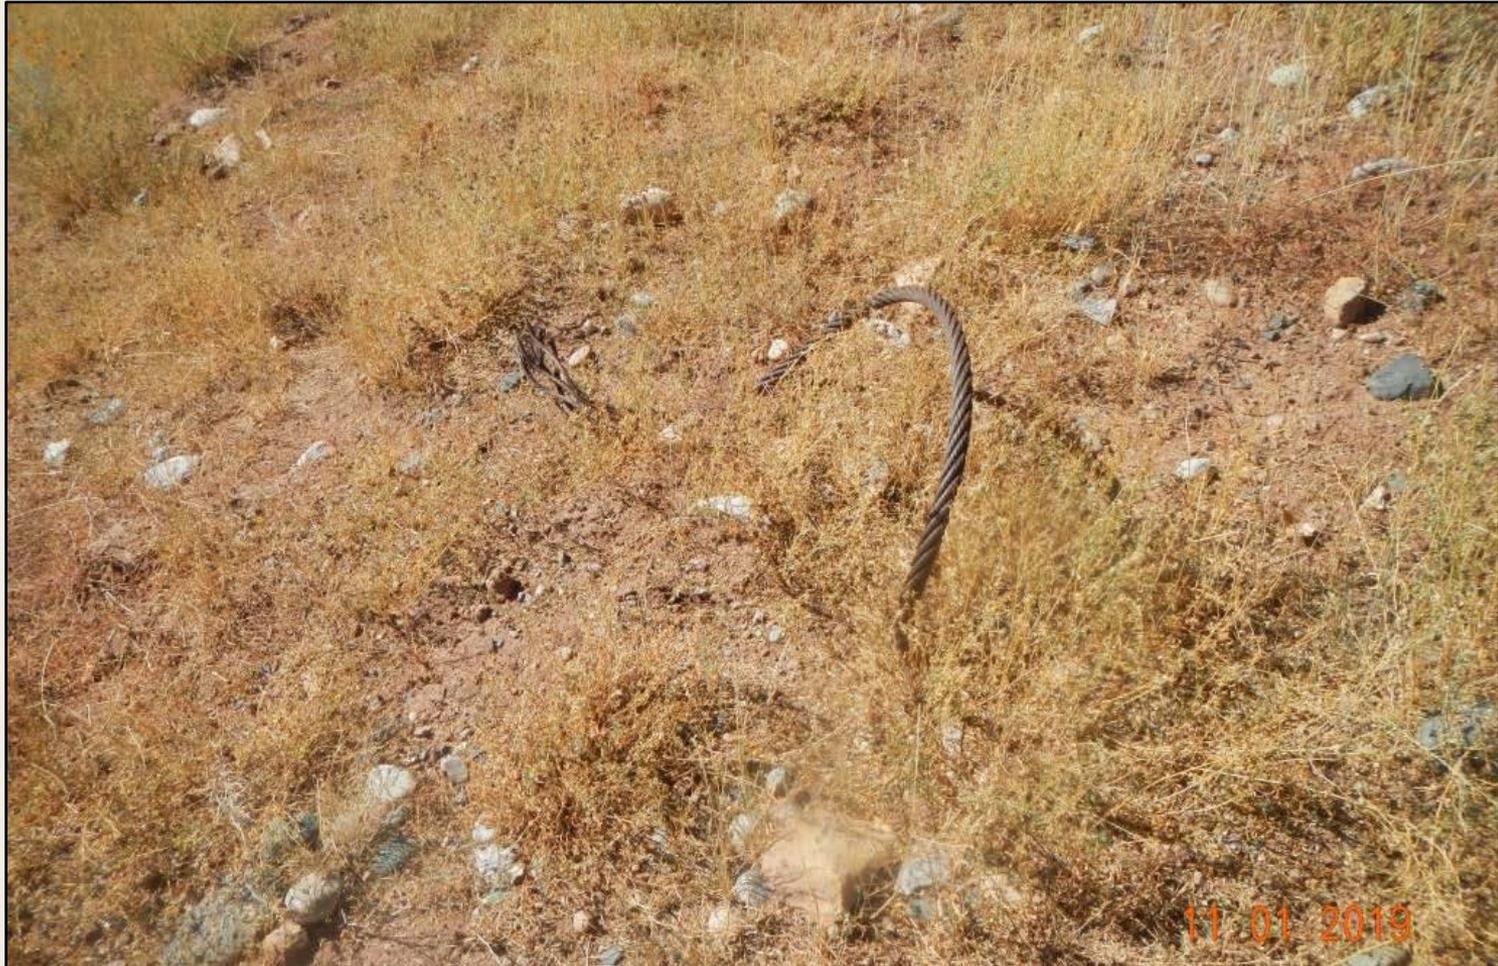
Photo 3. View of rig cable debris within the southeastern project area.

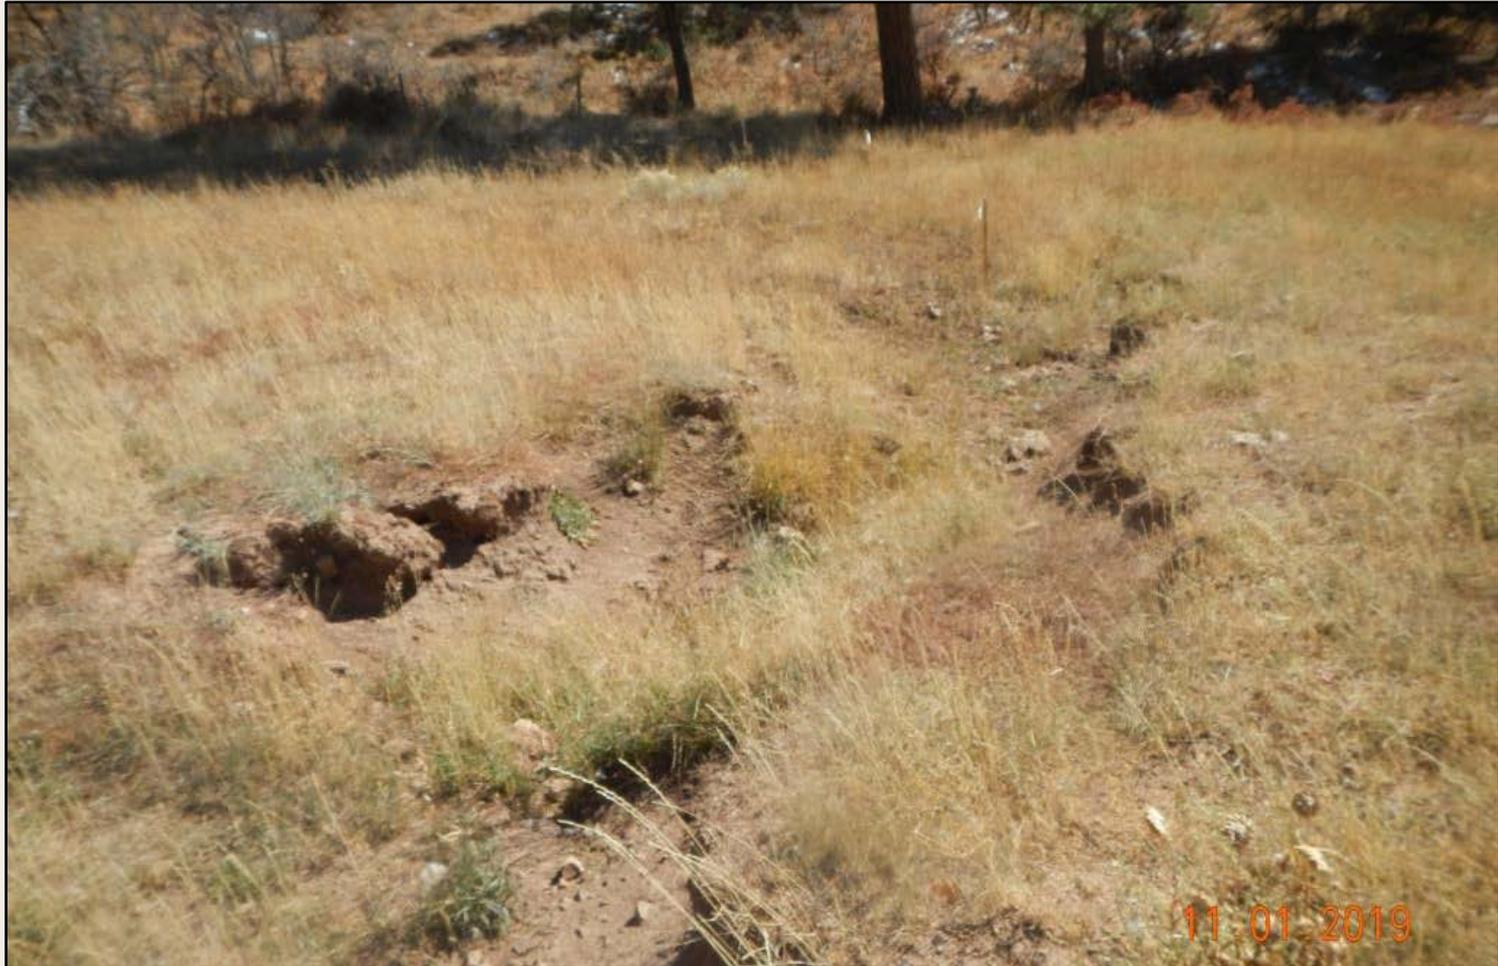
Photo 4. View of erosional channel, approximately 2 to 3 feet wide and 2 feet deep, within the southeastern project area.

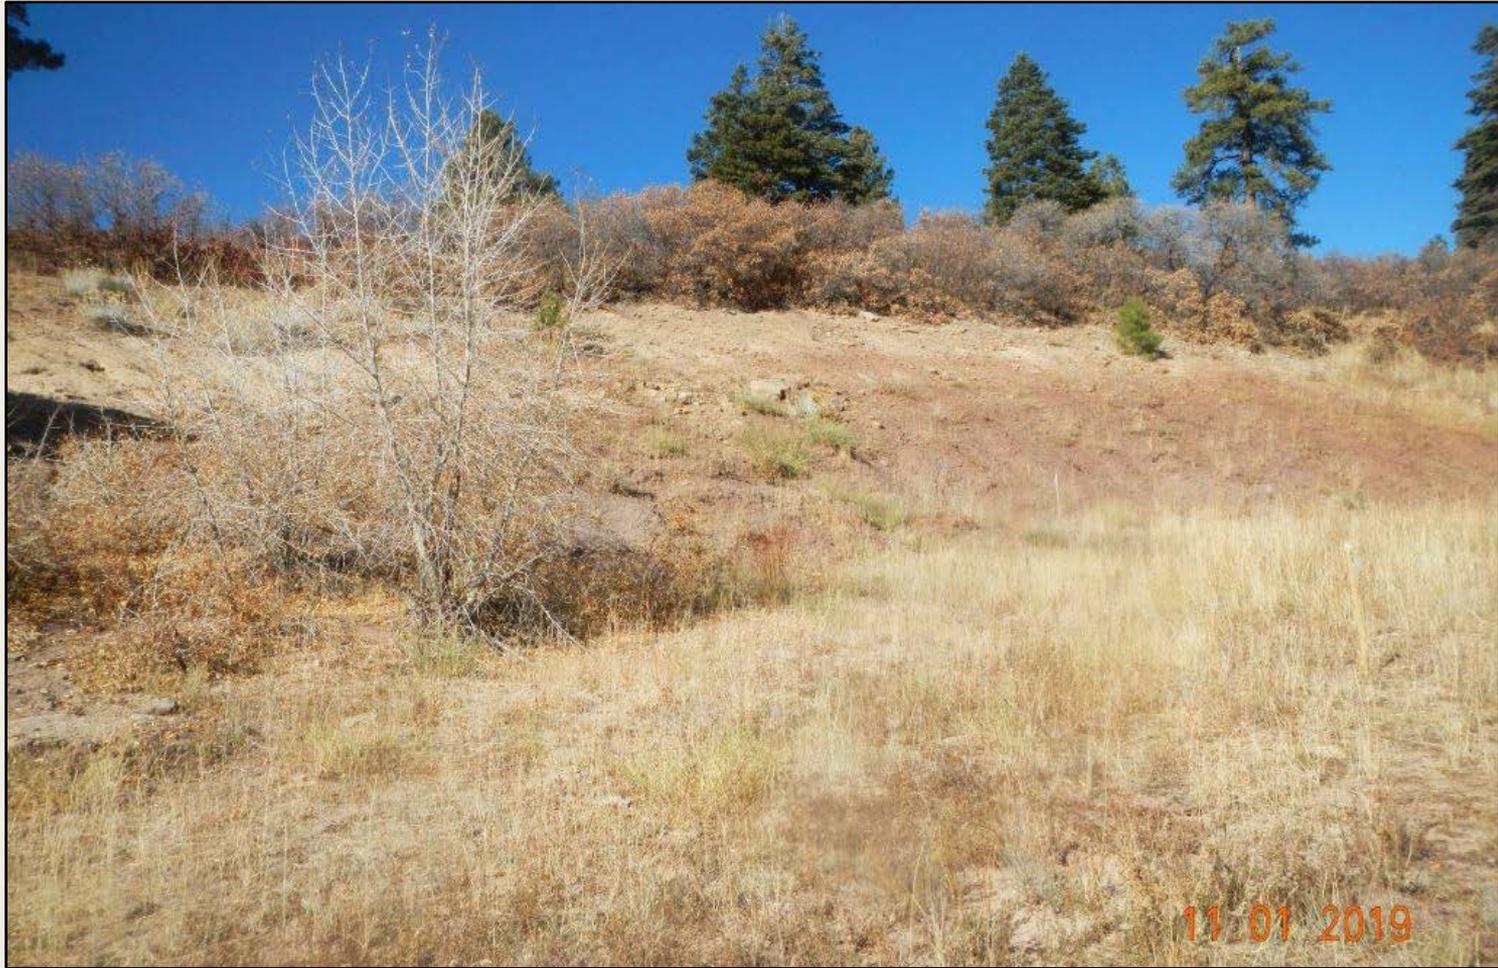
Photo 5. View of well pad cut-slope with poor revegetation. Rilling and scouring observed on bare soils.

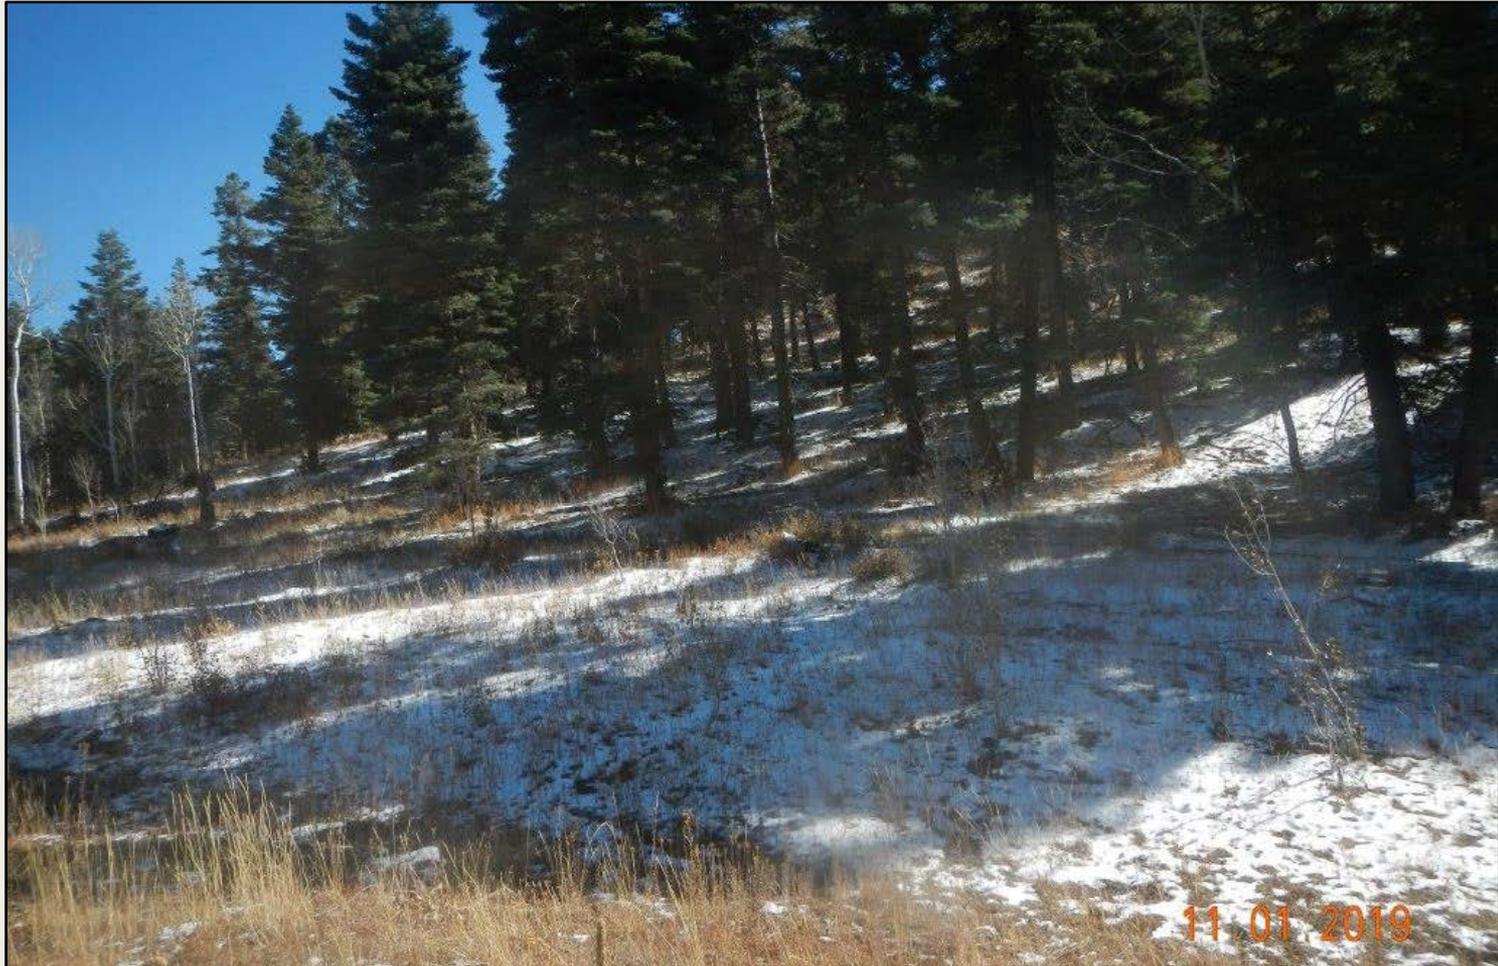
Photo 6. View of reference area vegetation, comprised of mixed conifer woodland with grass and gambel oak-dominated understory.

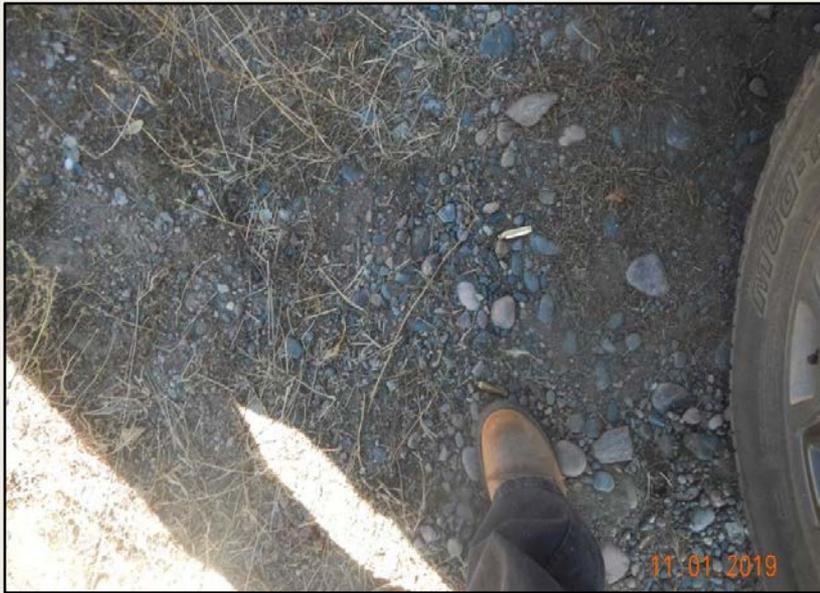
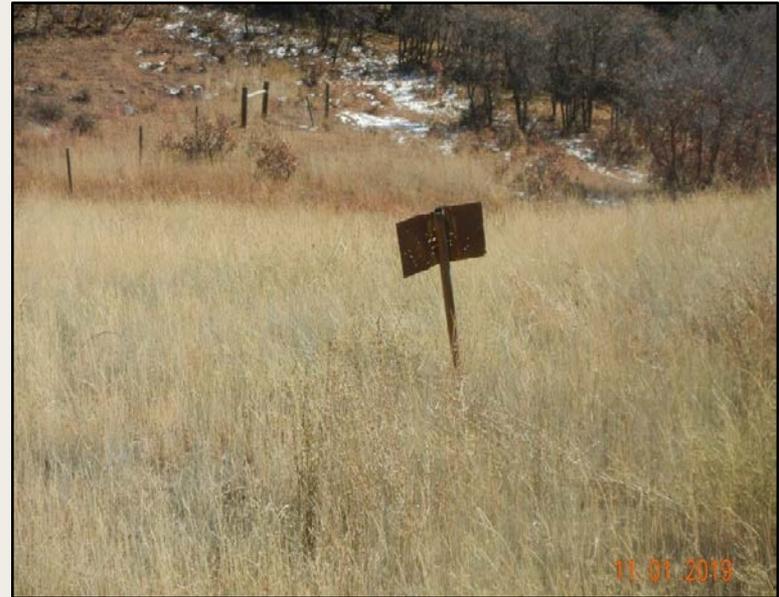
Photos 7, 8. View of shells from firearms and sign with shot-holes observed within the project area.
