Inspection Photos

Location Name: Piceance 29-07 Pad

Location ID: #334436

Inspection Date: November 08, 2019

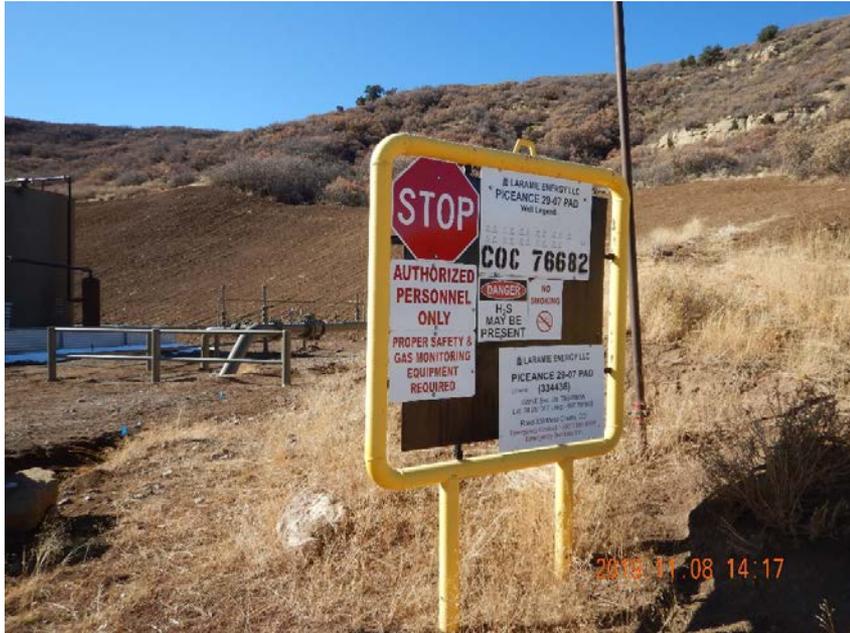
Photo #1 – Facility sign.

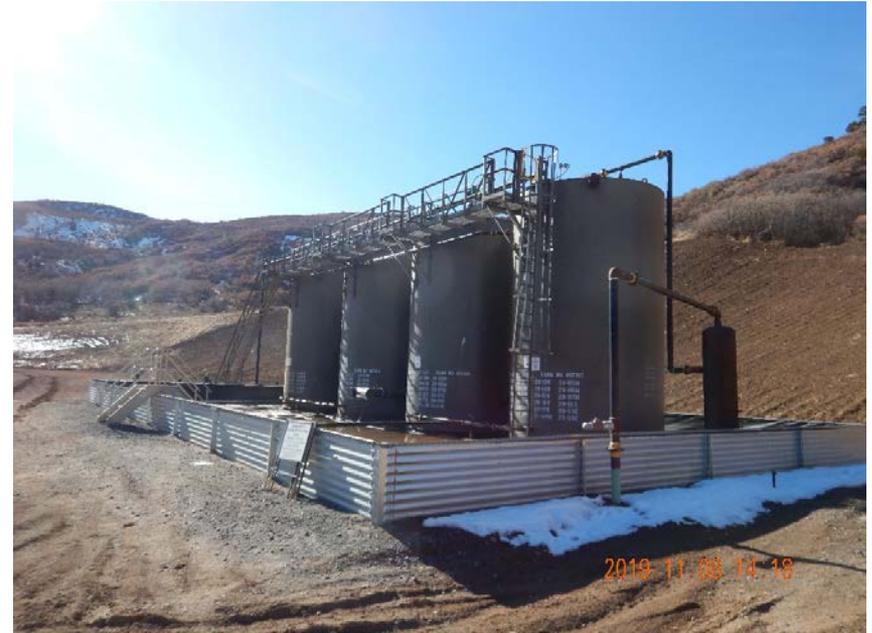
Photo #2 – Overview of tank battery from northeast.

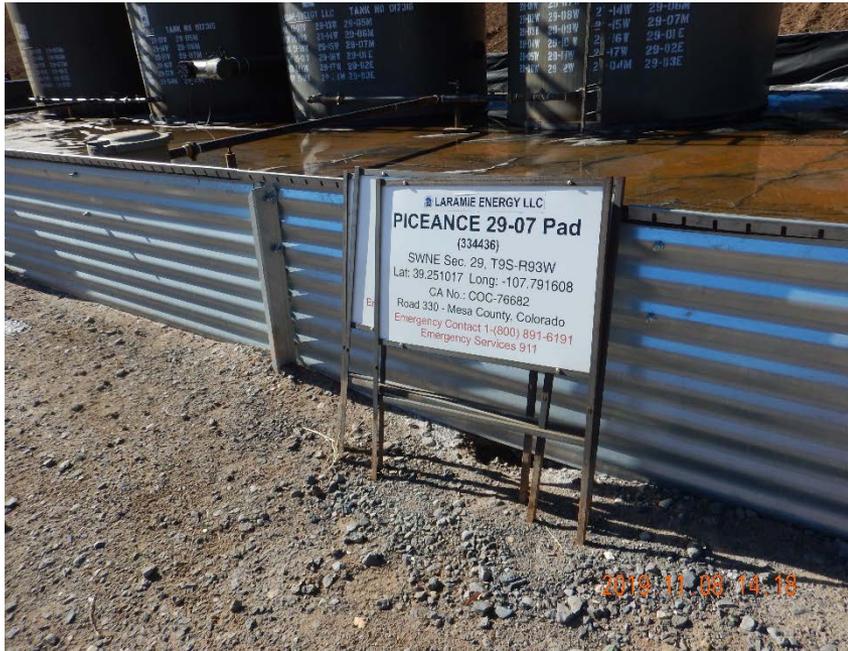
Photo #3 – Signs stored outside NE corner of tank battery were not installed on inspection date.

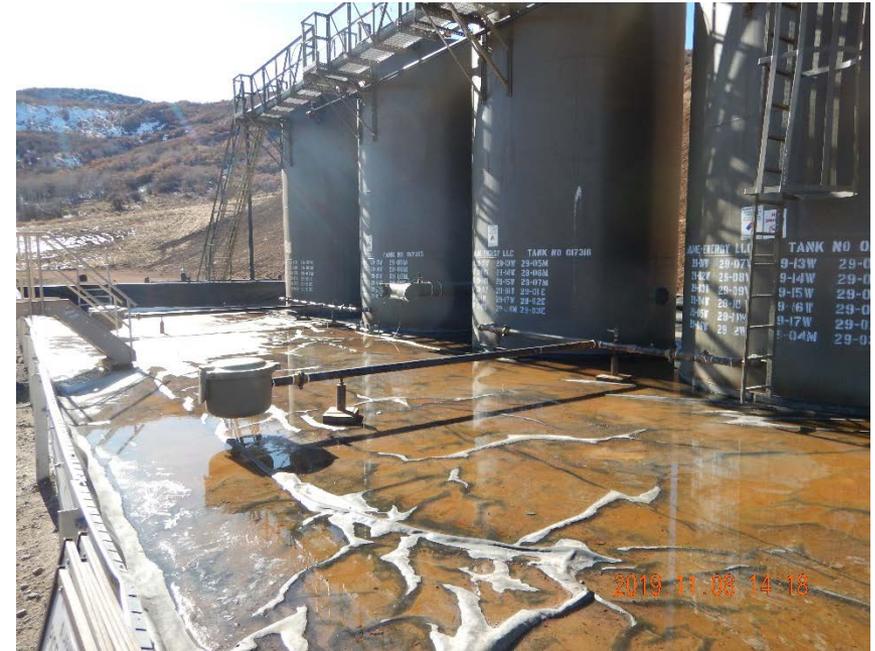
Photo #4 – View inside of tank battery containment area from NE. Note fluids inside of lined tank battery area.

Tank NFPA placards on east side of tanks read “Produced Water.”

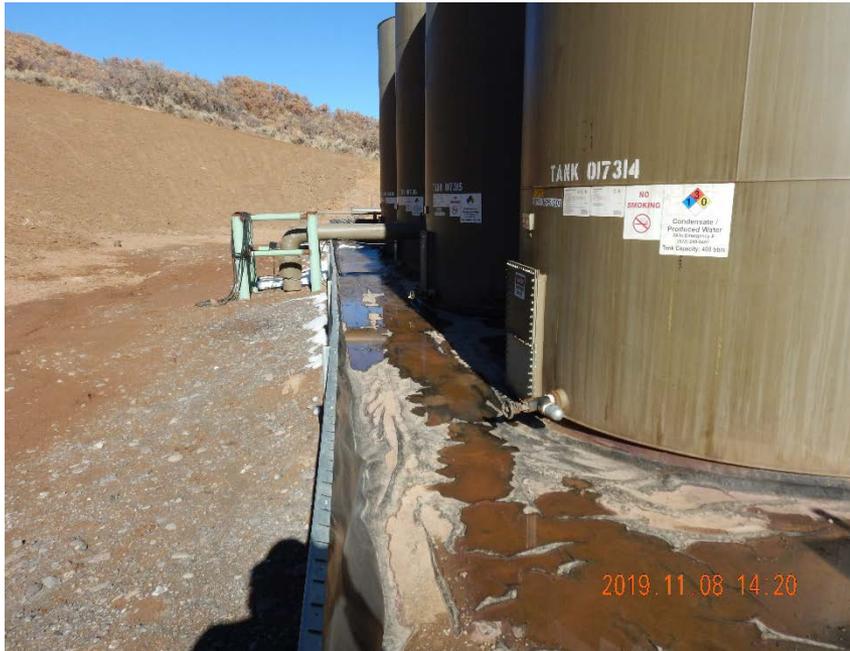
Photo #5 – View of tank battery from SW corner.

Tank NFPA placards on west side of tanks read
“Condensate/Produced Water.”

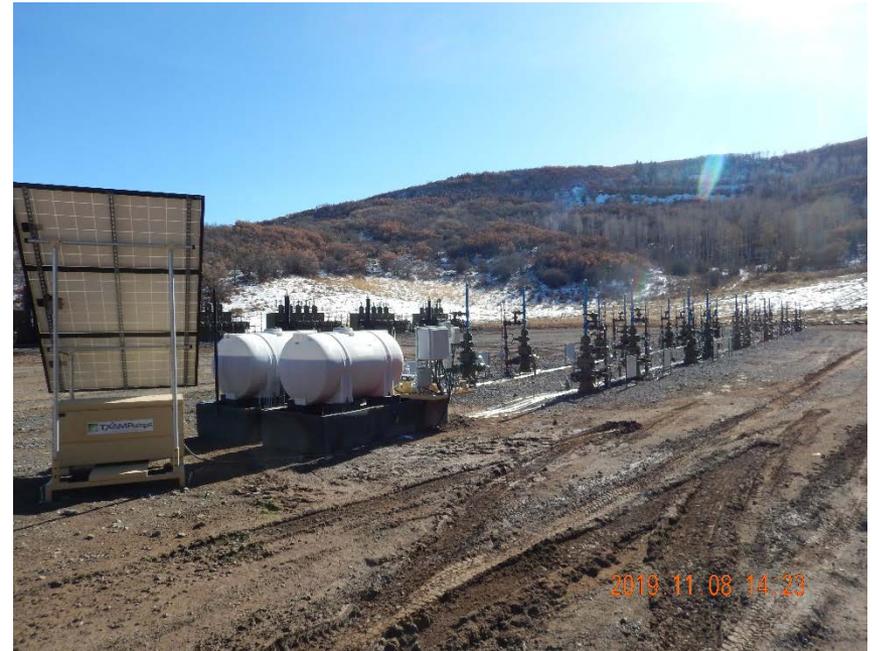
Photo #6 – Overview of wellheads from NW corner.

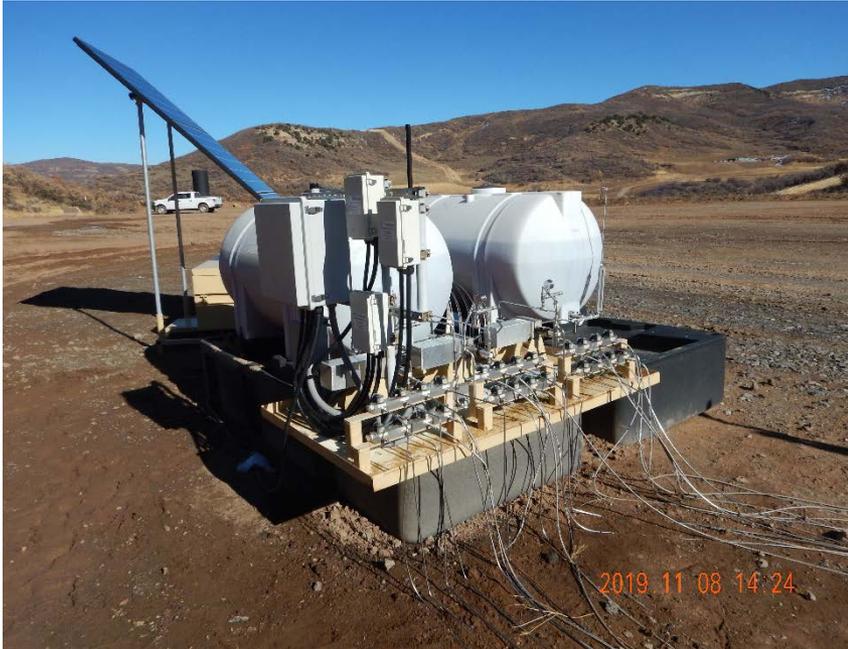
Photo #7 – View of day tanks and chemical pumps located north of wellheads.

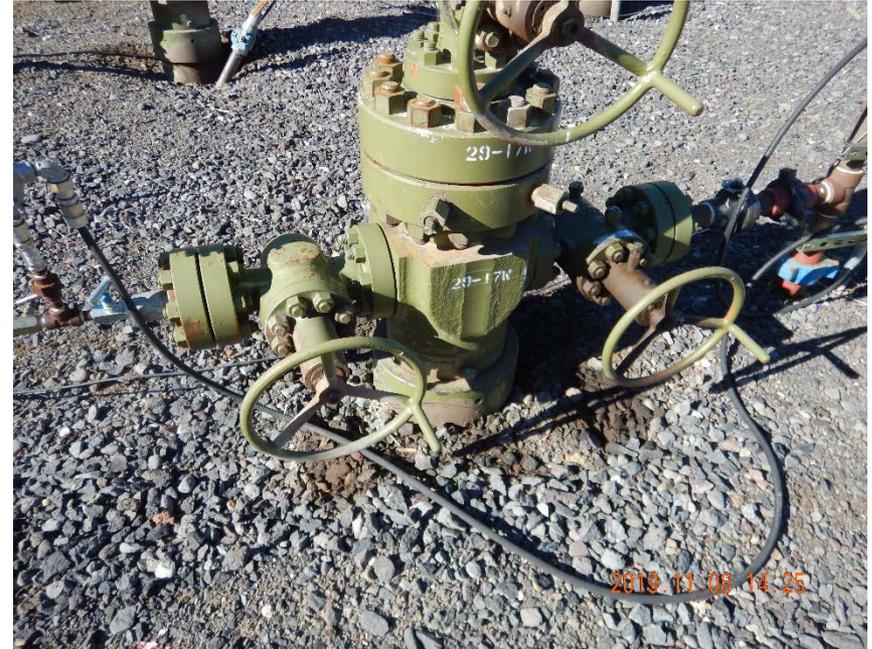
Photo #8 – View of oily waste accumulation beneath 29-17W wellhead.

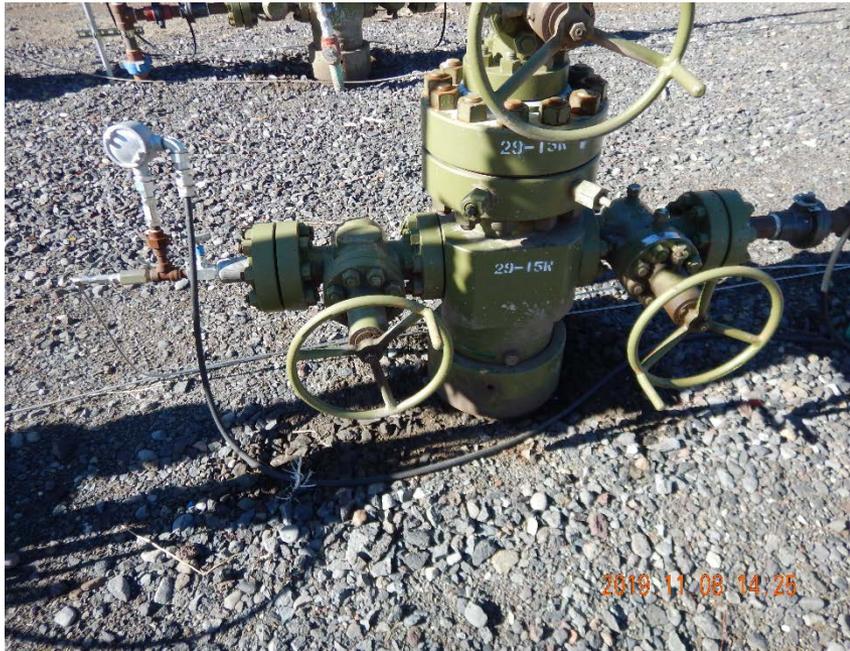
Photo #9 - View of oily waste accumulation beneath 29-15W wellhead.

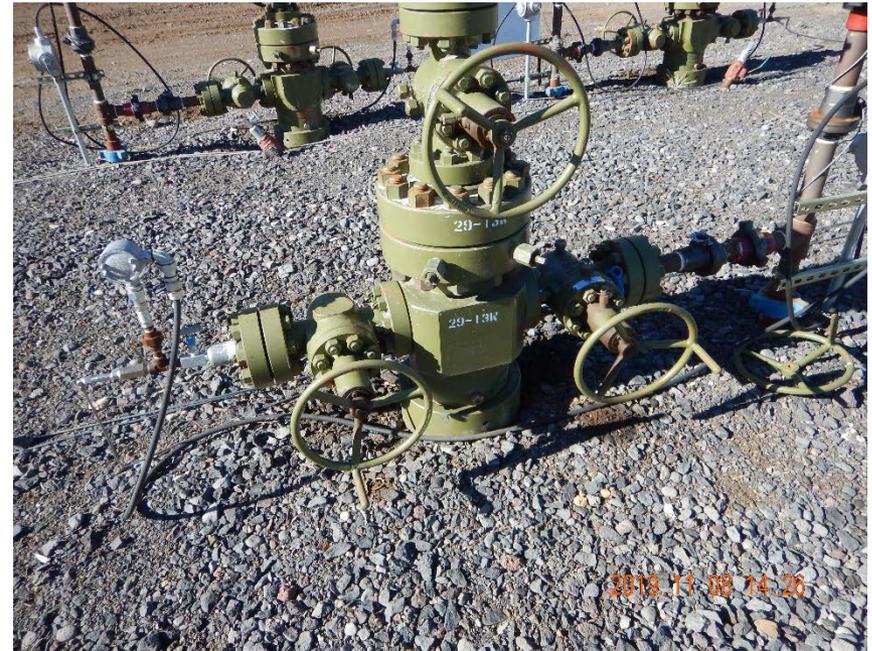
Photo #10 - View of oily waste accumulation beneath 29-13W wellhead.

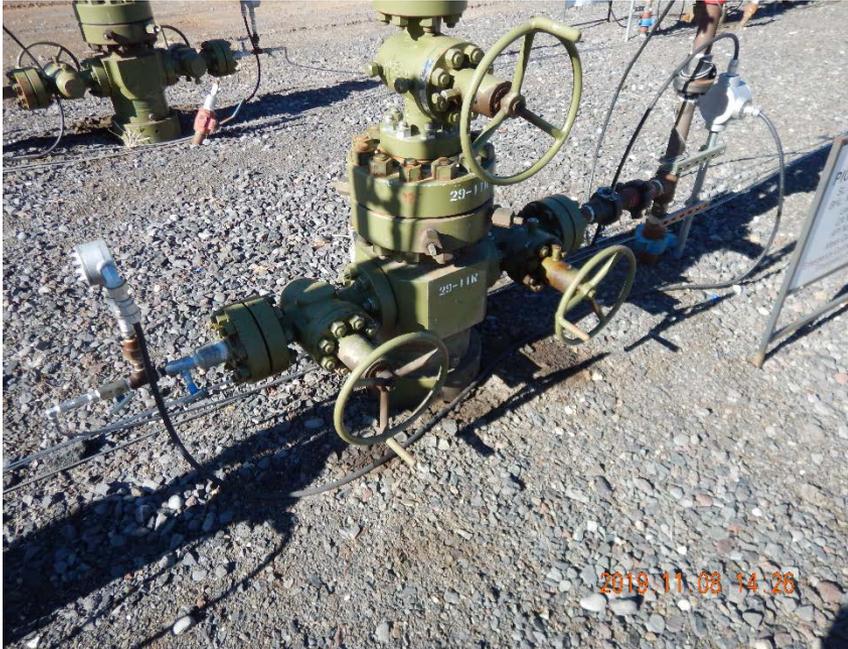
Photo #11 - View of oily waste accumulation beneath 29-11W wellhead.

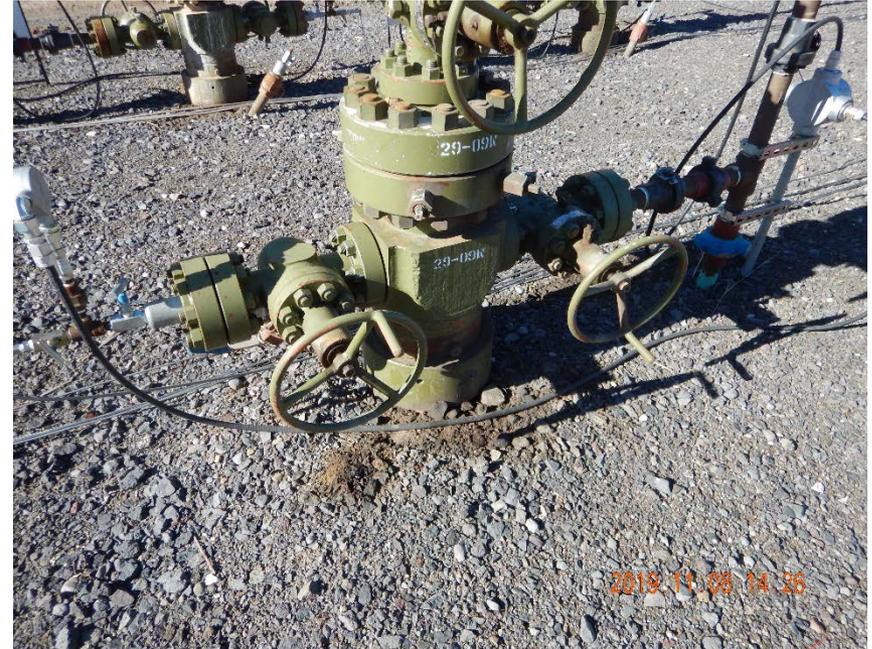
Photo #12 - View of oily waste accumulation beneath 29-09W wellhead.

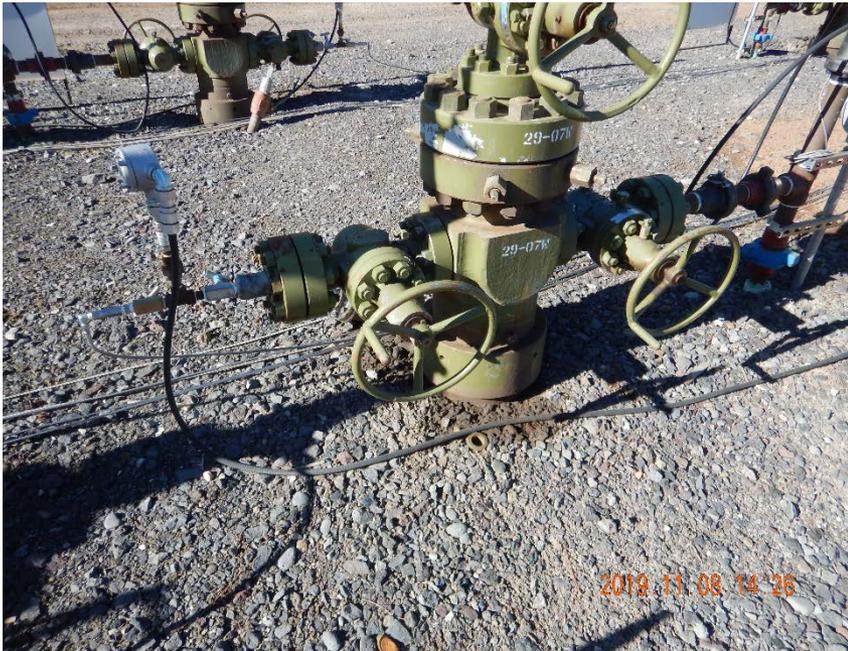
Photo #13 -View of oily waste accumulation beneath 29-07W wellhead.

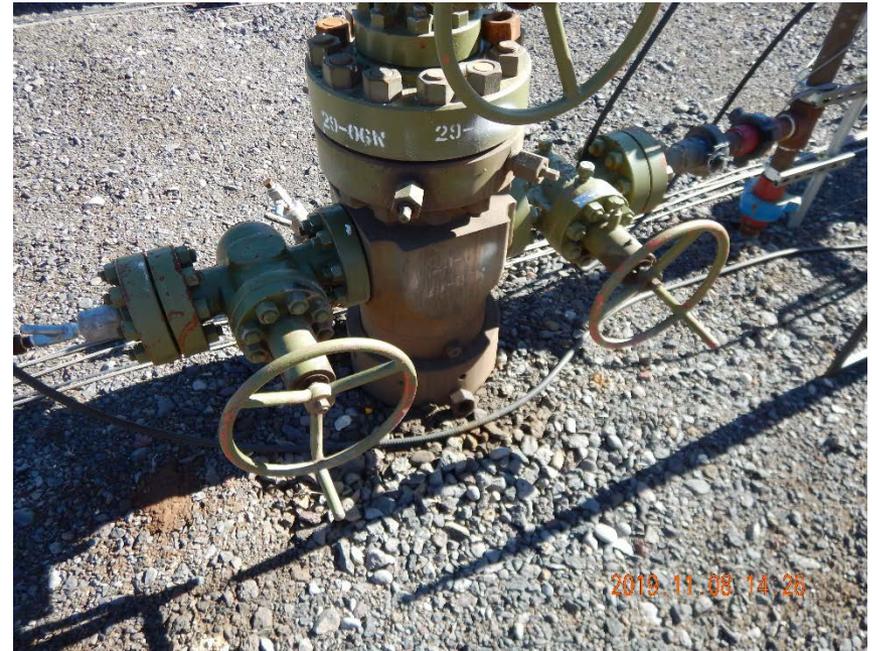
Photo #14 - View of oily waste accumulation beneath 29-06W wellhead.

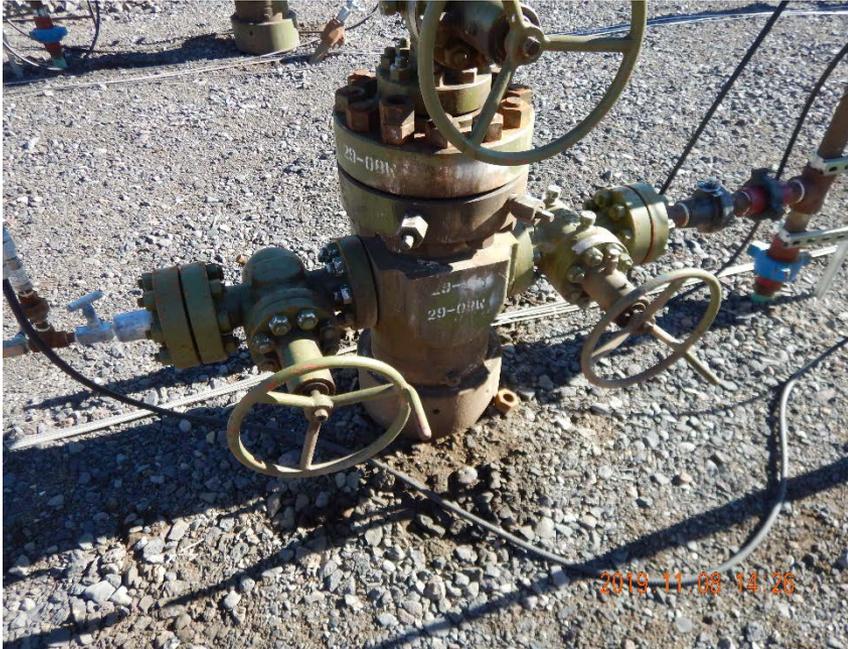
Photo #15 - View of oily waste accumulation beneath 29-08W wellhead.

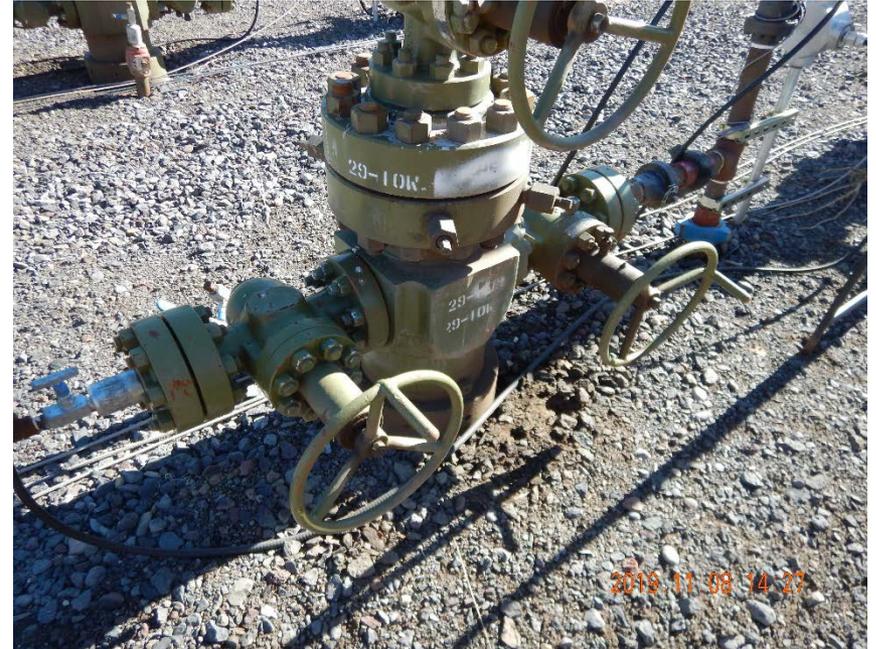
Photo #16 - View of oily waste accumulation beneath 29-10W wellhead.

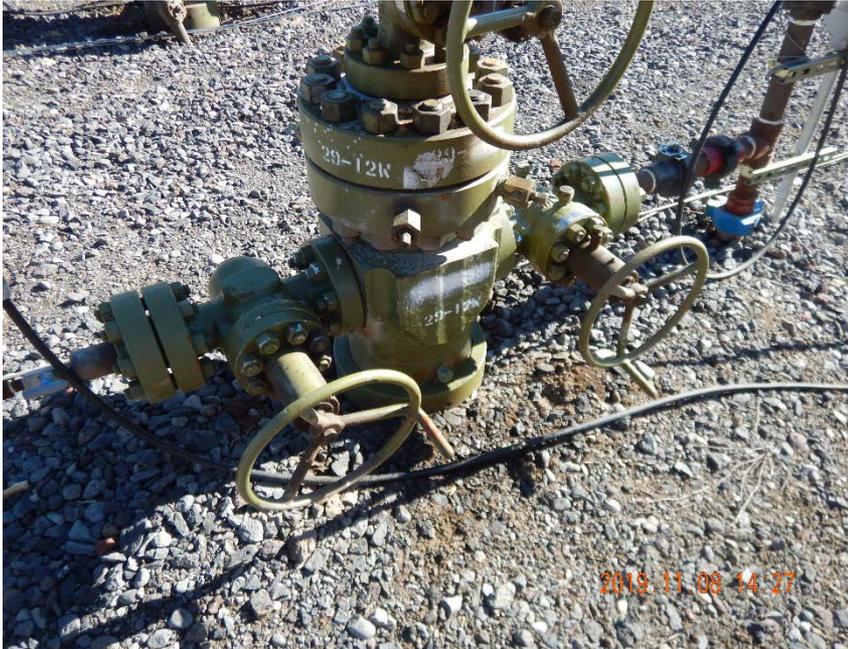
Photo #17 - View of oily waste accumulation beneath 29-12W wellhead.

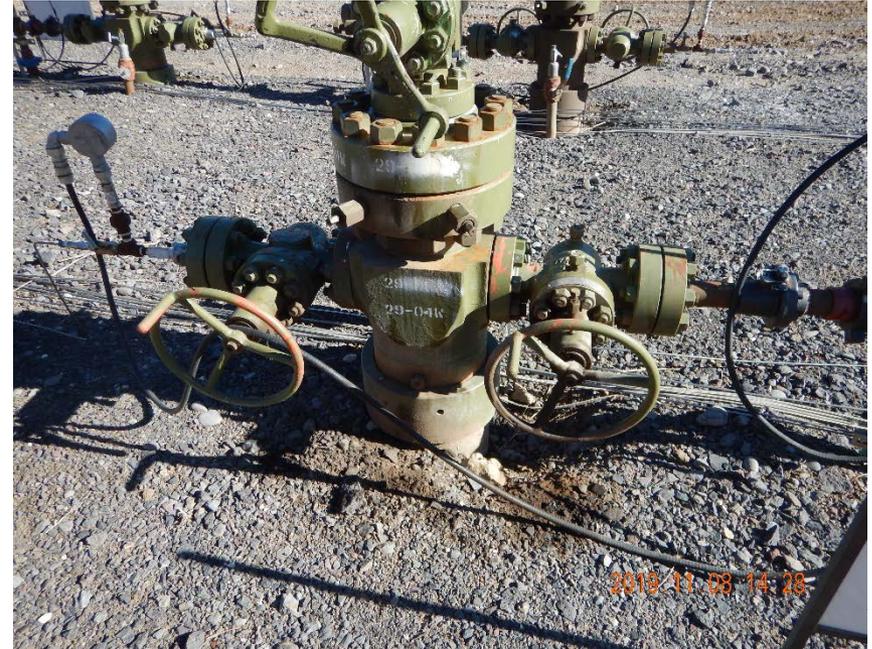
Photo #18 - View of oily waste accumulation beneath 29-04W wellhead.

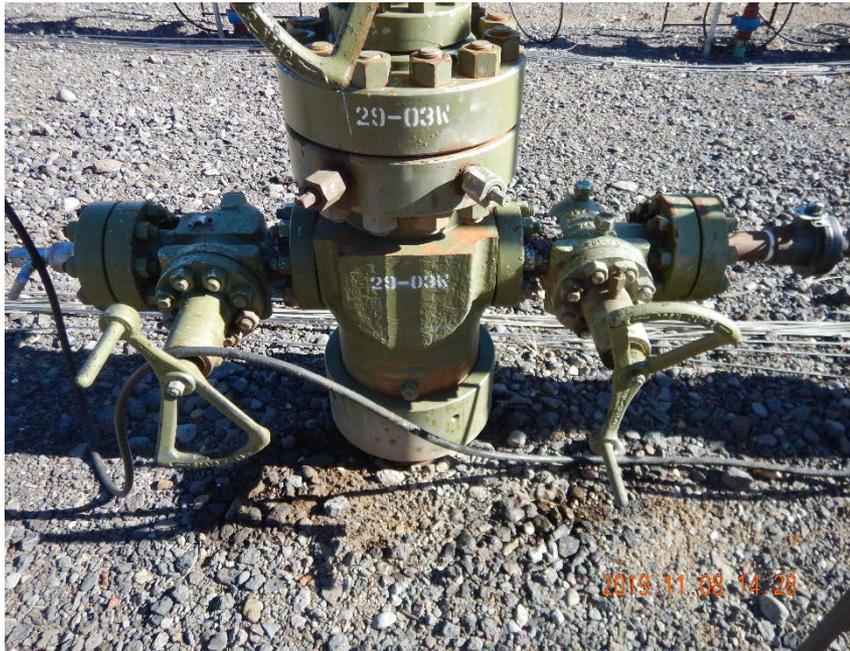
Photo #19 - View of oily waste accumulation beneath 29-03W wellhead.

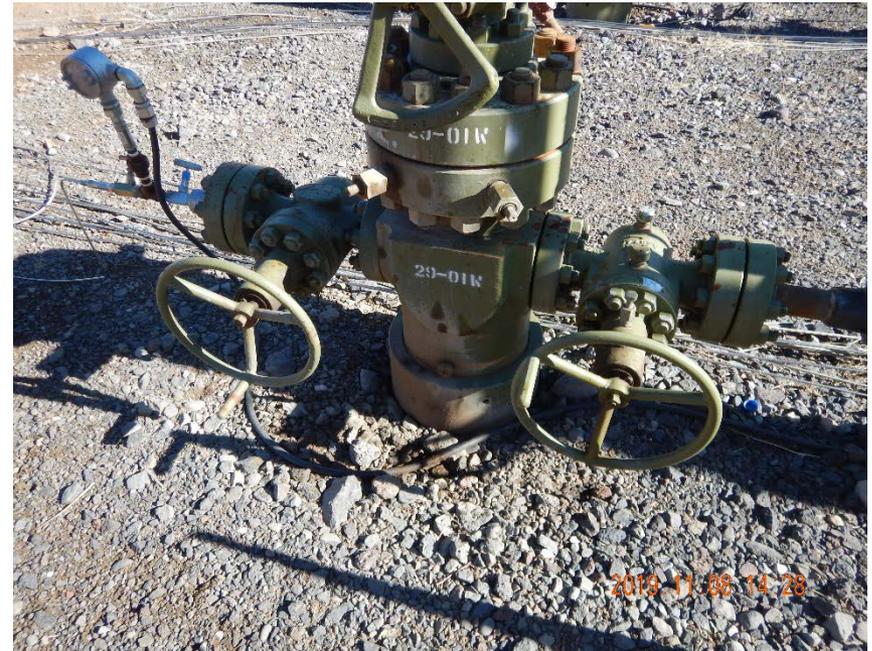
Photo #20 - View of oily waste accumulation beneath 29-01W wellhead.

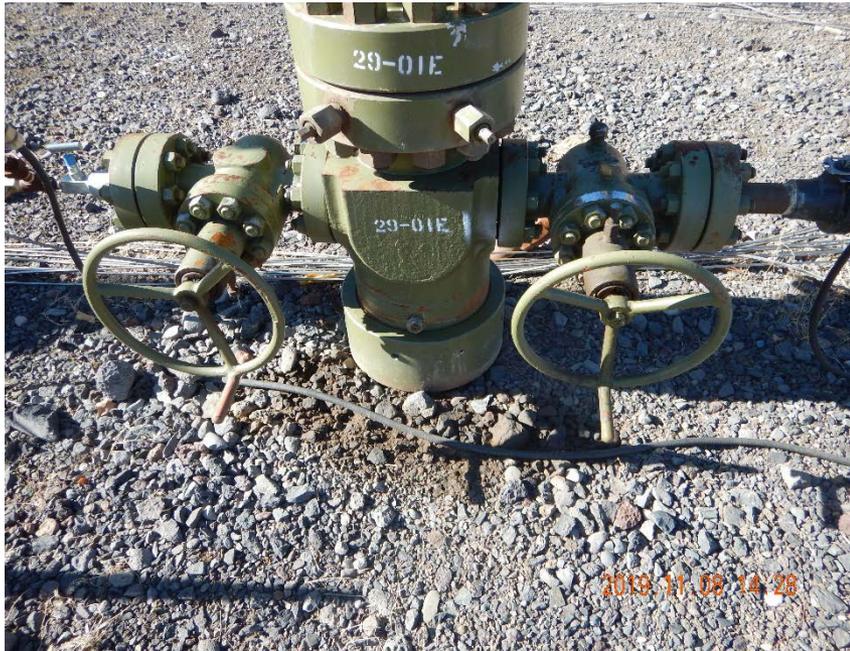
Photo #21 - View of oily waste accumulation beneath 29-01E wellhead.

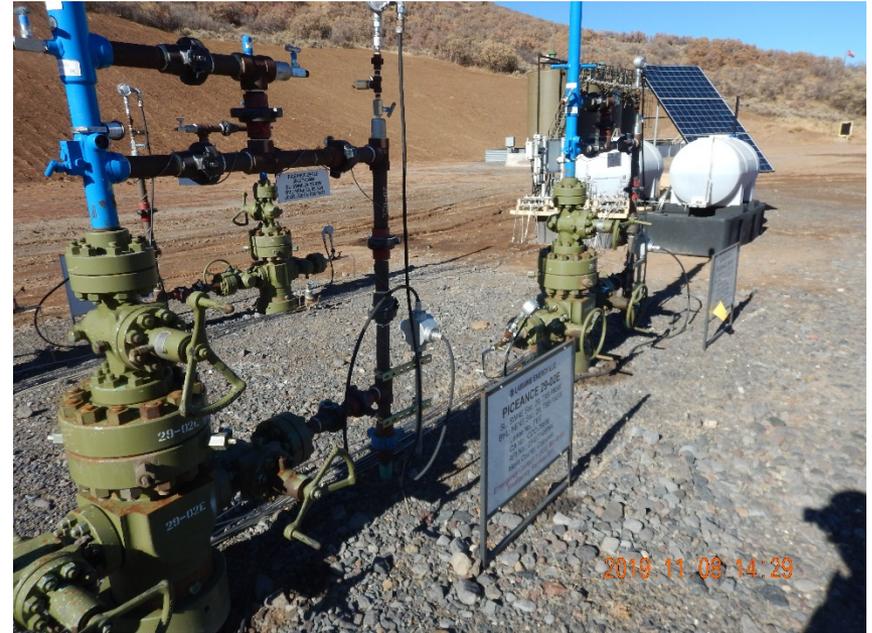
Photo #22 - View of oily waste accumulation beneath 29-02E well sign.

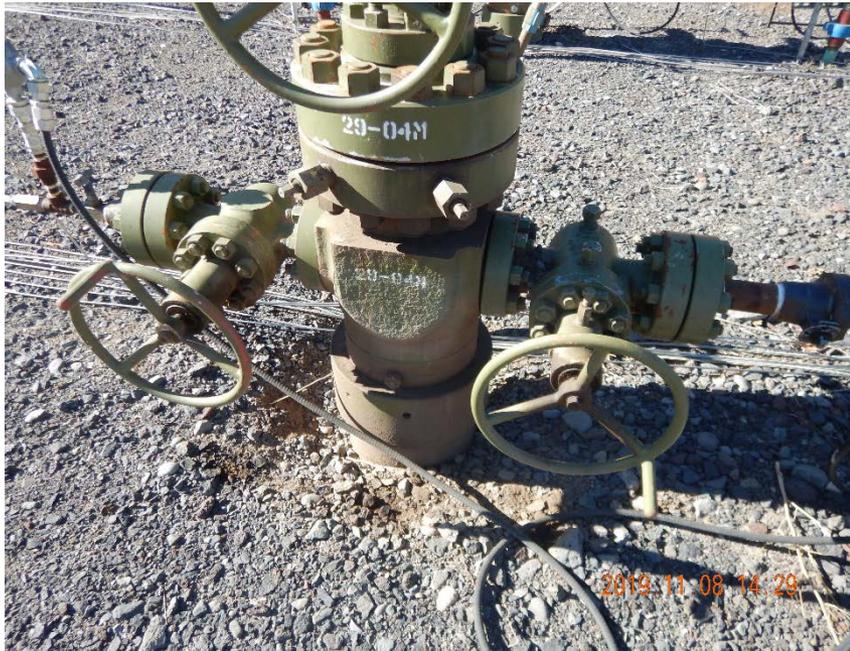
Photo #23 - View of oily waste accumulation beneath 29-04M wellhead.

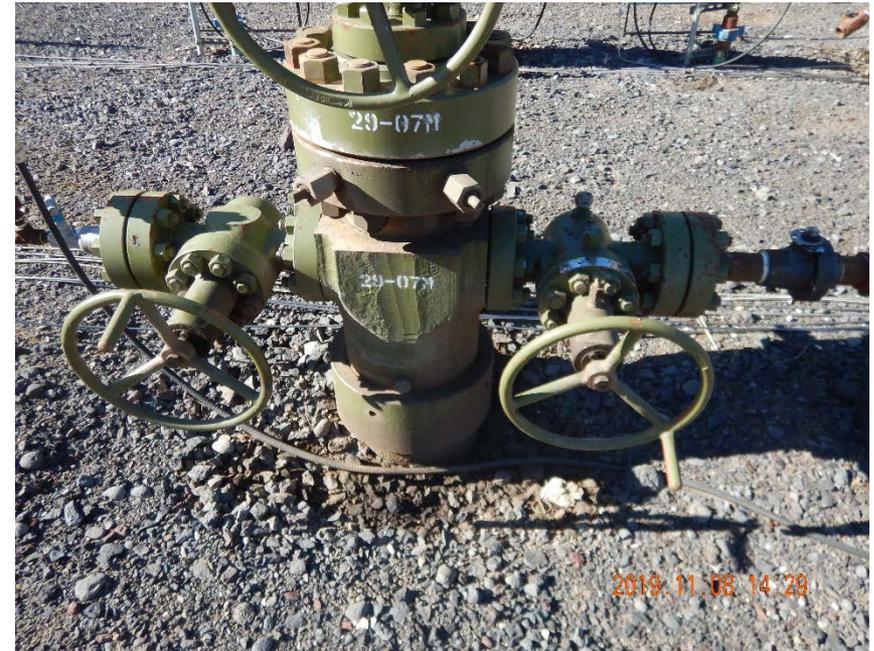
Photo #24 - View of oily waste accumulation beneath 29-07M wellhead.

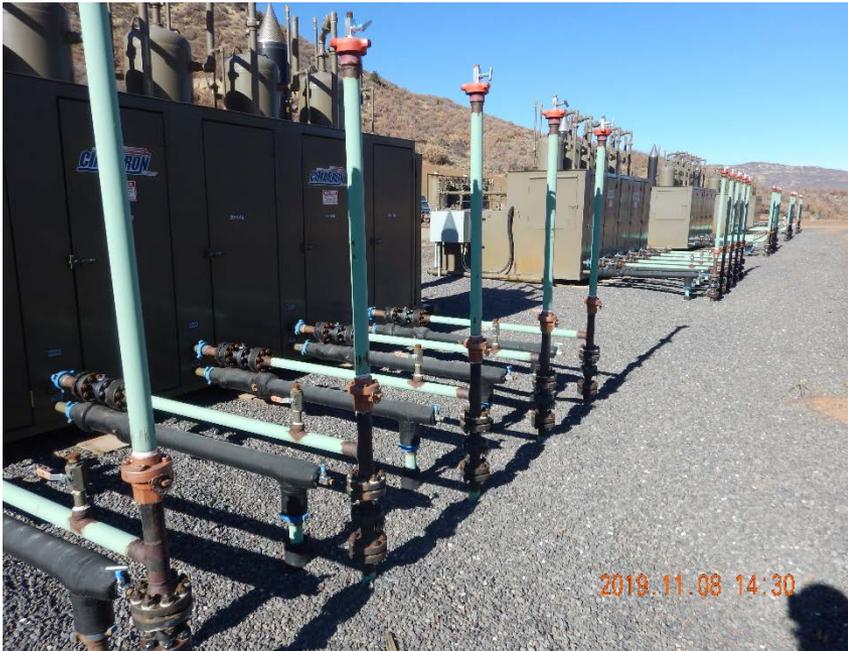
Photo #25 – Overview of heated vertical separators from southeast.

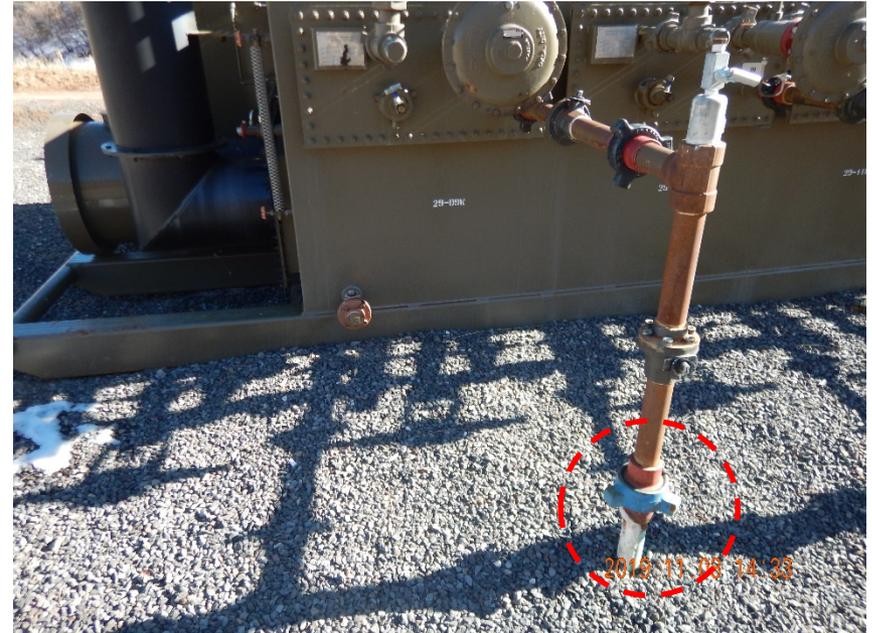
Photo #26 – View of 29-09W separator and flowline riser from west side. Note scale buildup on flowline riser, beneath hammer union (circled).

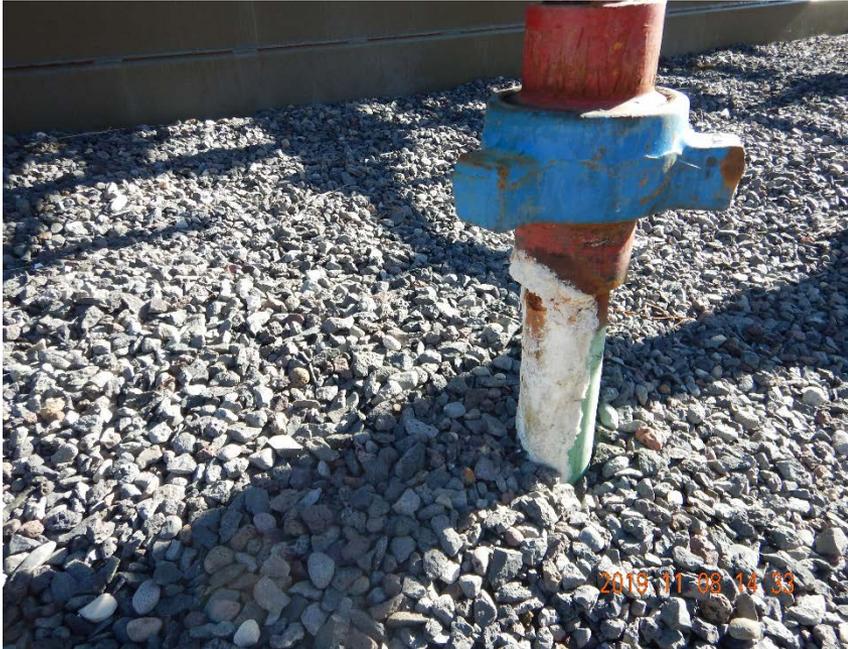
Photo #27 – Close-up view of scale buildup beneath hammer union on flowline riser from previous photo.

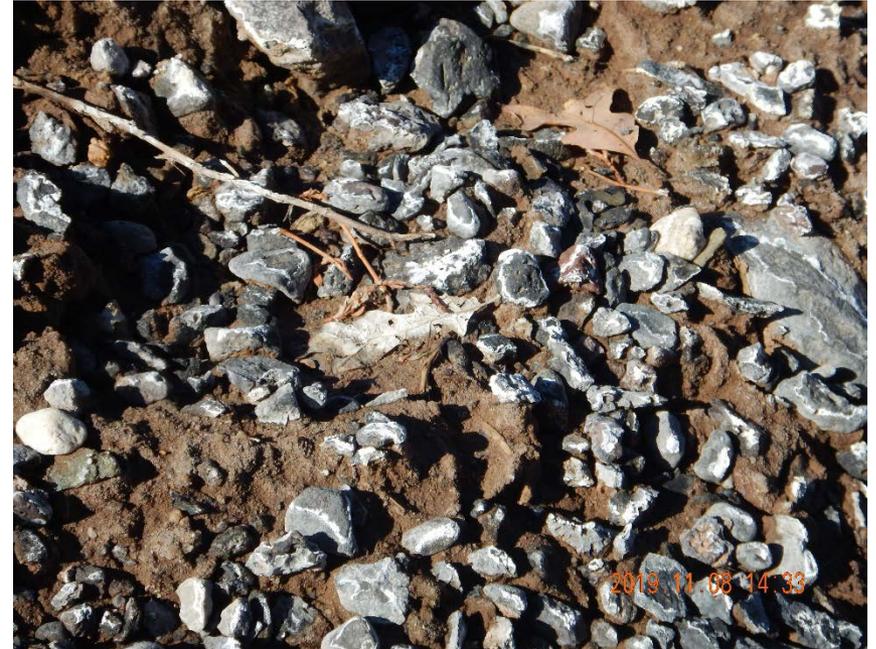
Photo #28 – View of salt staining on gravel in vicinity of 29-09W separator.
