**Inspection Photos**  
**Operator: BP America**  
**Location/API #: 067-06482**  
**Date: 11-1-2019**

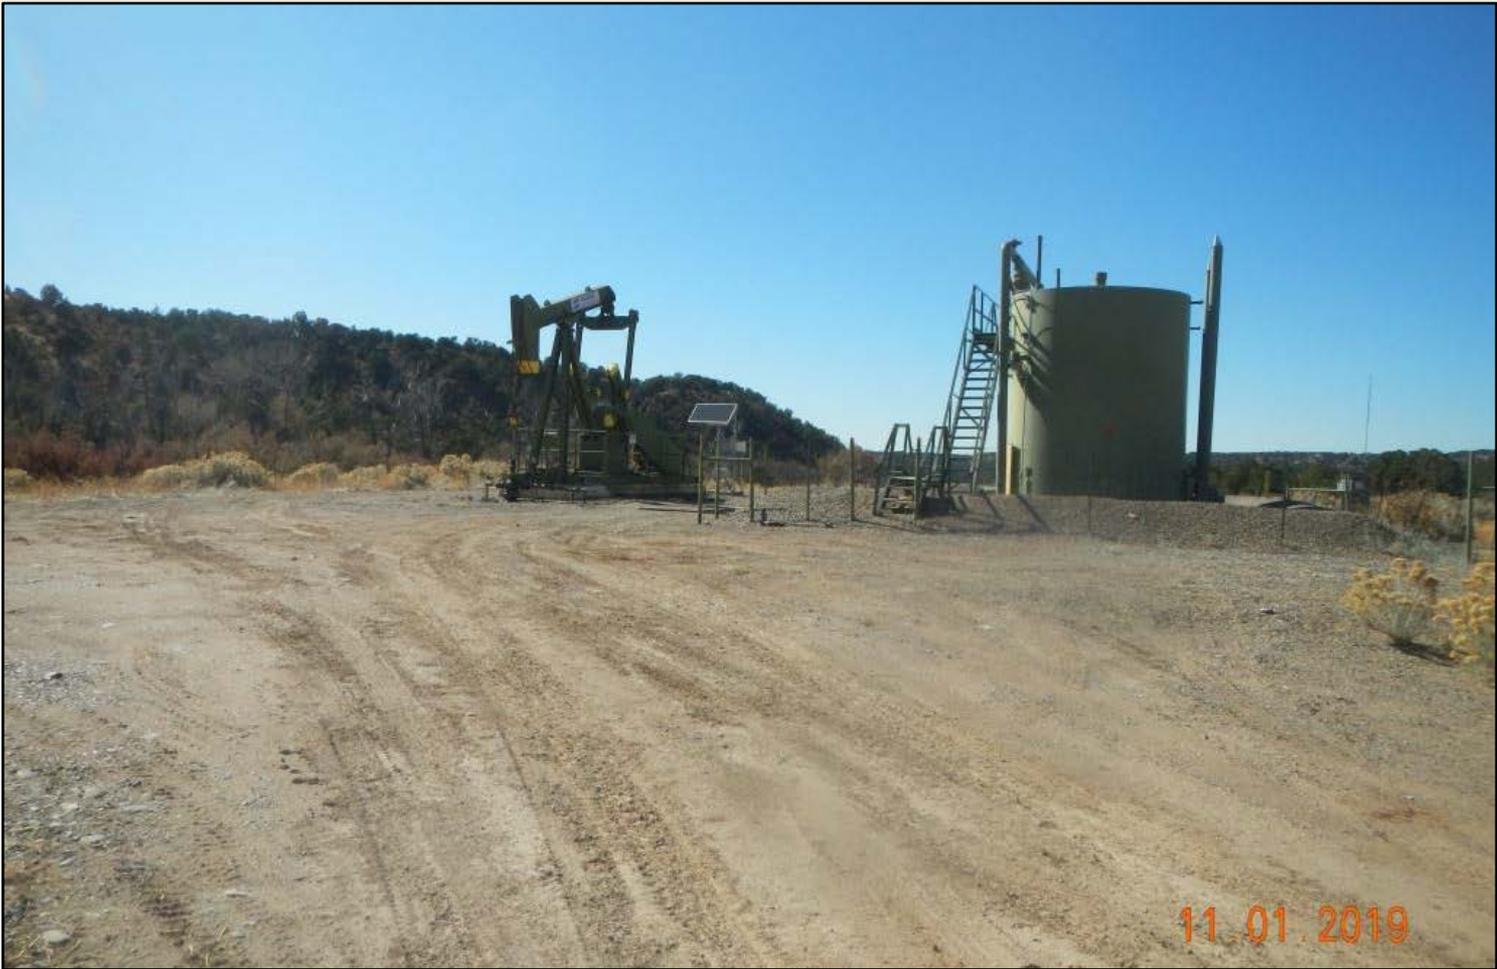
Photo 1. View of the project area from the well pad entrance facing center.

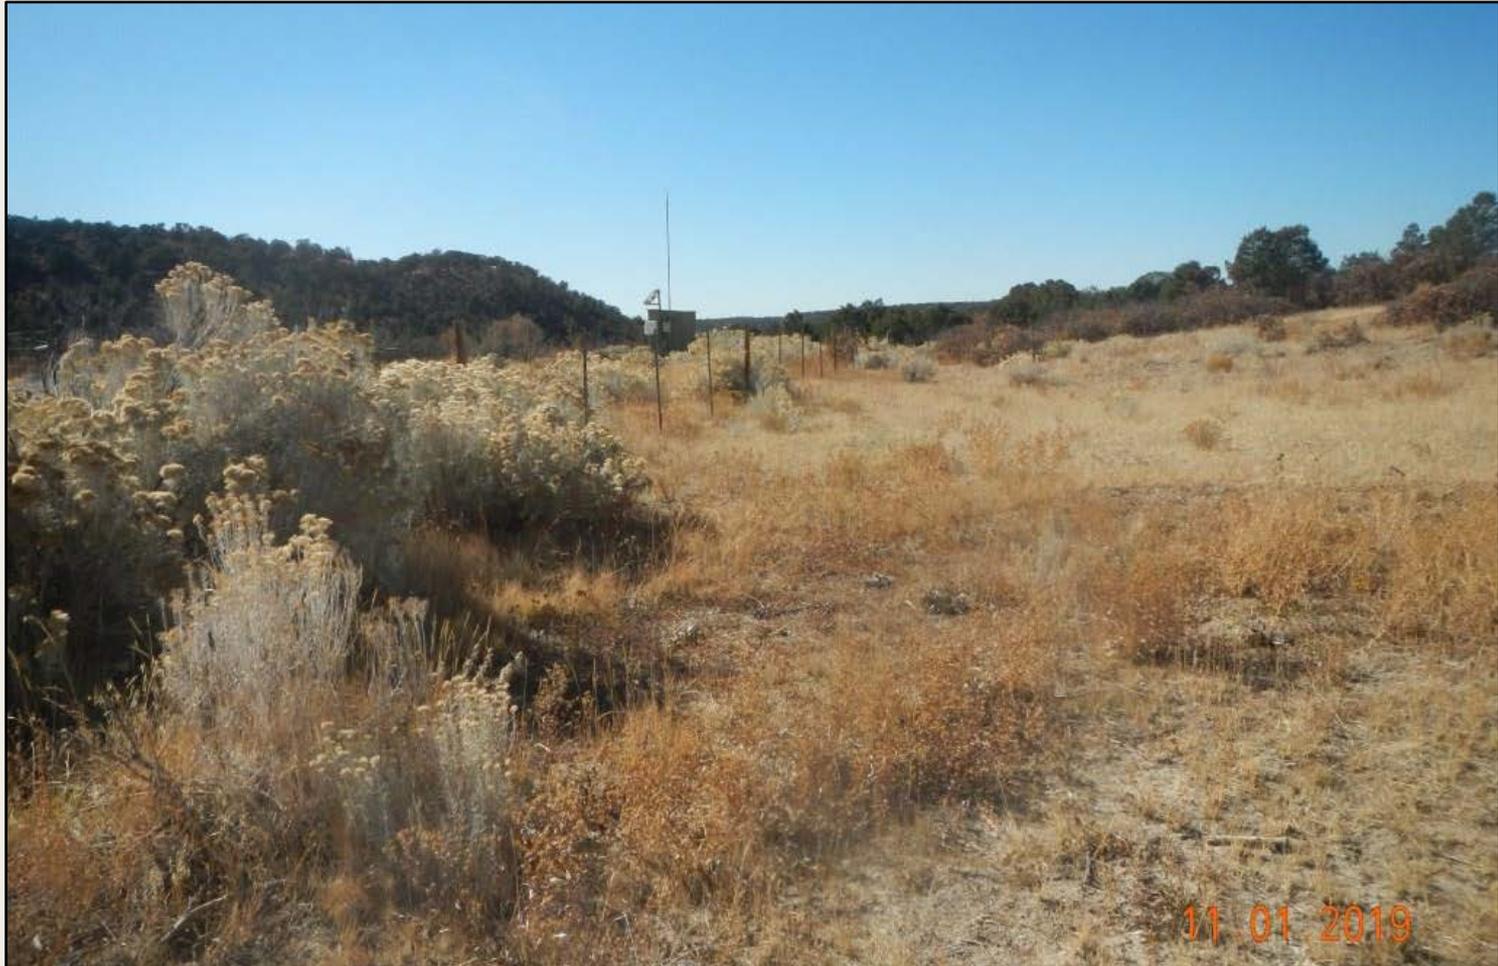
Photo 2. View of the northern project area from the northeastern corner facing westward. Revegetation is progressing here with grasses such as western wheatgrass and shrubby rubber rabbitbrush.

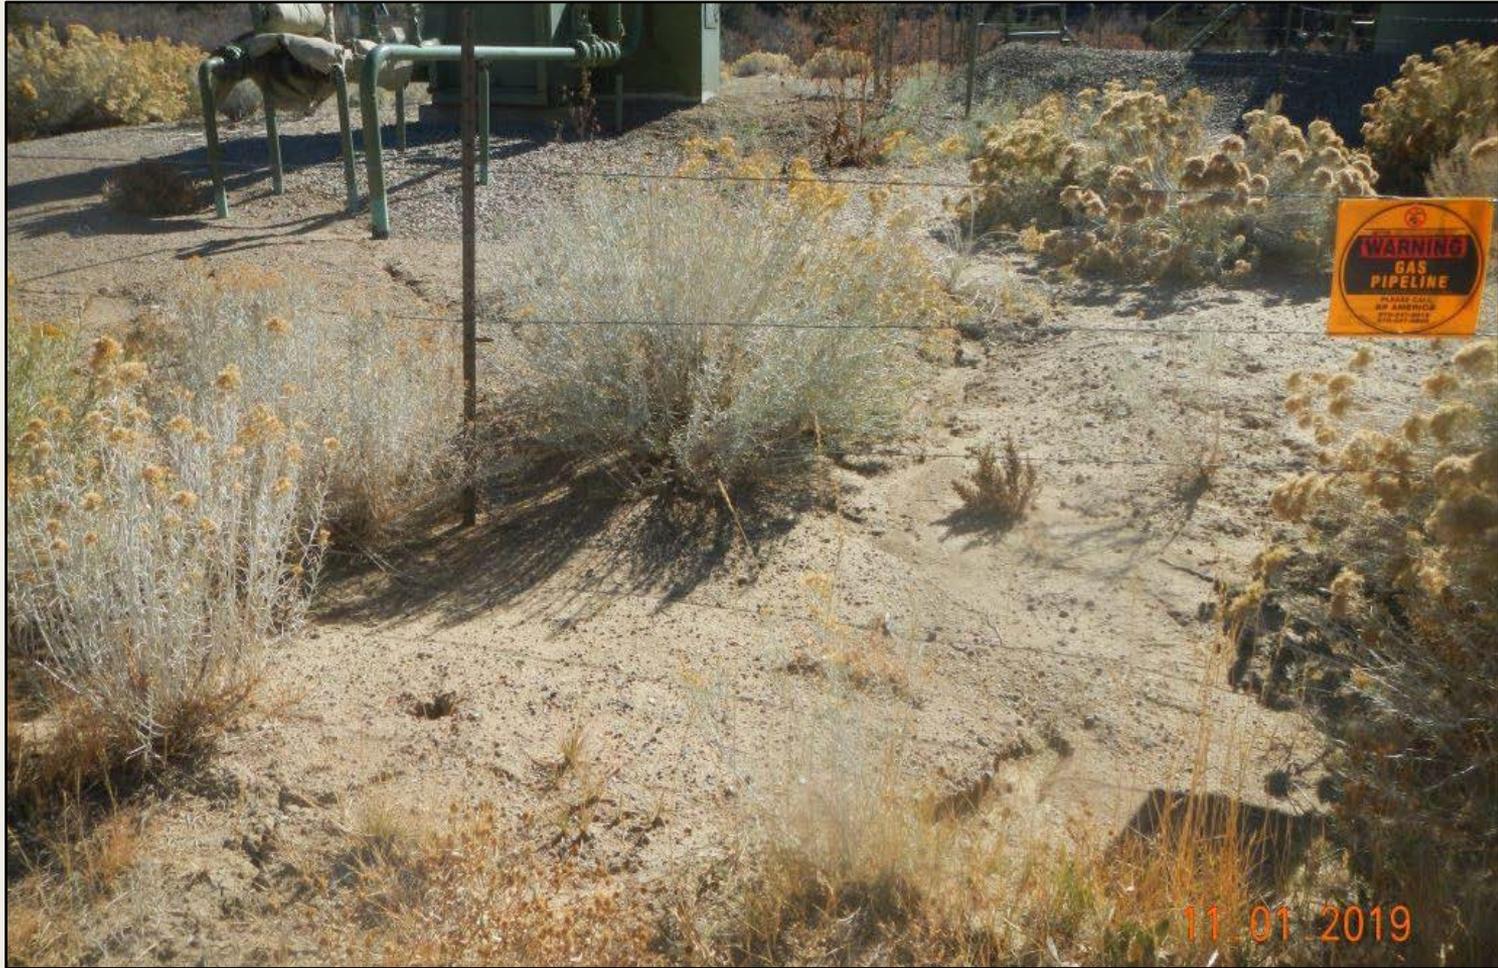
Photo 3. View of area adjacent to the northern facilities where stormwater flows off of the well pad westward, and resulting in erosion within the northwestern project area.

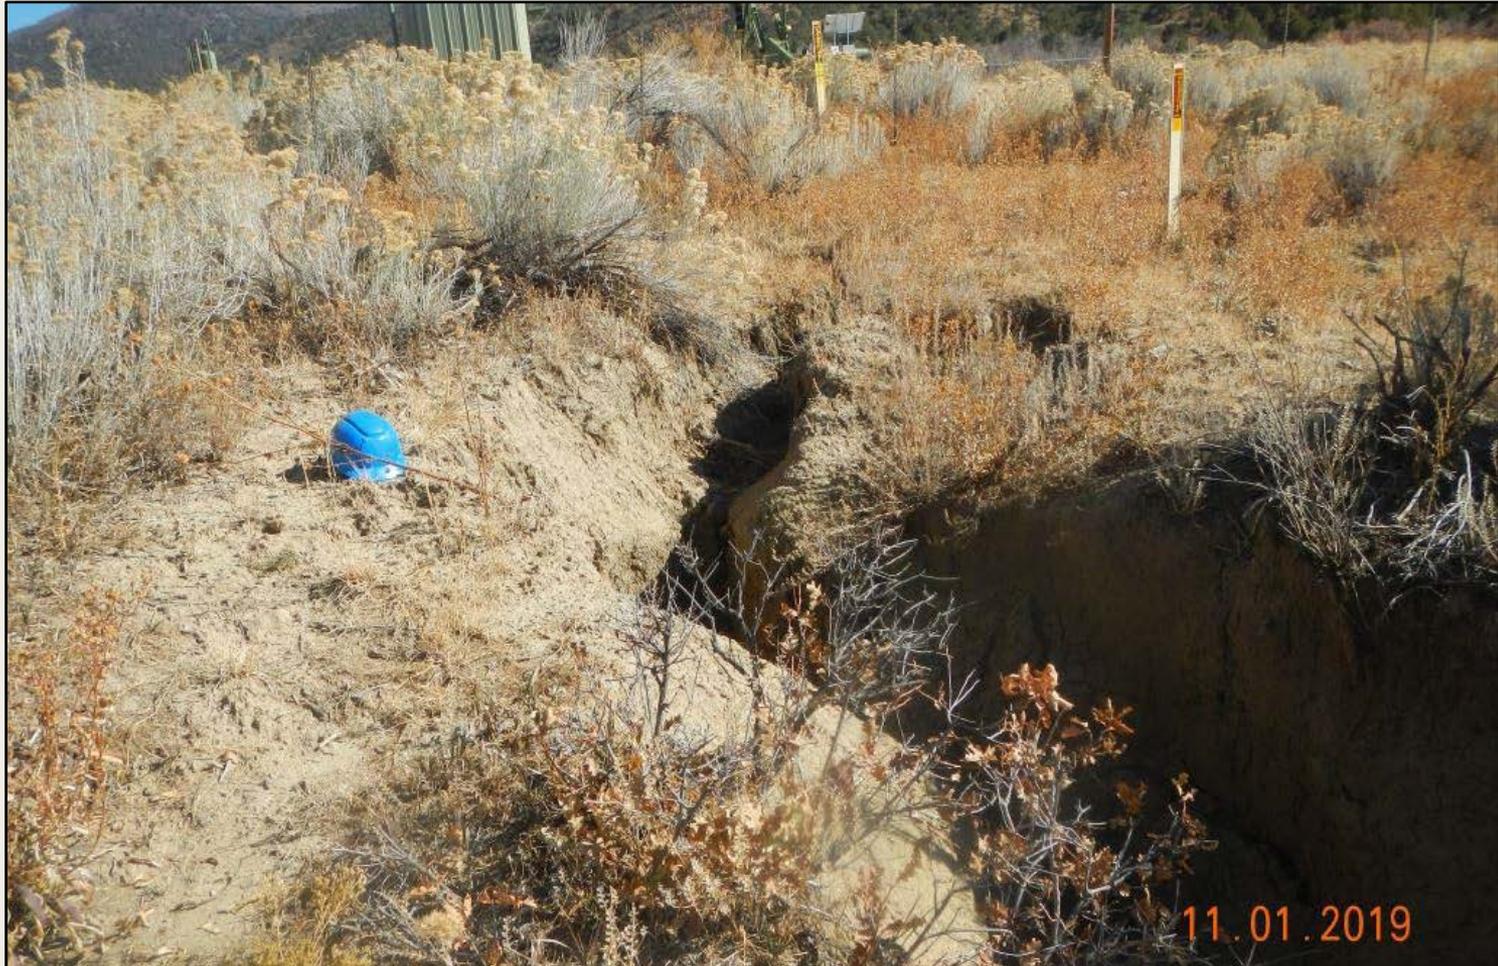
Photo 4. View of erosional headcut in the northwestern project area facing upstream. Erosional channel is approximately 1 to 3 feet wide and deep.

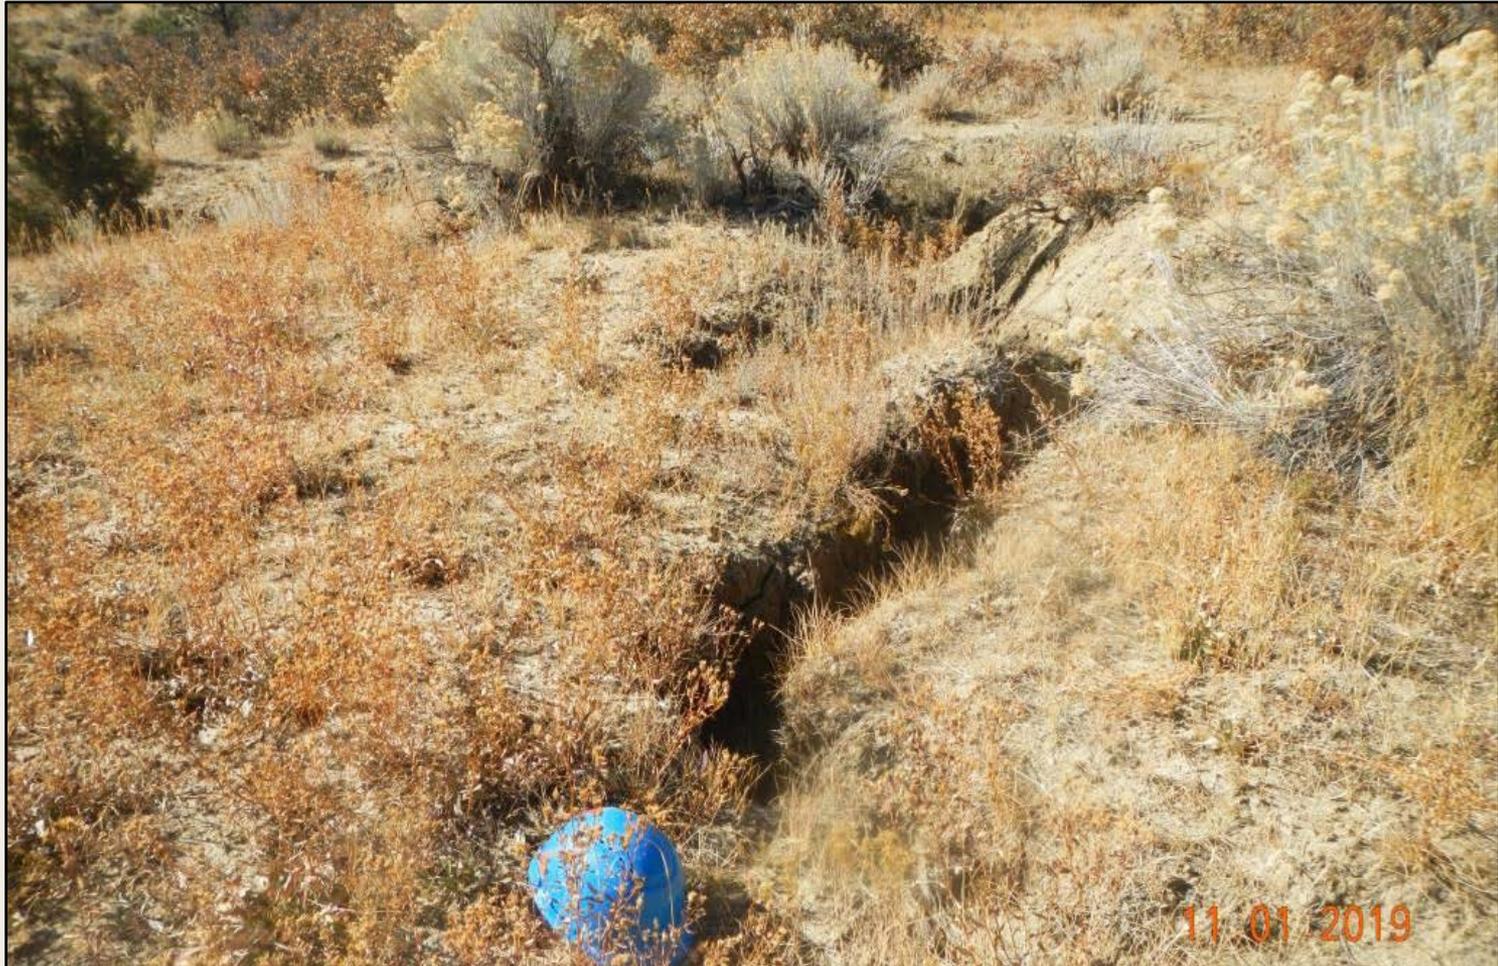
Photo 5. View of erosional channeling within the northwestern project area, facing downslope.

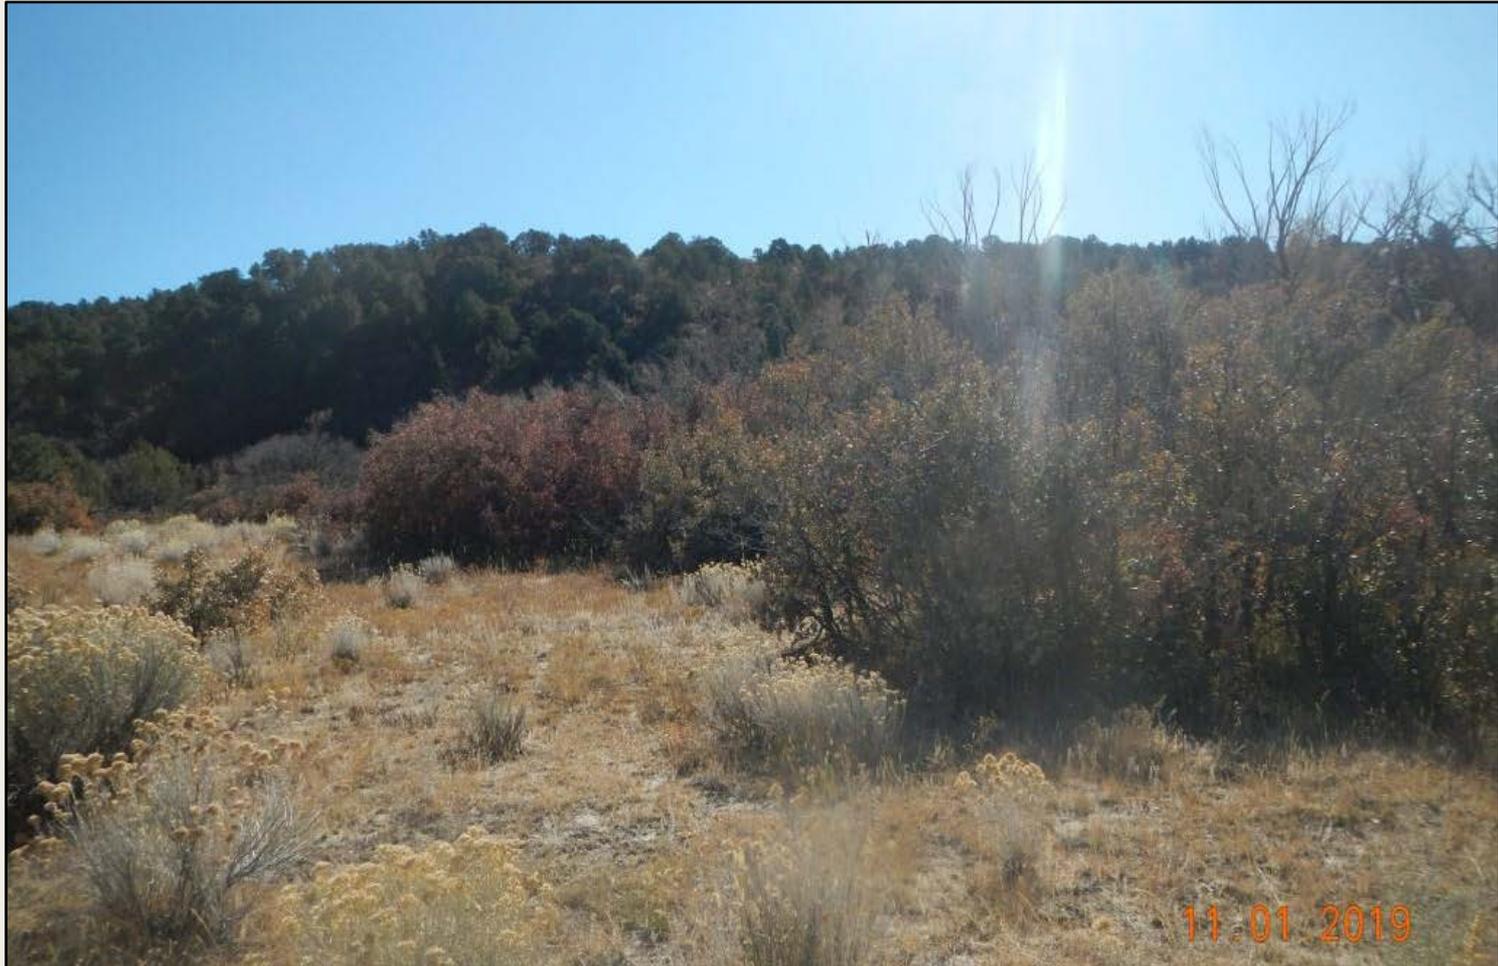
Photo 6. View of reference area vegetation comprised of open gambel oak and mountain mahogany shrubland mosaic with open grass fields and pinyon/juniper stands.
