# Construction and Stormwater Inspection

November 4, 2019

Operator: CCRP OPERATING INC- 10665

Inspection Photos  
Location Name: True Ranch Fee /27 East  
Location ID: 455554

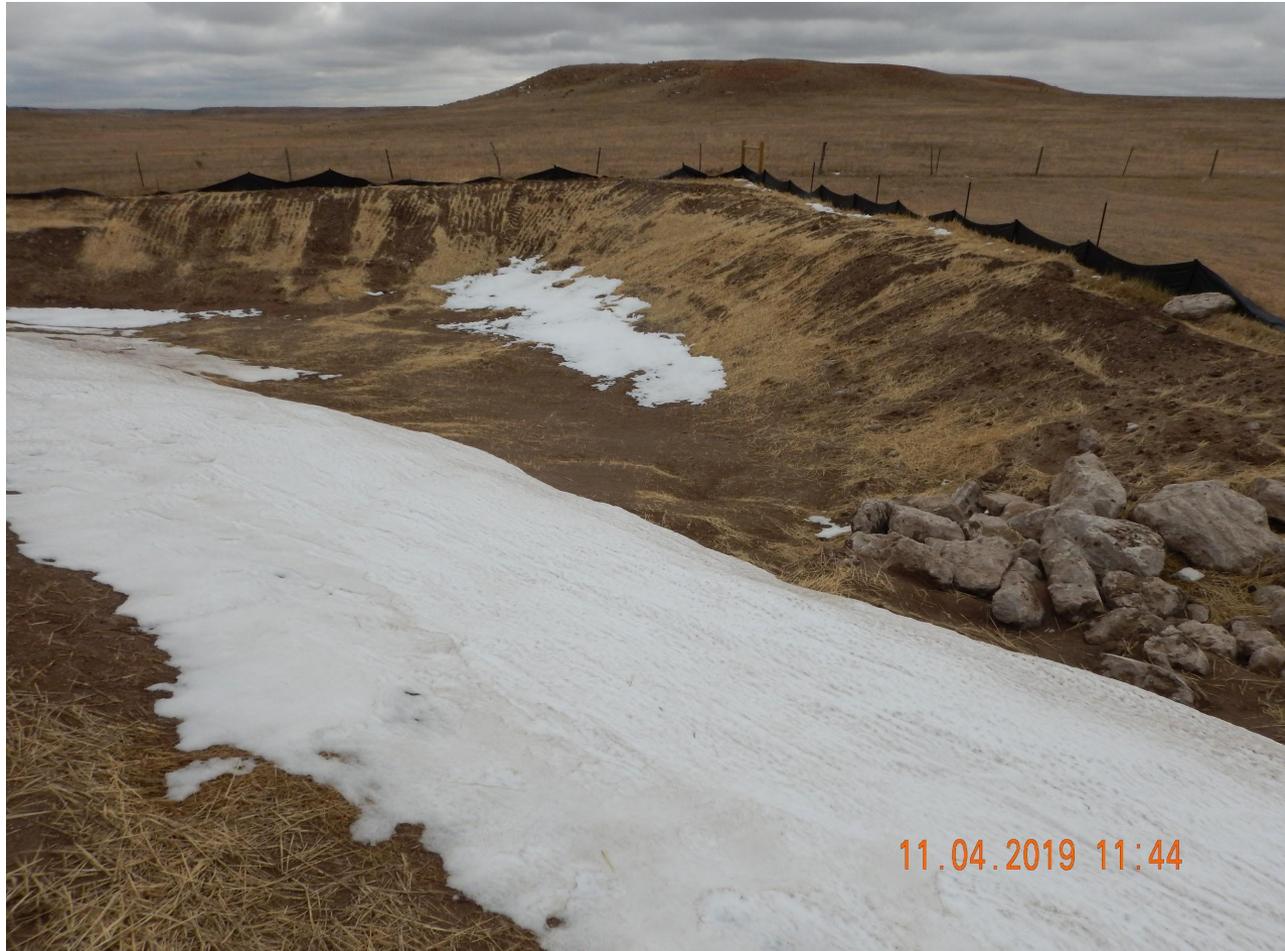
**Photo 1.** Photo taken from the southeastern location, facing East. Photo illustrates the new constructed sediment trap based off engineered designs. Note: Silt fence throughout the perimeter is in disrepair and not in proper functioning condition.

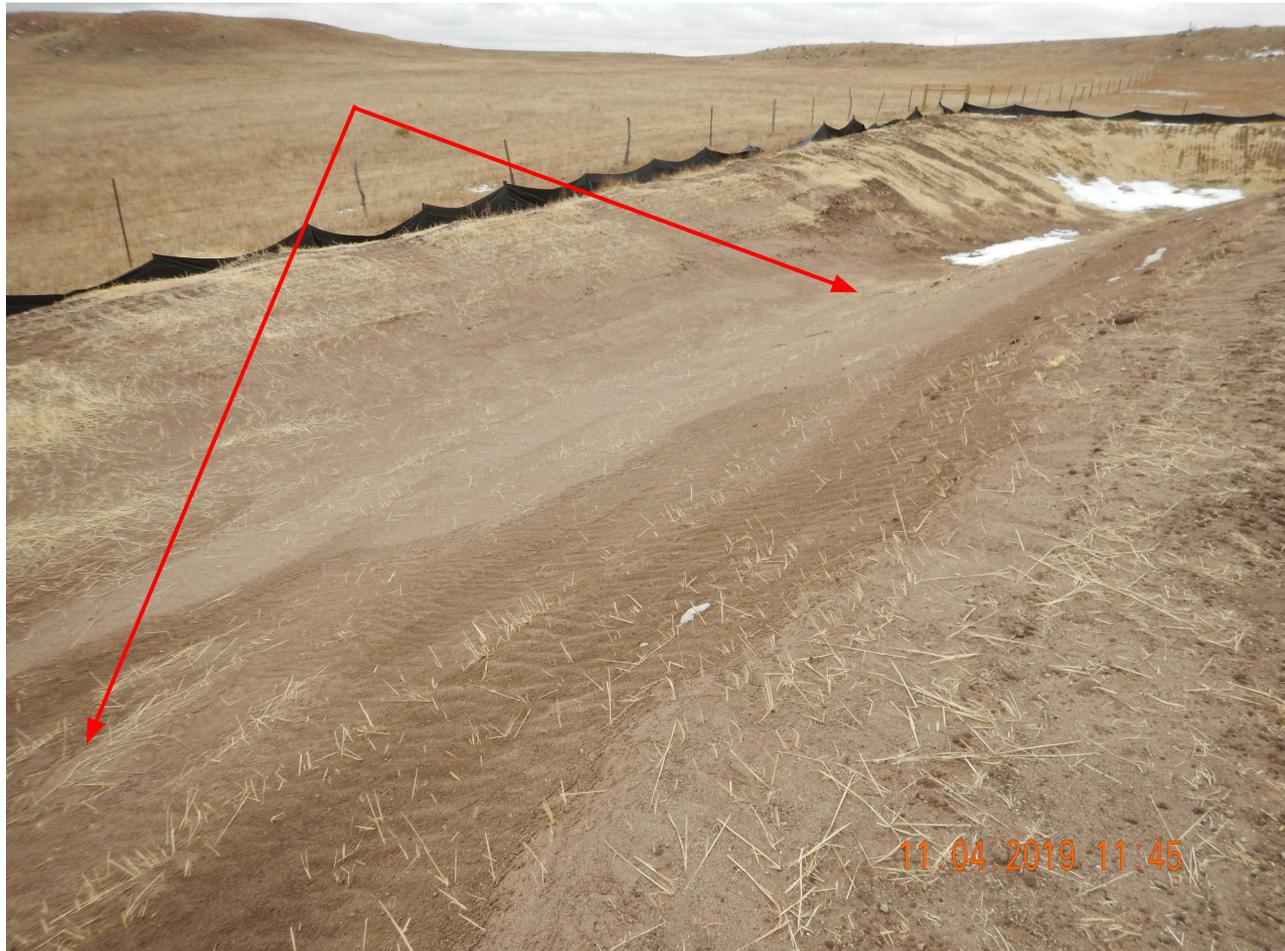
**Photo 2.** Photo taken from the southeastern location, facing South. Photo illustrates the ditch BMP installed in conjunction with the sediment trap. Note: Fine sediments from the well pad area are accumulating in the ditch BMP due to the well pad not properly stabilized.

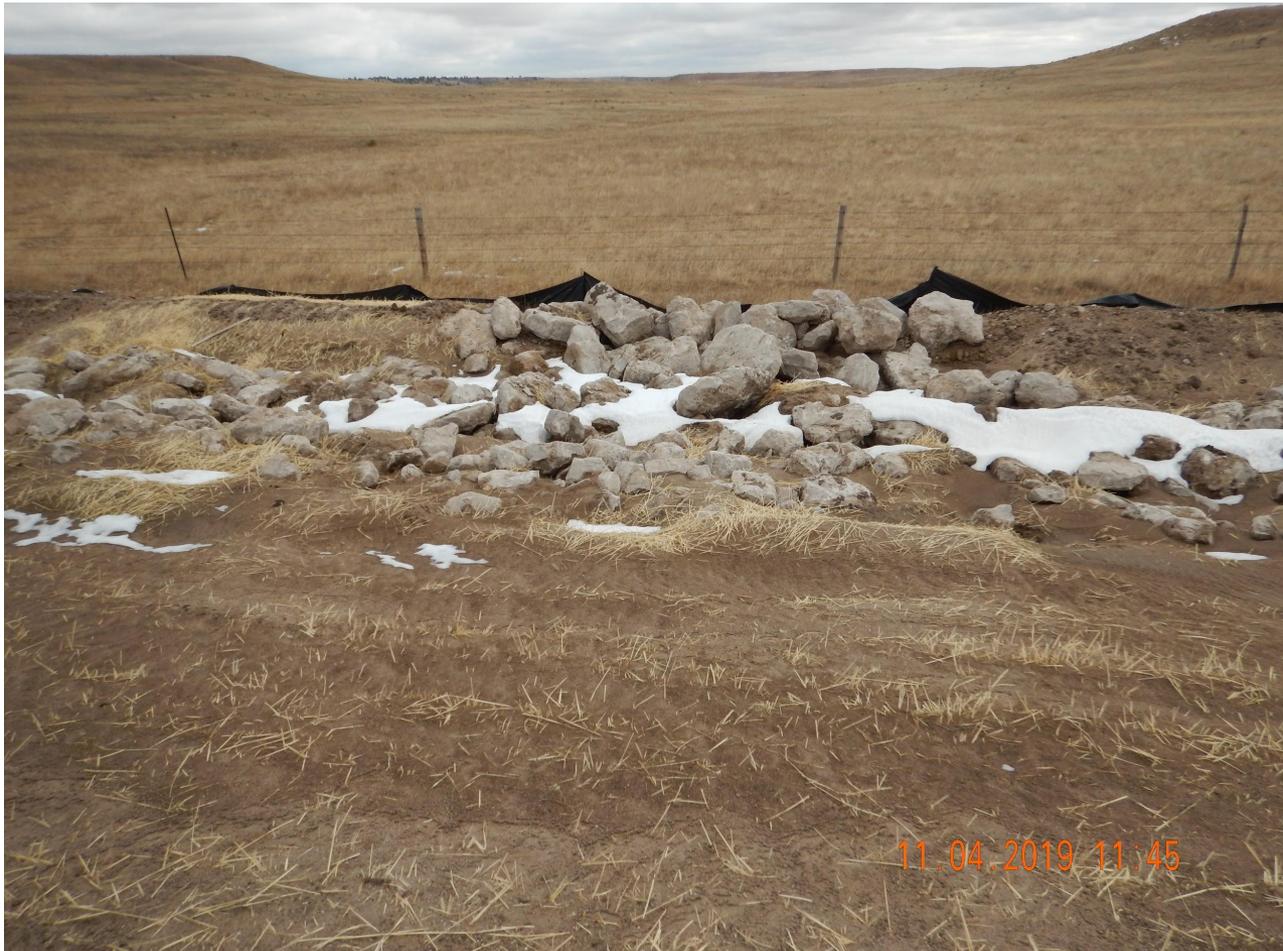
**Photo 3.** Photo taken from the eastern location, facing East. Photo illustrates the outflow area. The outflow area doesn't appear to be installed with good engineering practices.

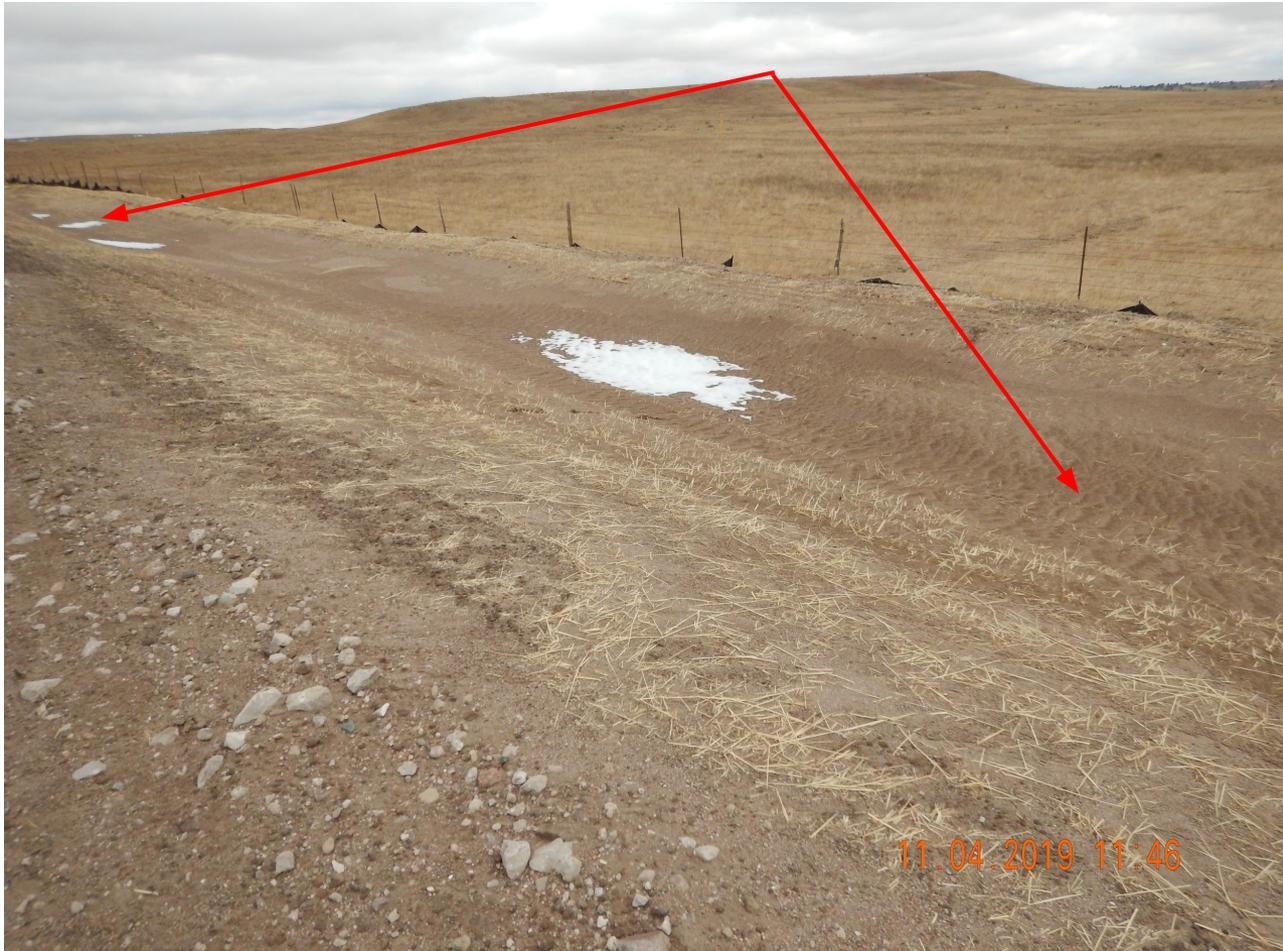
**Photo 4.** Photo taken from the eastern location, facing Northeast. Photo illustrates fine sediments from the well pad area are accumulating in the ditch BMP due to the well pad not properly stabilized.

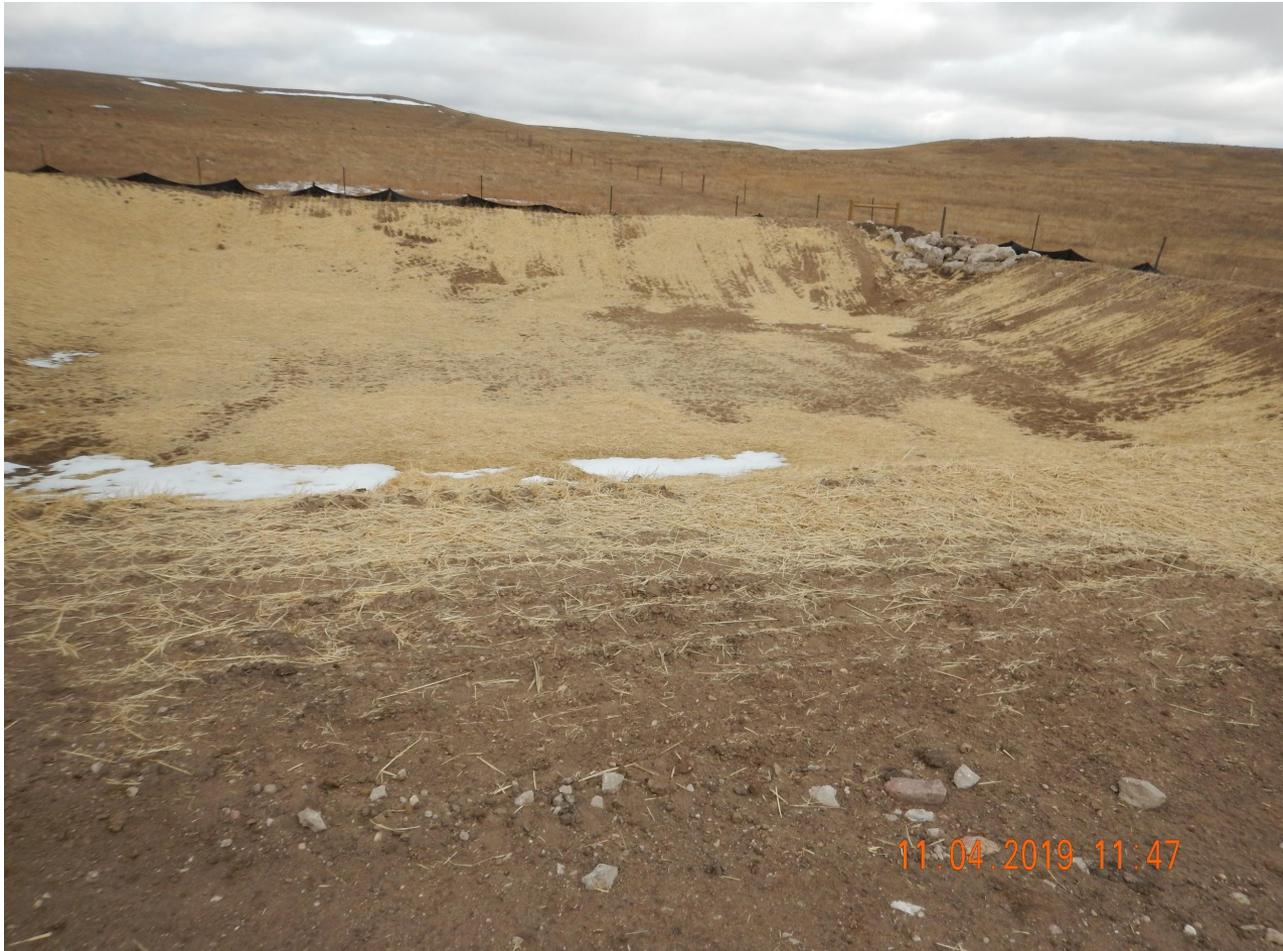
**Photo 5.** Photo taken from the northeastern location, facing North. Photo illustrates the new constructed sediment trap based off engineered designs.

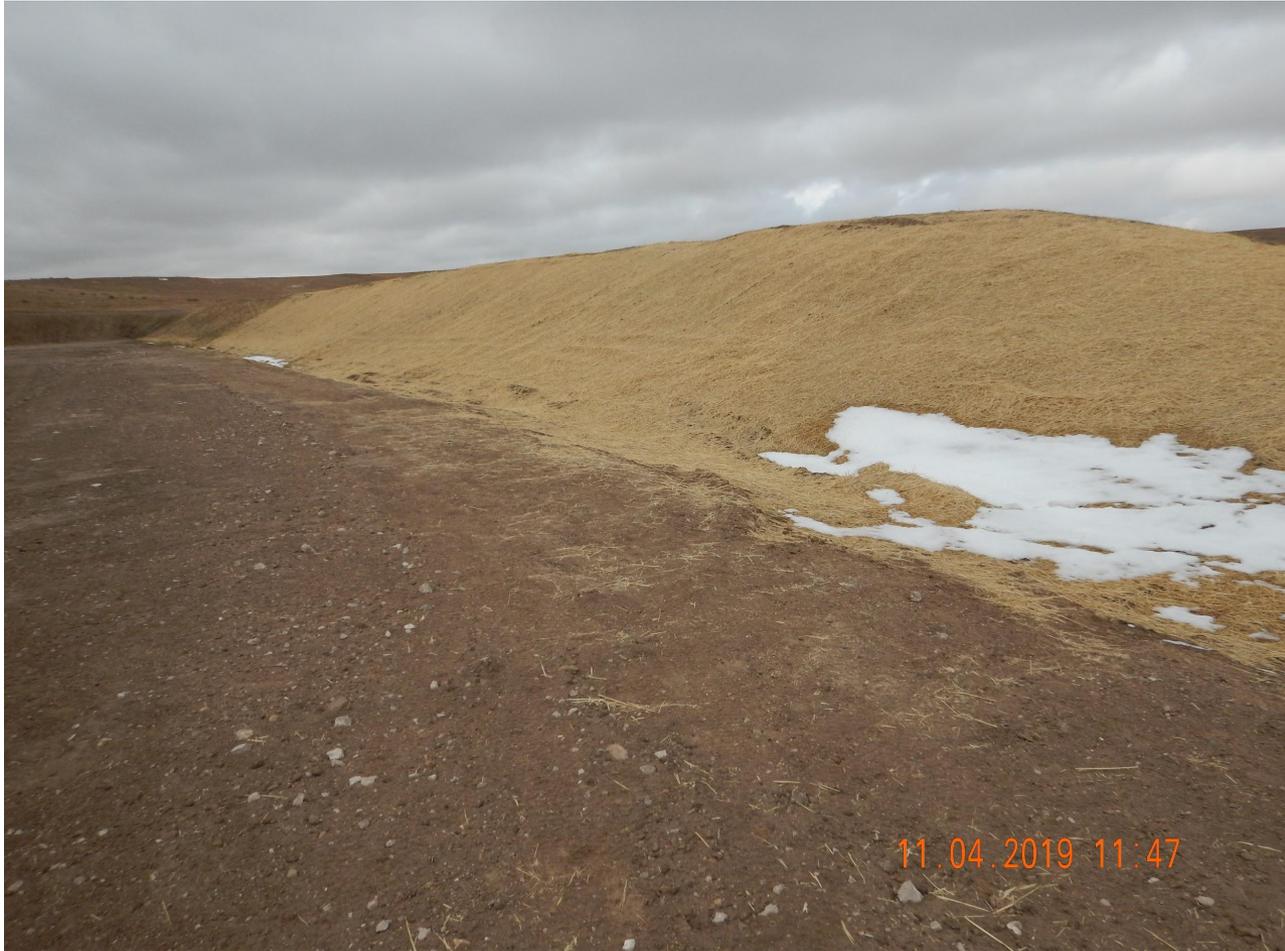
**Photo 6.** Photo taken from the topsoil stockpile along the northern location, facing West. Photo illustrates Operator has re-stabilized the topsoil stockpile.

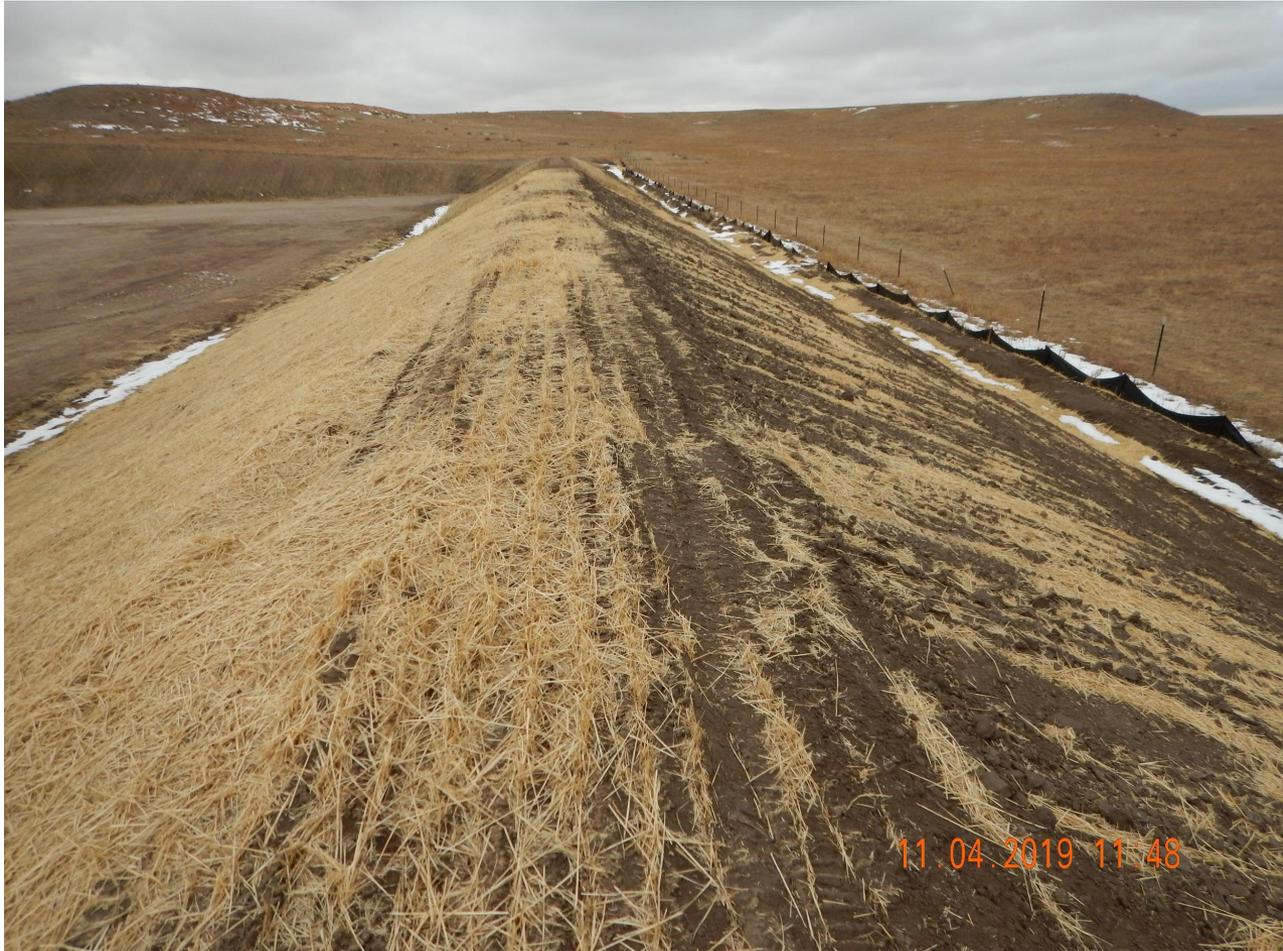
**Photo 7.** Photo taken from the topsoil stockpile along the northern location, facing West. See comments under Photo 6.

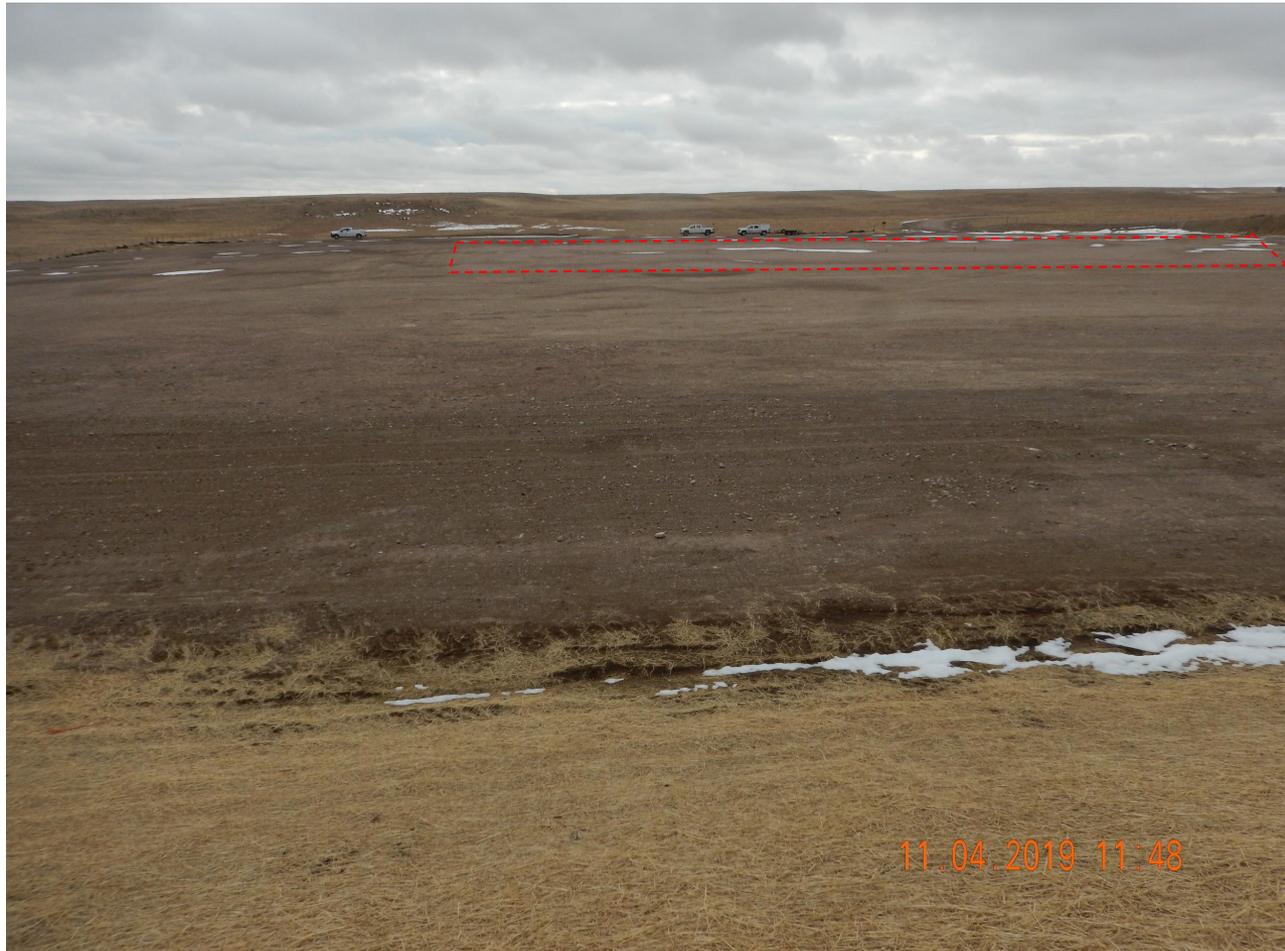
**Photo 8.** Photo taken from the topsoil stockpile, facing South. Photo is trying to illustrate the approximate rig area (dashed red lines). The rig area has CDOT Class 6 base; whereas, the rest of the well pad appears to remain unconsolidated as fines are accumulating the eastern ditch BMP.

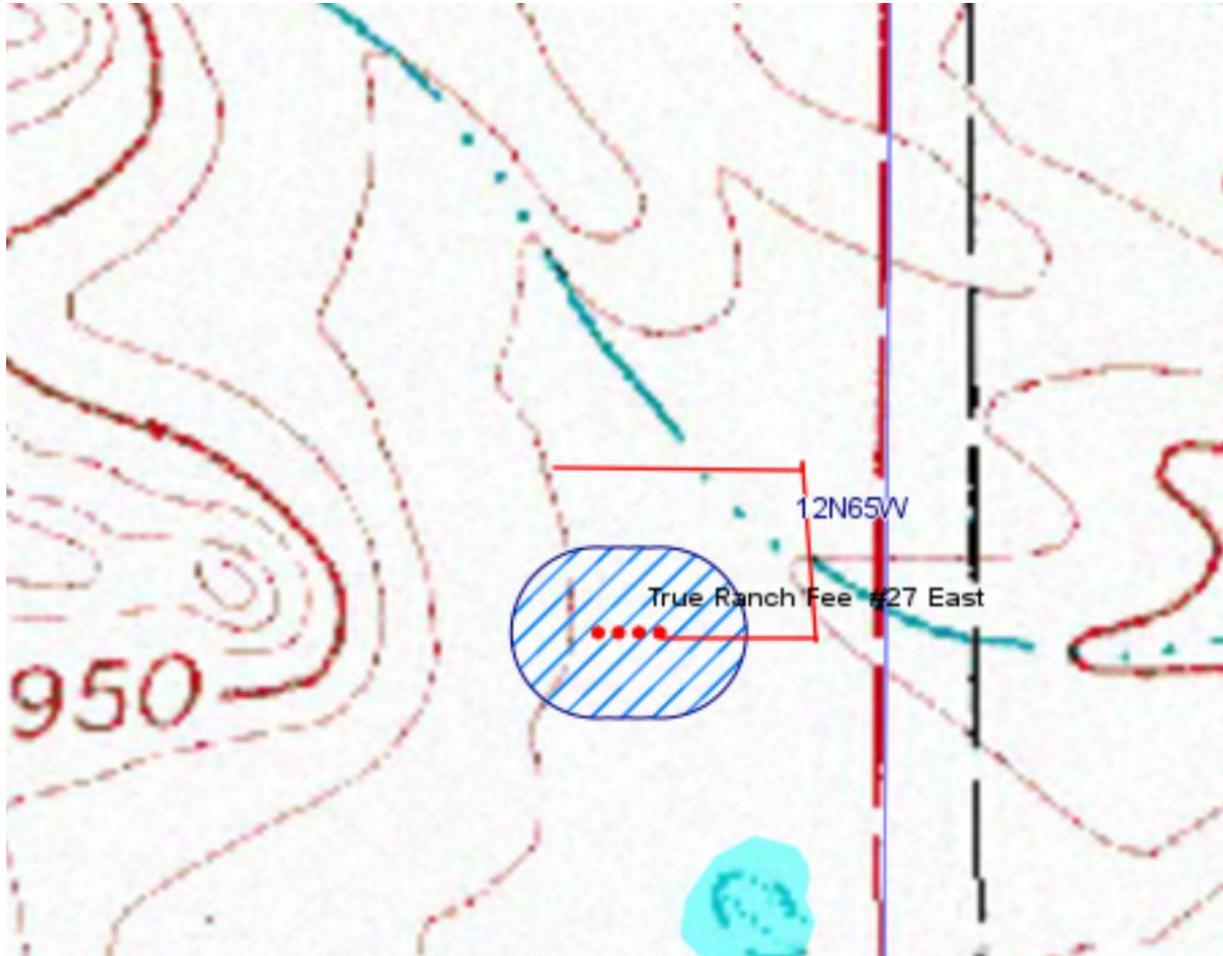
The 24K topo illustrates this location was built on top of an Intermittent stream. The red lines are the approximate northeast well pad perimeter, not including the topsoil stockpile or stormwater BMP areas, in relation to the Intermittent stream.
