Inspection Photos
Operator: BP America
Location/API #: 067-08393
Date: 11-6-2019

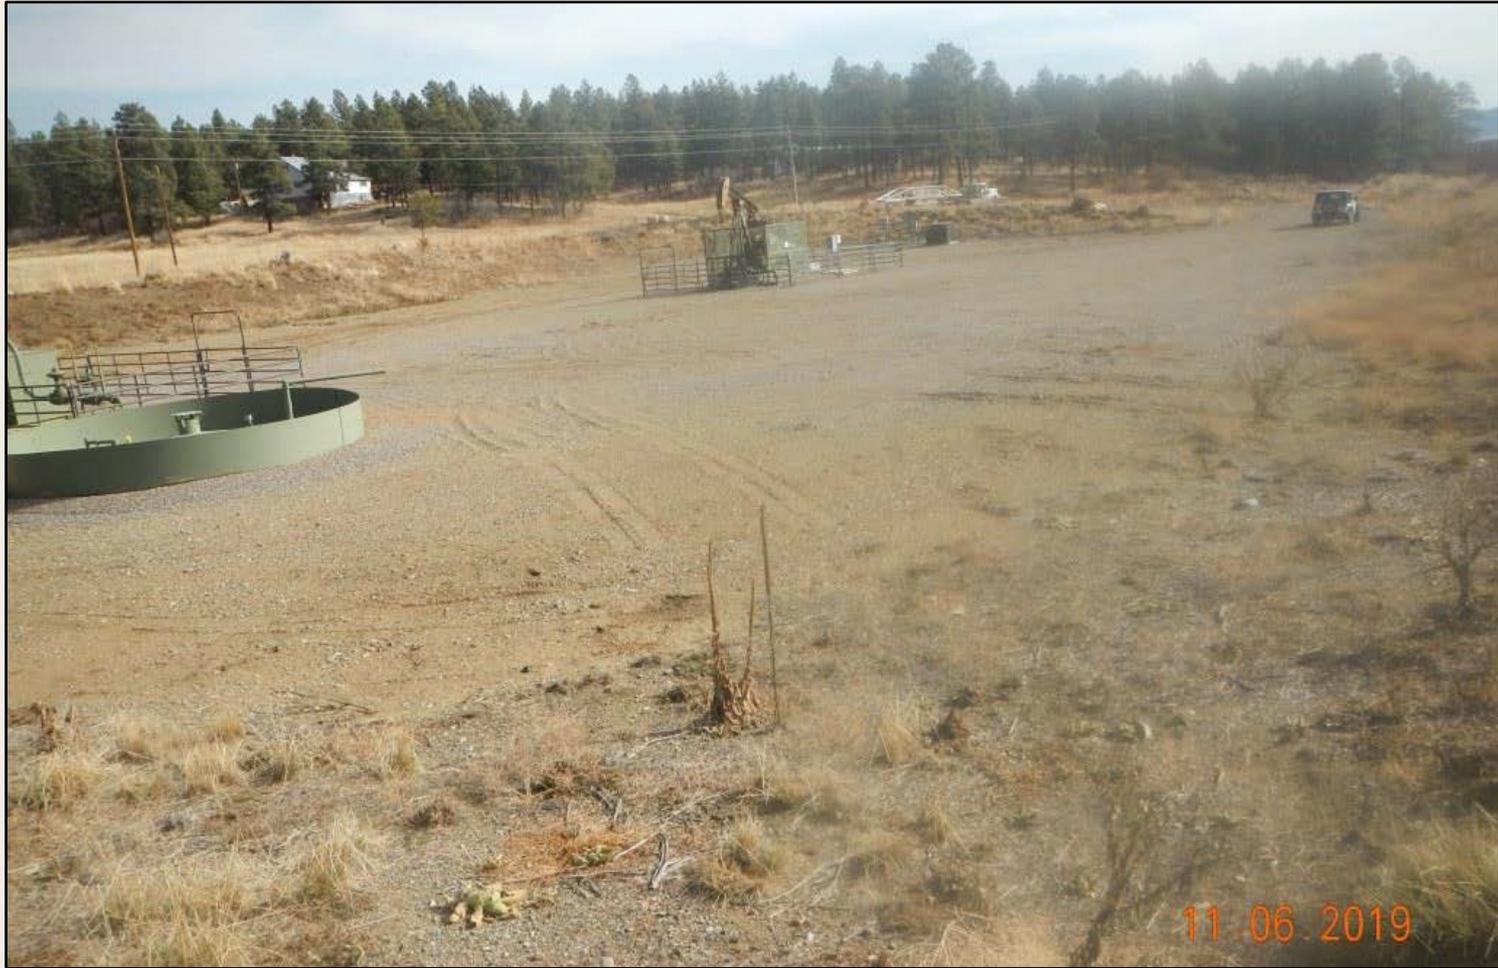
Photo 1. View of the project area from the southwestern corner facing center.

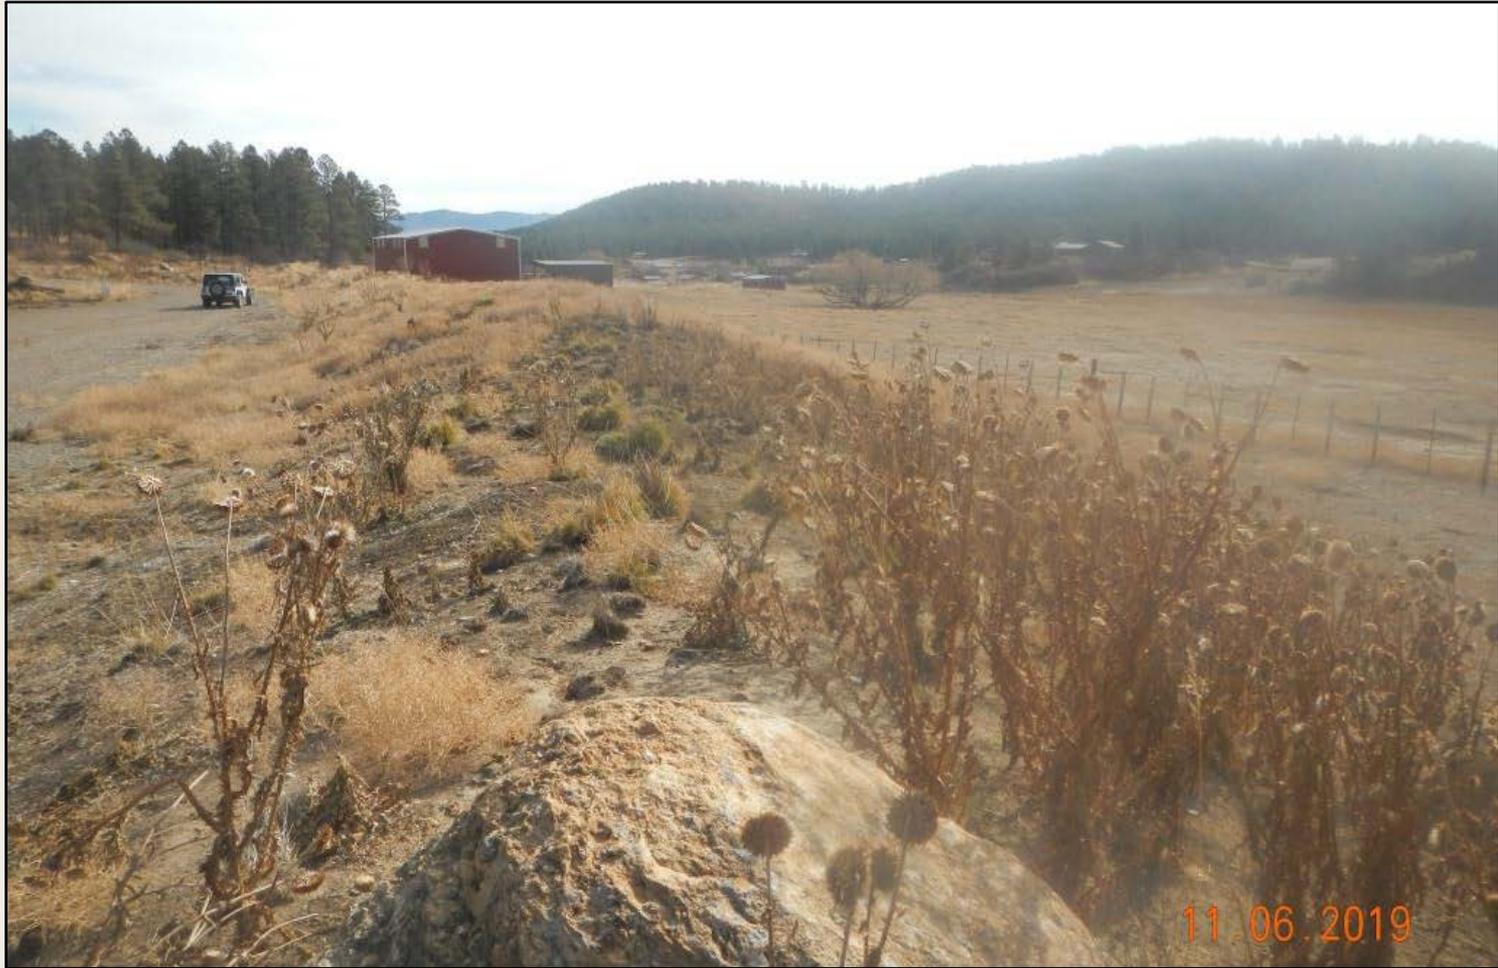
Photo 2. View of the southern project area from the southwestern corner facing eastward. Location is infested with weeds.

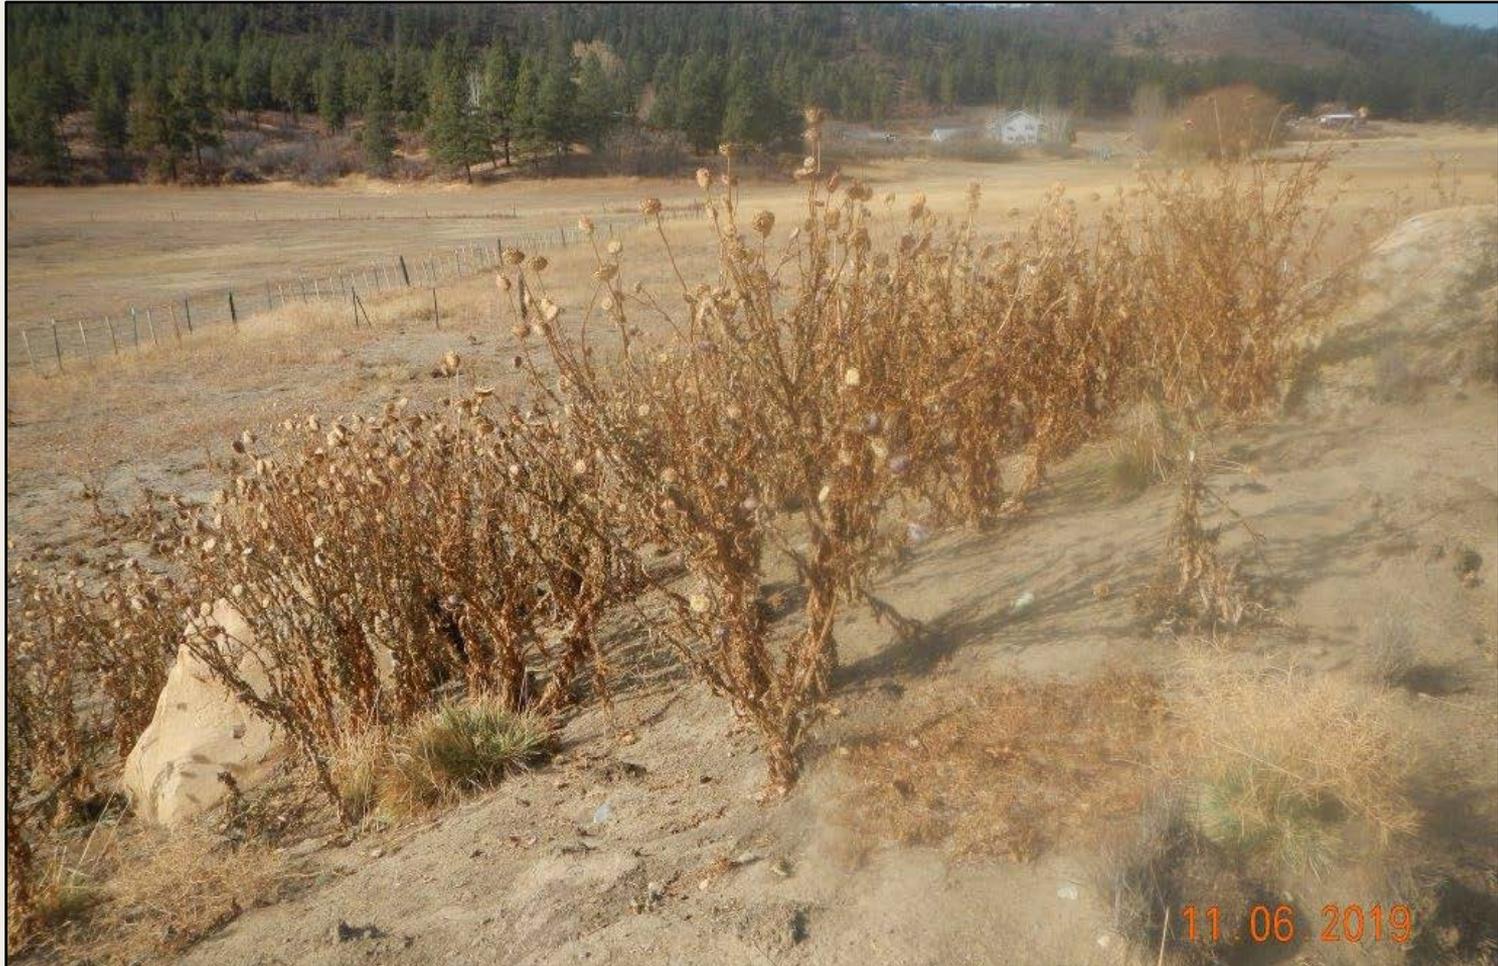
Photo 3. View of musk thistle infestation within the southwestern project area.

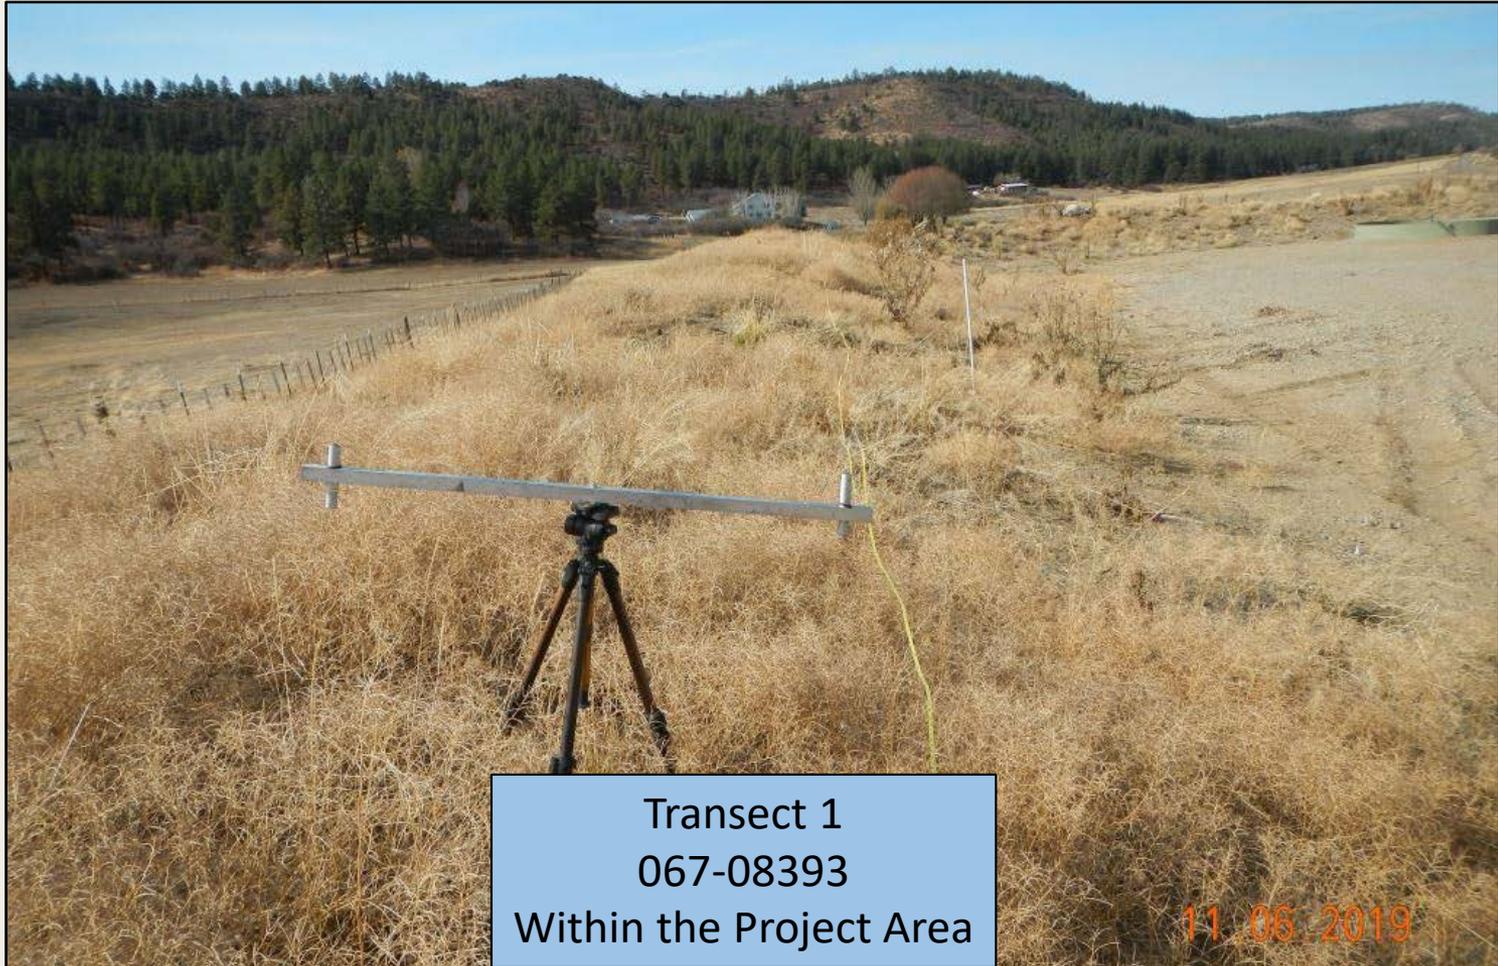
Photo 4. View of the beginning of Transect 1, within the project disturbance facing westward. Brown vegetation is dominated with weedy annual mustard. Scattered perennial grasses such as crested wheatgrass and intermediate wheatgrass are present, although poorly established.

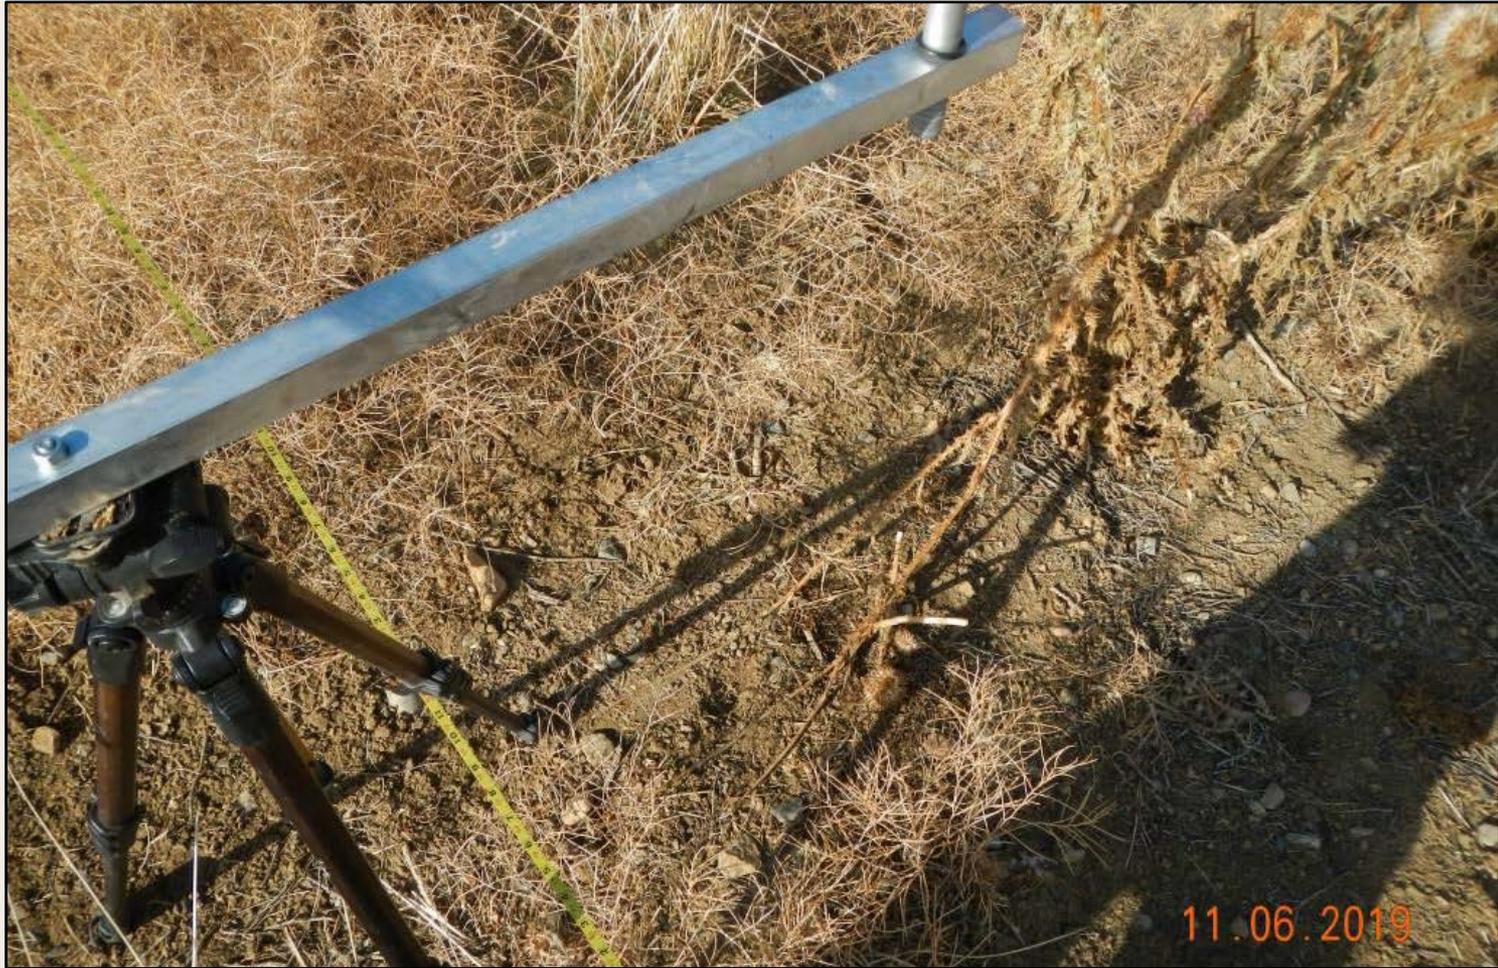
Photo 5. Birdseye view of vegetation at the midpoint along the vegetation transect, largely comprised of weedy mustard (likely *Sisymbrium altissimum*) and Canada thistle.

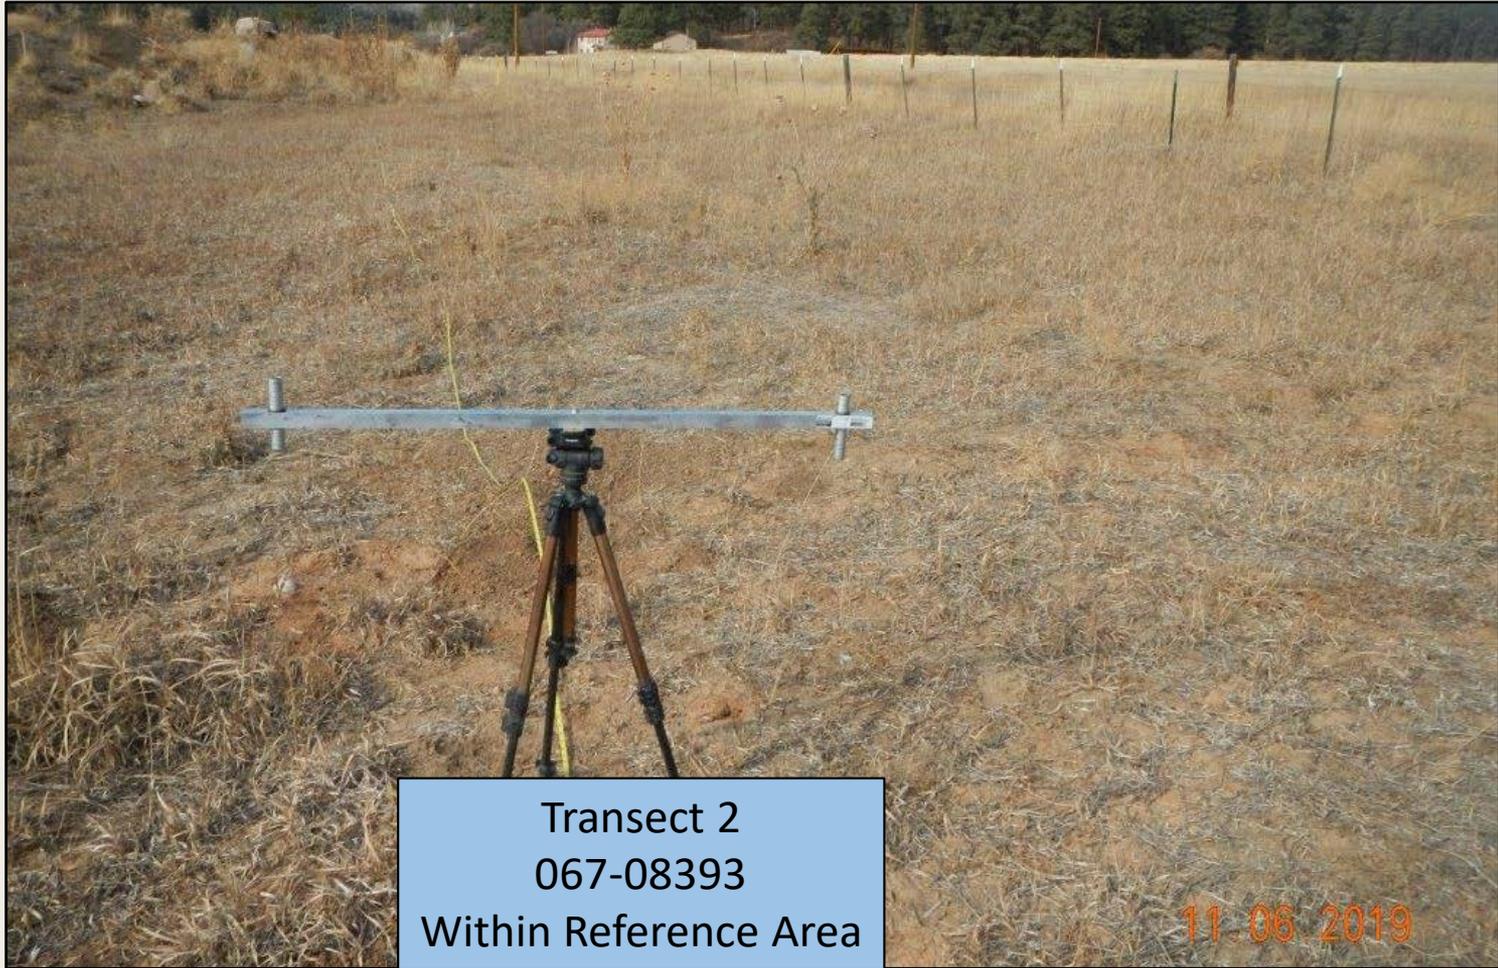
Photo 6. View from the beginning of Transect 2, within the reference area, facing westward.

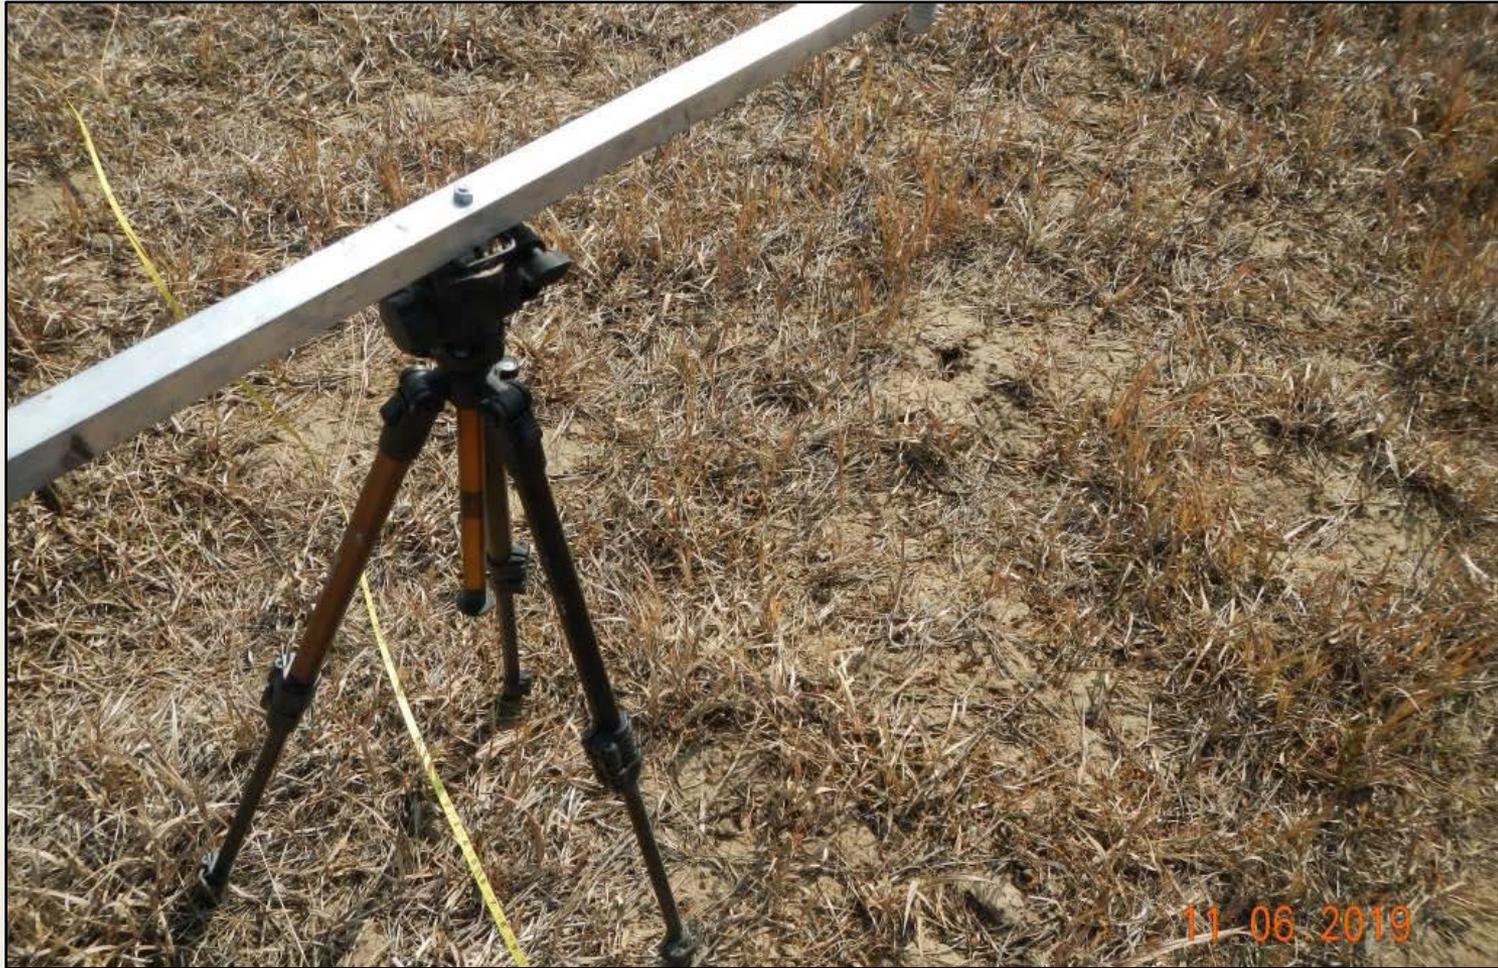
Photo 7. Birdseye view of vegetation along Transect 2, largely comprised of smooth brome.

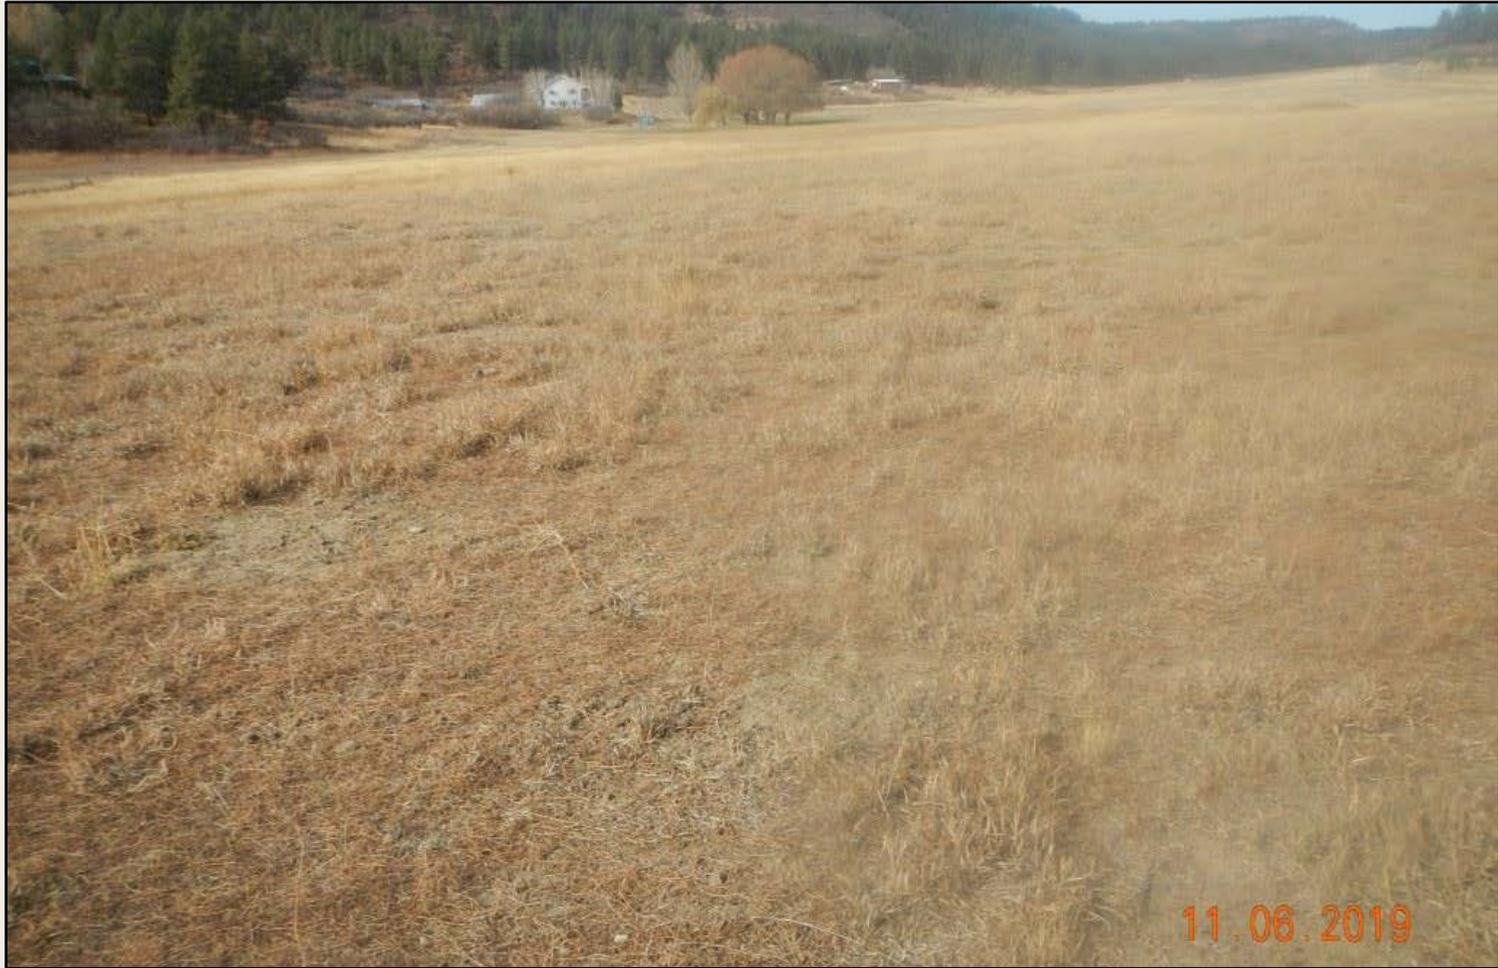
Photo 8. View of reference area west of the well pad, comprised of open grass field.
