Inspection Photos

API: 05-071-09381

Operator: XTO ENERGY INC

Inspection Date: 11/8/2019

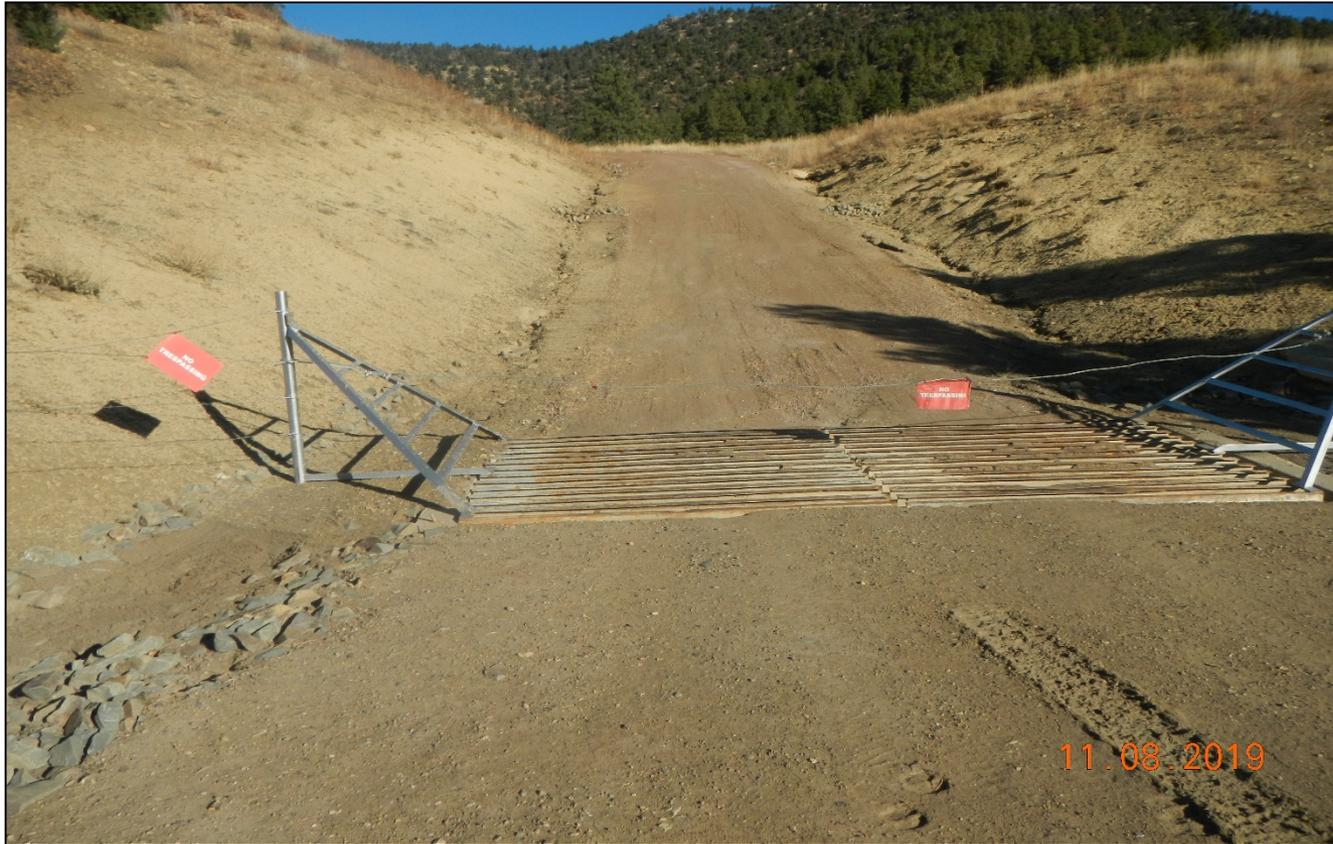
Photo 1. Facing north at the beginning of the access road. The cattle guard has been maintained and slopes have been hydro-mulched.

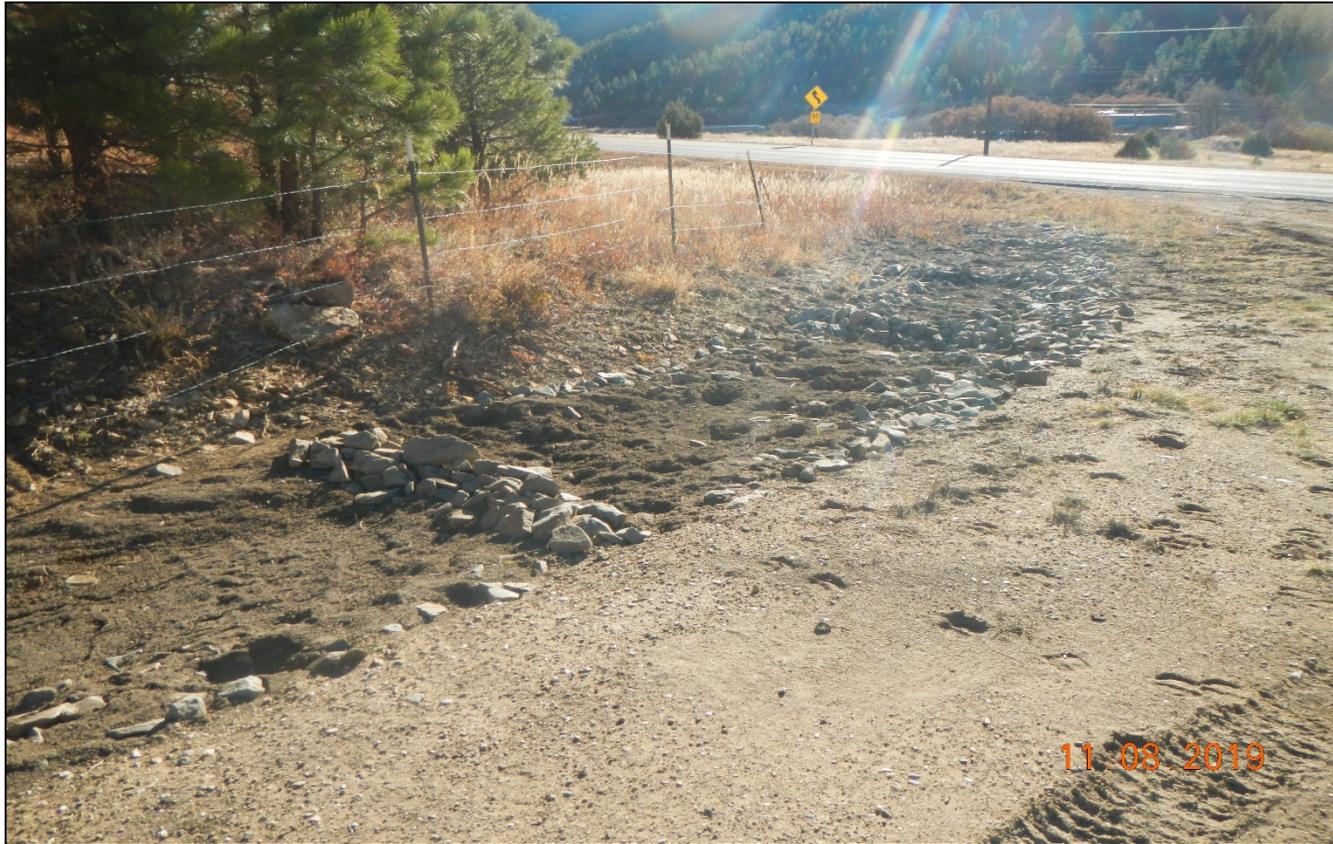
Photo 2. Rock rip/rap was installed on the side of the road at the beginning of the access road. Sediment has filled into rip rap indicating erosion is not controlled.

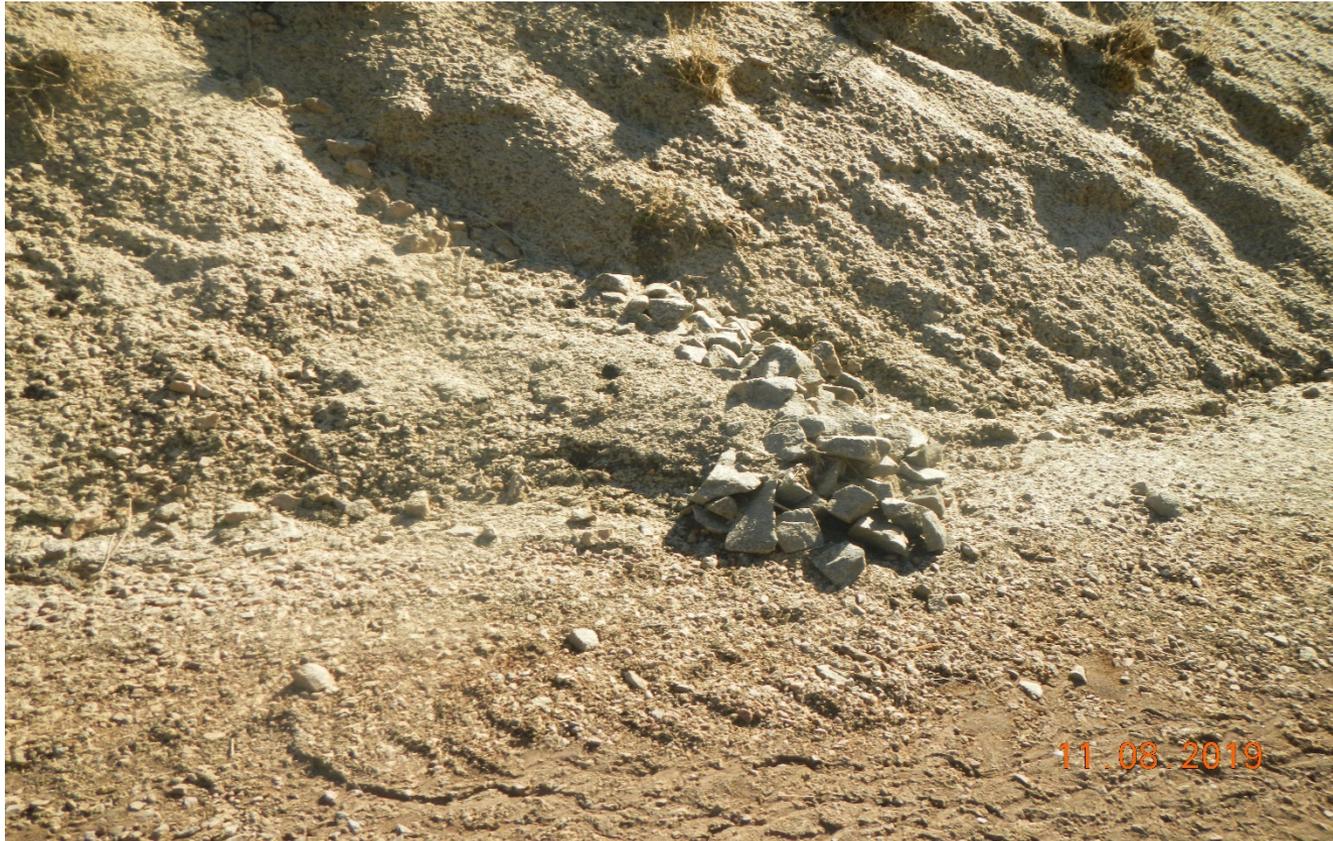
Photo 3. Rock check dams were installed along the road however, sediment has filled in the check dams. The check dams were not properly installed by trenching the sides into ground and creating a low area in the center of the check dams.

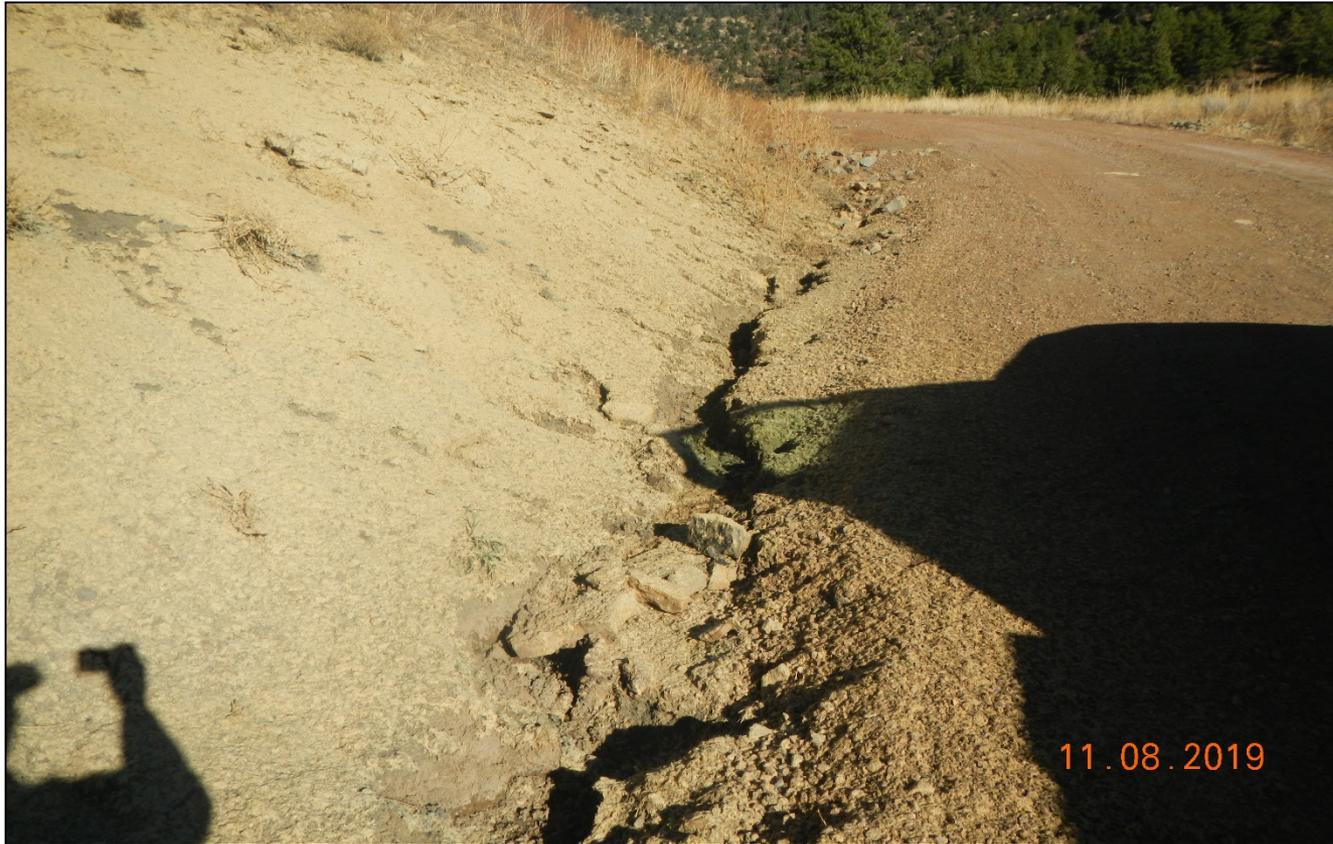
Photo 4. Erosion channel is developing along the side of the road which need to be repaired and controlled.

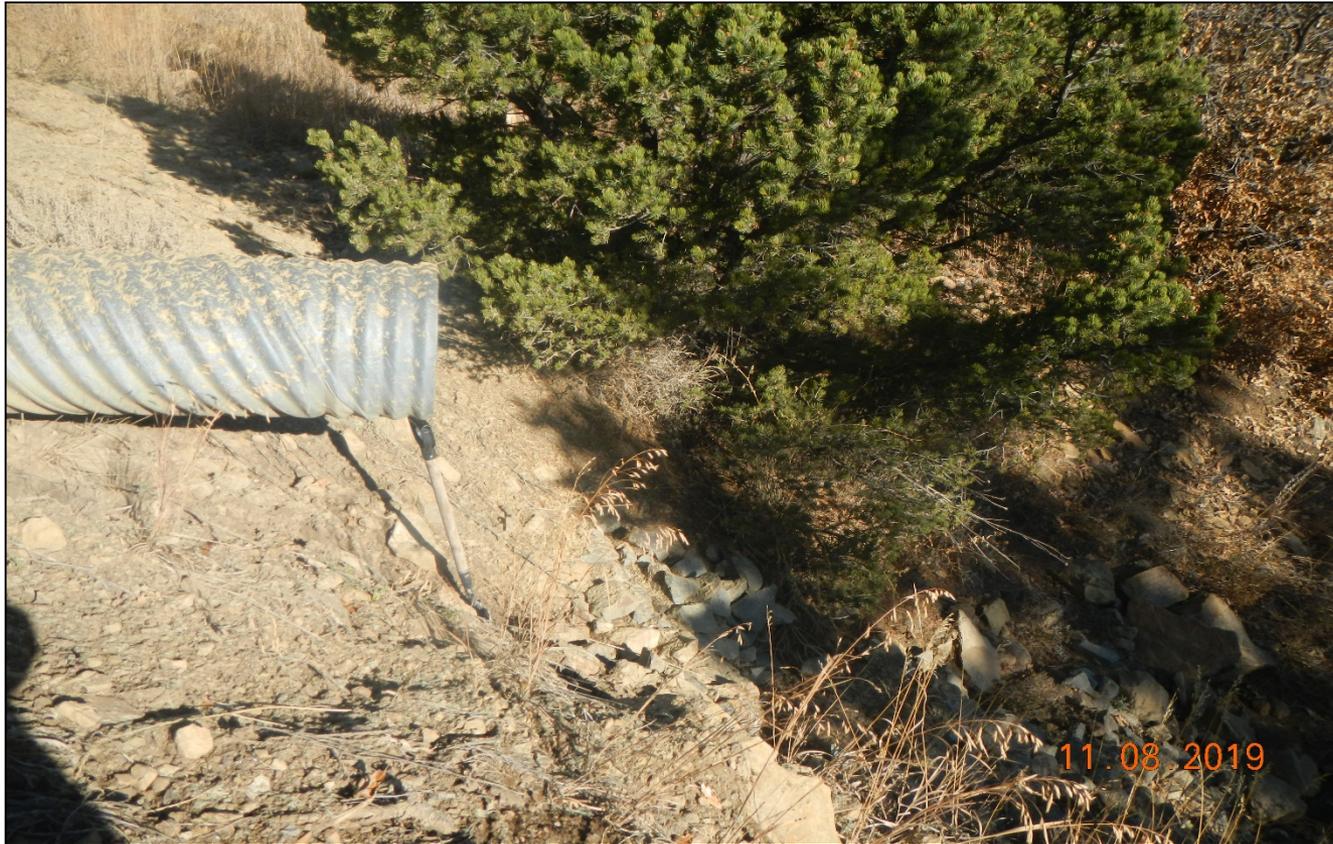
Photo 5. The culvert outlet extends to far out from the road which creates a 3 ft. vertical drop for stormwater which can accelerate erosion. The outlet protection is not adequate and the culvert should be cut closer to the road.

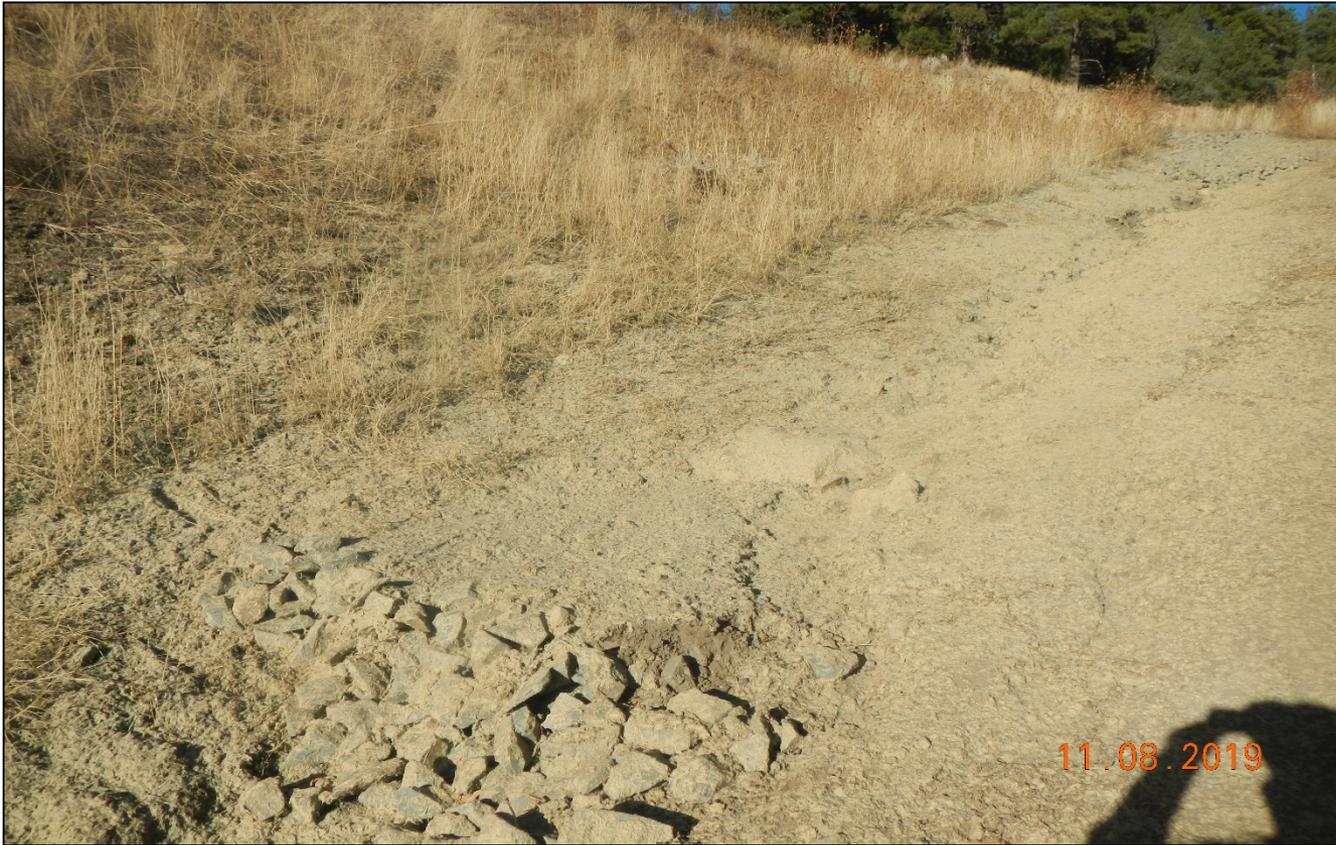
Photo 6. Sediment has filled into the check dam which requires maintenance.

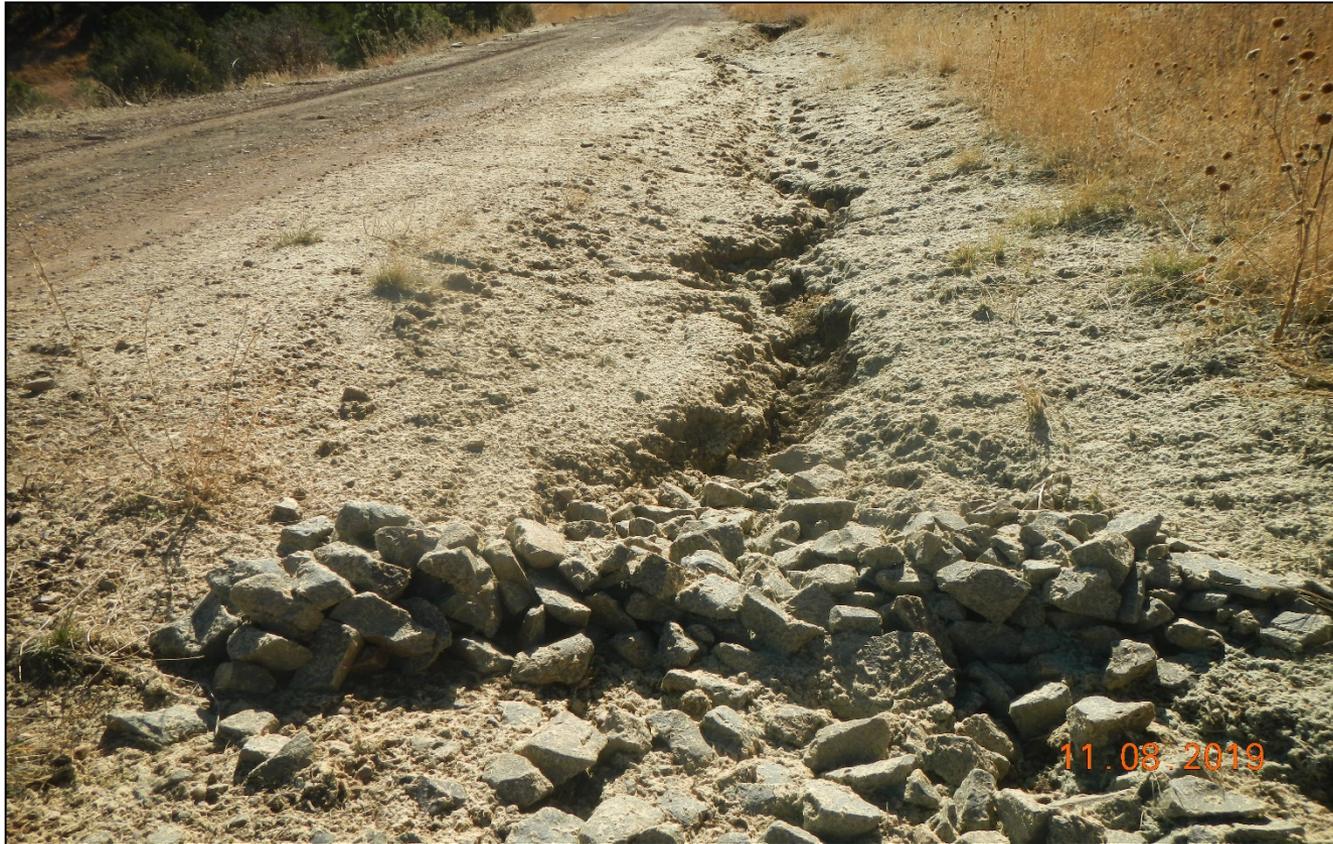
Photo 7. There is an erosion channel developing beyond the check dam which needs to be repaired.

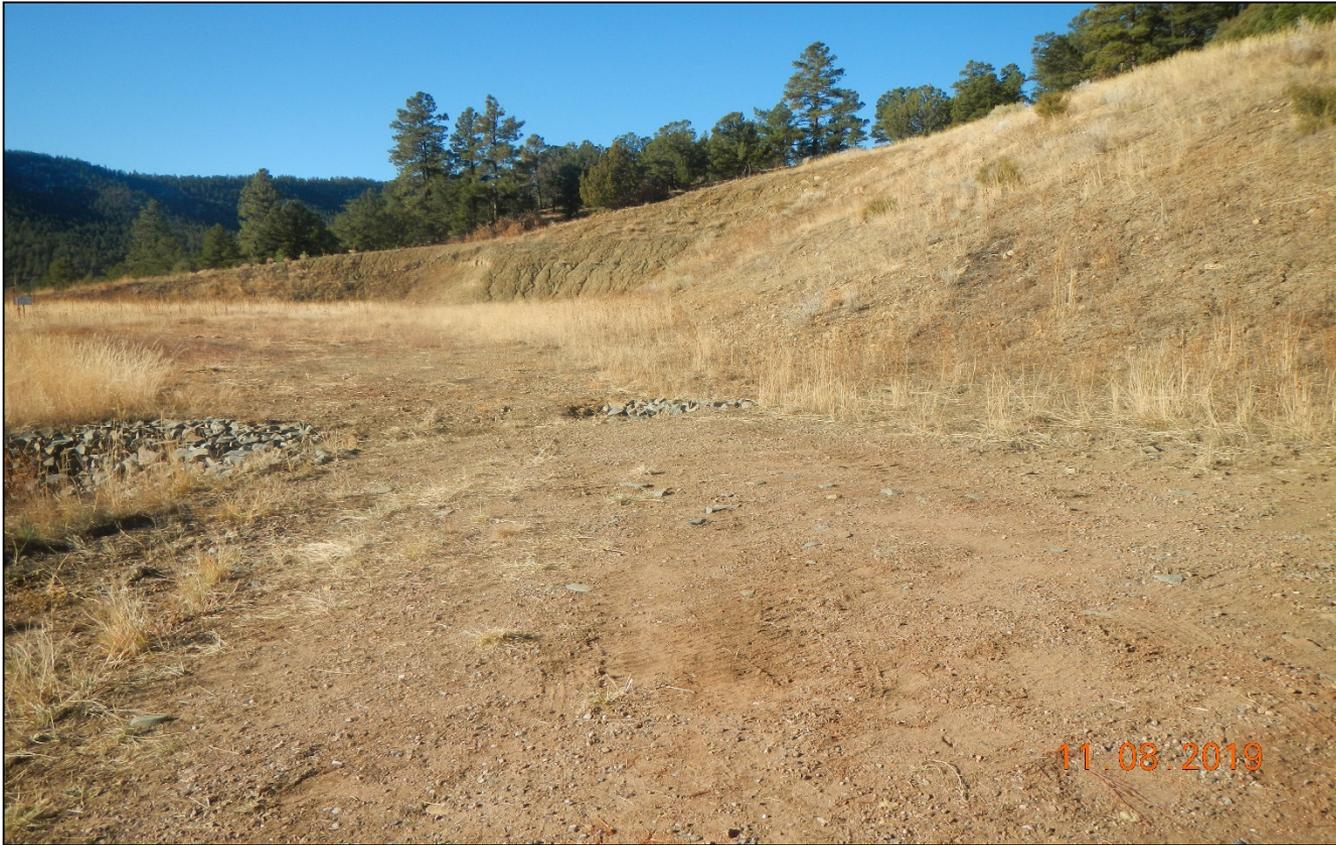
Photo 8. Facing southwest toward the location which has not been recontoured and reclaimed.

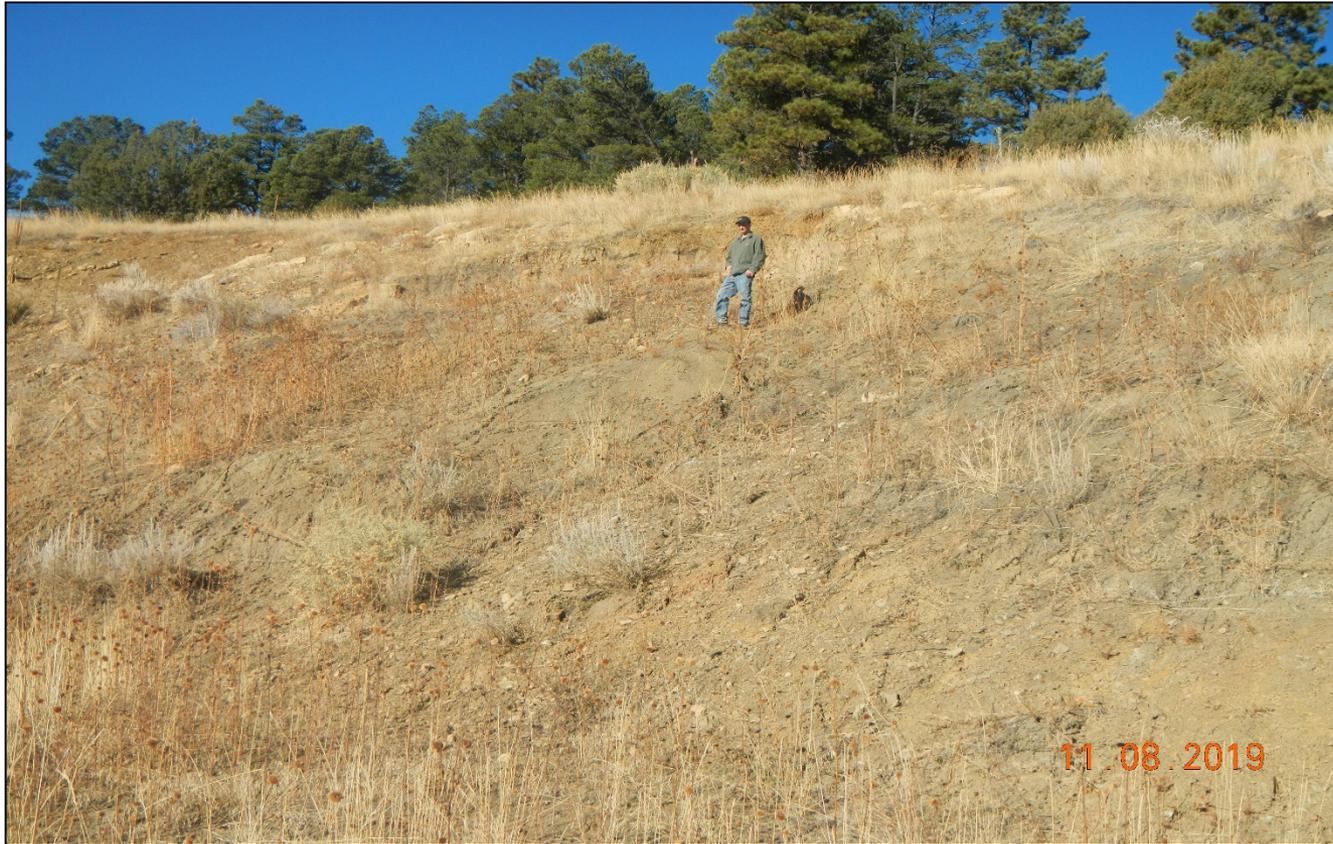
Photo 9. There is a soil slough where I am standing in the photo along the cut slope. There is erosion along the cut slope which is not stabilized.

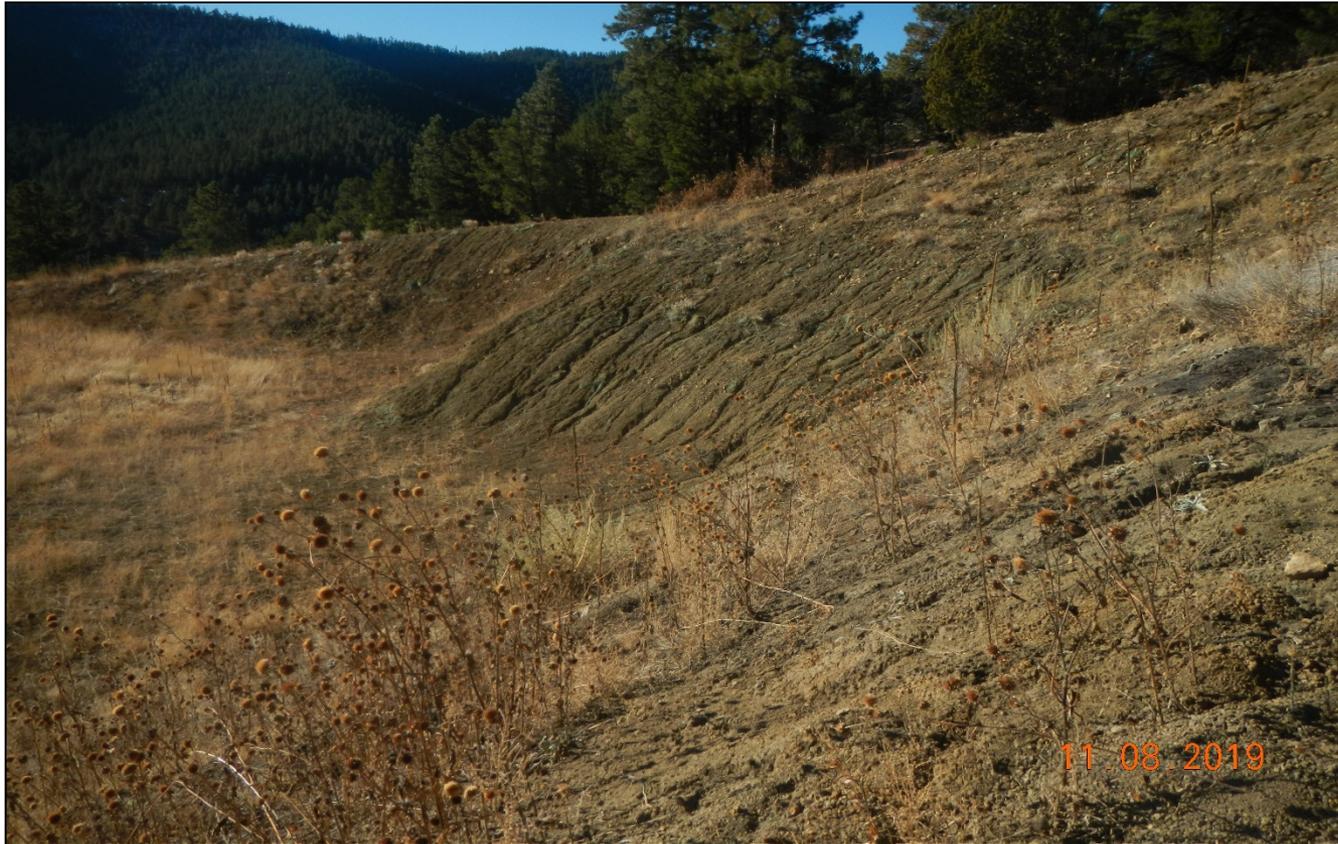
Photo 10. Facing southwest along the cut slope, There is erosion along the cut slope which is unstable.

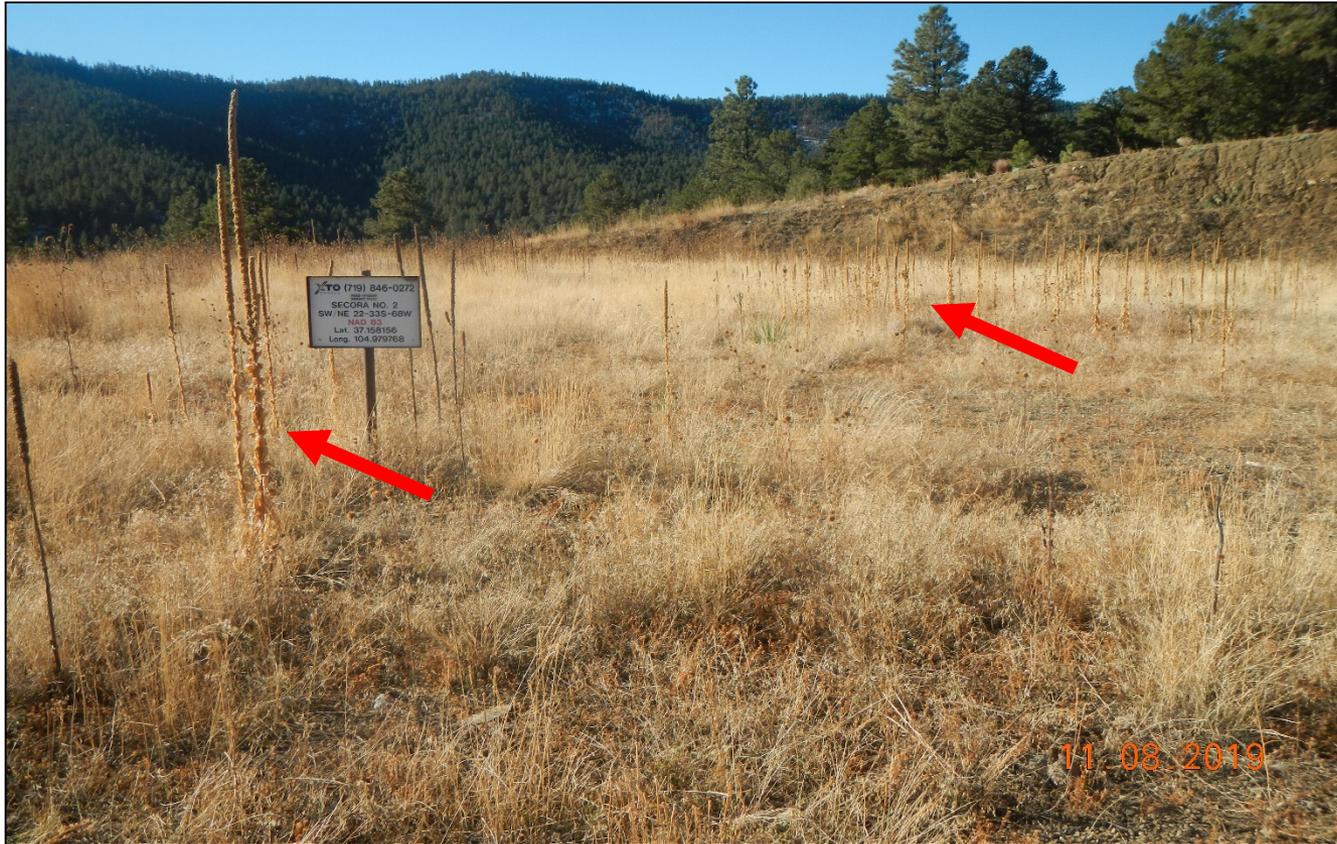
Photo 11. There are noxious weeds (Common mullein) on the pad surface.

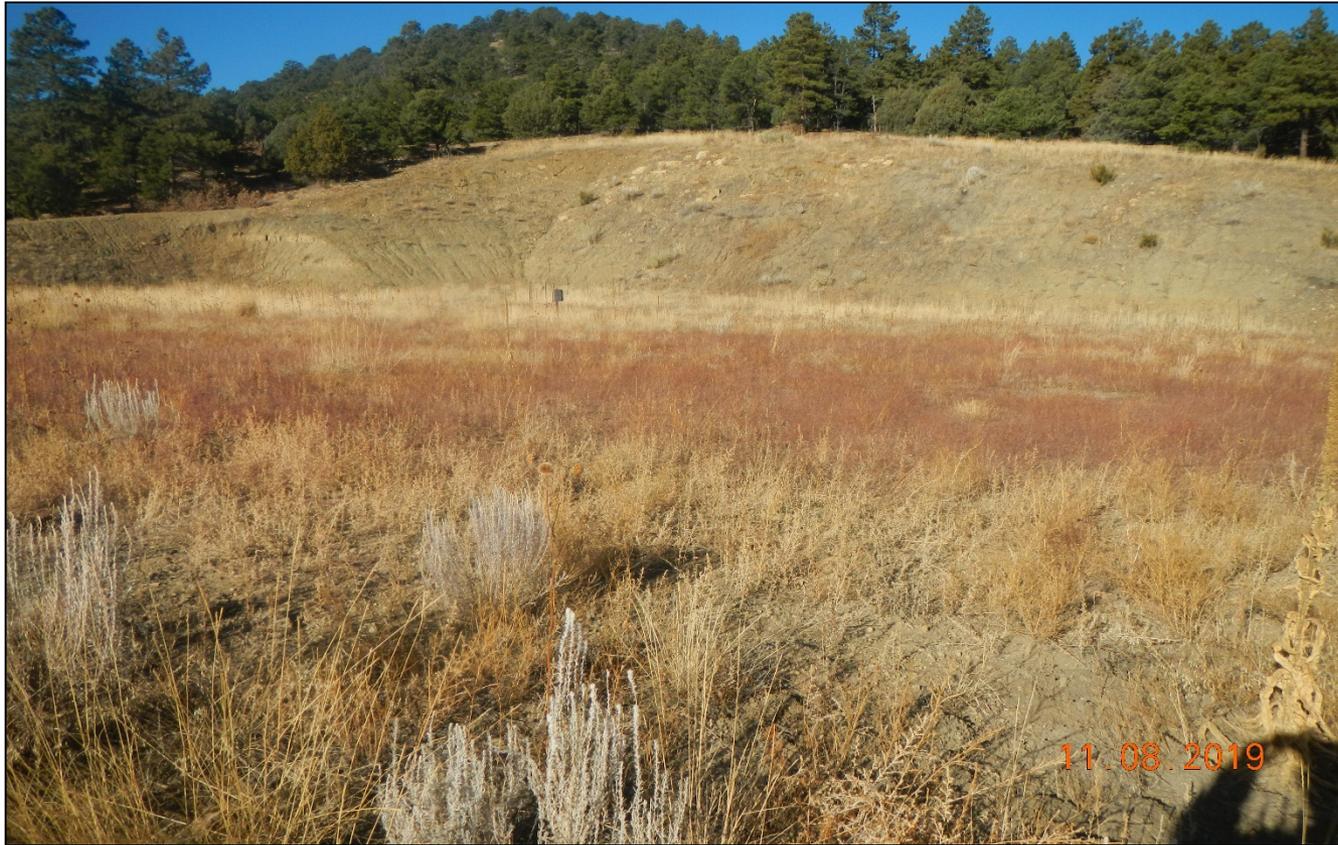
Photo 12. Facing northwest toward the location. The cut slope is bare of vegetation and not stabilized.

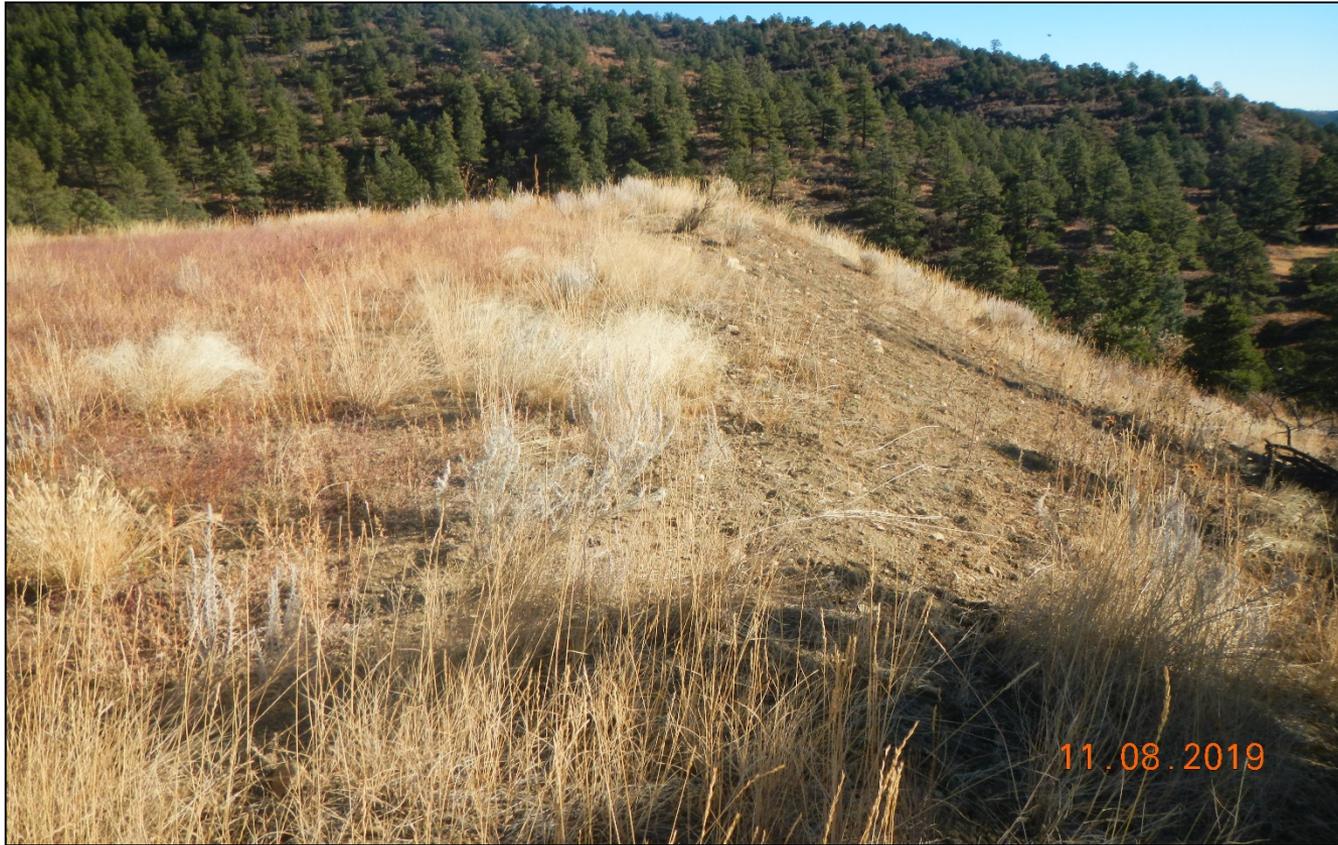
Photo 13. Facing east toward the fill slope.

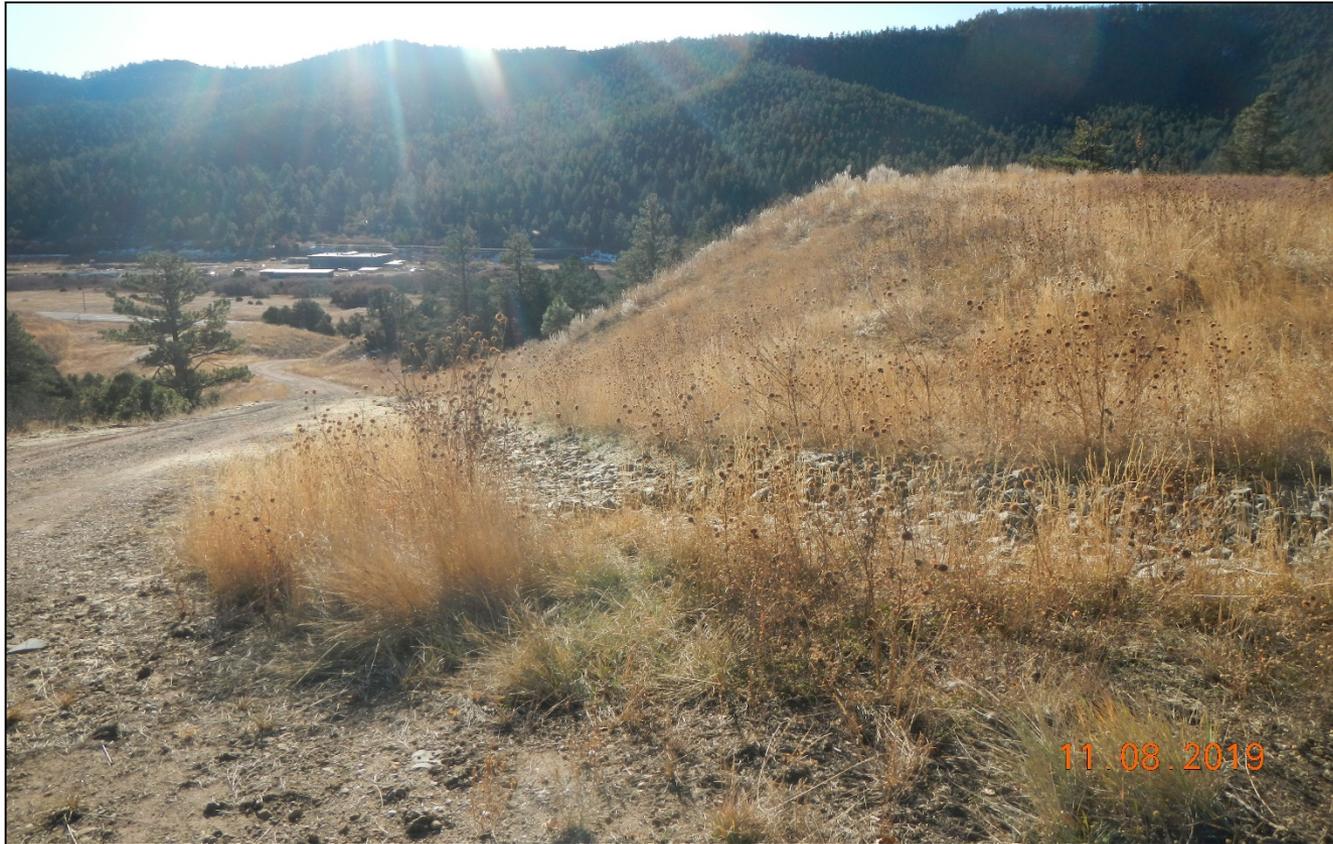
Photo 14. Facing southeast toward the access road at left of the photo which was approved to remain per variance request. The pad fill slope material is shown in right portion of the photo which the variance request was denied.
