# Inspection Photos

API: 05-071-08776

Operator: XTO ENERGY INC

Inspection Date: 11/8/2019

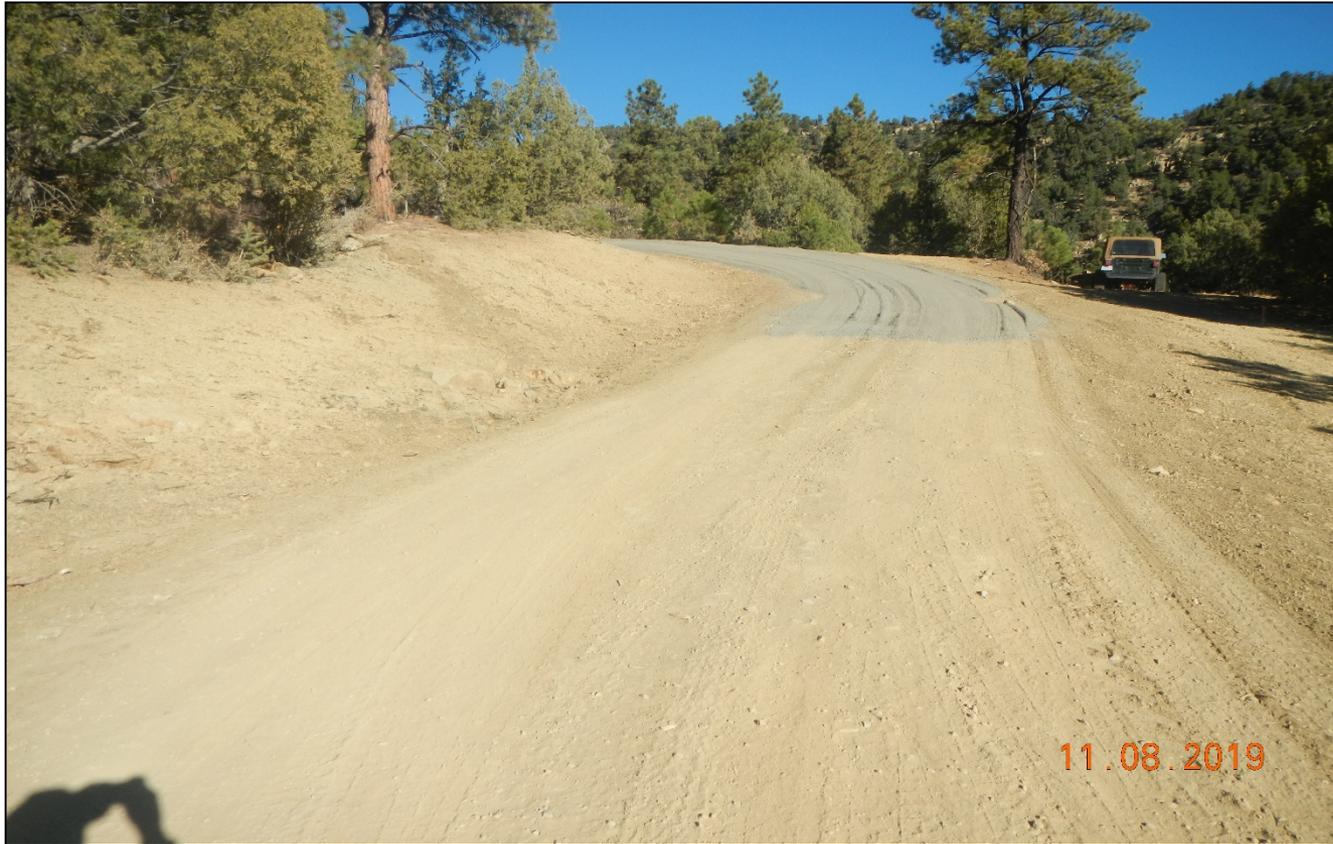
**Photo 1.** The access road has been regraded and gravel is being spread along the surface.

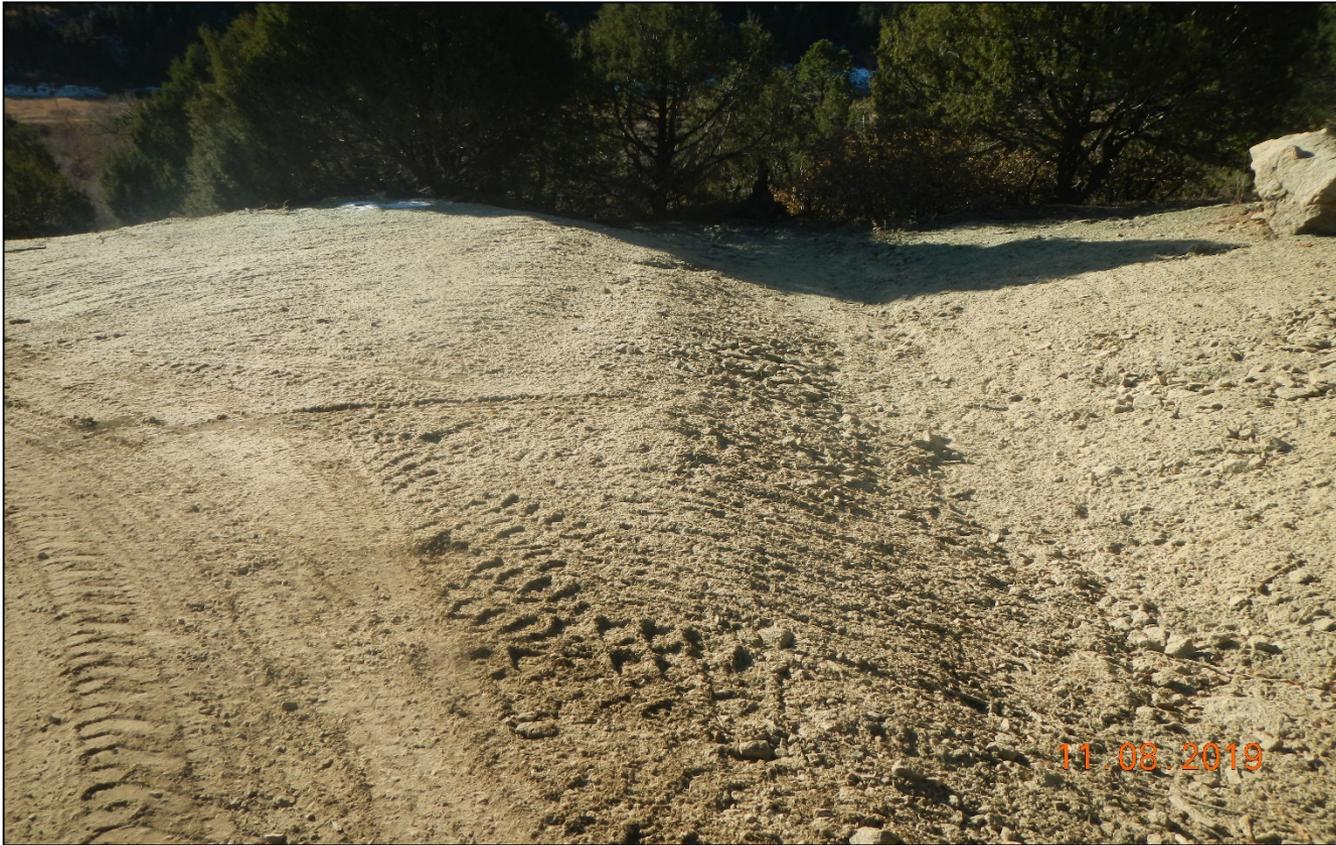
**Photo 2.** This drainage channel at the switchback of the road may require a sediment trap to slow the stormwater velocity to prevent erosion.

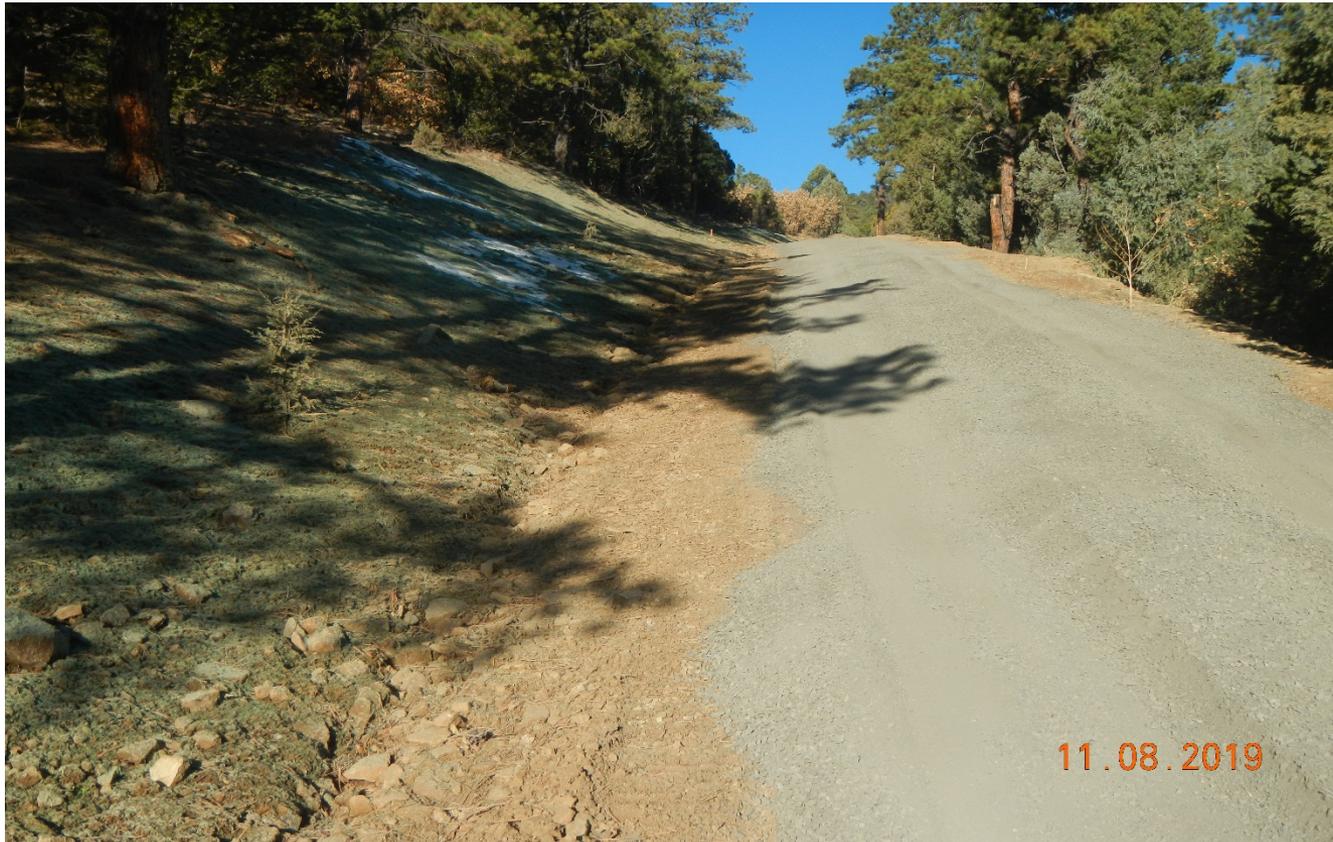
**Photo 3.** Facing west along the access road as it ascends the hill. The sides of the road are hydromulched.

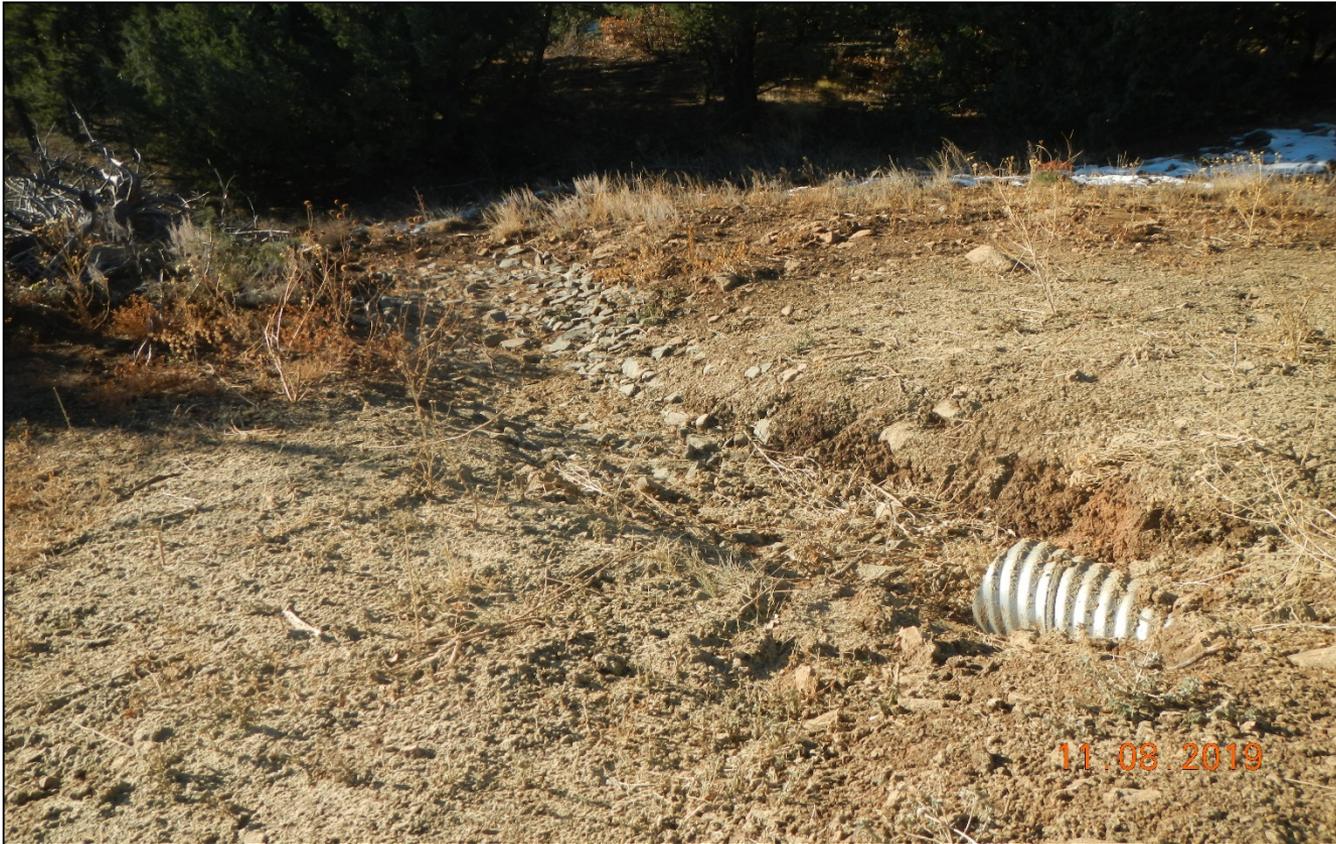
**Photo 4.** There is rock rip/rap in the culvert outlet but additional BMP's may be needed to slow the stormwater velocity.

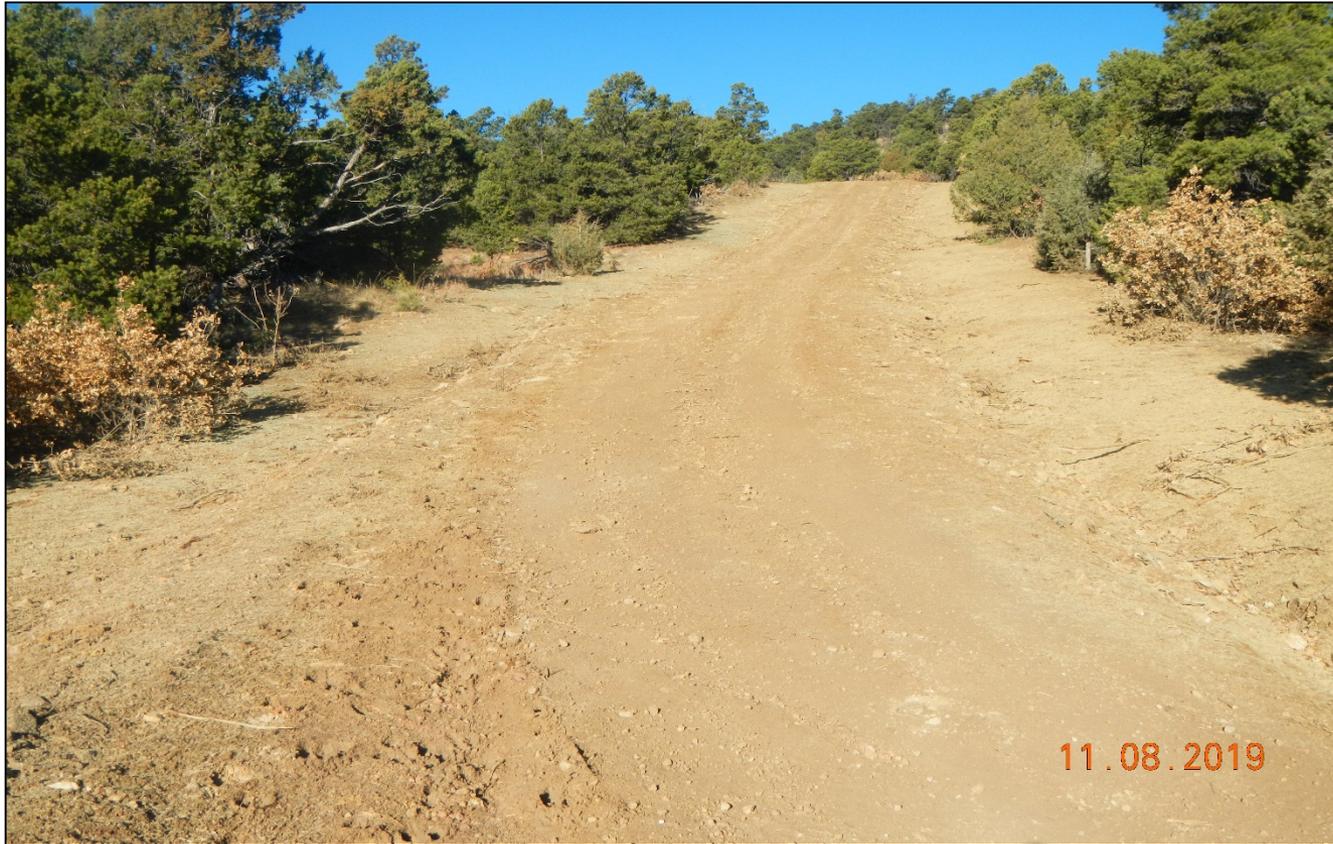
**Photo 5.** Facing west along the access road as it ascends the hill. Additional BMP's are needed to prevent erosion along the side of the road.

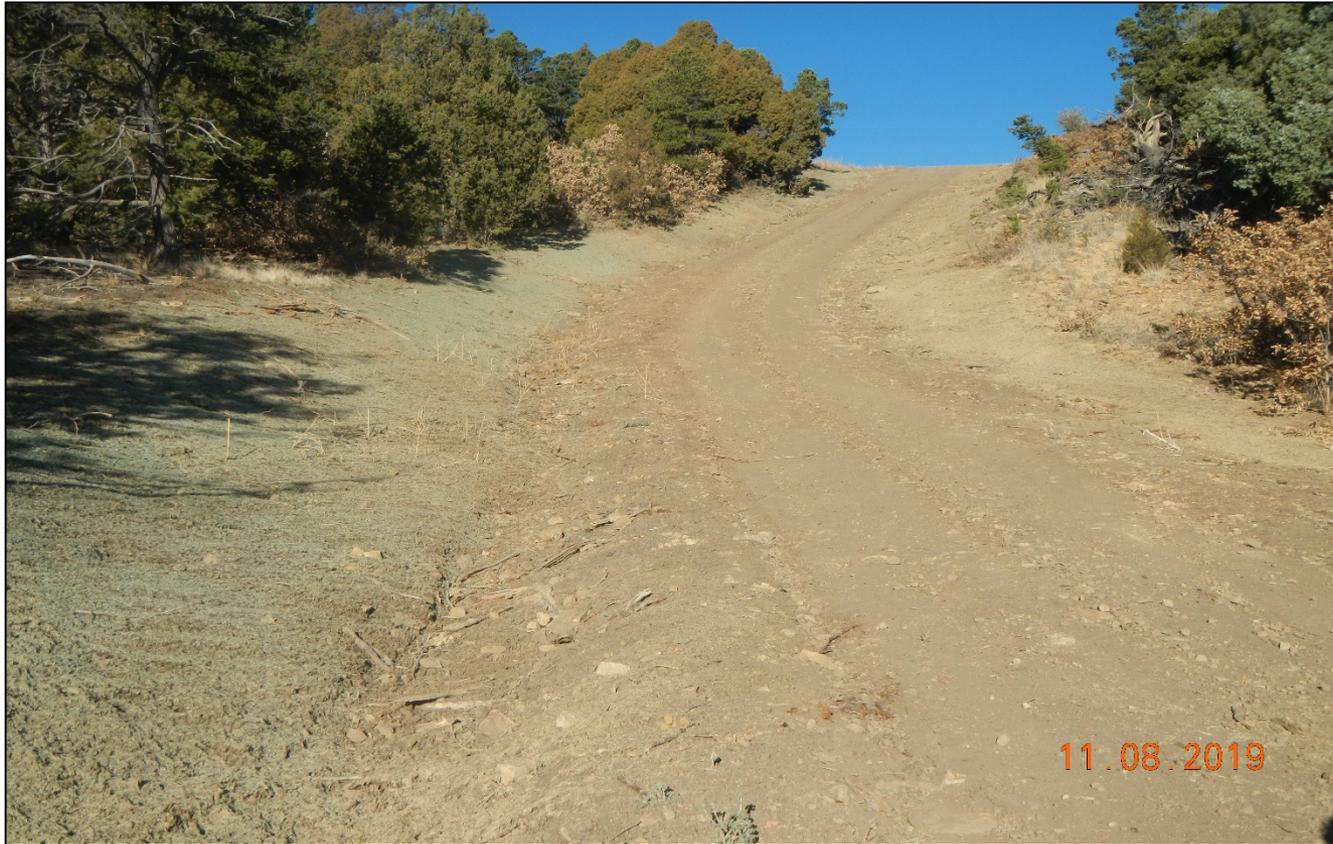
**Photo 6.** Facing west along the access road as it ascends the hill. Additional BMP's are needed to prevent erosion along the side of the road.

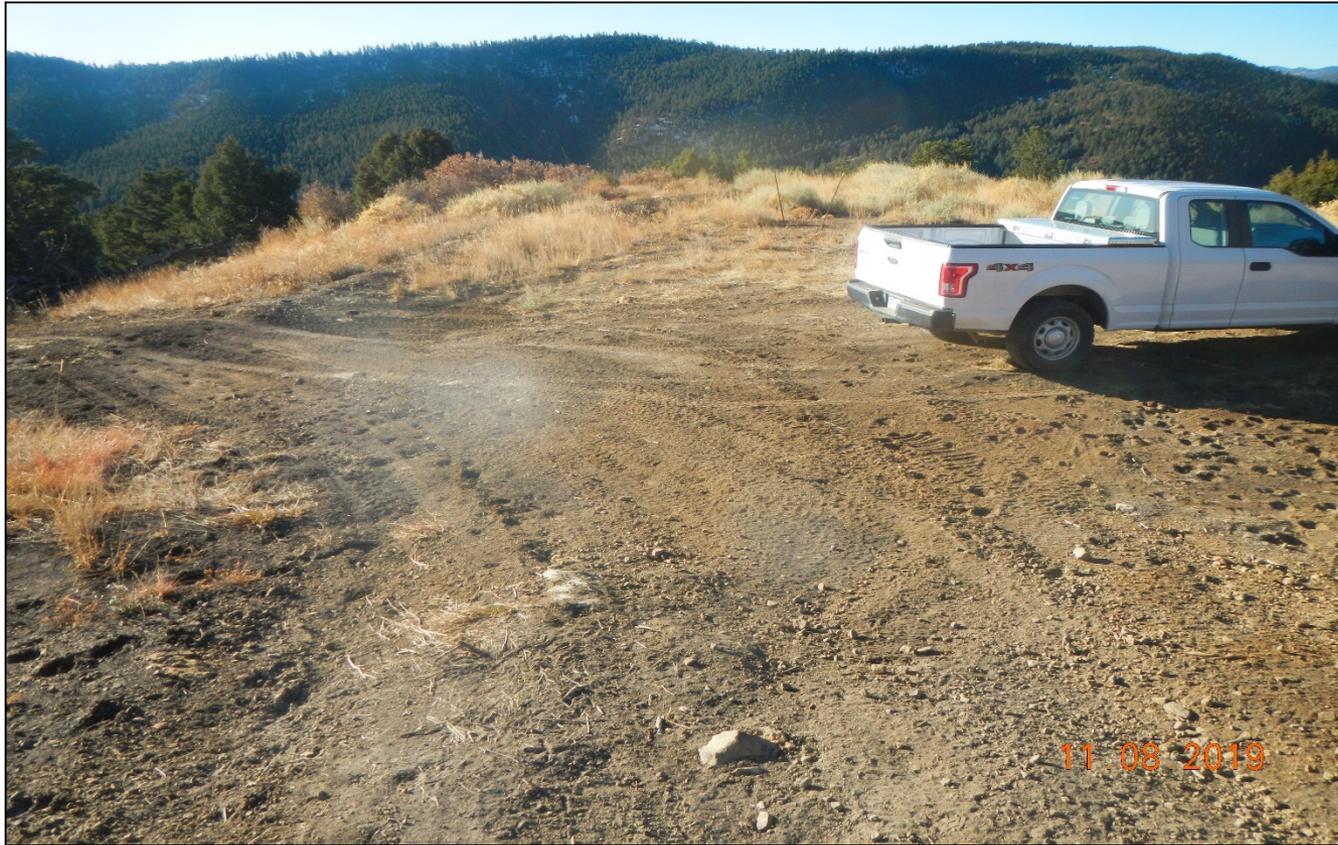
**Photo 7.** Facing south at the location.

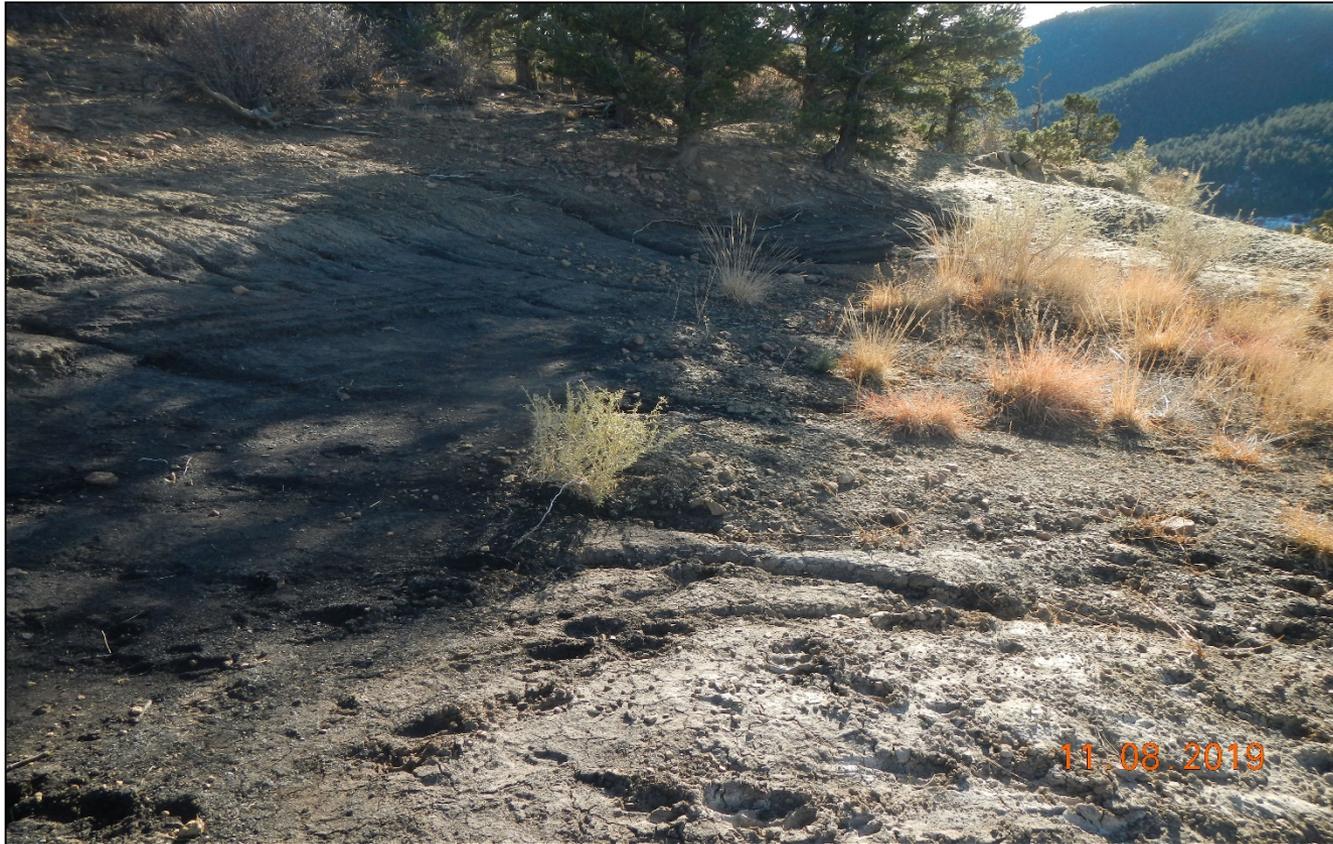
**Photo 8.** The east cut slope area is bare of vegetation and needs to be stabilized. Soil is needed in this area to establish vegetation.

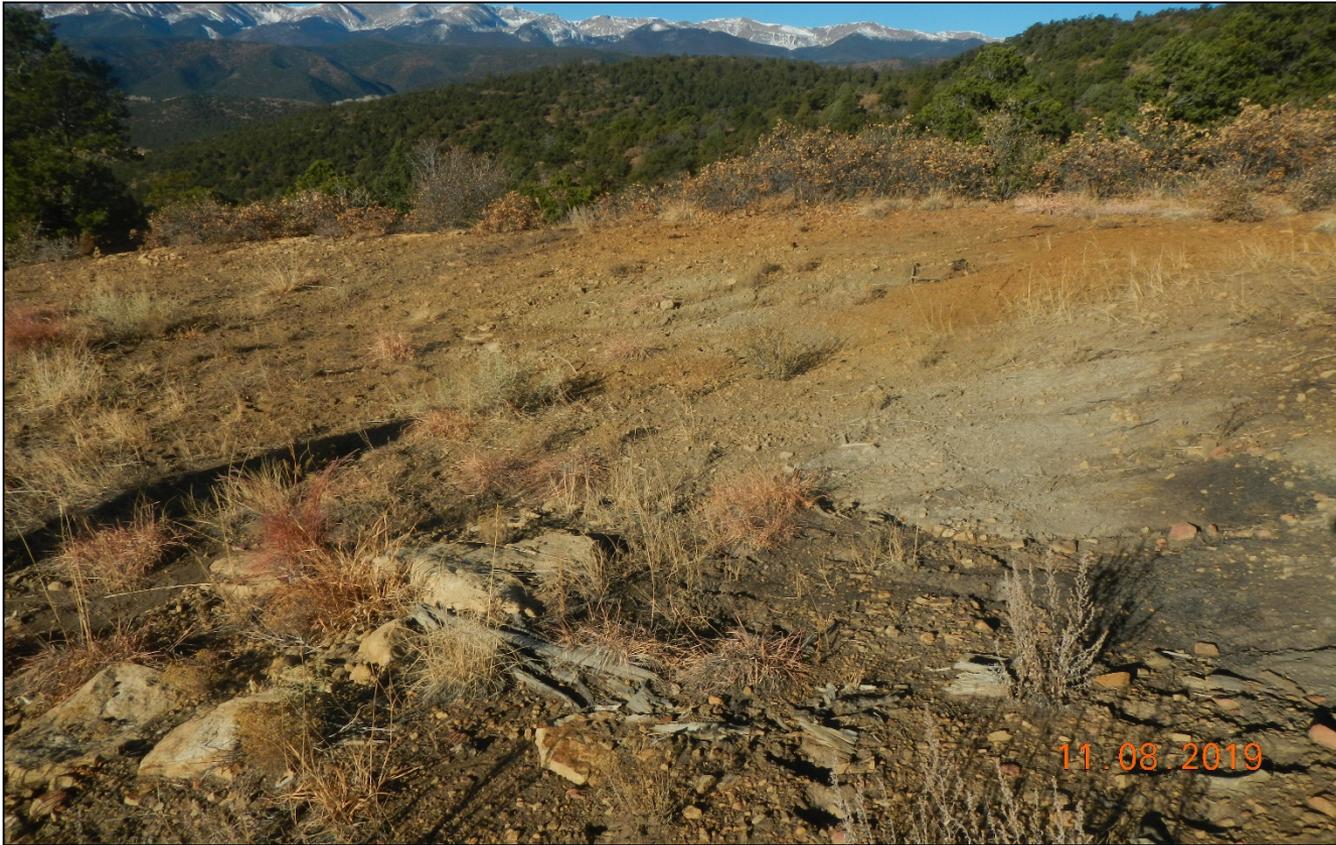
**Photo 9.** Facing west at the north side of the location. This area is not stabilized.

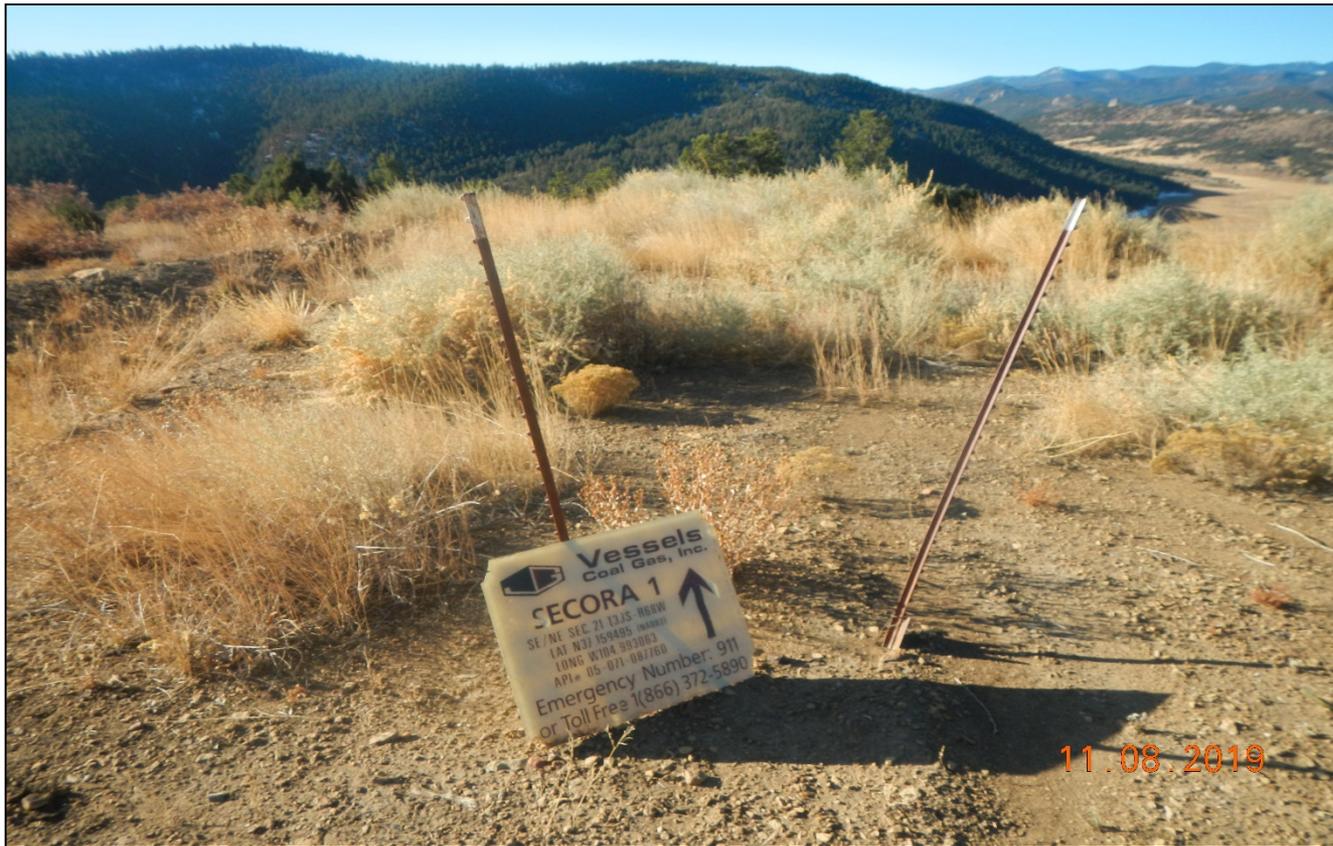
**Photo 10.** The two t posts and sign remain which need to be removed.
