Pit Status Evaluation Form

Pit Name: SACK 1	Facility ID: 113817
Current Status: Unknown	Status Date: 9/23/1999
Current Operator: AMOCO PRODUCTION COMPANY / 2500	
Updated Operator:	
Form 15 Pit Permit Doc #:	Permit Date:
Related Facilities: SACK, CASPER J #1 (API 05-001-07702)

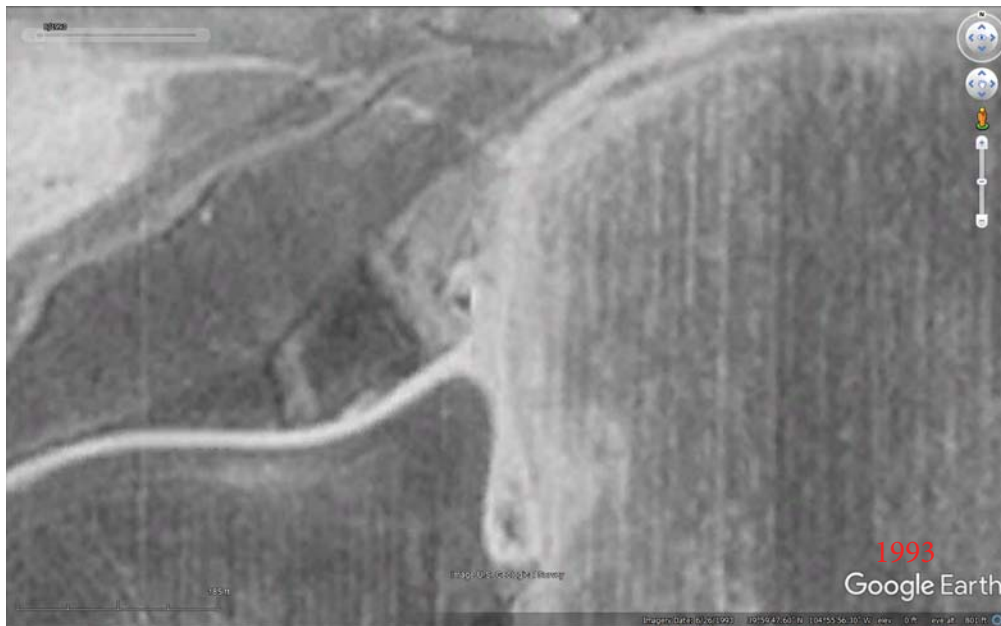
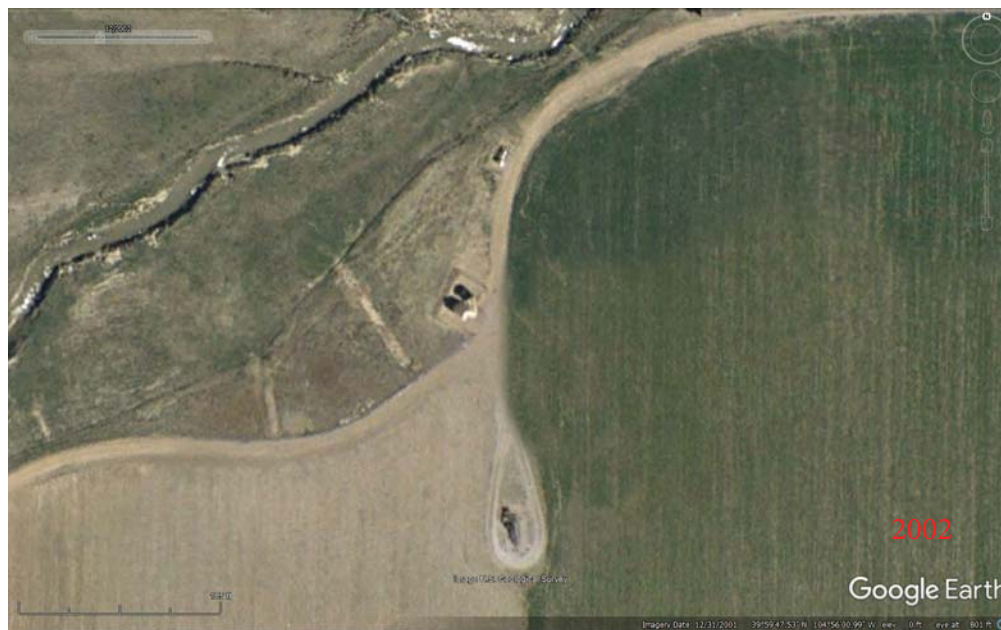
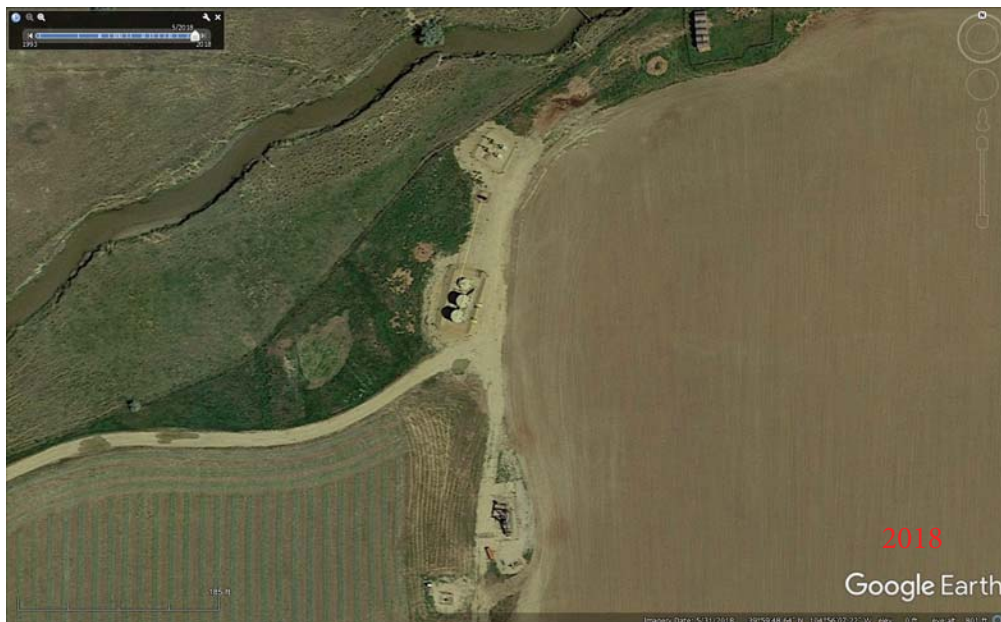
Based on records review there is no evidence that there was a pit on location. Inspection reports and pit inventory document a cement vault then fiberglass tank on location. Pit status has been changed to Closed.
