Inspection Photos
Operator: BP America
Location/API #: 067-07174
Date: 11-6-2019

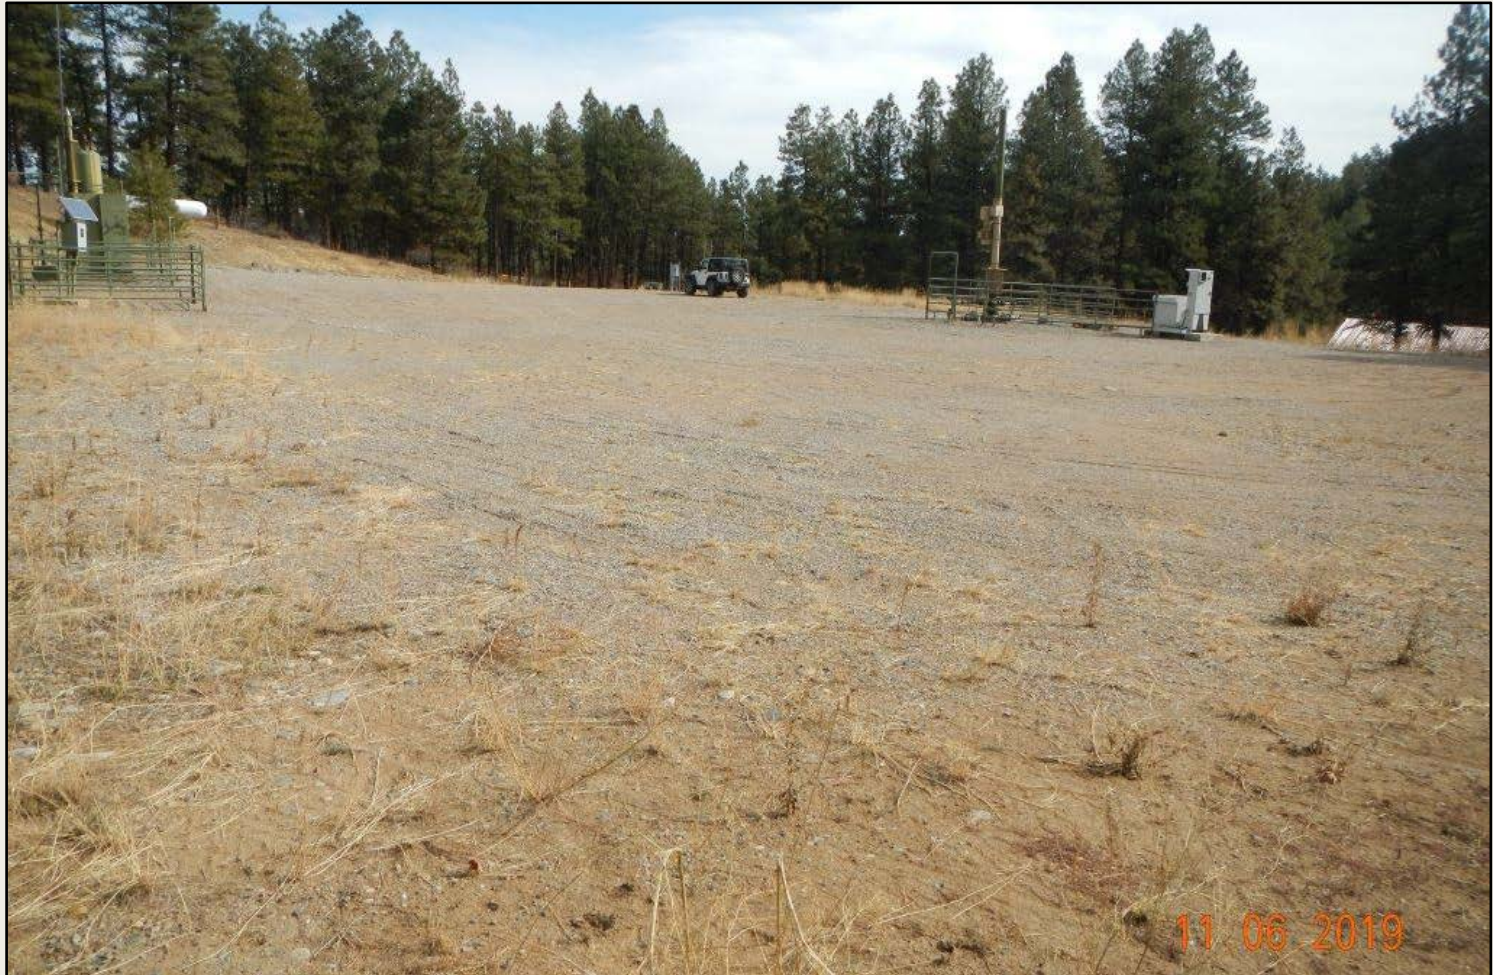
Photo 1. View of the project area from the eastern corner facing center.

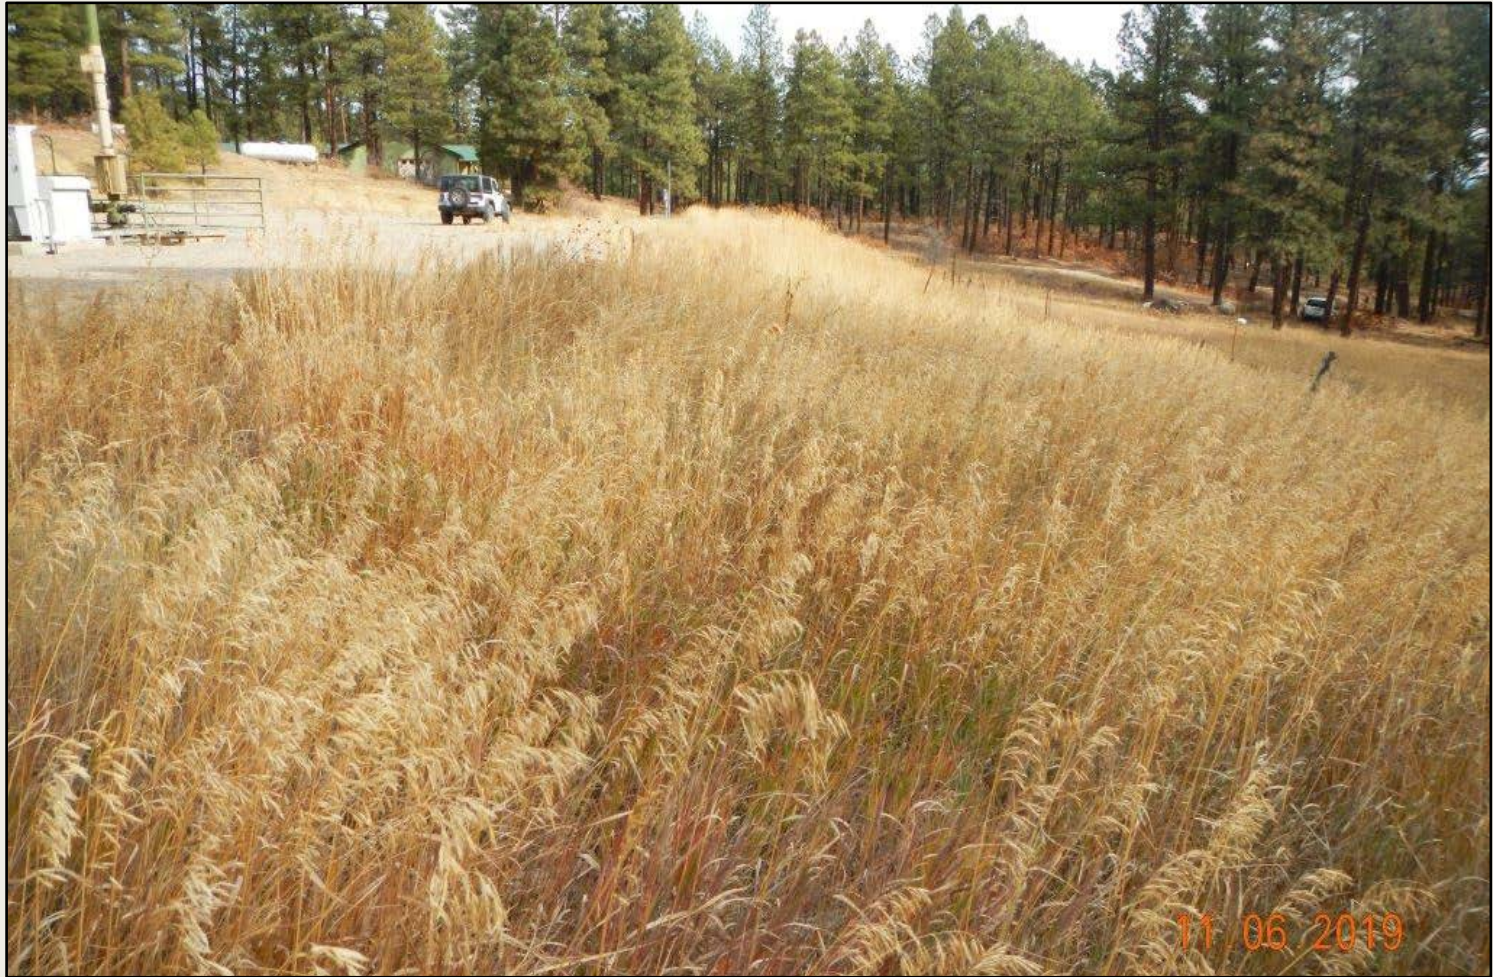
Photo 2. View of the northern project area from the northwestern corner facing eastward. Revegetation is progressing here, largely with smooth brome.

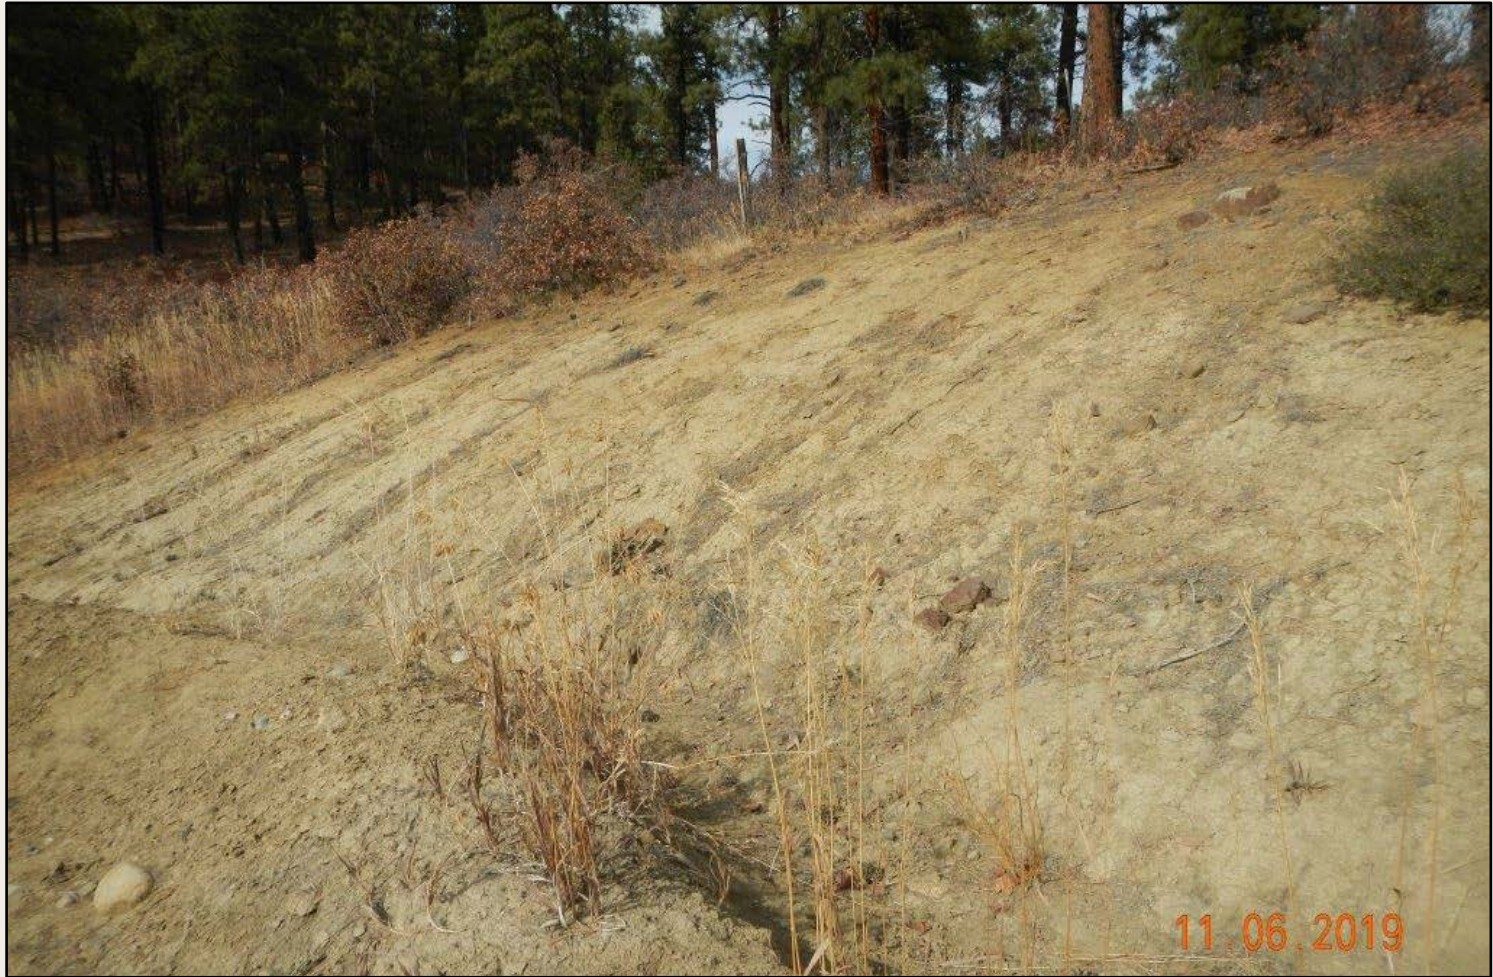
Photo 3. View of the northeastern cut-slope. Stabilization measures are needed on bare and eroding soils here.

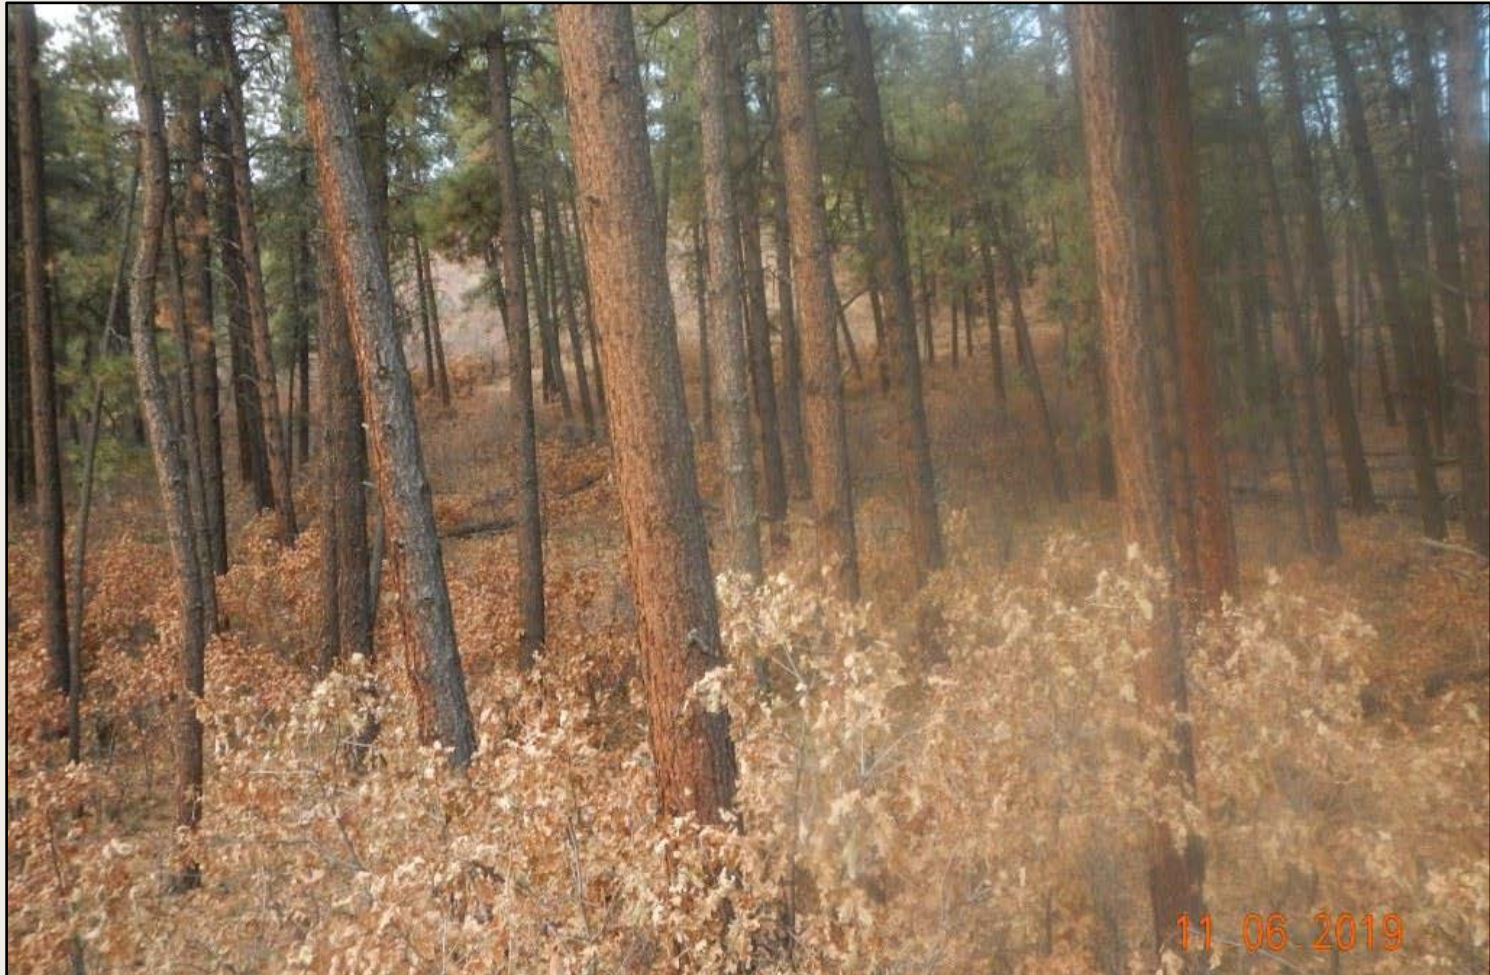
Photo 4. View of reference area west of the well pad, comprised of ponderosa pine forest with gambel oak understory.
