Inspection Photos
Operator: Hilcorp Energy
Location/API #: 067-09904
Date: 11-6-2019

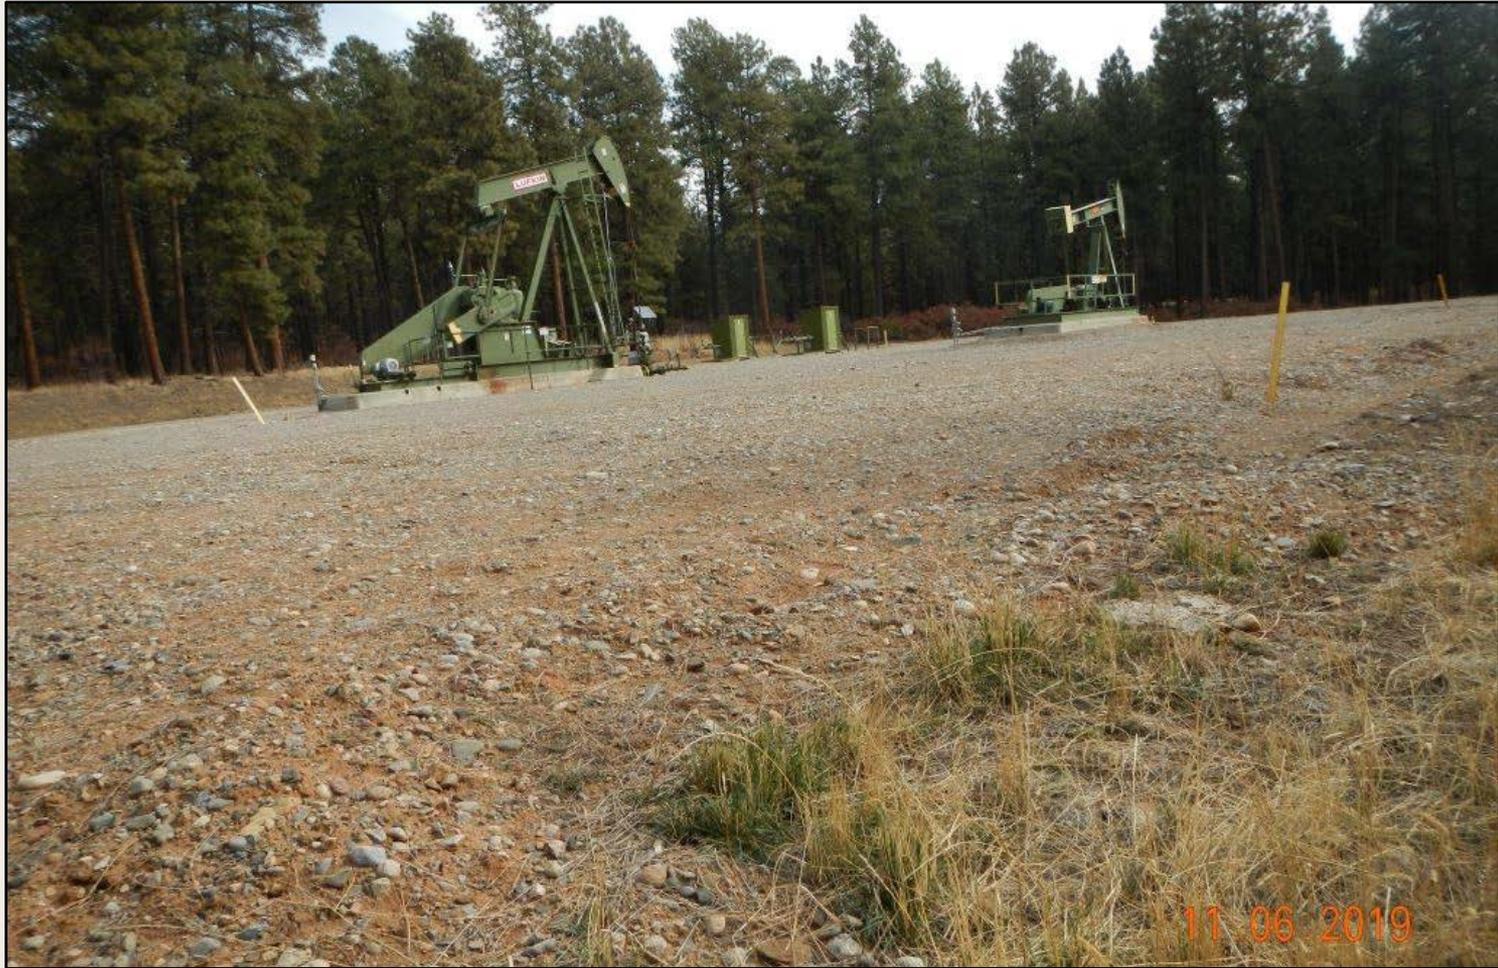
Photo 1. View of the project area from the northwestern corner facing center.

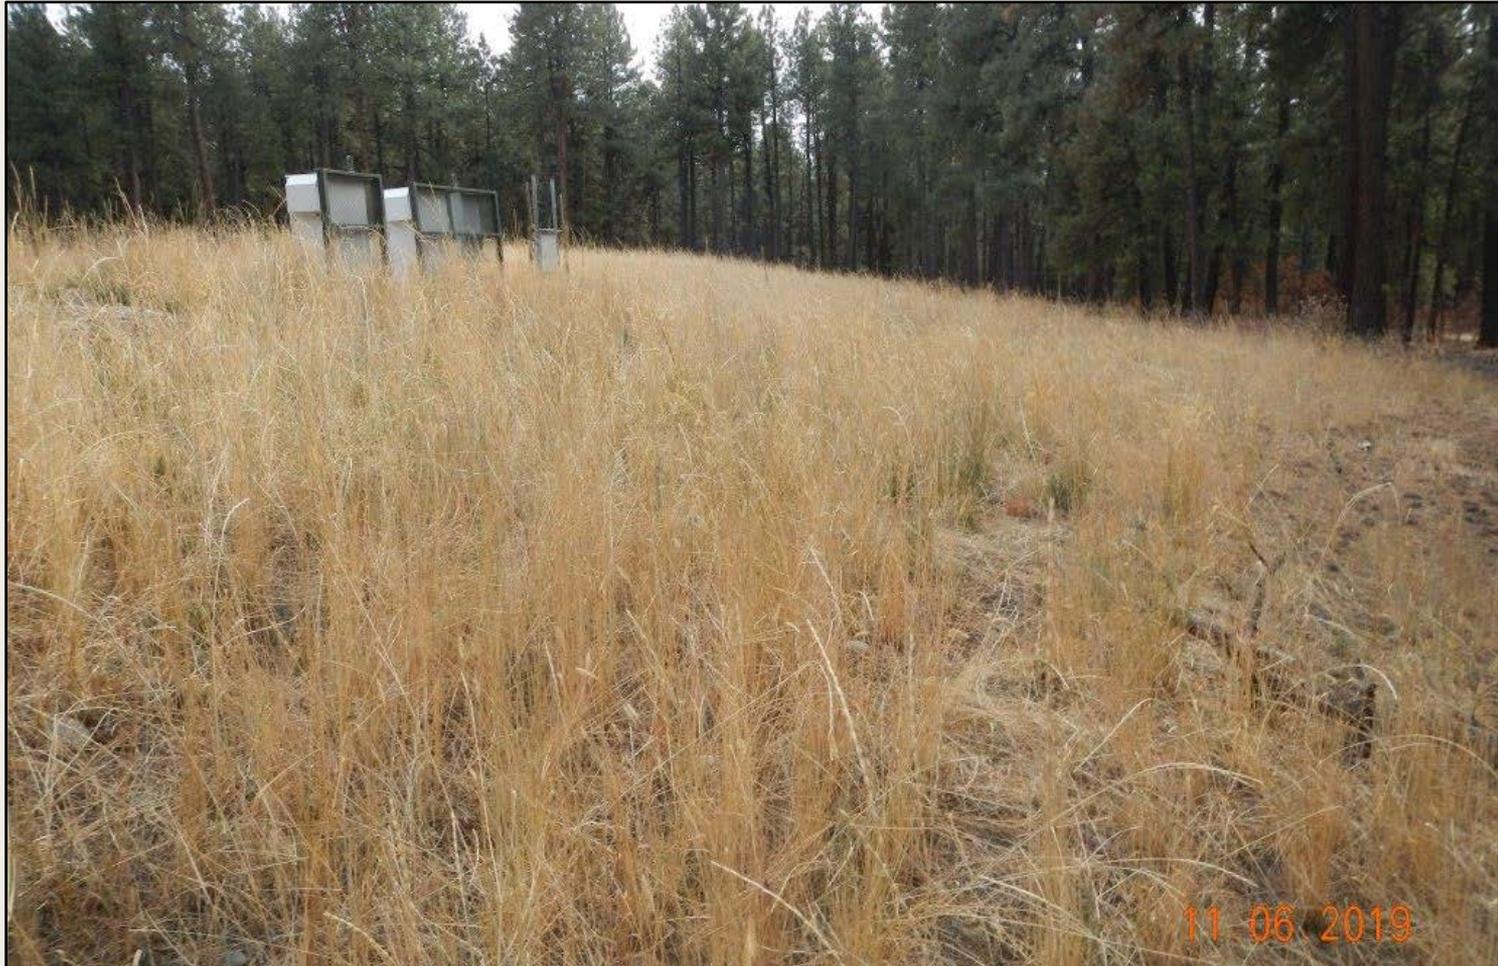
Photo 2. View of the western project area from the northwestern corner facing southward. Revegetation is progressing here, largely with western wheatgrass and smooth brome.

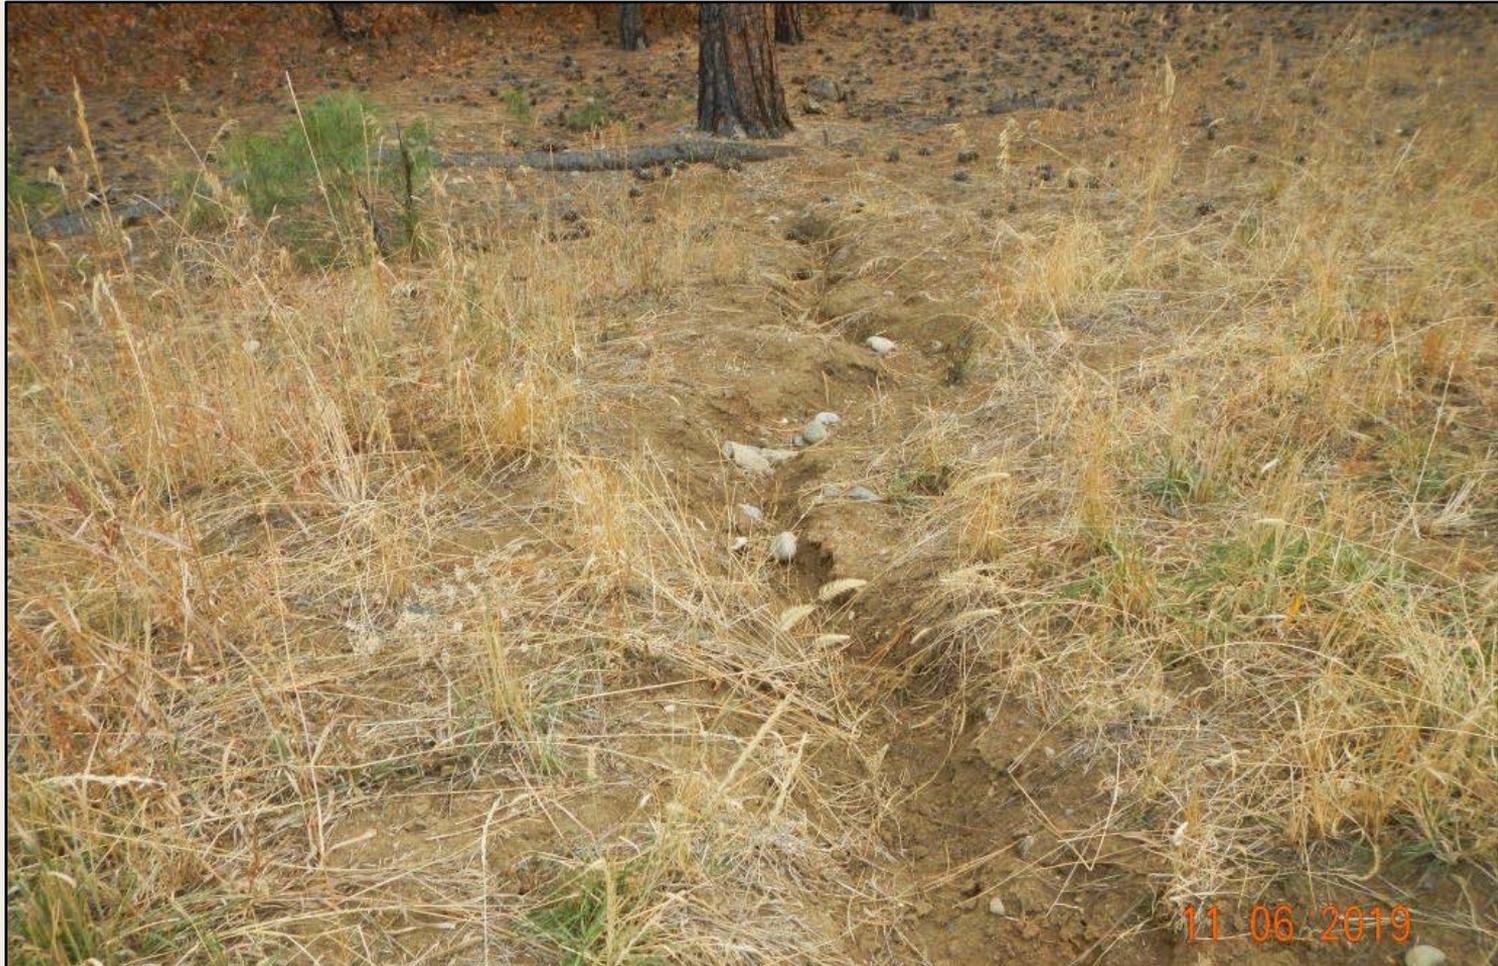
Photo 3. View of erosional channel approximately 1 foot wide and deep, forming within the southwestern project area.

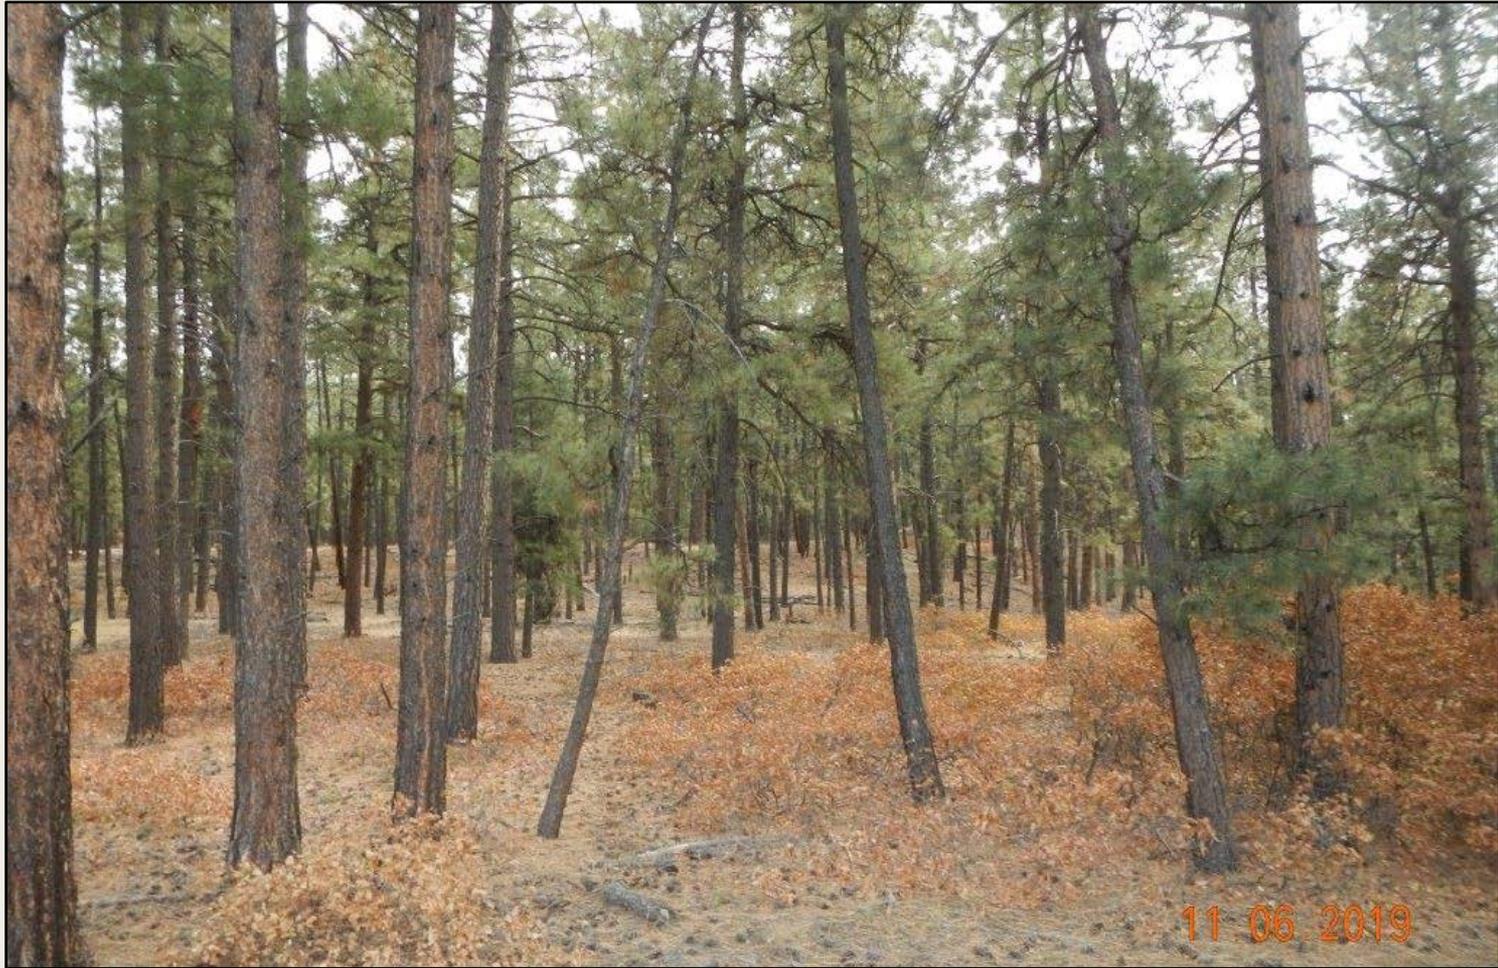
Photo 4. View of reference area west of the well pad, comprised of ponderosa pine forest with gambel oak understory.
