Inspection Photos

API: 05-055-06309

Operator: ALTA MESA SERVICES

Inspection Date: 11/6/2019

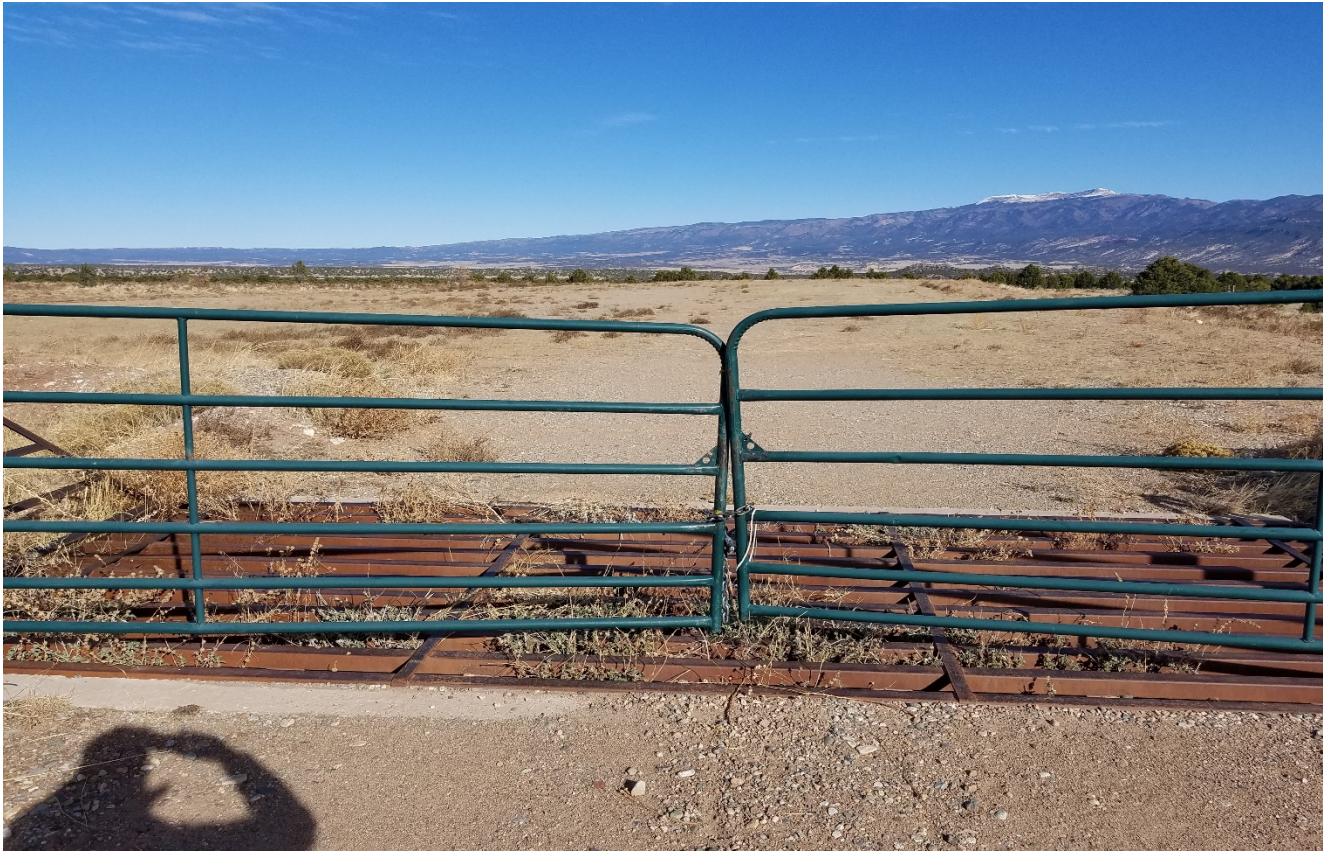
Photo 1. Facing north toward the location.

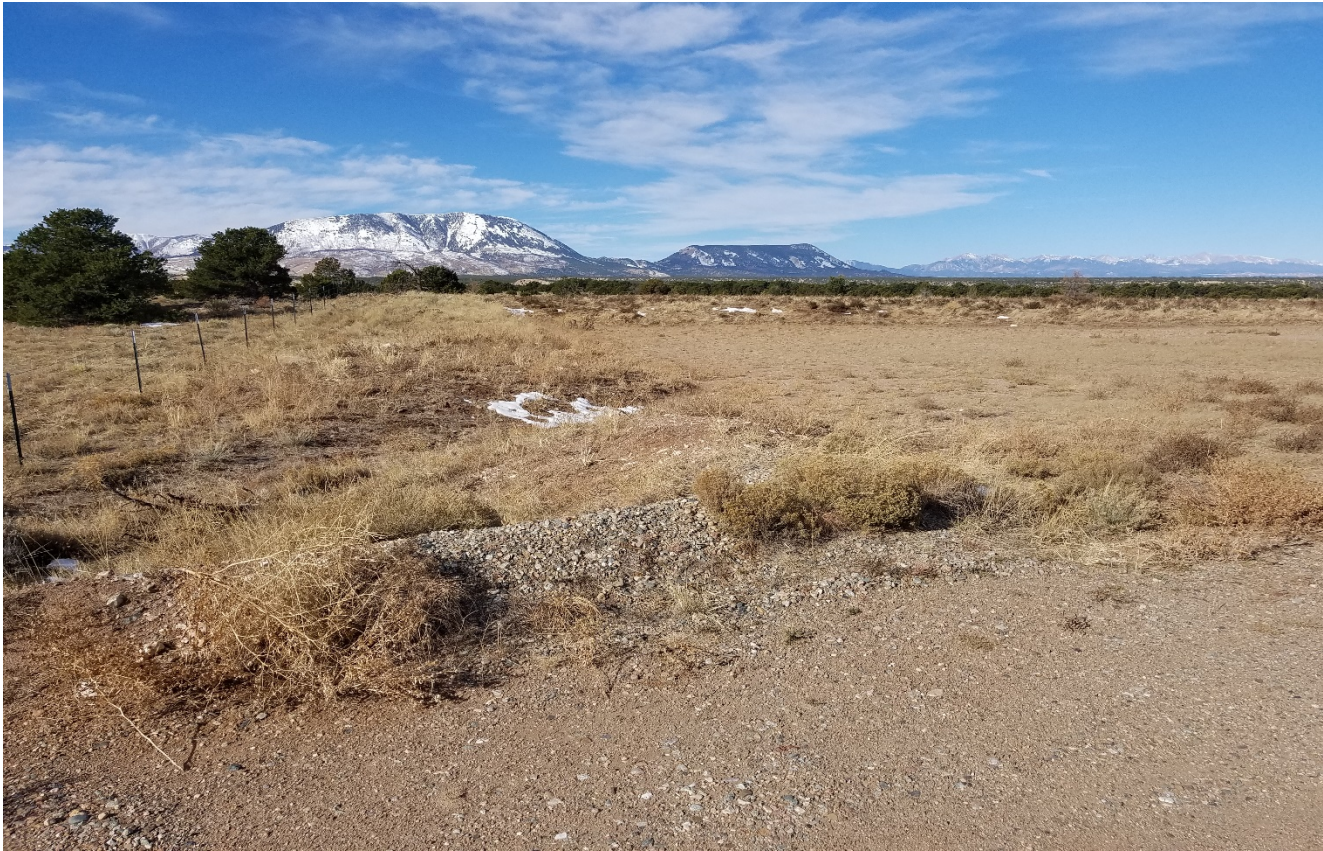
Photo 2. Facing west toward the location.

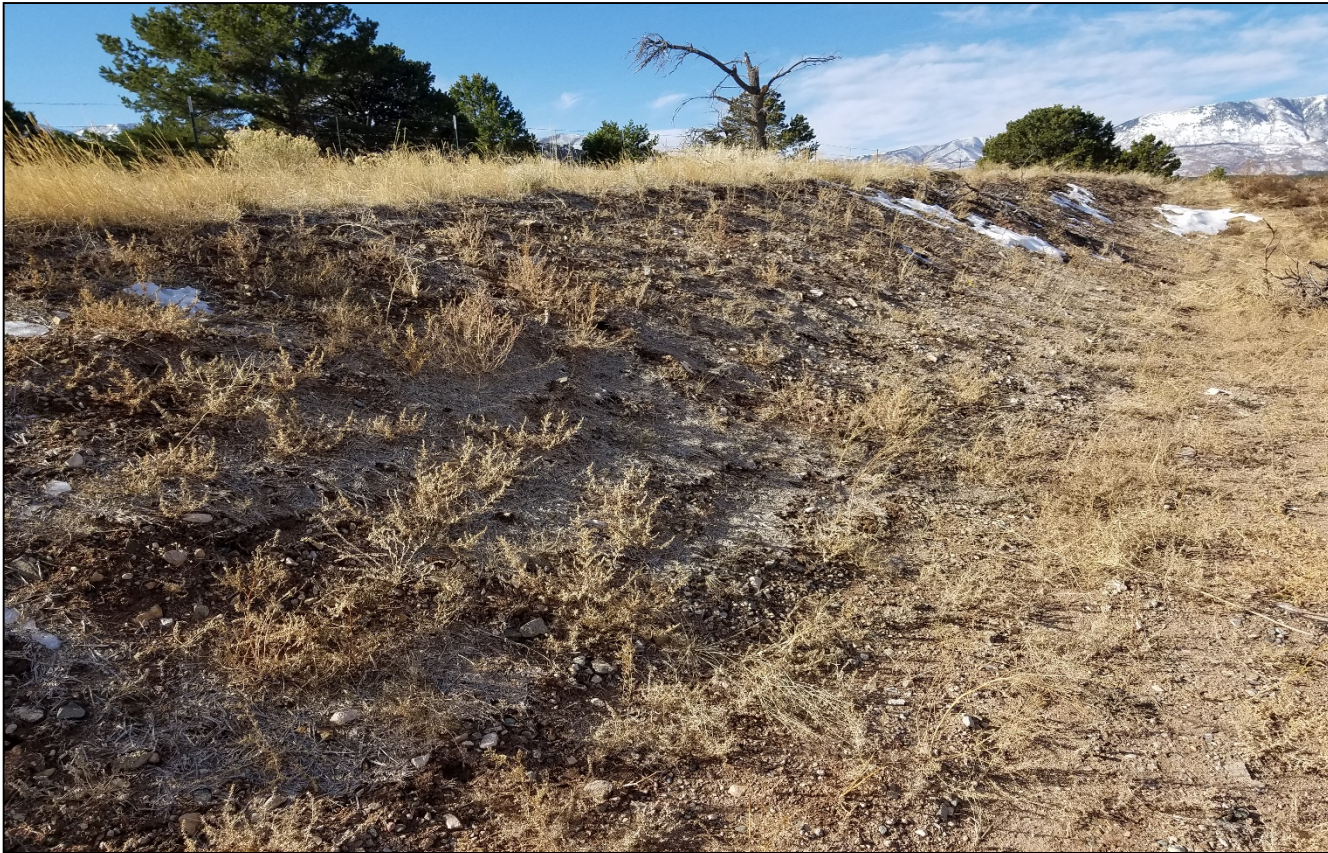
Photo 3. Facing west along the cut slope.

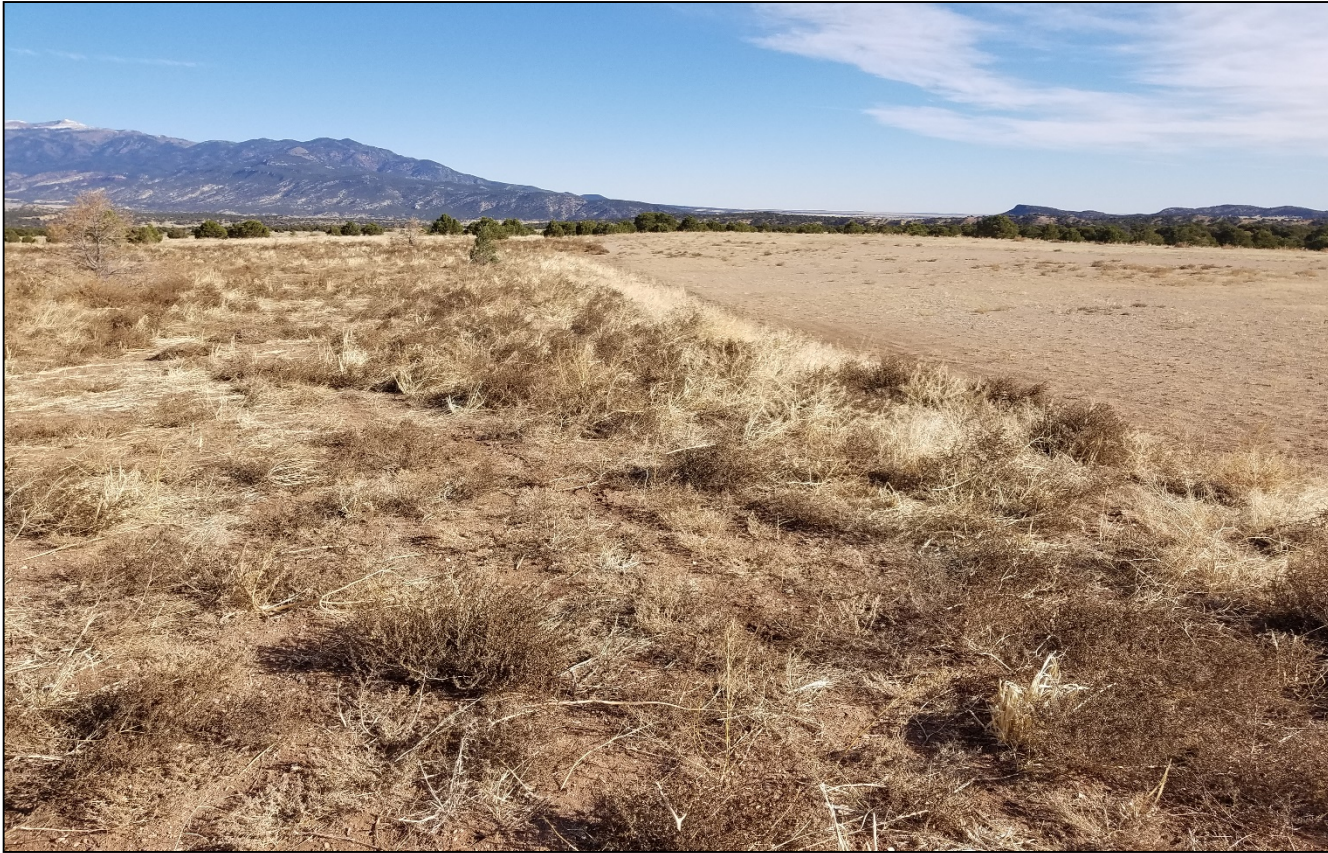
Photo 4. Facing northeast toward the location. Reclamation was performed at the west side of the location (left side of photo) and the east side of the location (right side of photo) was not reclaimed.

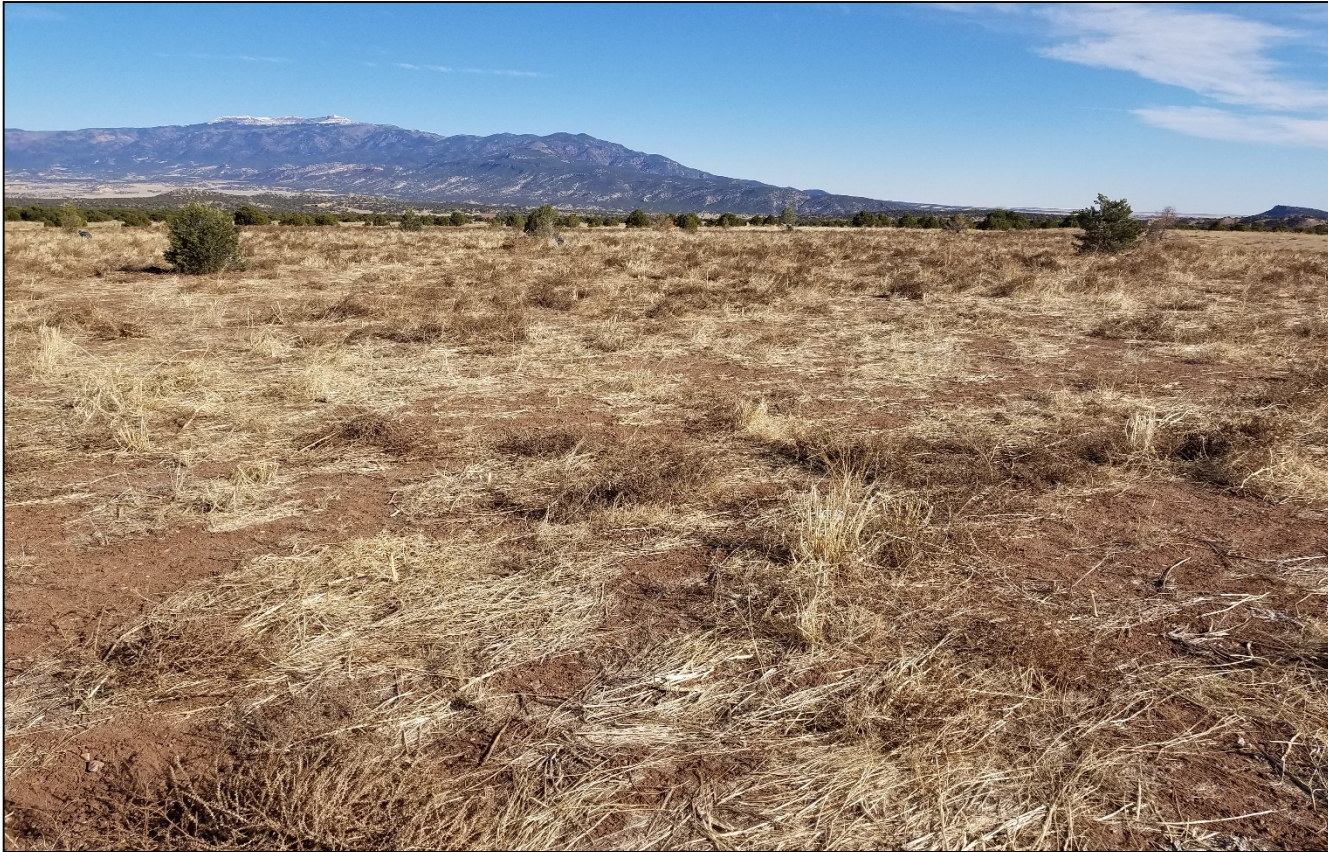
Photo 5. Facing north toward the area that was reclaimed. Reclamation was not successful. There are weed and cover crop debris throughout the area.

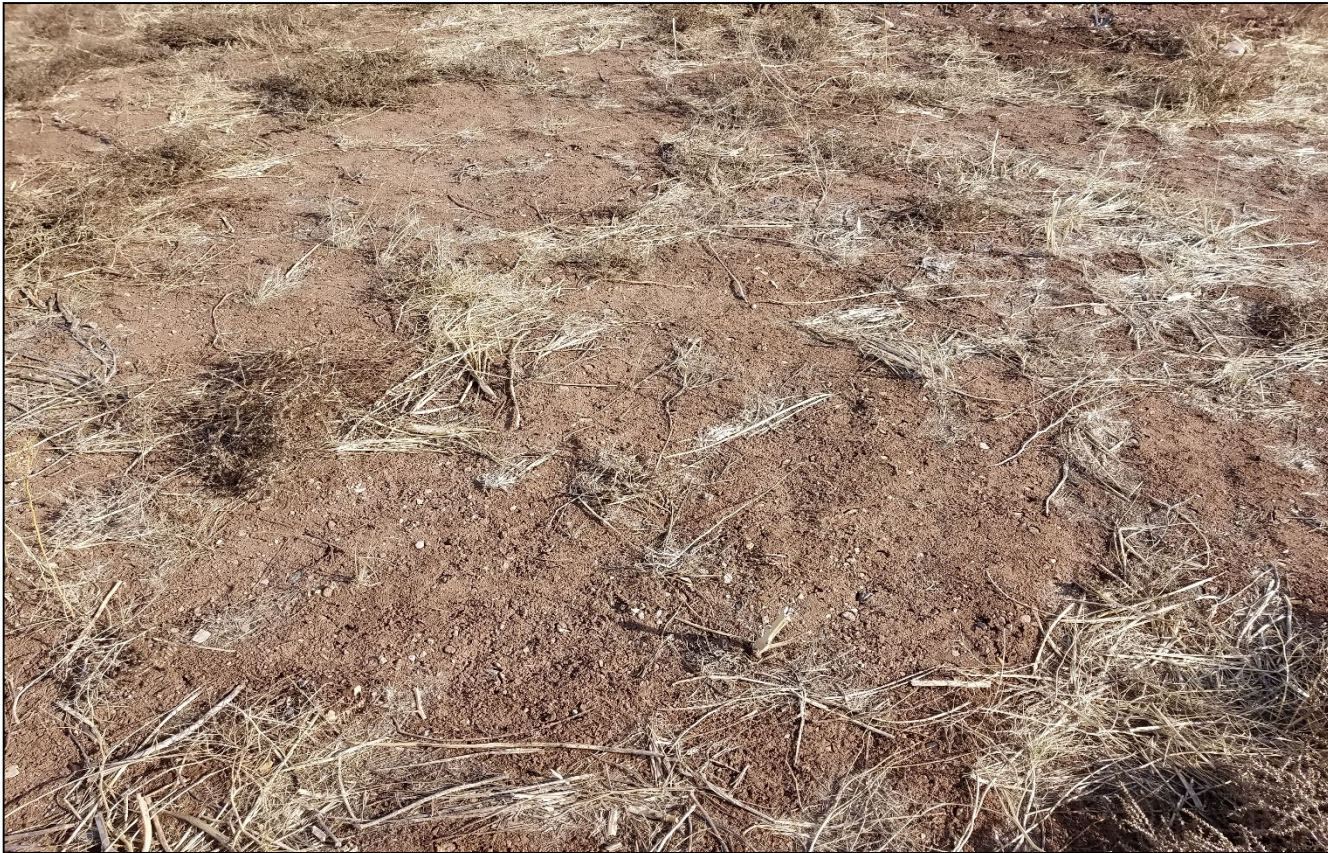
Photo 6. View of ground cover shows cover crop and weed debris.

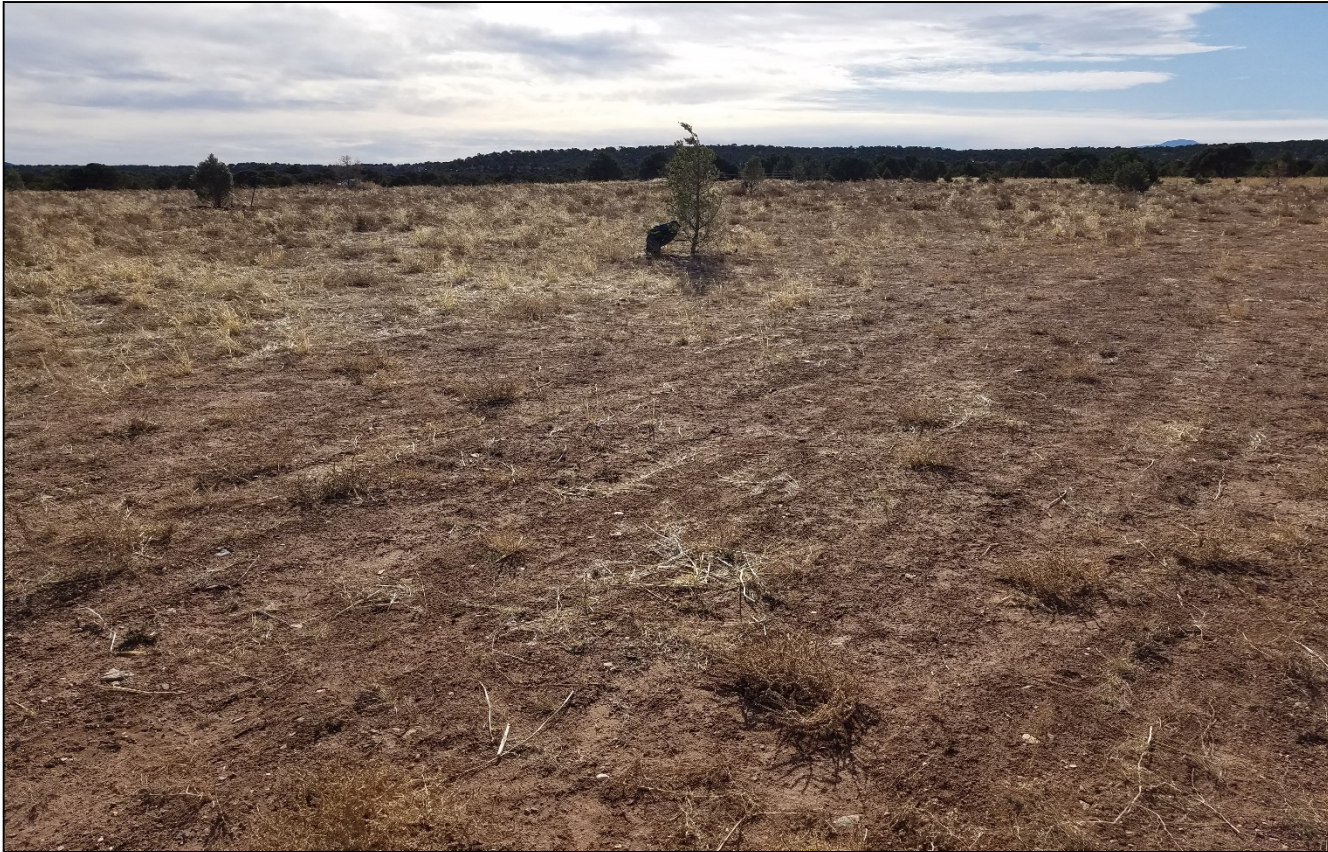
Photo 7. Northwest side of the location facing southeast toward the location.

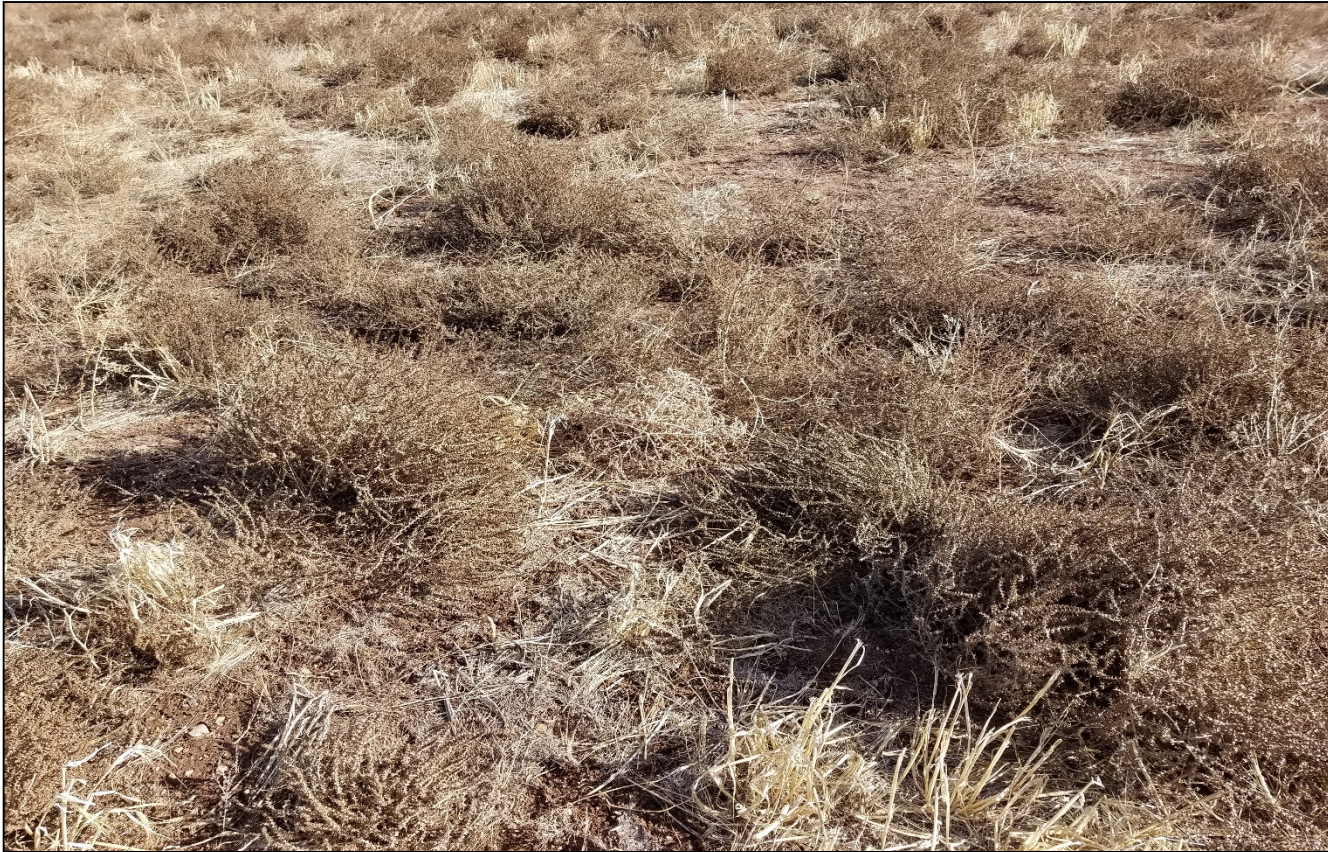
Photo 8. View of ground cover shows cover crop and weed debris.

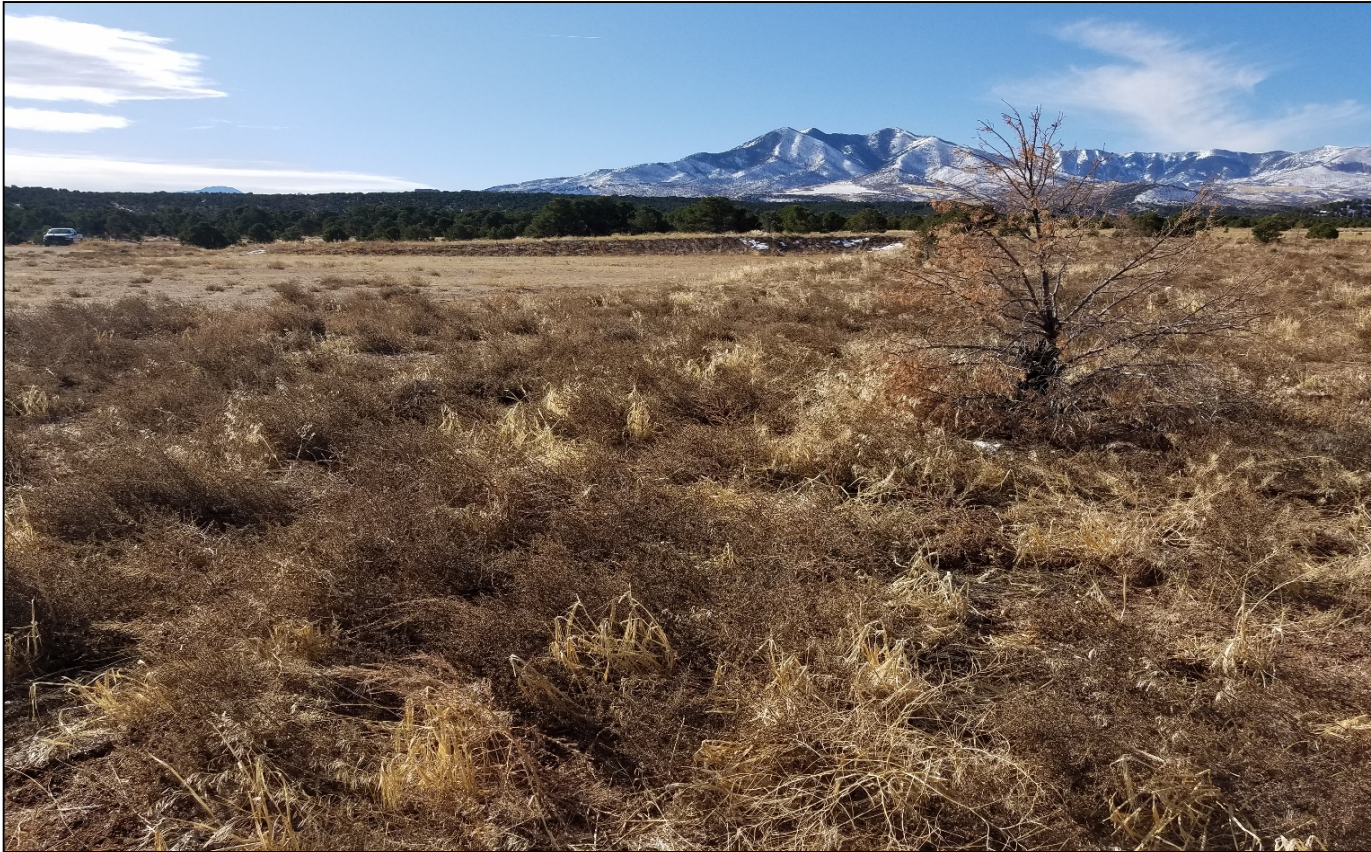
Photo 9. Facing southwest at the reclaimed portion of the location (right) and area not reclaimed (upper left). There are numerous undesirable weeds growing throughout the area. (Russian thistle, Pigweed). There are numerous dead trees that remain.

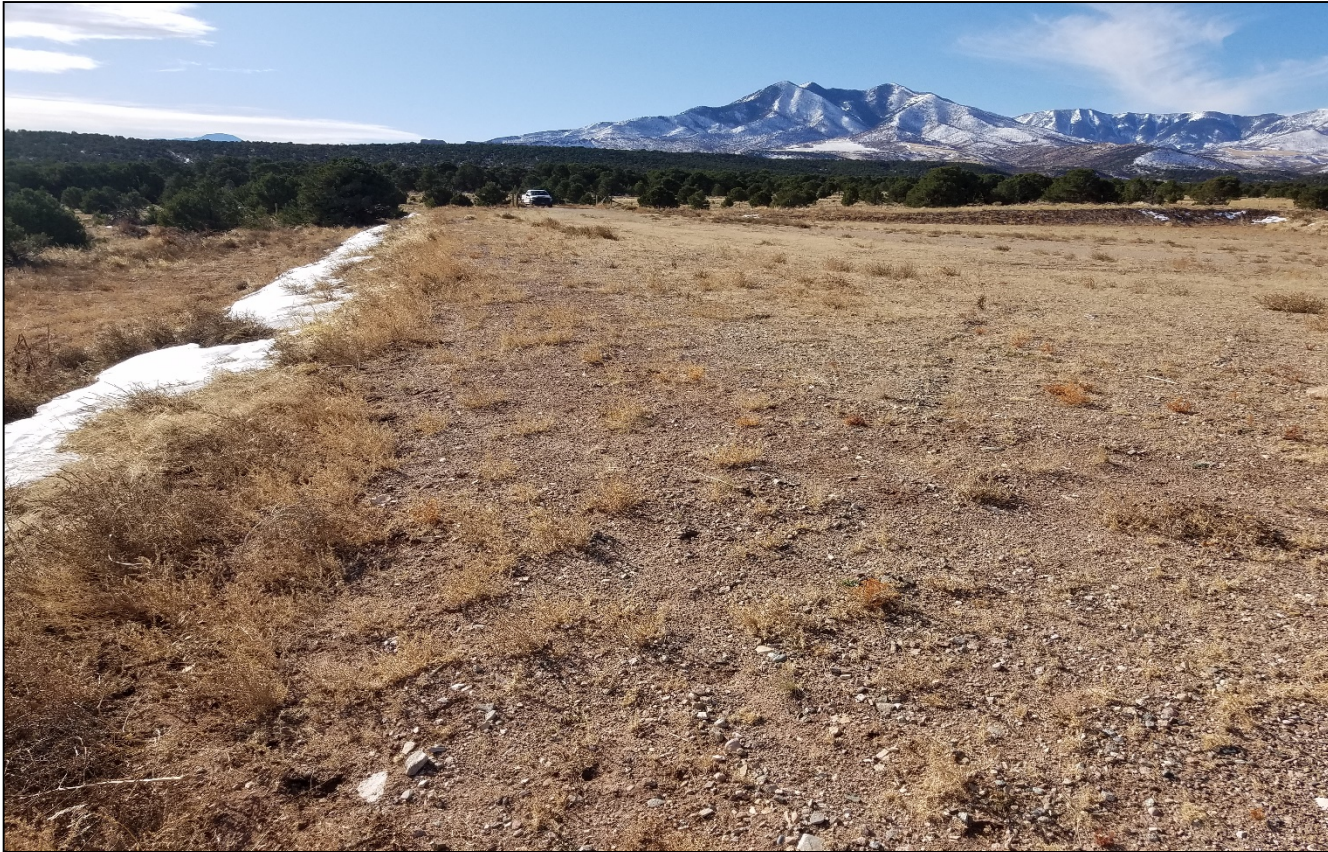
Photo 10. Facing southwest toward the area that was not reclaimed. Gravel remains in this area. The fill slope is shown in the left side of the photo.

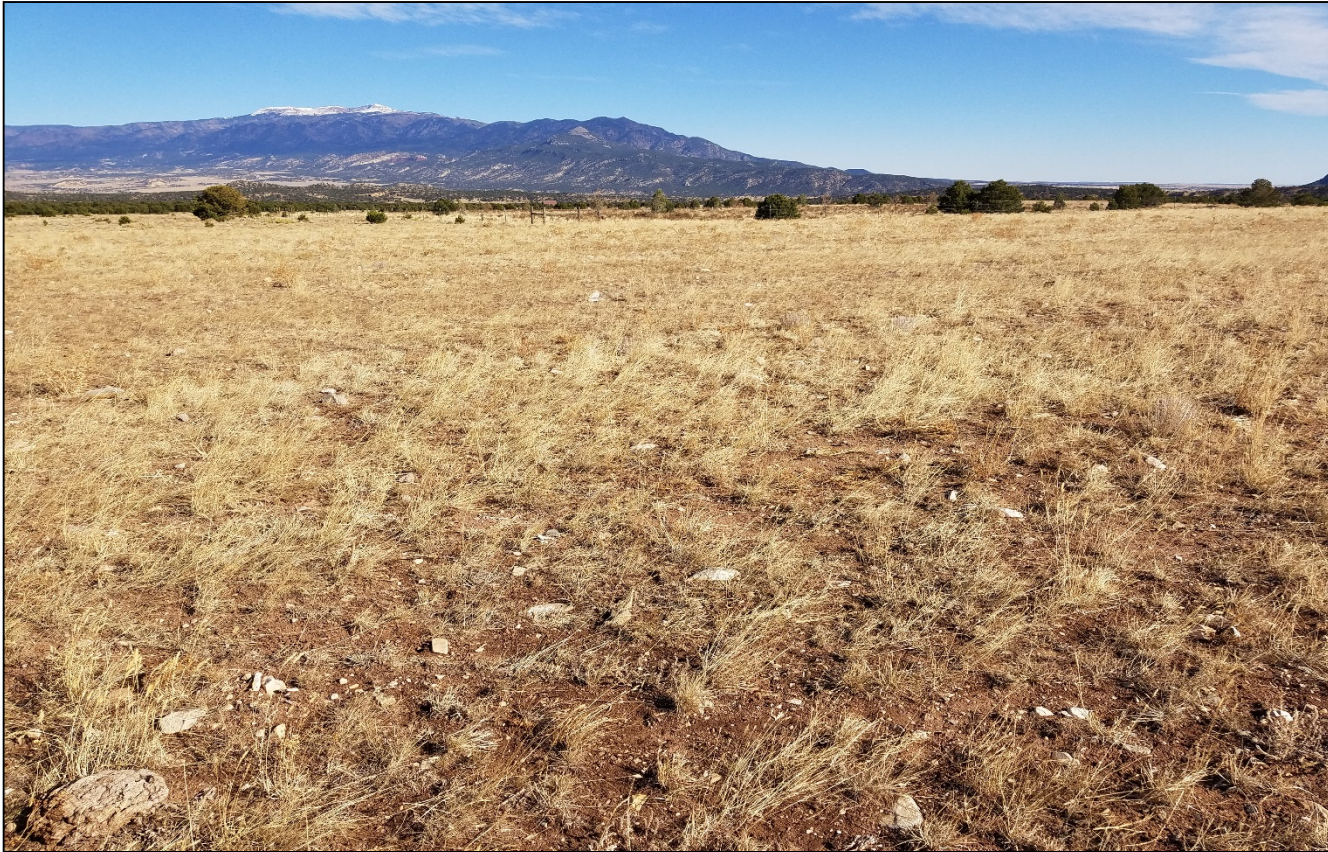
Photo 11. Southwest of the location where unpermitted disturbance occurred. Facing northeast. Vegetation is established throughout this area. The predominate species observed is Crested wheatgrass which is not present in the surrounding reference area.

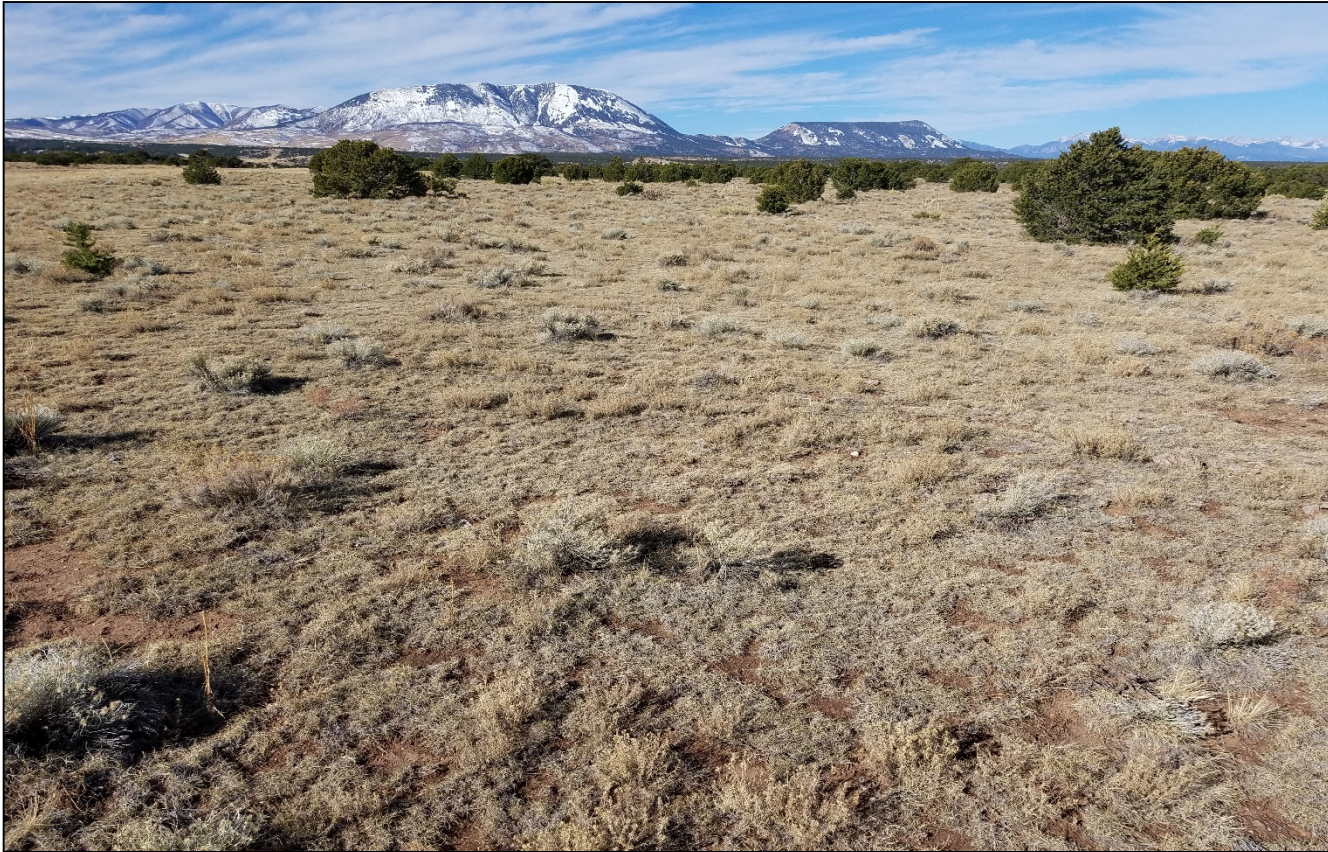
Photo 12. Facing west toward the surrounding undisturbed reference area.
