Inspection Photos

API: 05-055-06017

Operator: OXY USA INC

Inspection Date: 11/6/2019

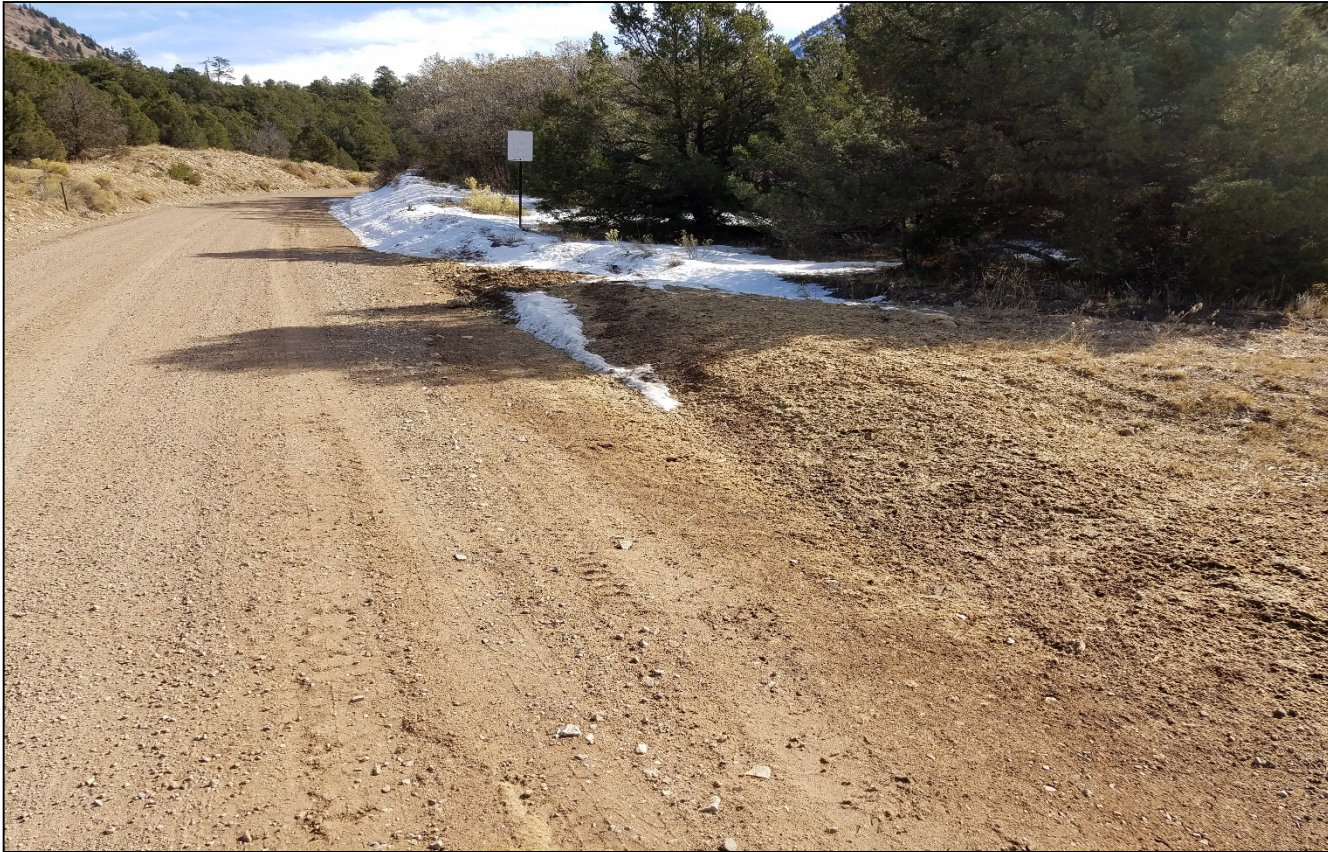
Photo 1. The disturbance along the side of the access road has been seeded and hydro-mulched.

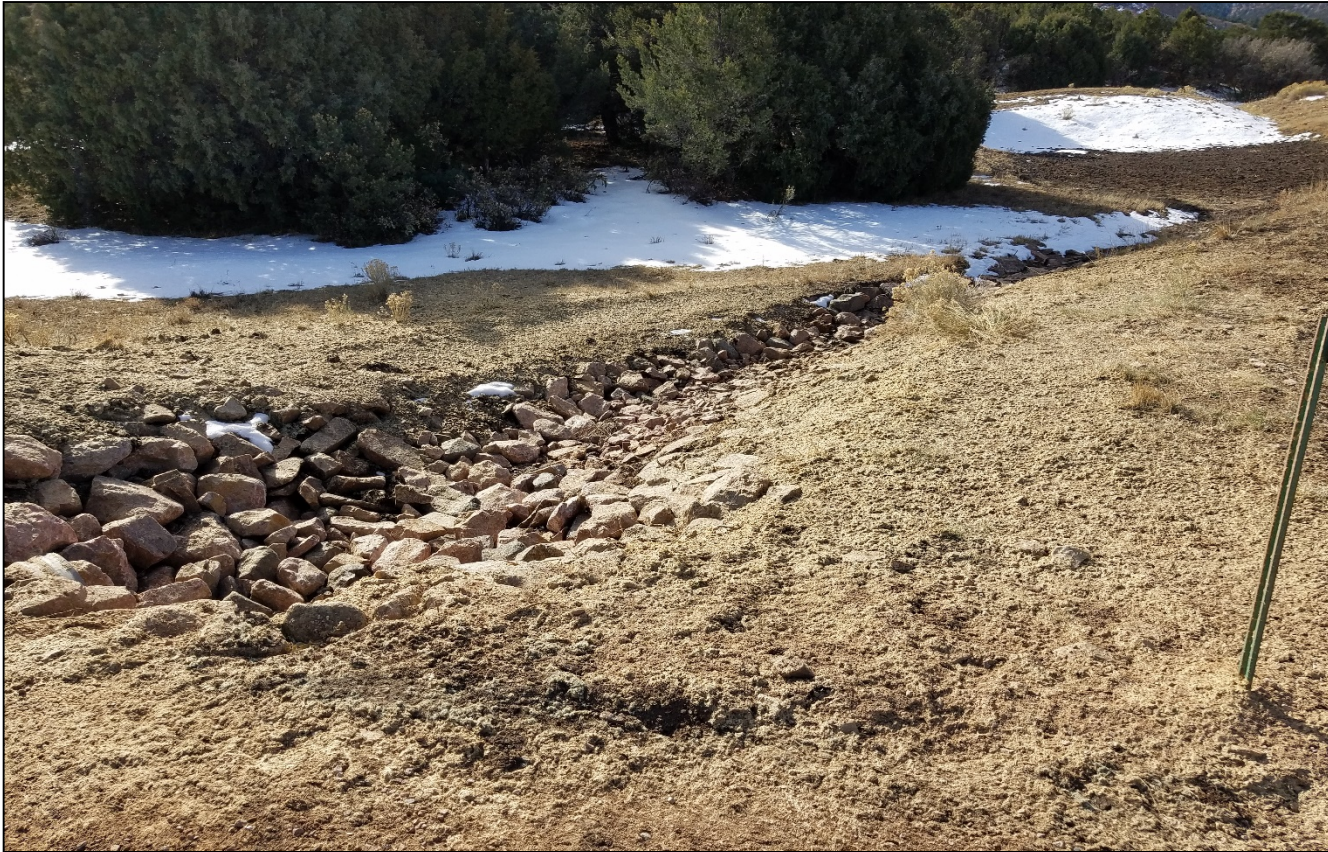
Photo 2. The culvert outlet protection has been installed.

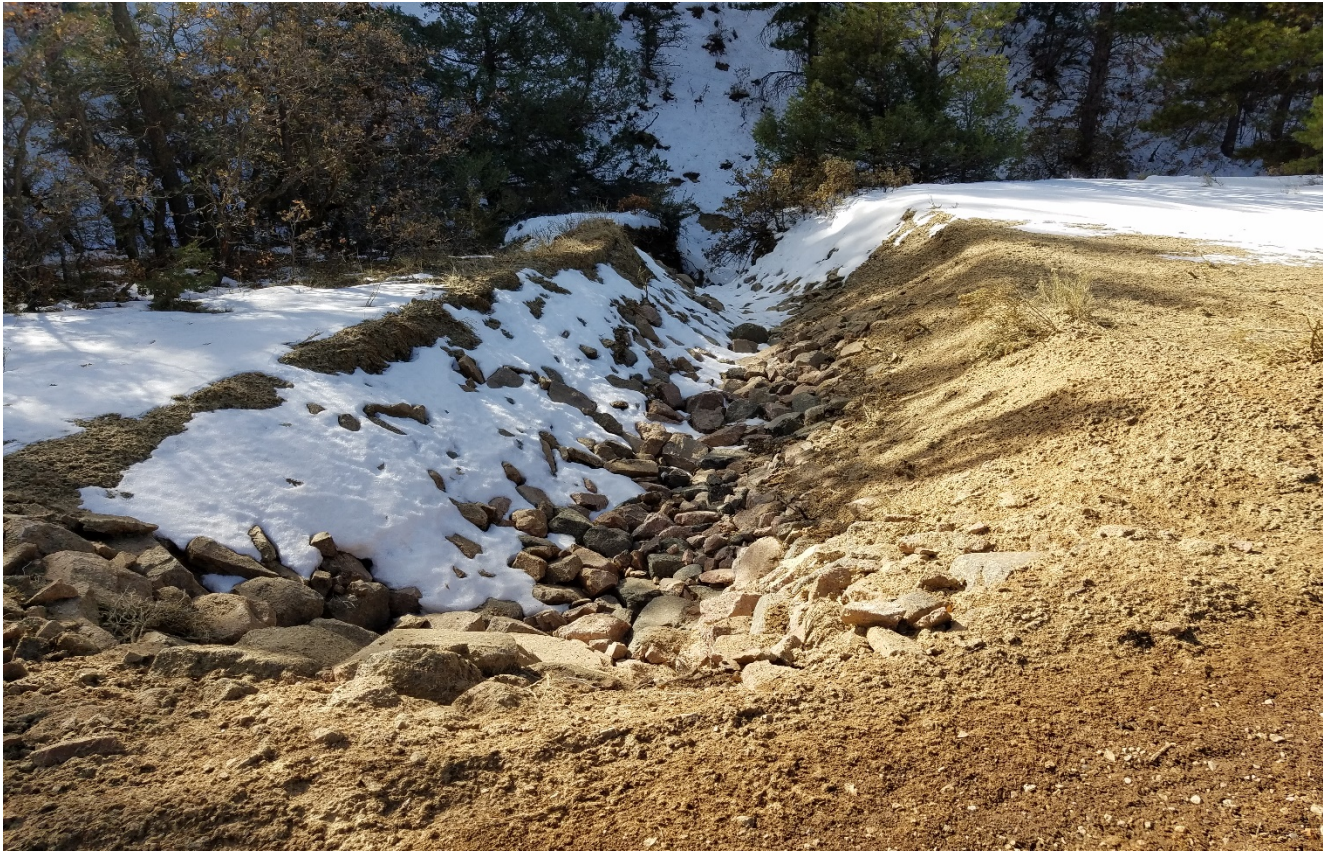
Photo 3. Erosion channel has been repaired at the culvert outlet. Rock rip/rap, wattles, and erosion matting was placed in channel. Larger rip rap was installed.

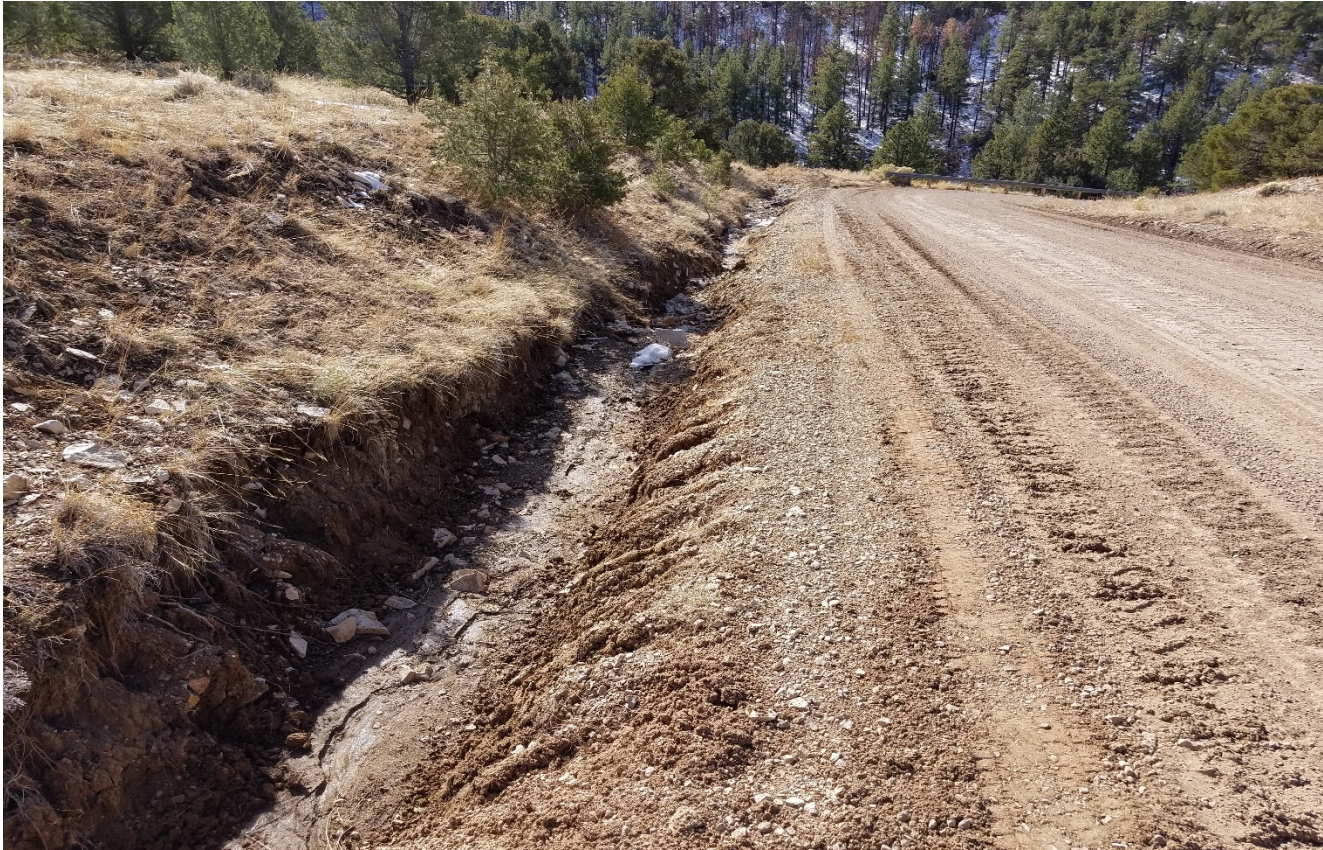
Photo 4. Facing south. This area along the side of the road has a deep erosion channel and BMP's have not been repaired. Lat/Long:37.69860,-105.21673

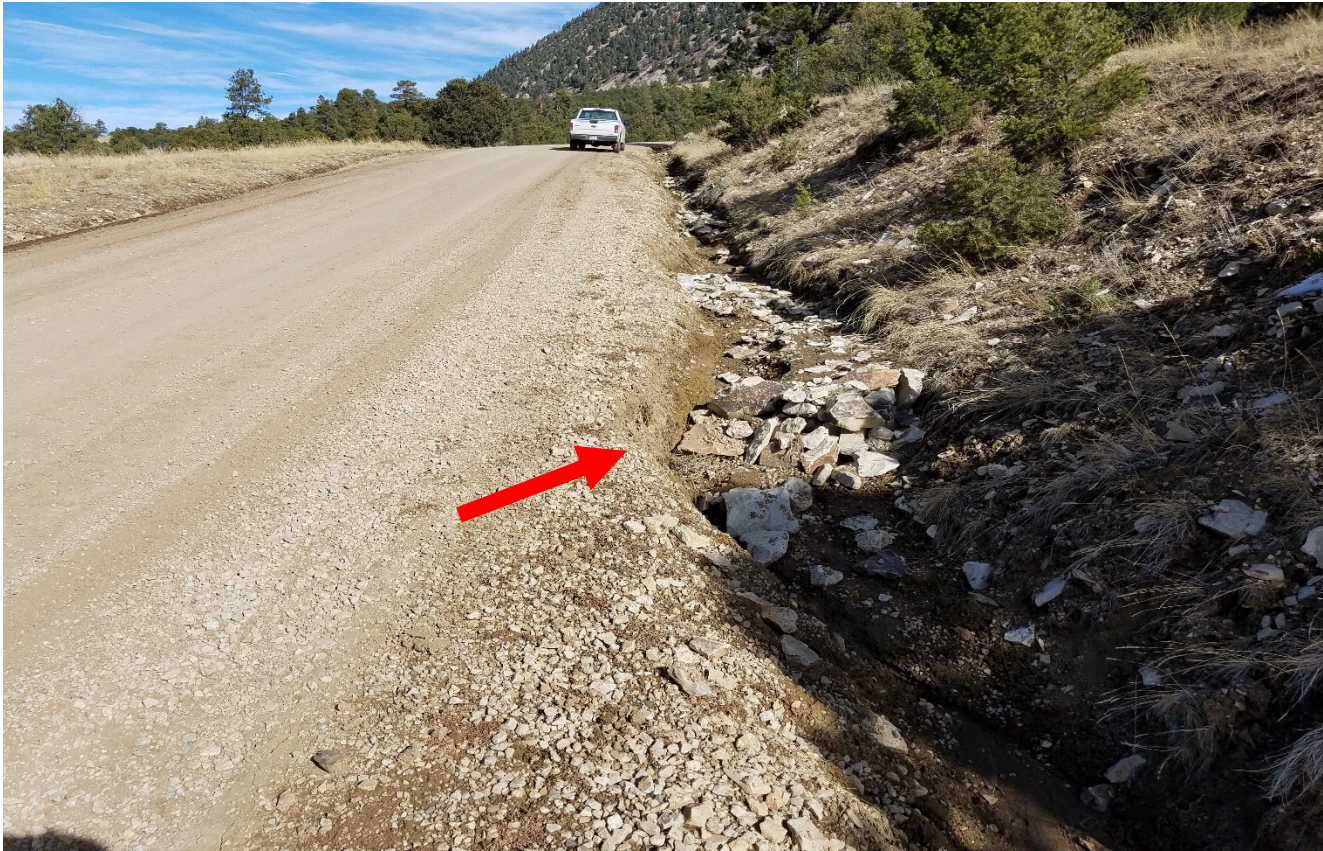
Photo 5. Facing north. This area along the side of the road has a deep erosion channel and BMP's have not been repaired. Rock check dams have been displaced. As stated in the previous inspection "Stormwater will flow toward the side and will erode the into road."
Lat/Long:37.69860,-105.21673

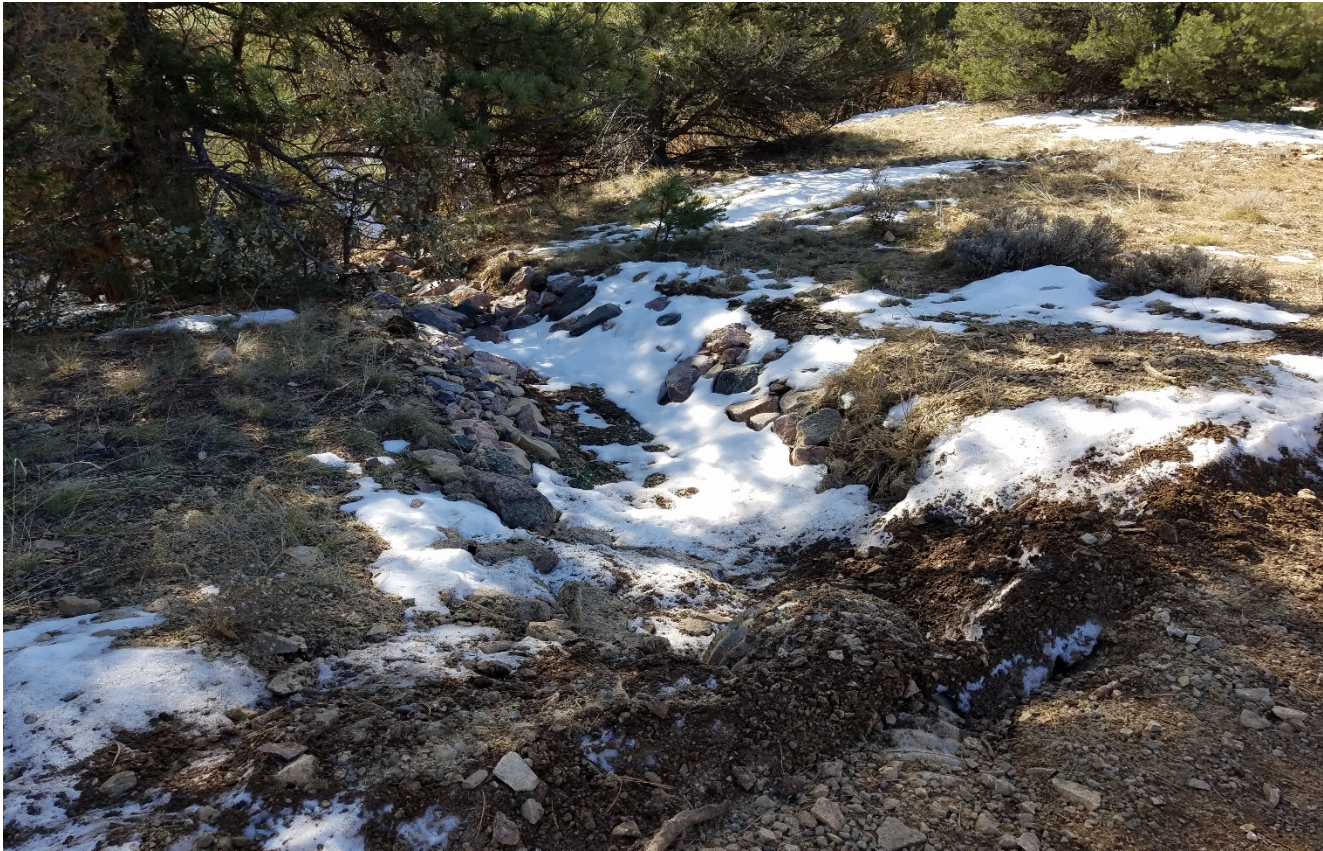
Photo 6. Erosion channel has been repaired at the culvert outlet. Rock rip/rap and erosion matting was placed in channel. Lat/Long:37.70004,-105.21143

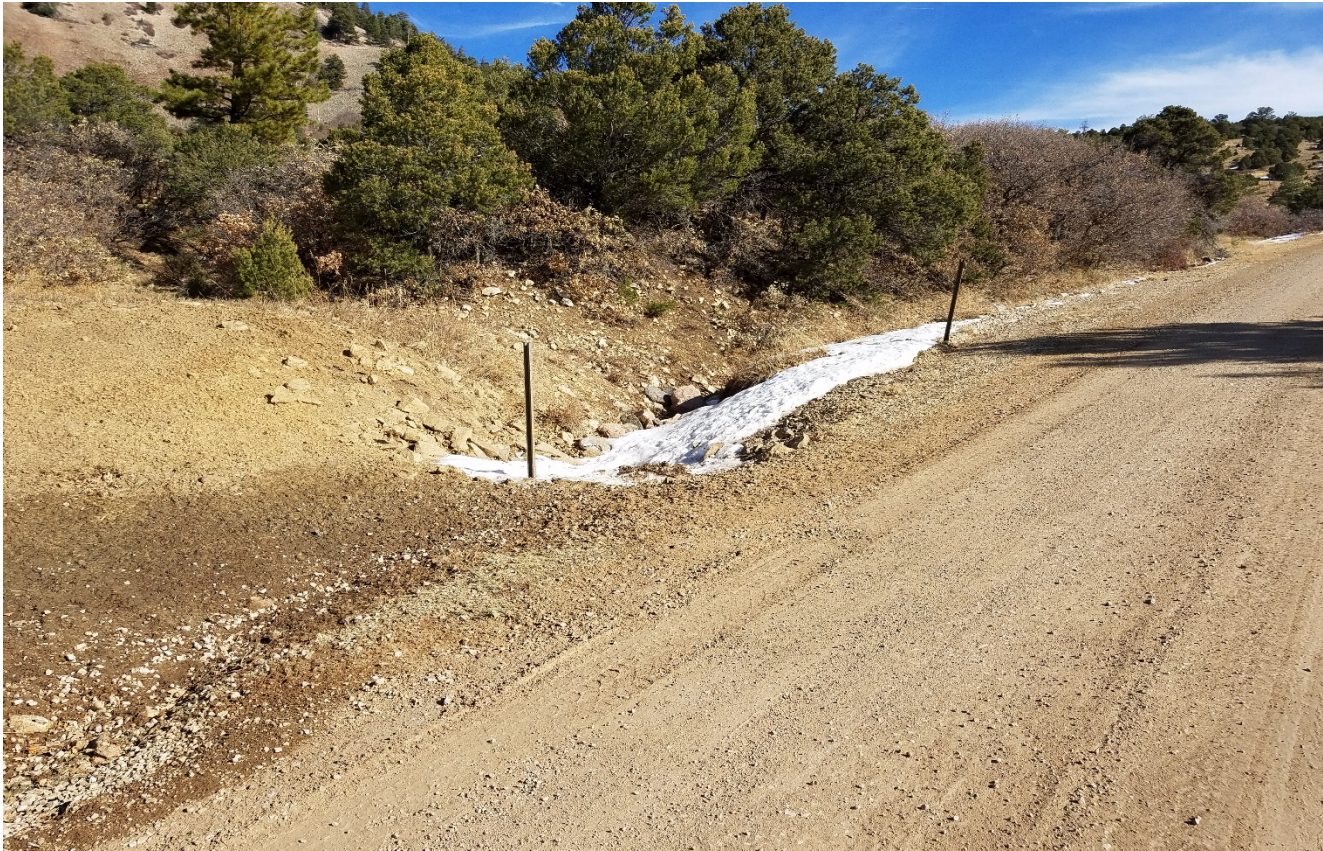
Photo 7. The disturbance along the side of the access road has been seeded and hydro-mulched. Inlet protection is installed at the culvert.

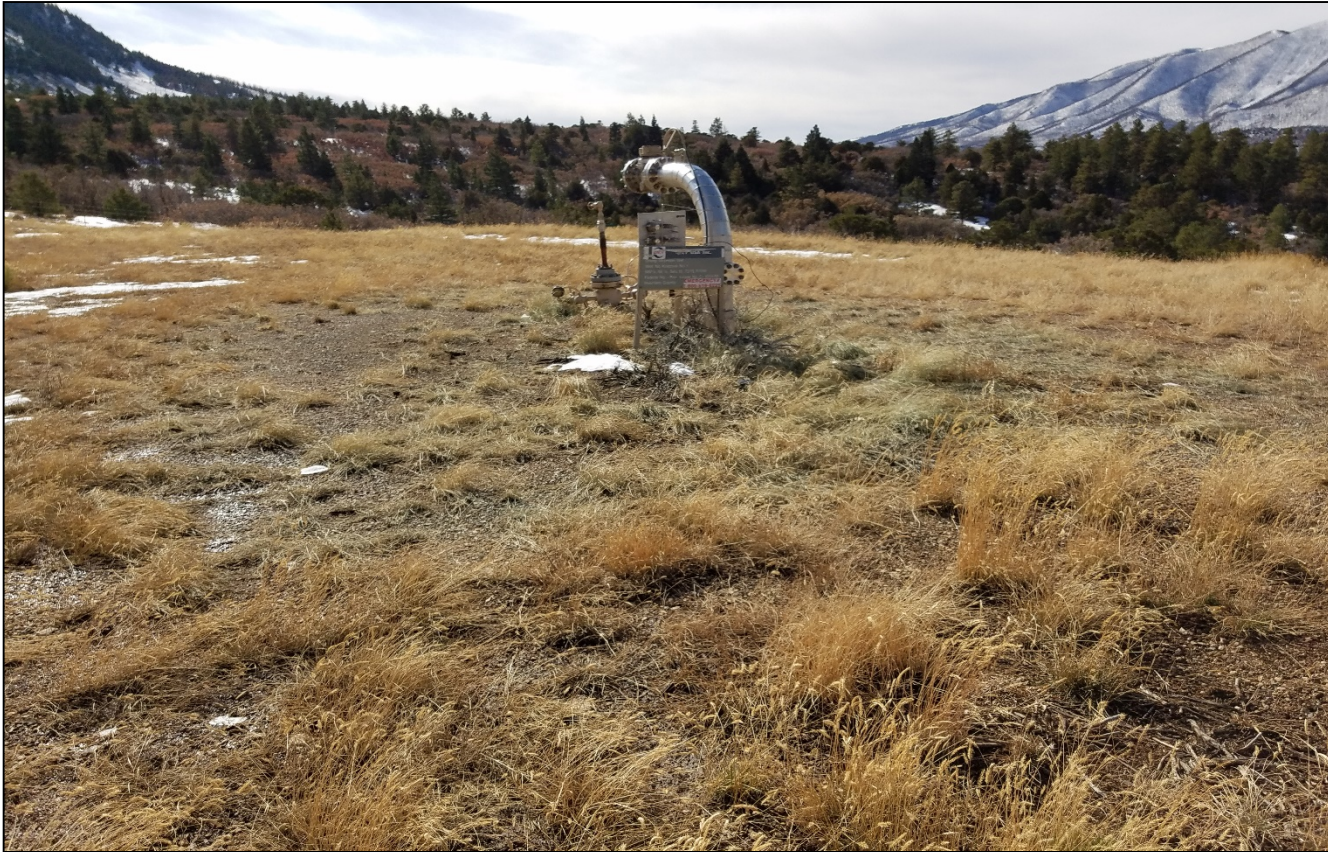
Photo 8. Facing south toward the location. It appears noxious weeds were removed and controlled.
