# Inspection Photos

API: 05-055-06314

Operator: OXY USA INC

Inspection Date: 11/6/2019

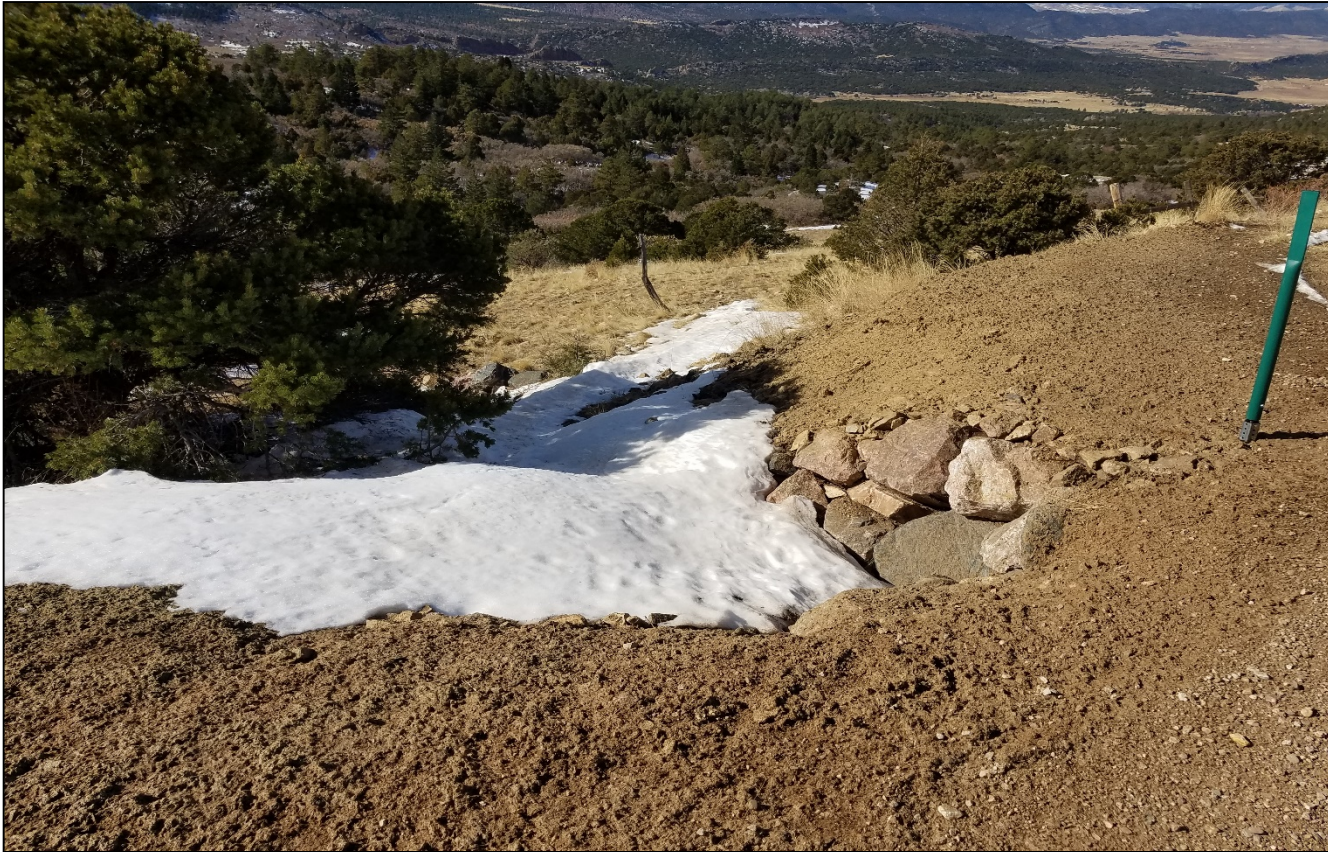
**Photo 1.** Outlet protection has been installed and disturbance area was hydro mulched. Lat/Long:37.69799,-105.20237.

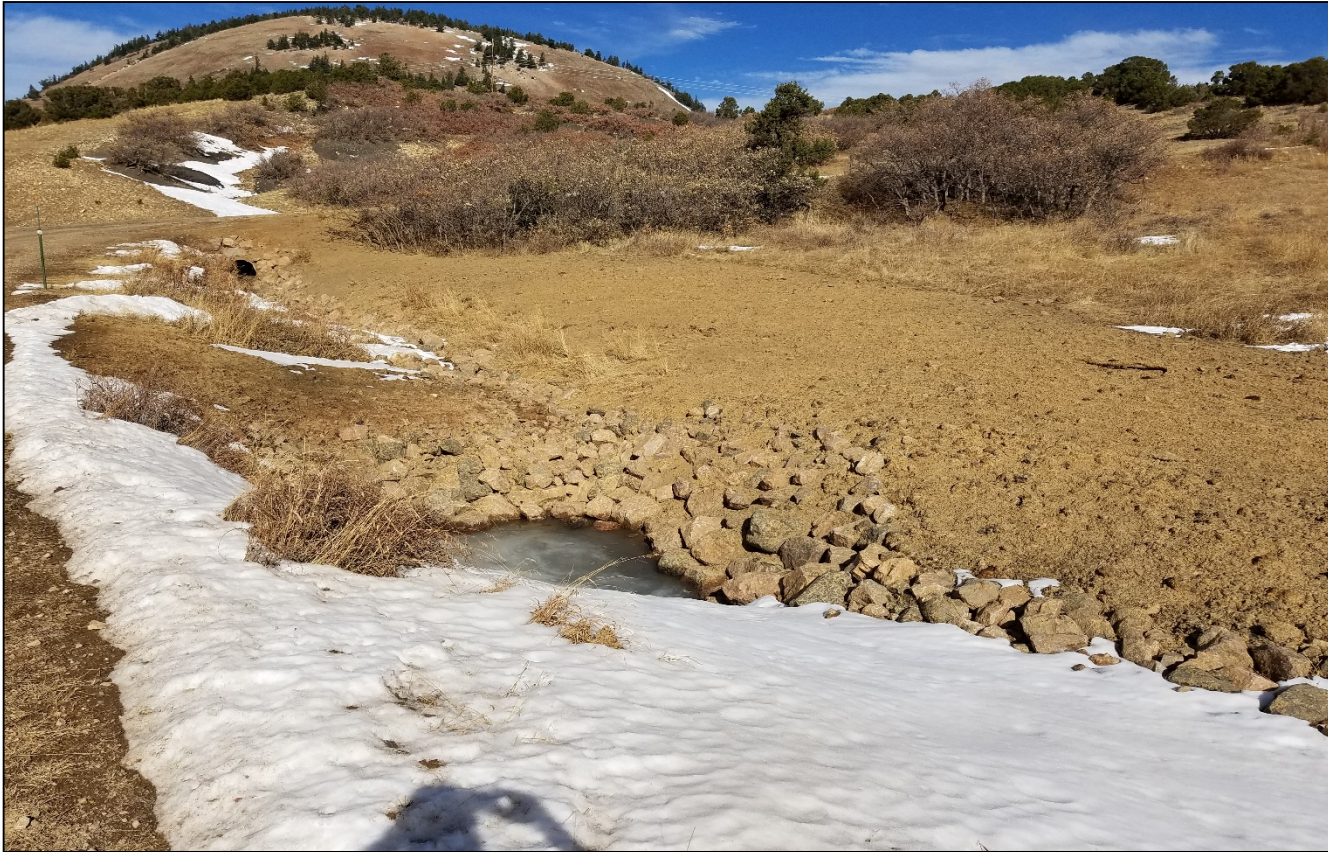
**Photo 2.** The disturbance at the culvert inlet has been seeded and hydro-mulched. Rock rip/rap has been installed. Lat/Long:37.69730,-105.19998

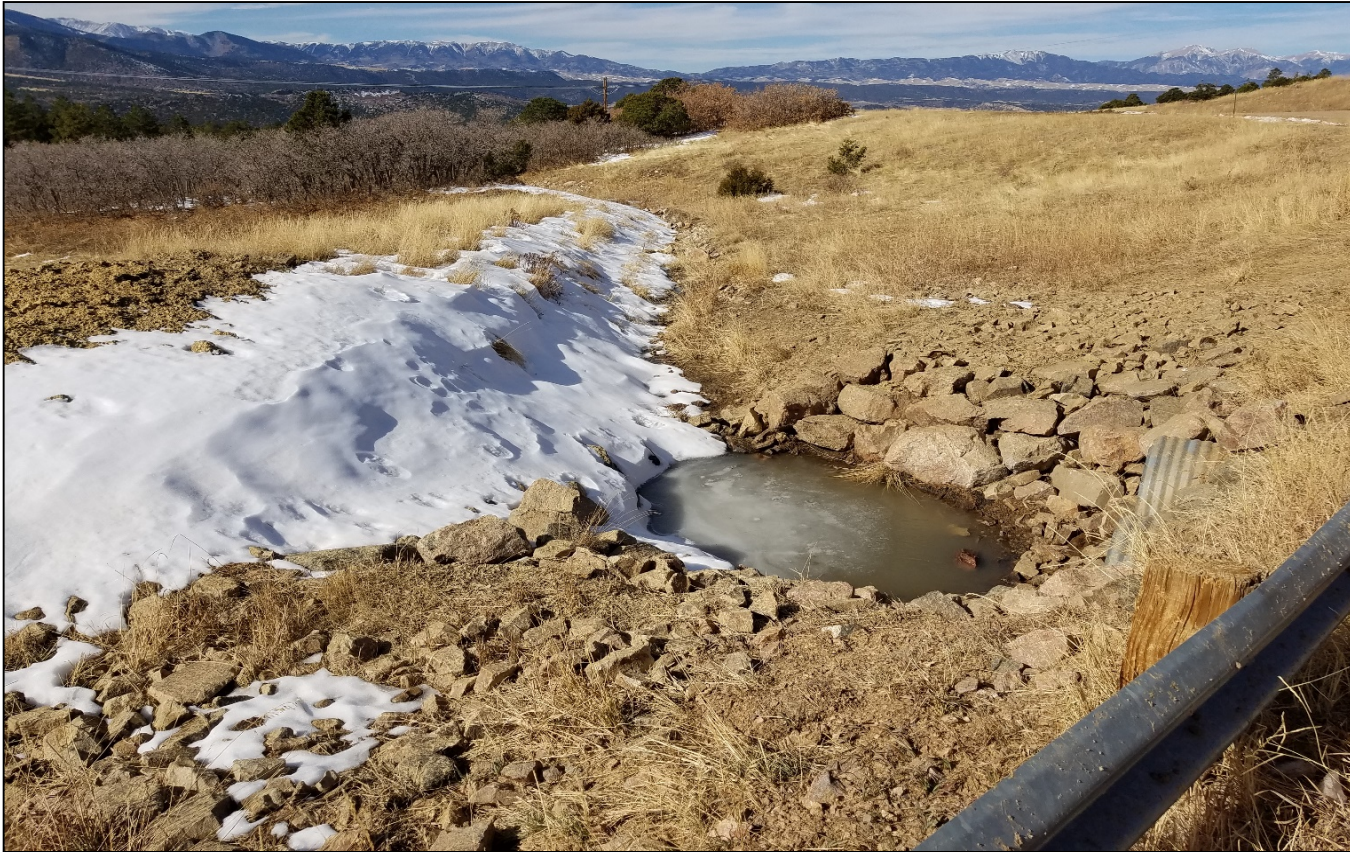
**Photo 3.** The disturbance at the culvert inlet has been seeded and hydro-mulched. Rock rip/rap and sediment trap has been installed. Lat/Long:37.69730,-105.19998

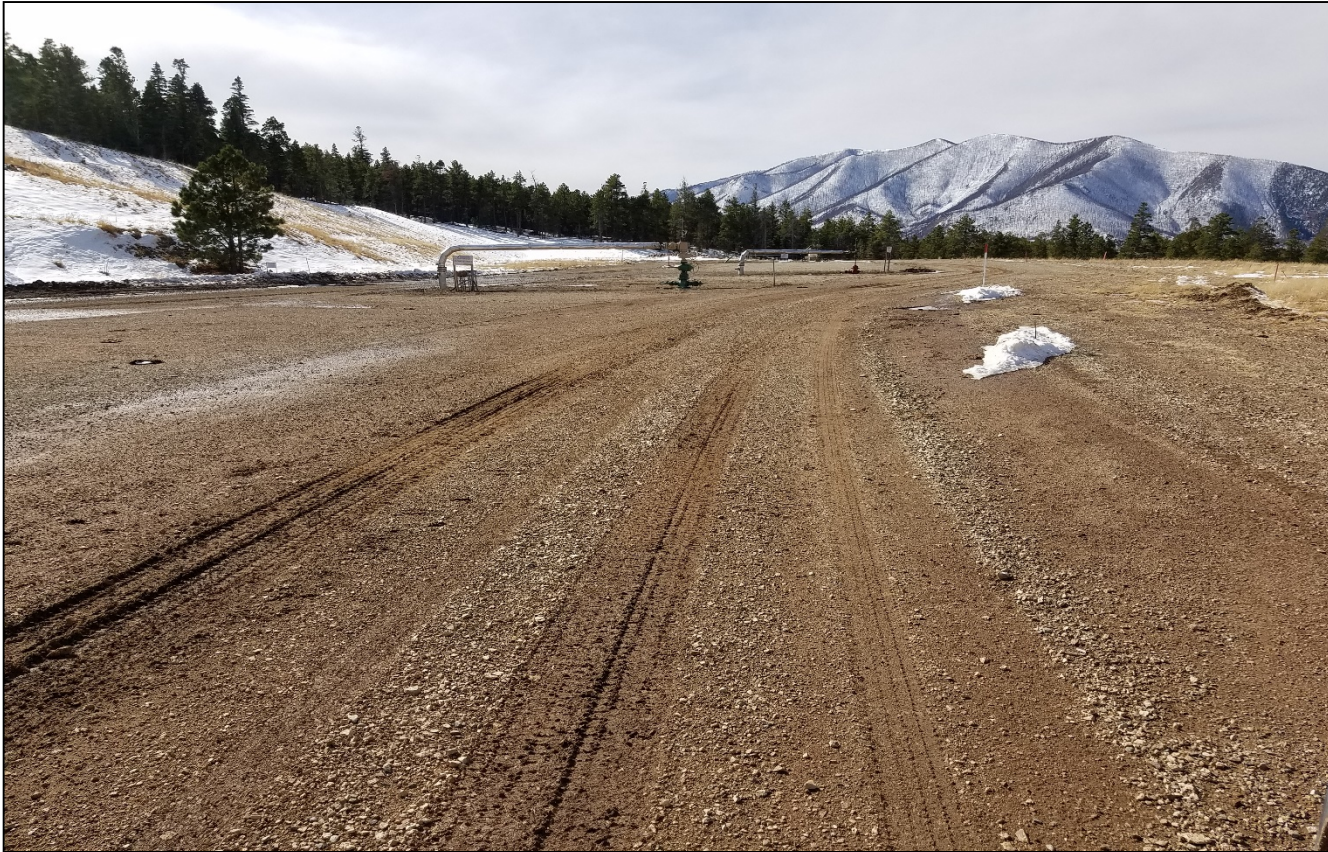
**Photo 4.** Facing southwest toward the location.

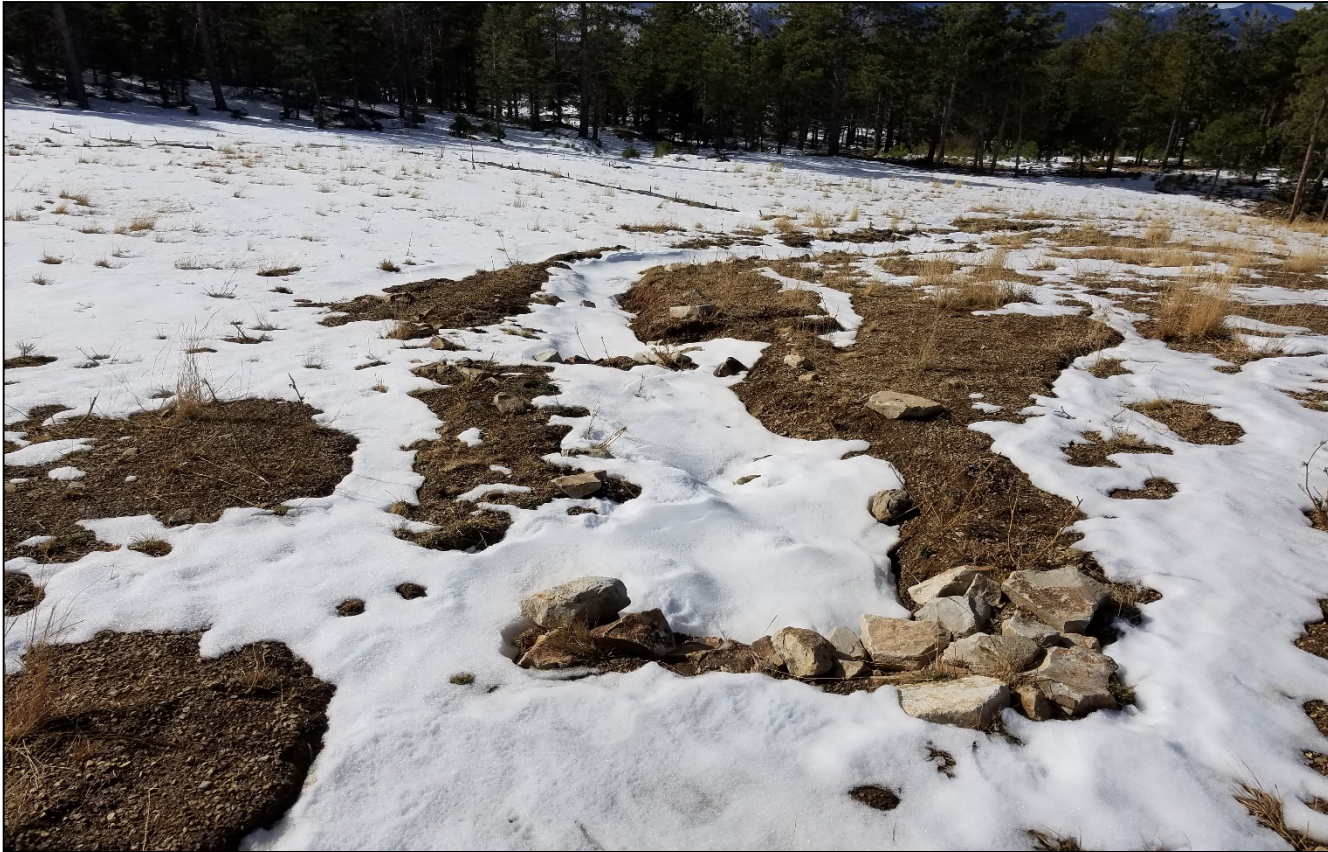
**Photo 5.** There is erosion channels at the reclaimed area at the south side of the location. There are signs that the check dams and wattles have failed.

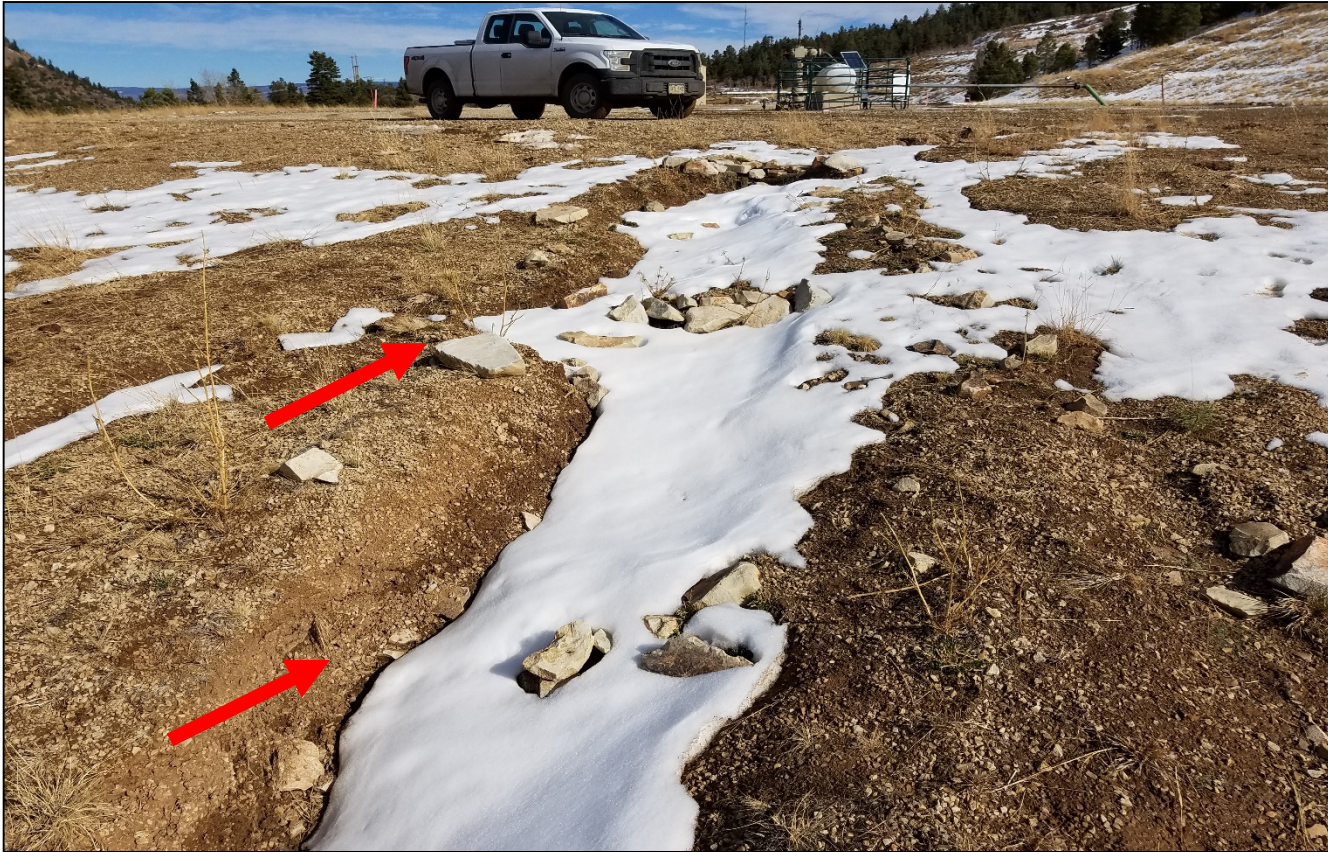
**Photo 6.** The above photo shows the erosion channel and check dams which have failed.

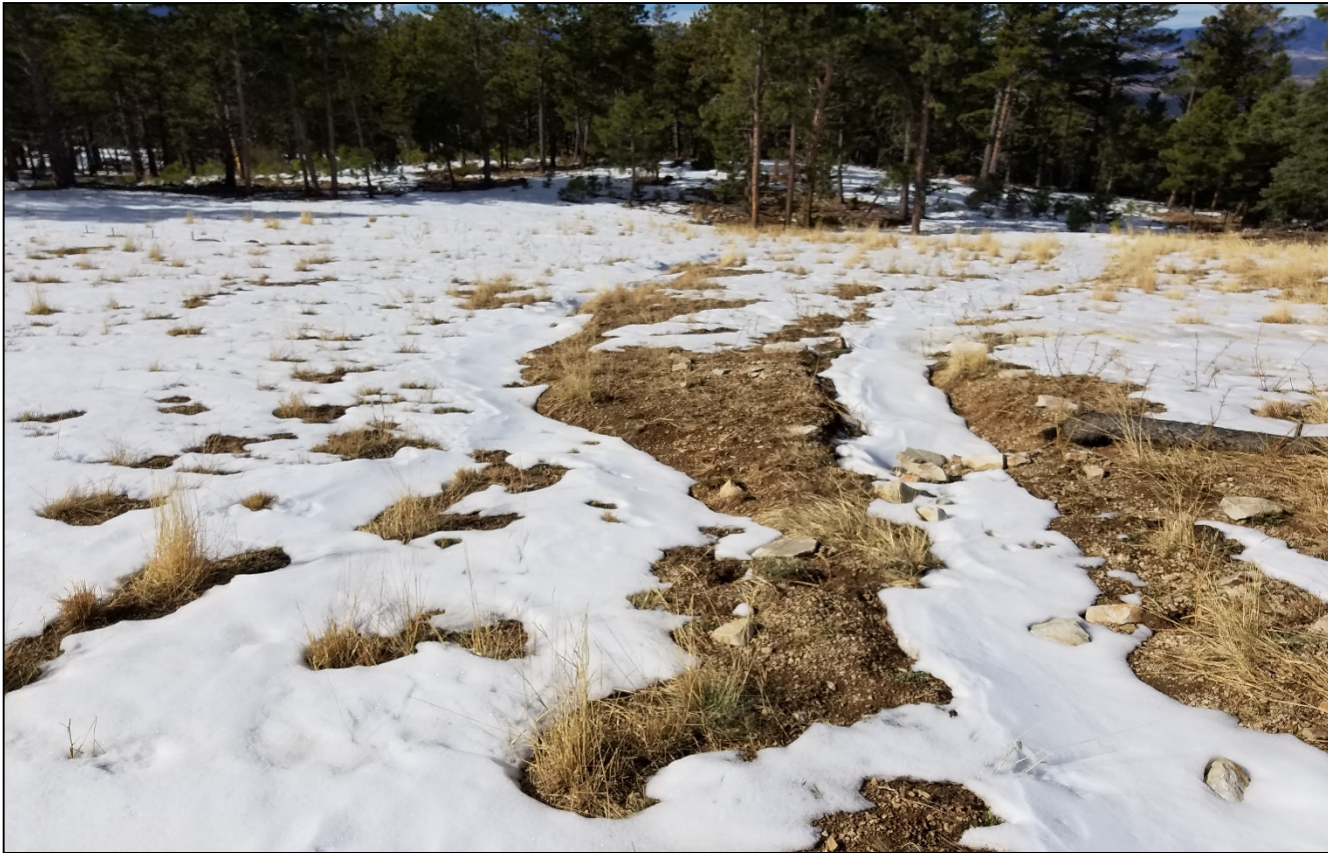
**Photo 7.** Facing west. Snow covers most of the area, erosion can occur when snow melts.

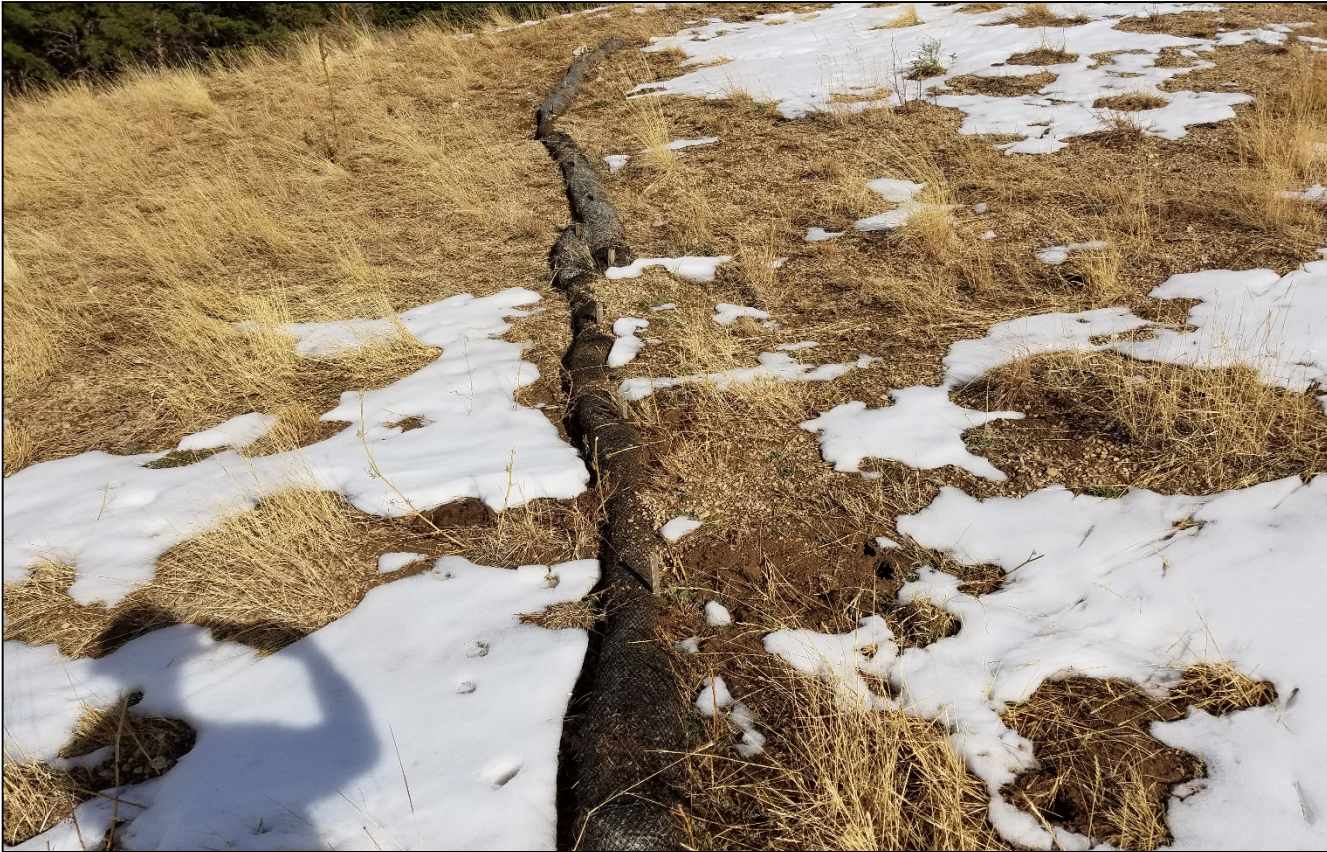
**Photo 8.** This wattle has filled in with sediment and has not been maintained.

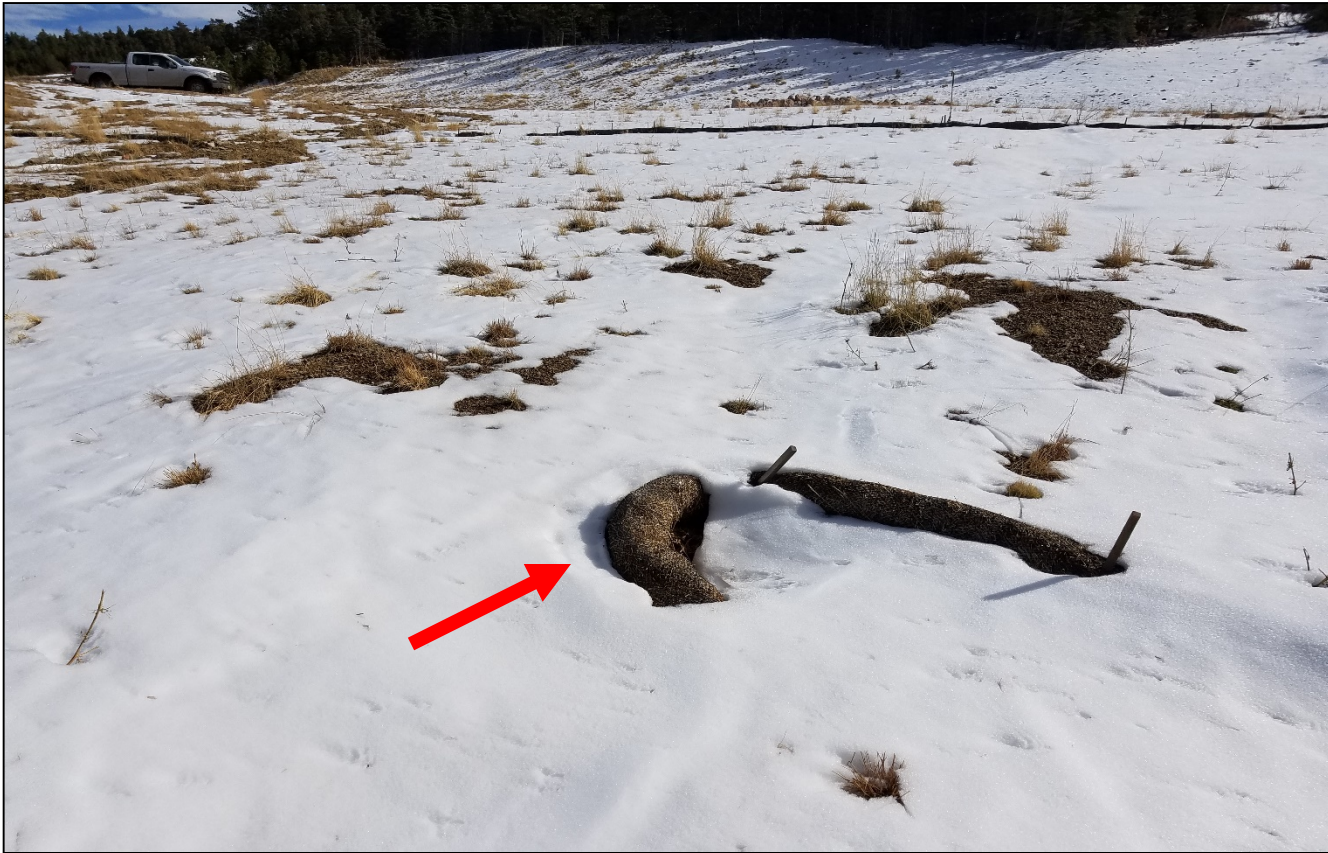
**Photo 9.** This photo shows the wattle displaced.

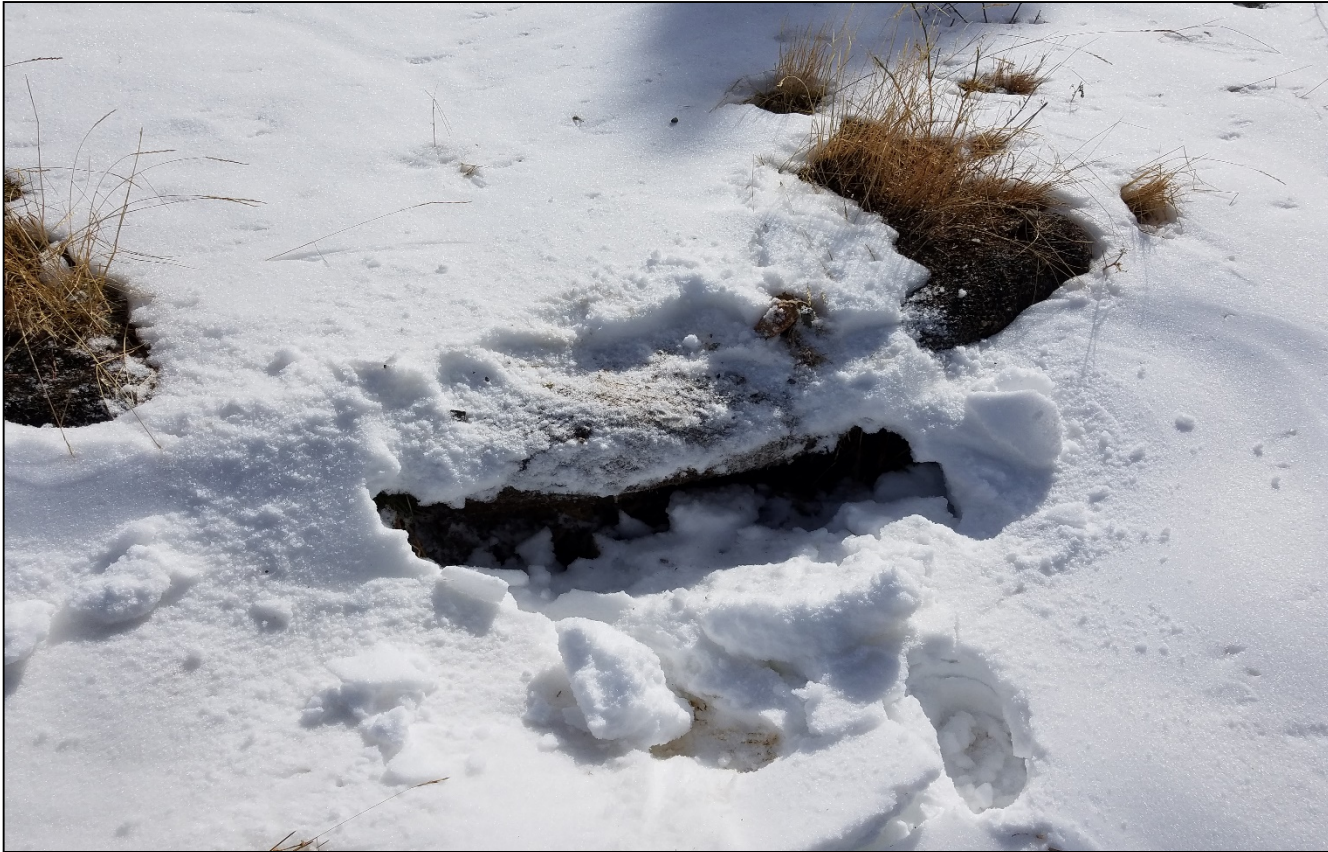
**Photo 10.** This wattle was filled in with sediment and erosion undercut.

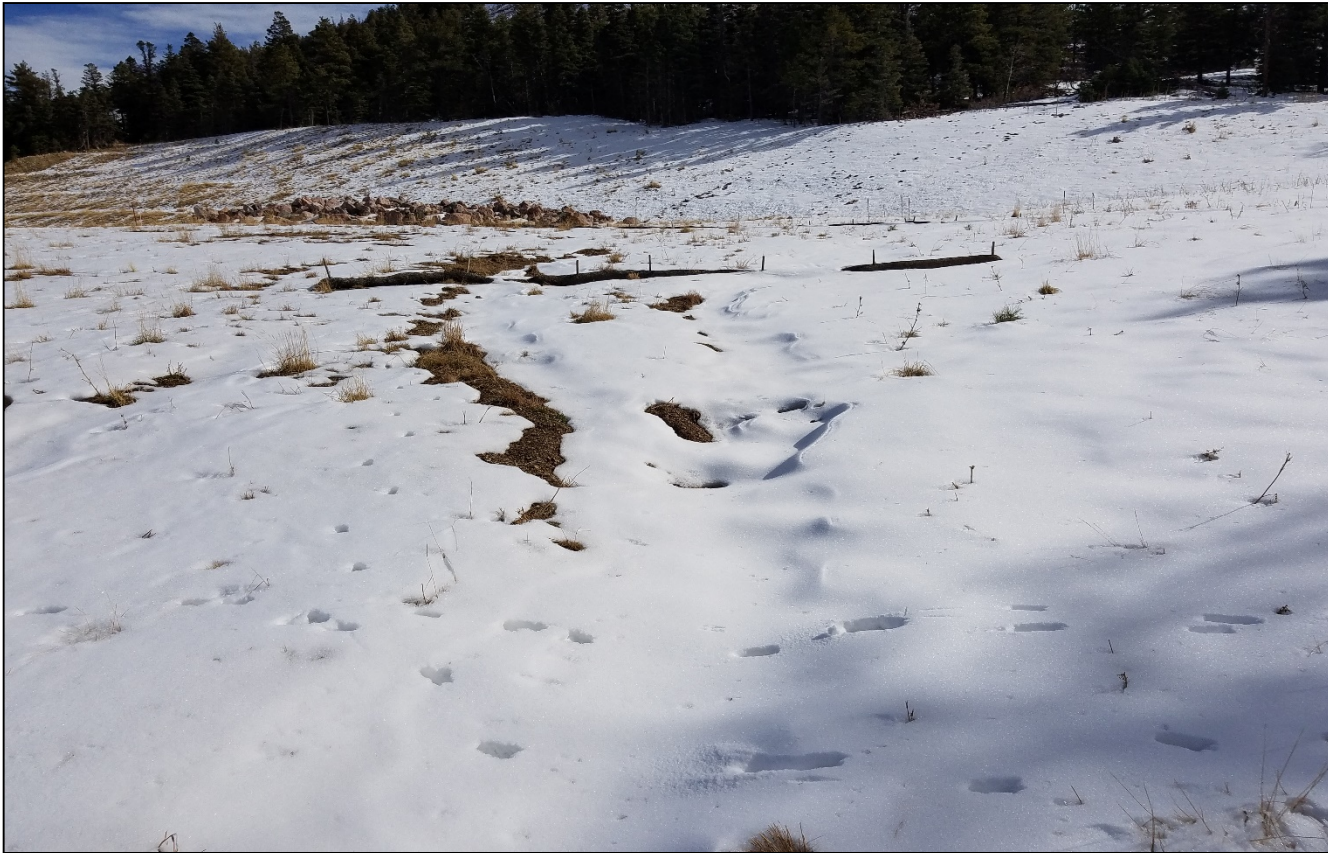
**Photo 11.** Facing east at the location. There are erosion channels evident in this area.

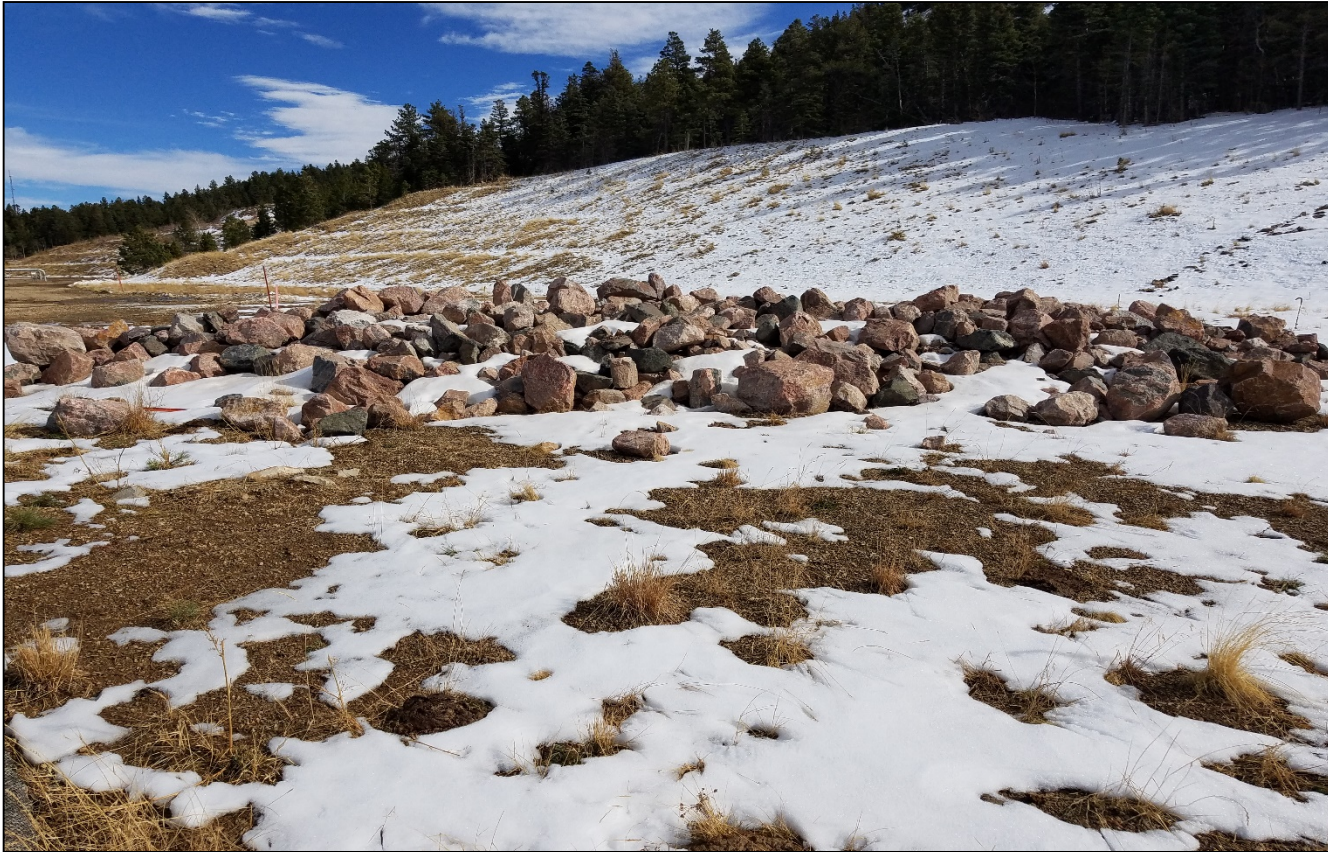
**Photo 12.** There is a pile of large rocks scattered at this side of the location which is disturbing the interim reclamation.

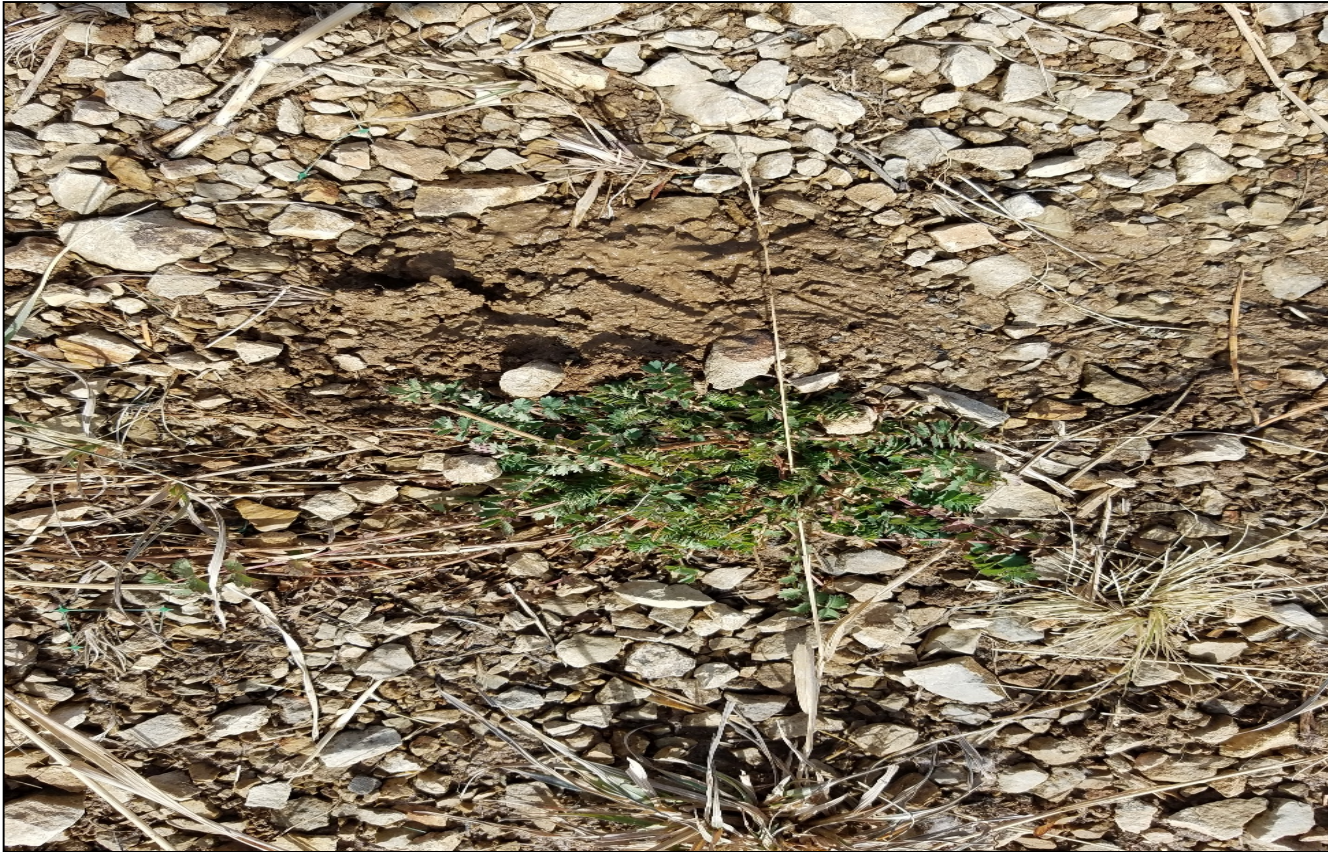
**Photo 13.** There are numerous non native Small burnet (*Sanguisorba minor*) plants growing in the interim reclamation area. The plants are not reflective of reference area vegetation and not a desired landowner specie. The plants must be eradicated.

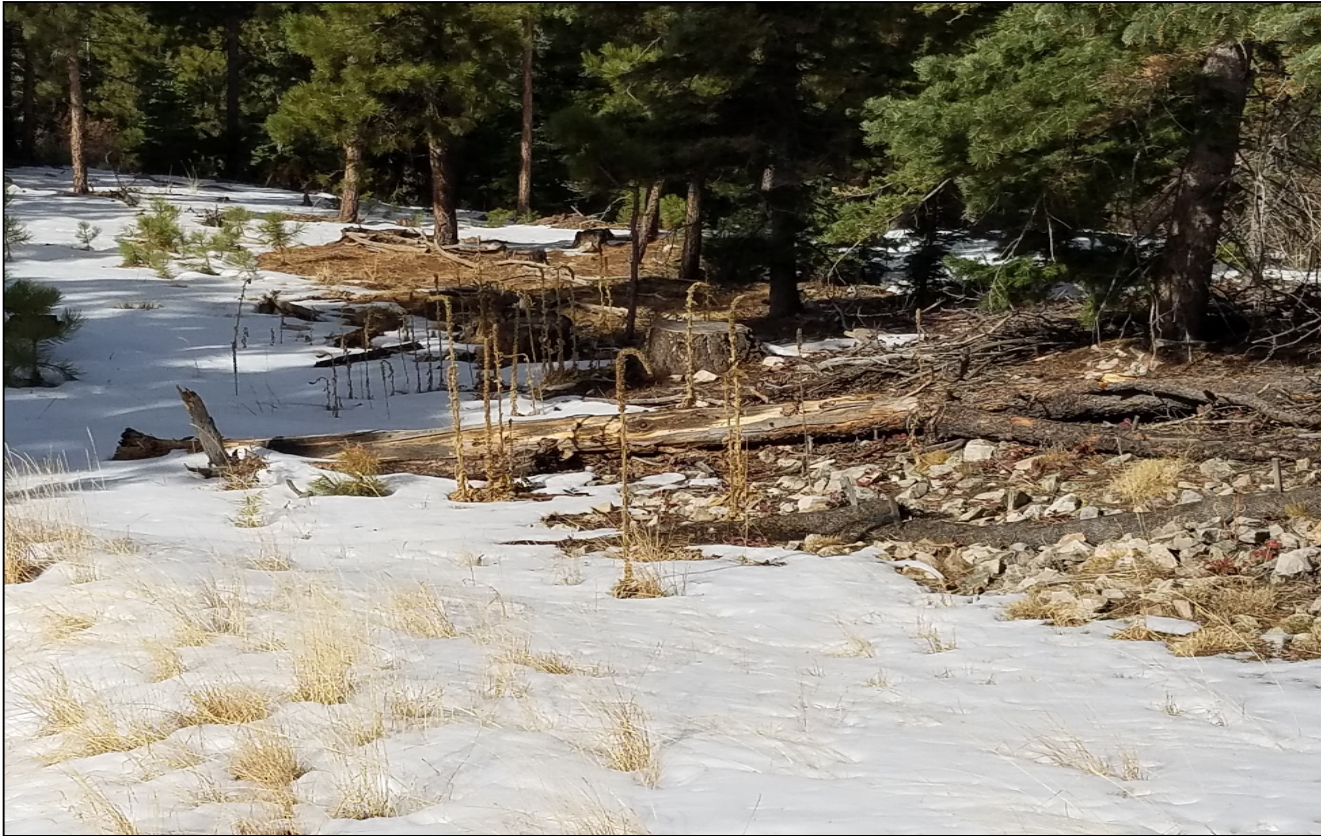
**Photo 14.** It appears biennial noxious weeds were wilted however, the seed heads were not removed.
