# Inspection Photos

API: 05-055-06064

Operator: OXY USA INC

Inspection Date: 11/6/2019

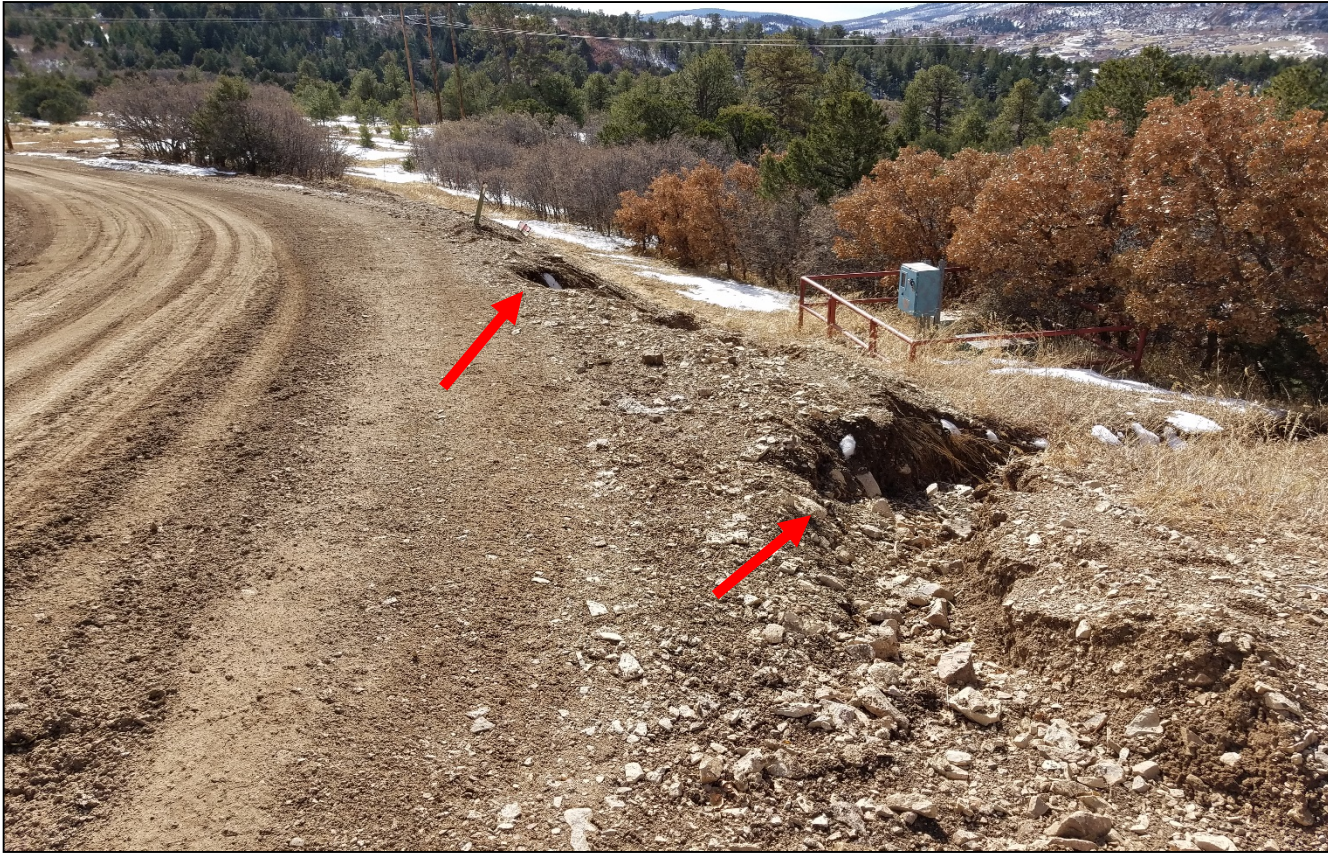
**Photo 1.** There is erosion occurring along the access road to the location. Stormwater is directed off the road at the point creating an erosion channel. Lat/Long:37.70081,-105.20980.

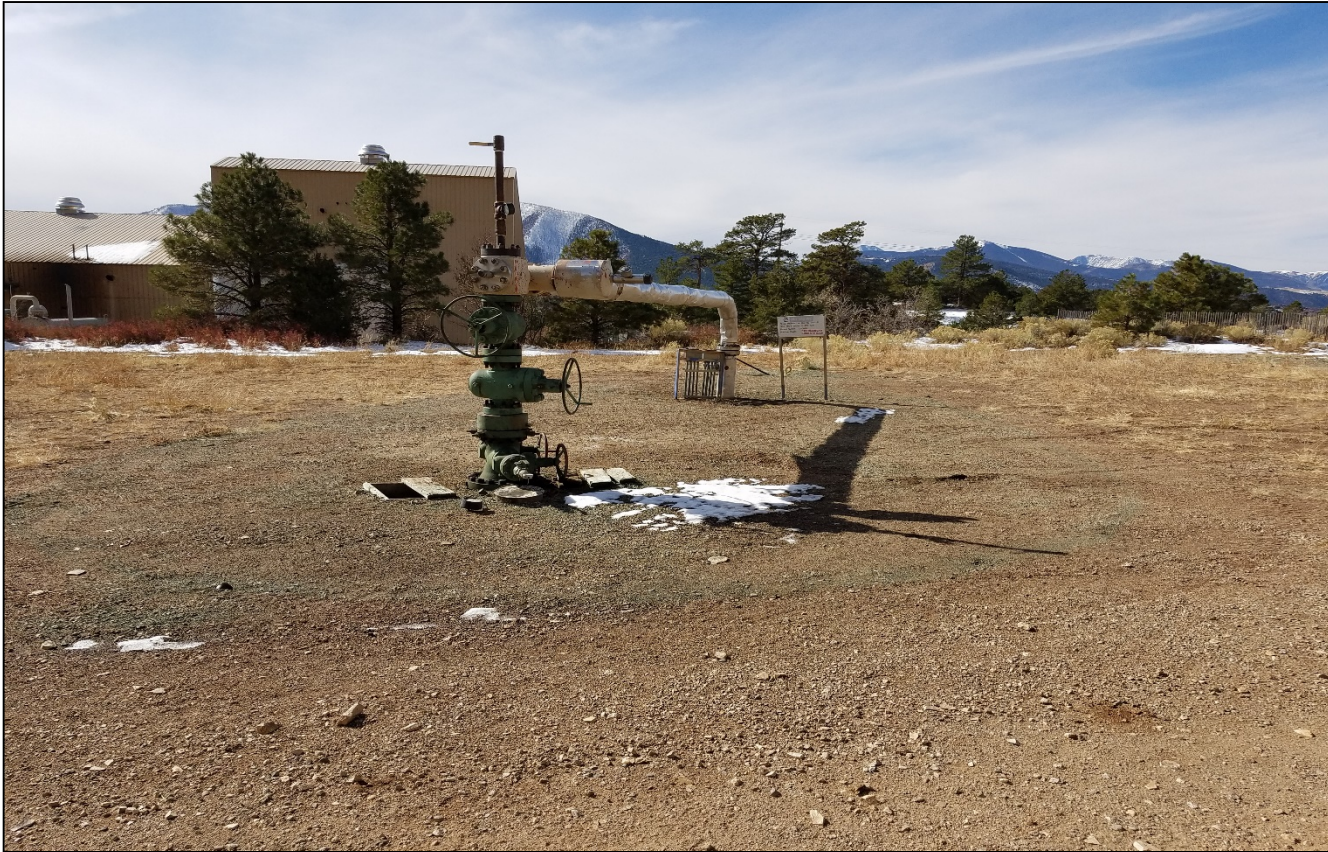
**Photo 2.** It appears noxious weeds have been removed and controlled for the season.
