Inspection Photos
Location Name: State Anderson 1-36
Location ID: 307182

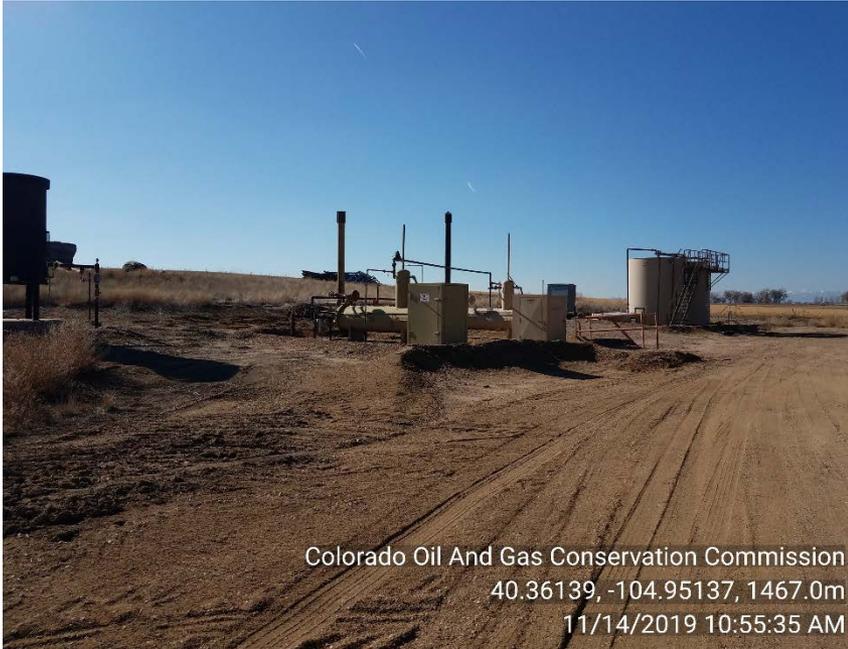
Production facility

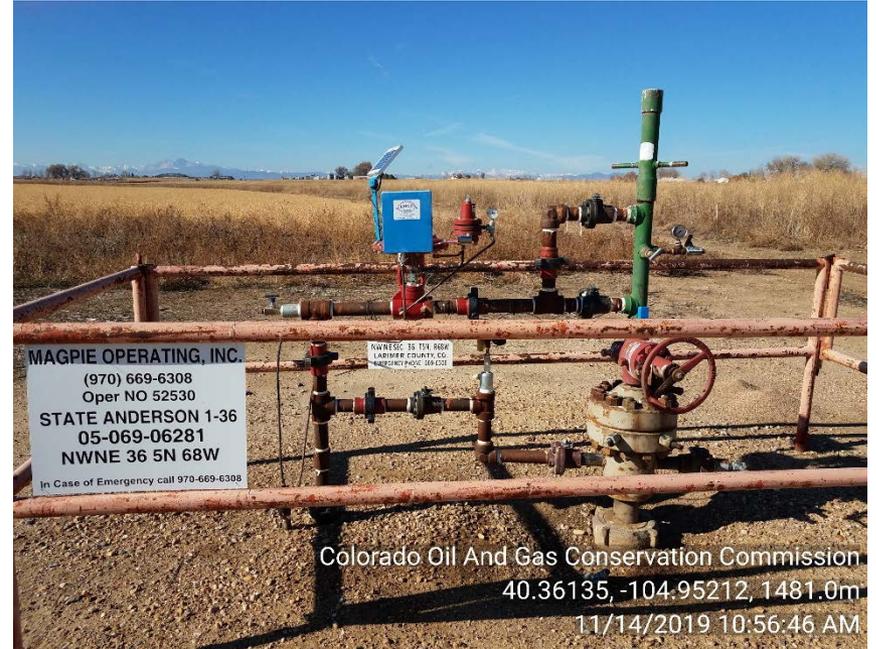
Wellhead

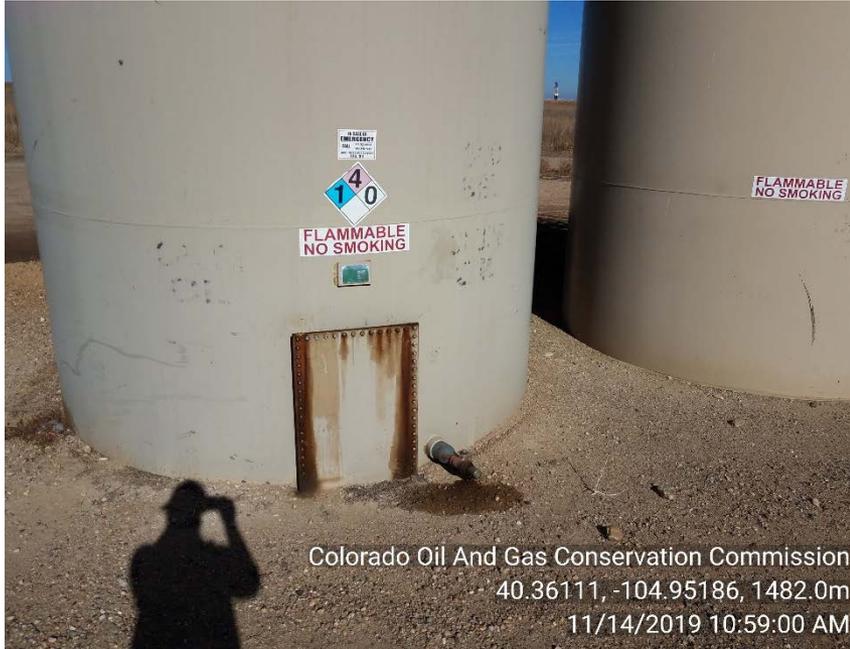
West crude oil tank leaks and stained soil

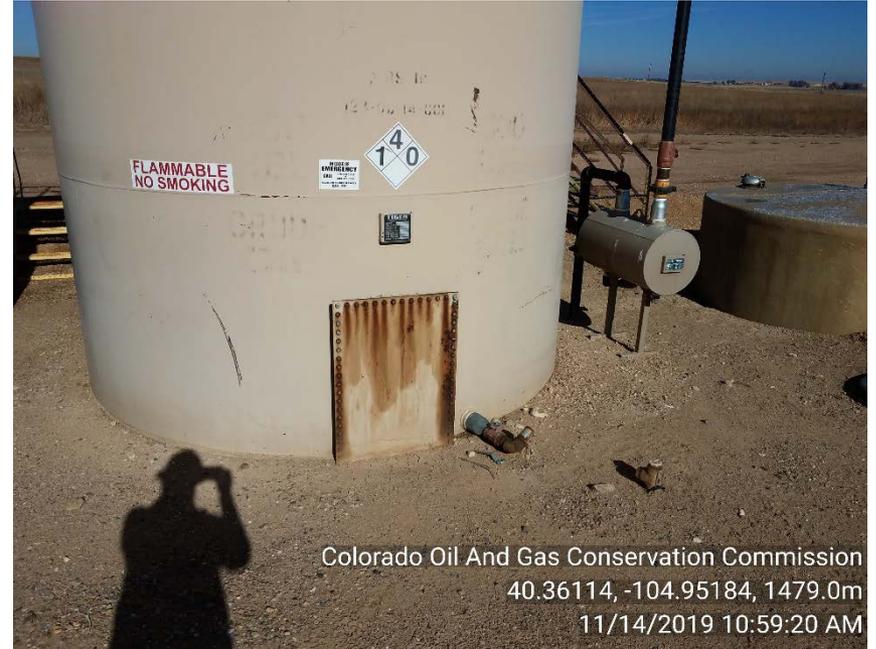
East crude oil tank leak

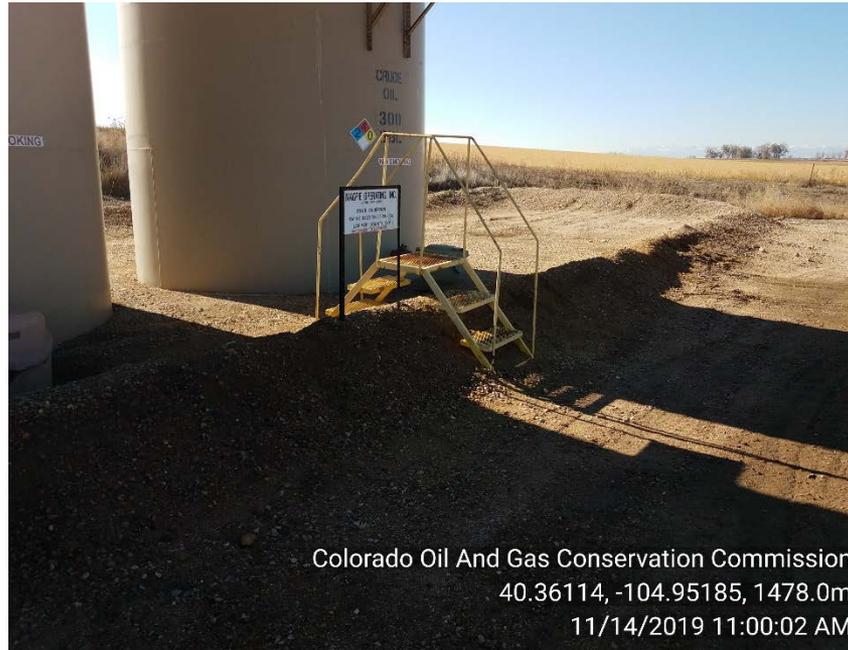
Crude oil tank berm
