Inspection Photos
Location Name: SHINING 33-22
API#: 05-071-09398
INSP. #: 695101745

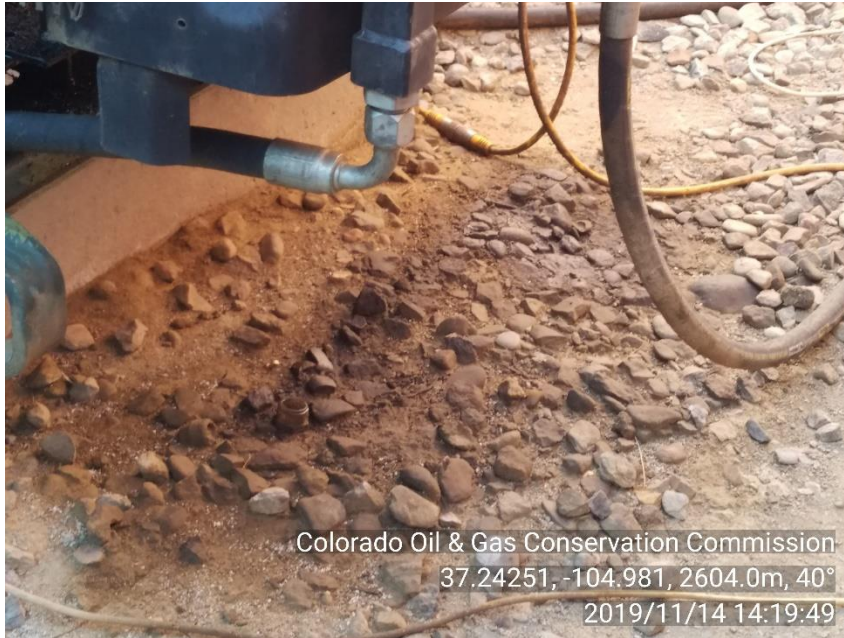
PHOTO 3: AREA OF IMPACTED SOIL NEAR PRIME MOVER (ENGINE SKID). Remove and dispose impacted material in approved manner, service and maintain equipment and self inspect to prevent recurrence of conditions per 1002.f(2) and 907. CA DATE 12-14-19.

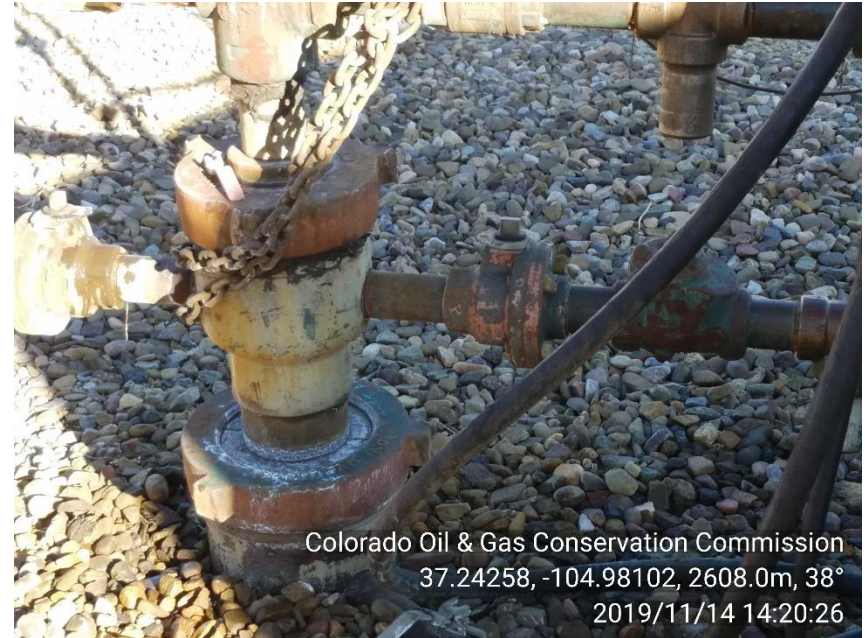
PHOTO 4: AREA OF IMPACTED SOIL AROUND WELLHEAD. Remove and dispose impacted material in approved manner, service and maintain equipment and self inspect to prevent recurrence of conditions per 1002.f(2) and 907. CA DATE 12-14-19.
