# Inspection Photos

API: 05-071-06339

Operator: TIMBER CREEK OPERATING LLC

Inspection Date: 11/8/2019

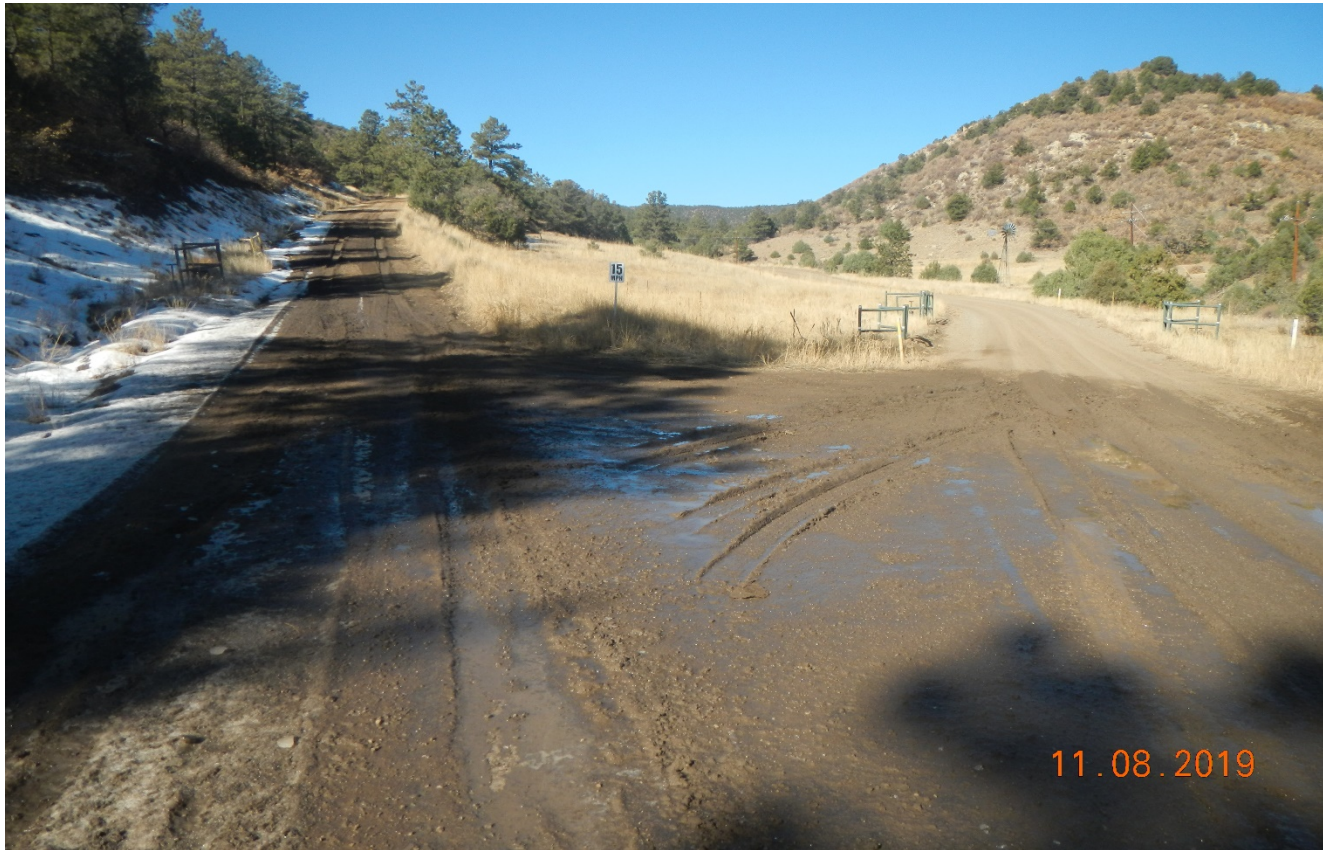
**Photo 1.** Stormwater is not properly diverted off the road at this point. This issues is causing vehicle ruts and road damage.

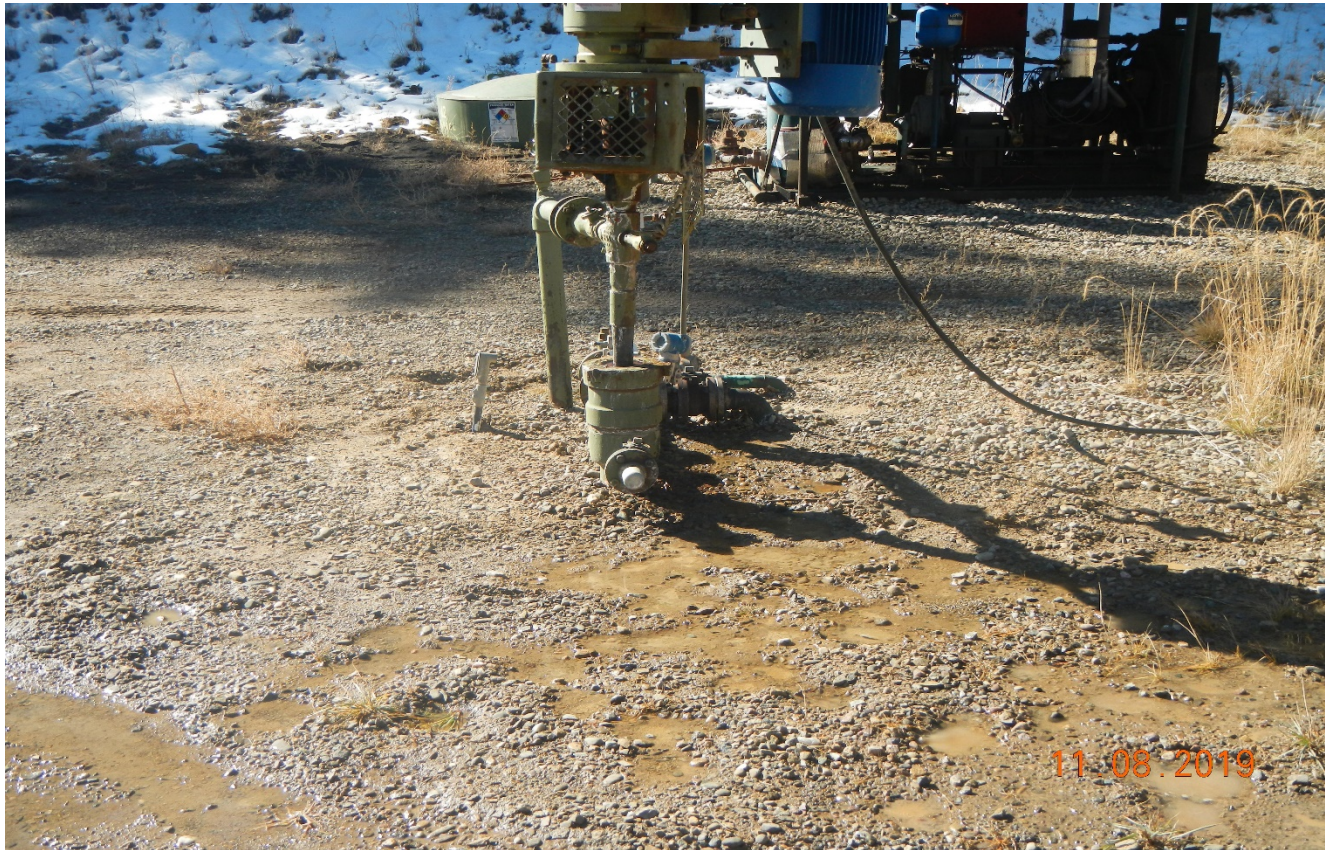
**Photo 2.** The water leak at the wellhead has not been repaired.
