Inspection Photos

API: 05-071-06130

Operator: TIMBER CREEK OPERATING LLC

Inspection Date: 11/8/2019

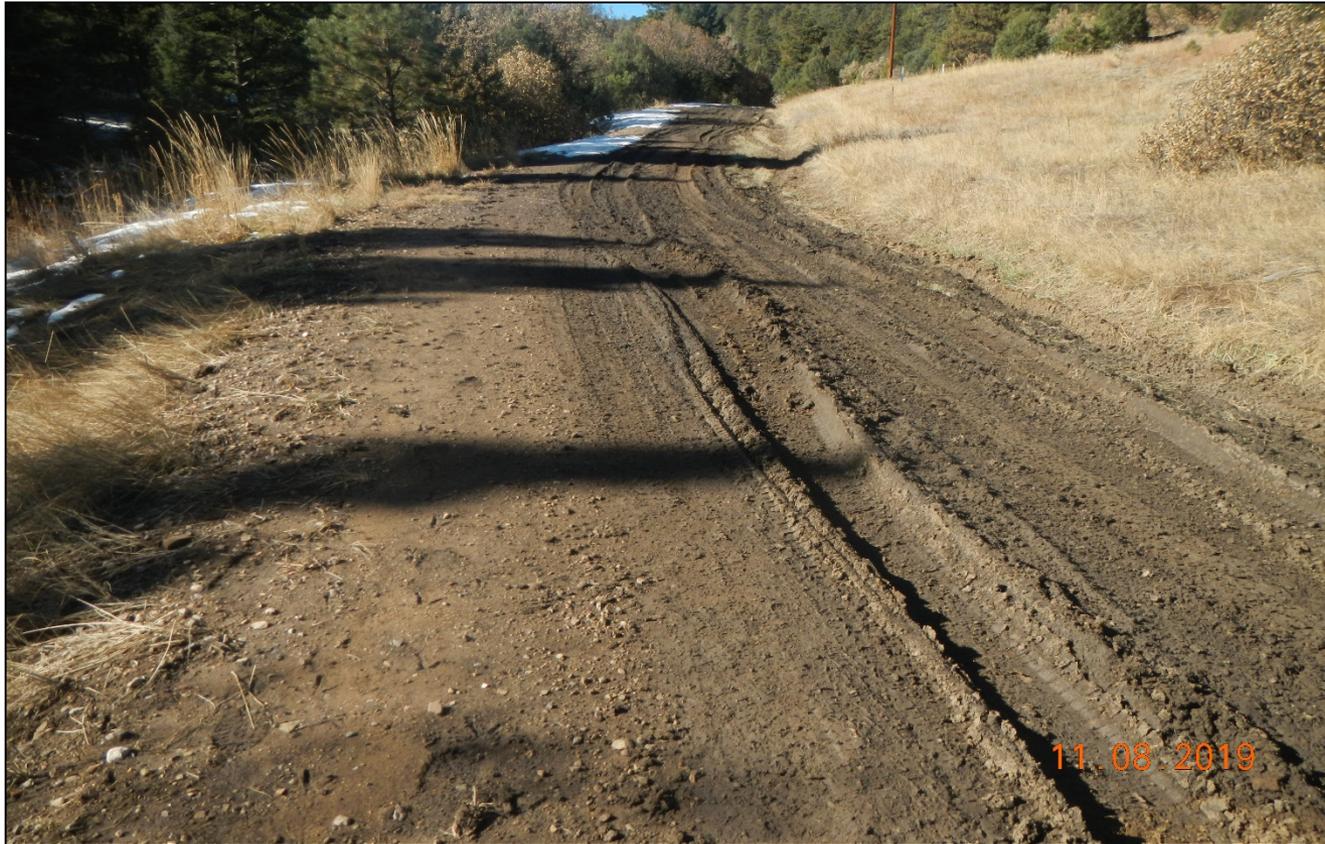
Photo 1. There are vehicle ruts and road damage along the main road to the location. This area is very slick and is a safety issue. The road requires gravel in this area.

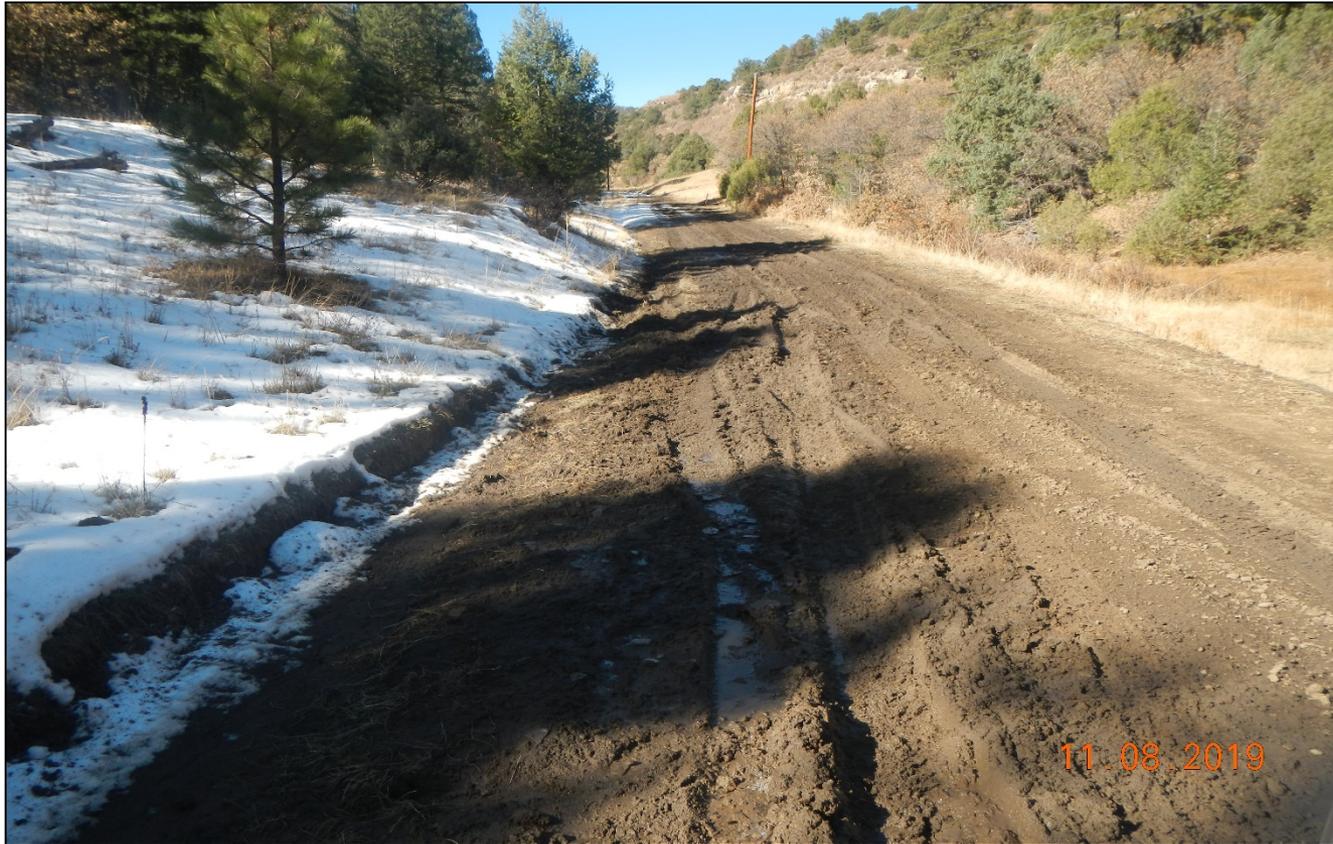
Photo 2. There are vehicle ruts and road damage along the main road to the location. This area is very slick and is a safety issue. The road requires gravel in this area.

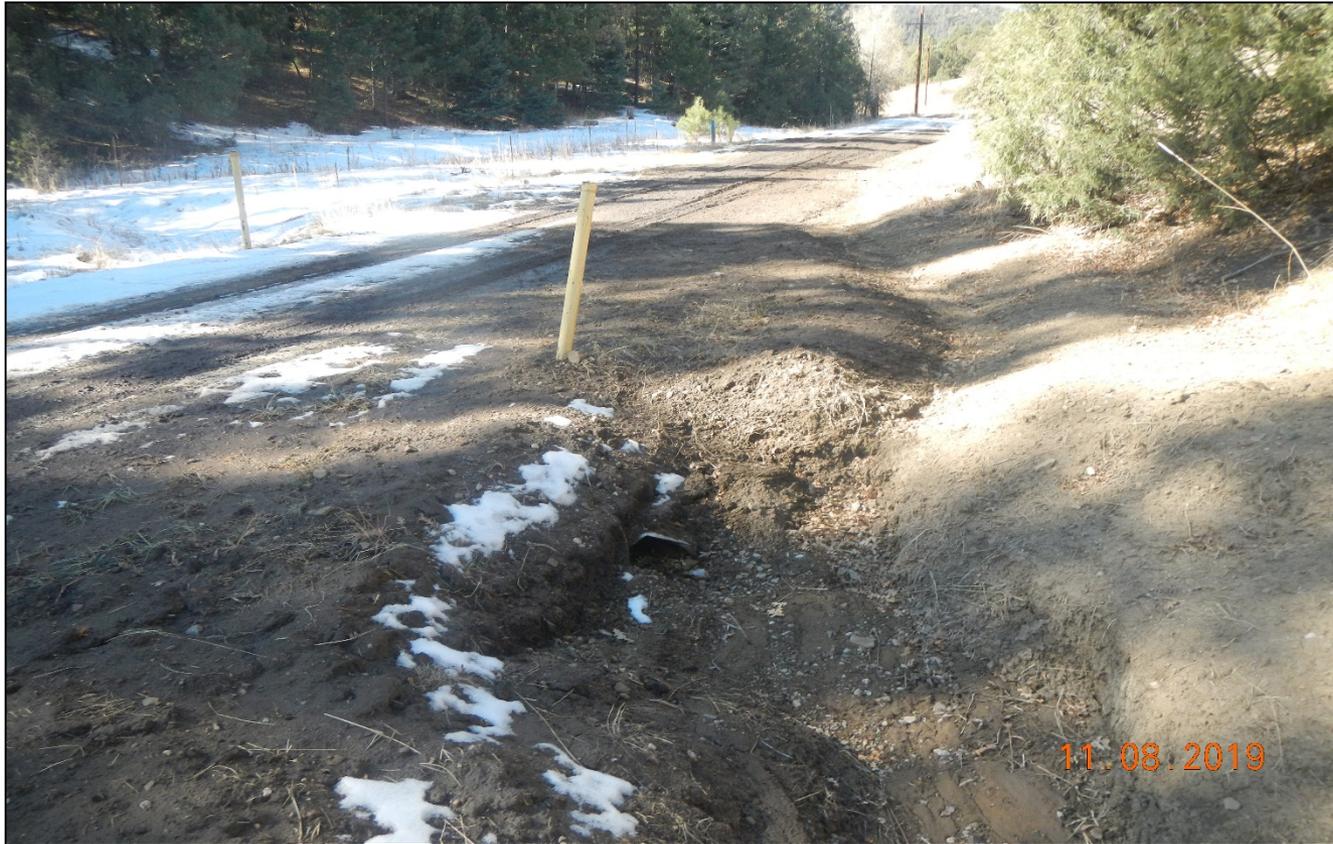
Photo 3. Sediment is beginning to accumulate in the culvert outlet at the stream crossing.

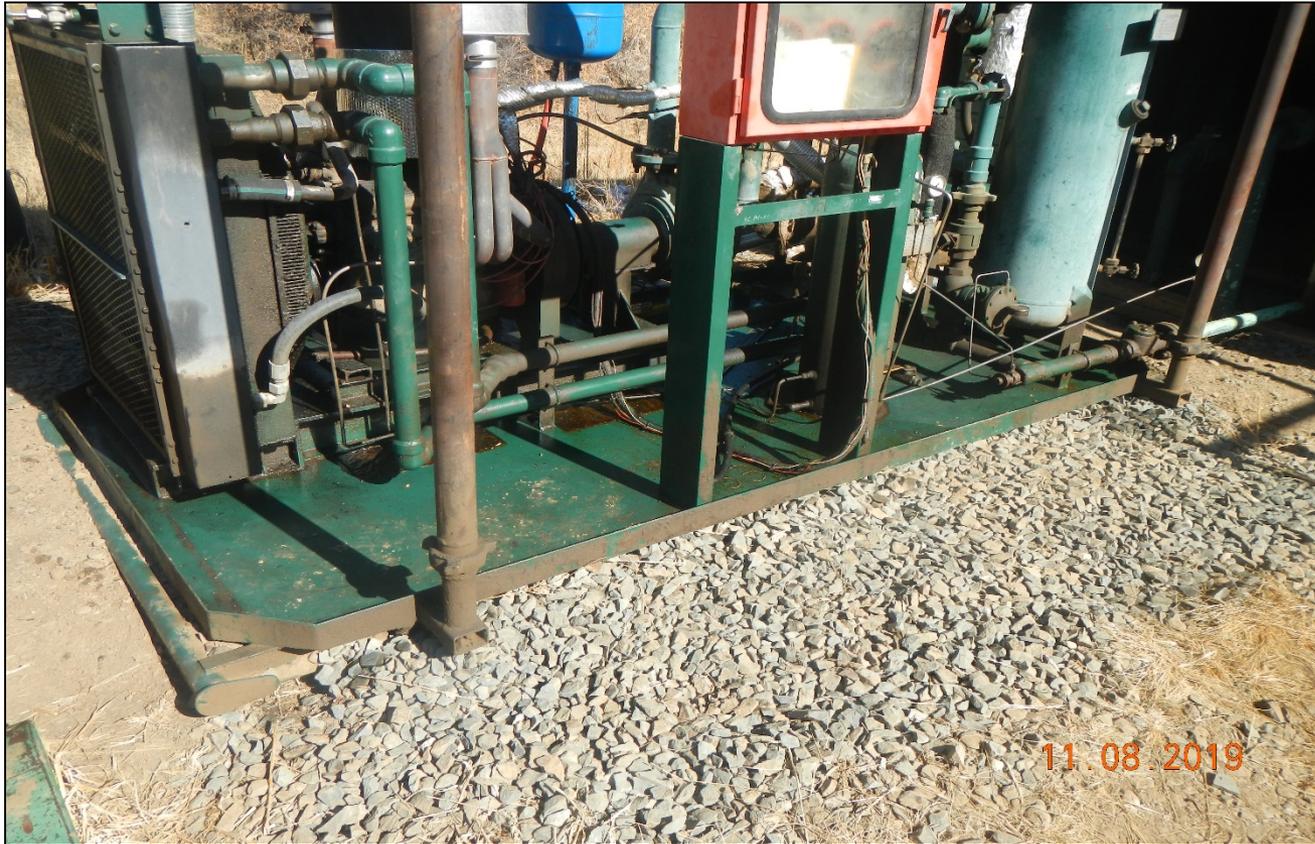
Photo 4. The oil on the engine skid has been cleaned up.

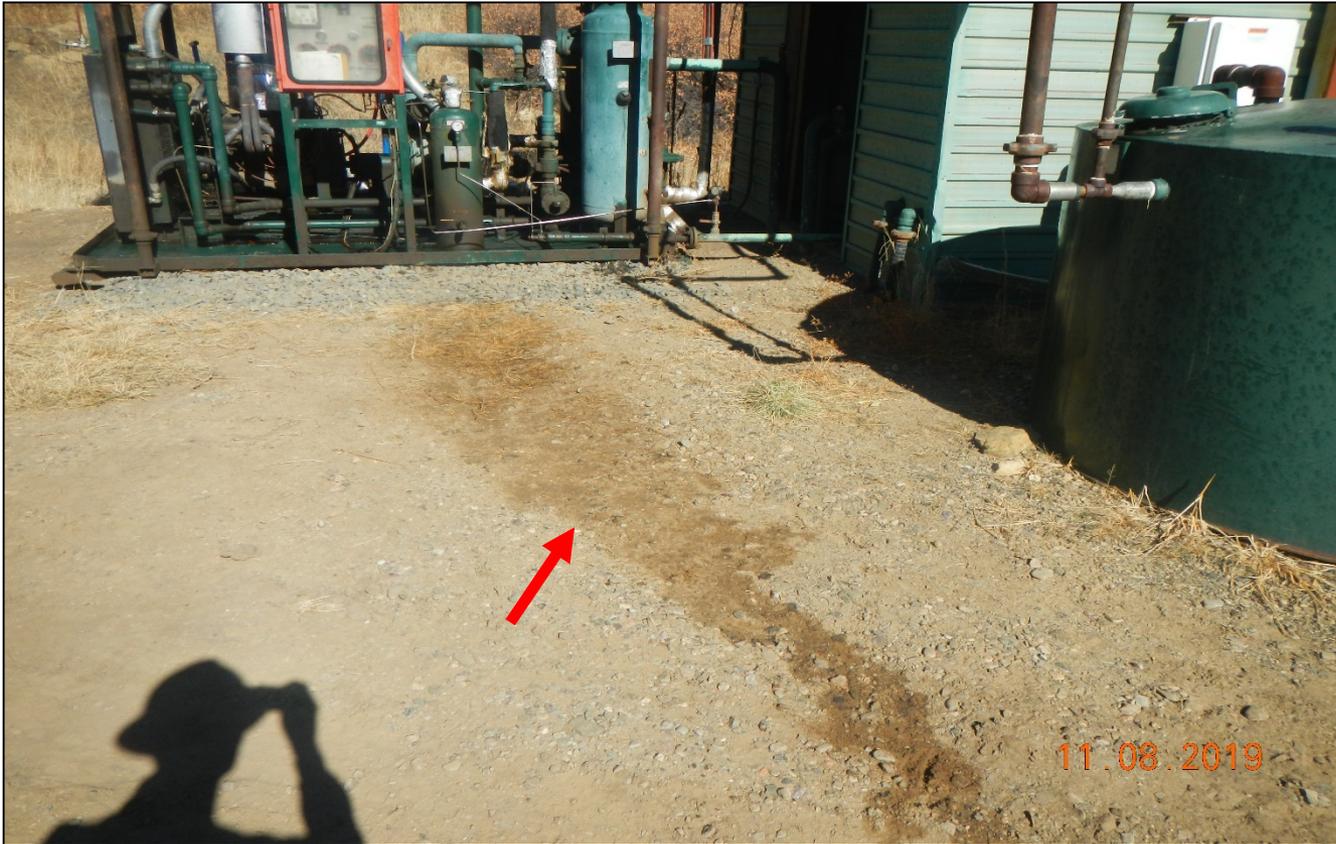
Photo 5. There is an area of oil stain soil near the engine skid that needs to be cleaned up.
