# Inspection Photos

API: 05-071-06218

Operator: MERIDIAN OIL INC

Inspection Date: 11/8/2019

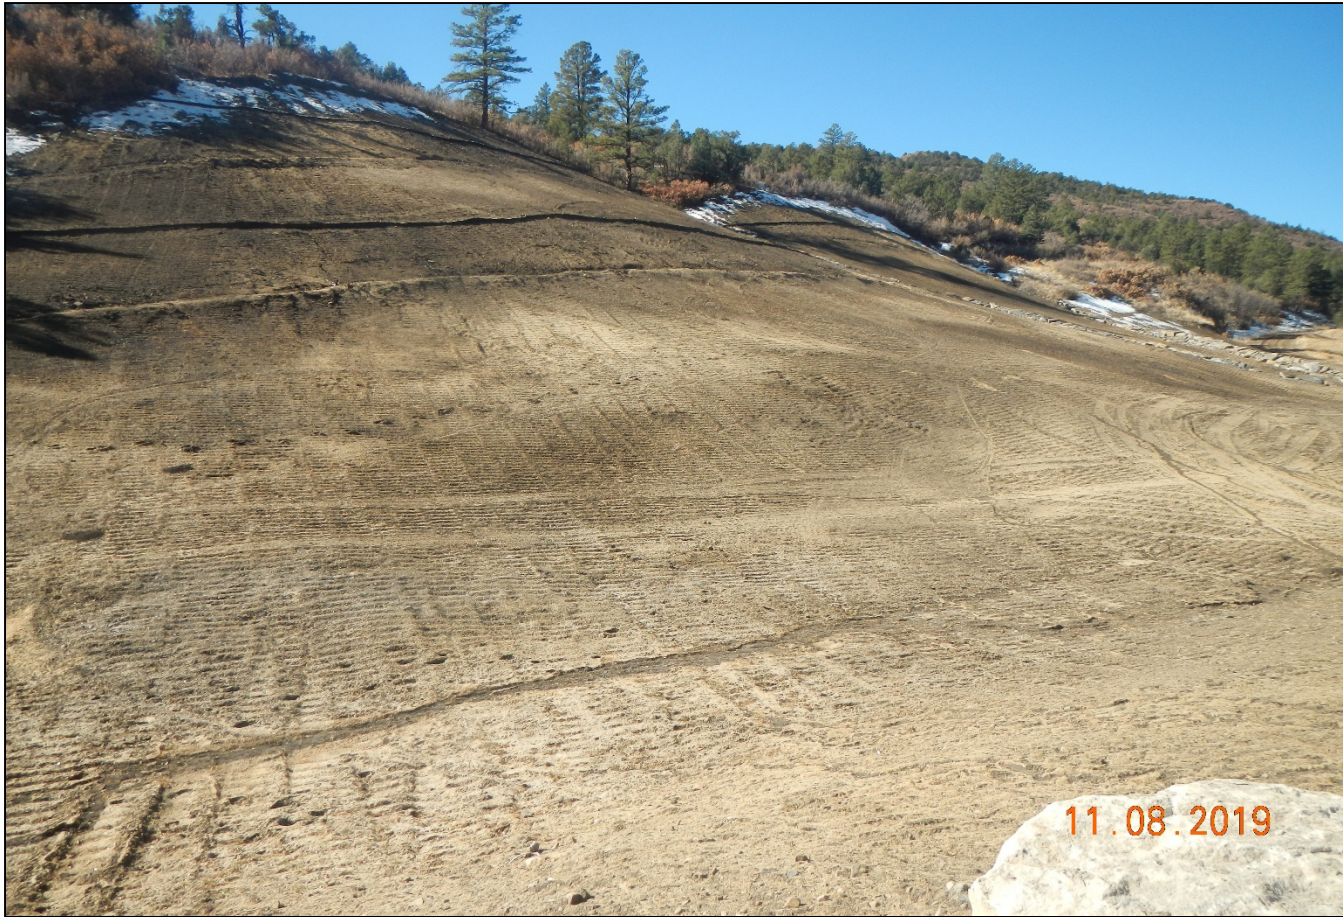
**Photo 1.** Facing southwest toward the location which has been recontoured and reclaimed.

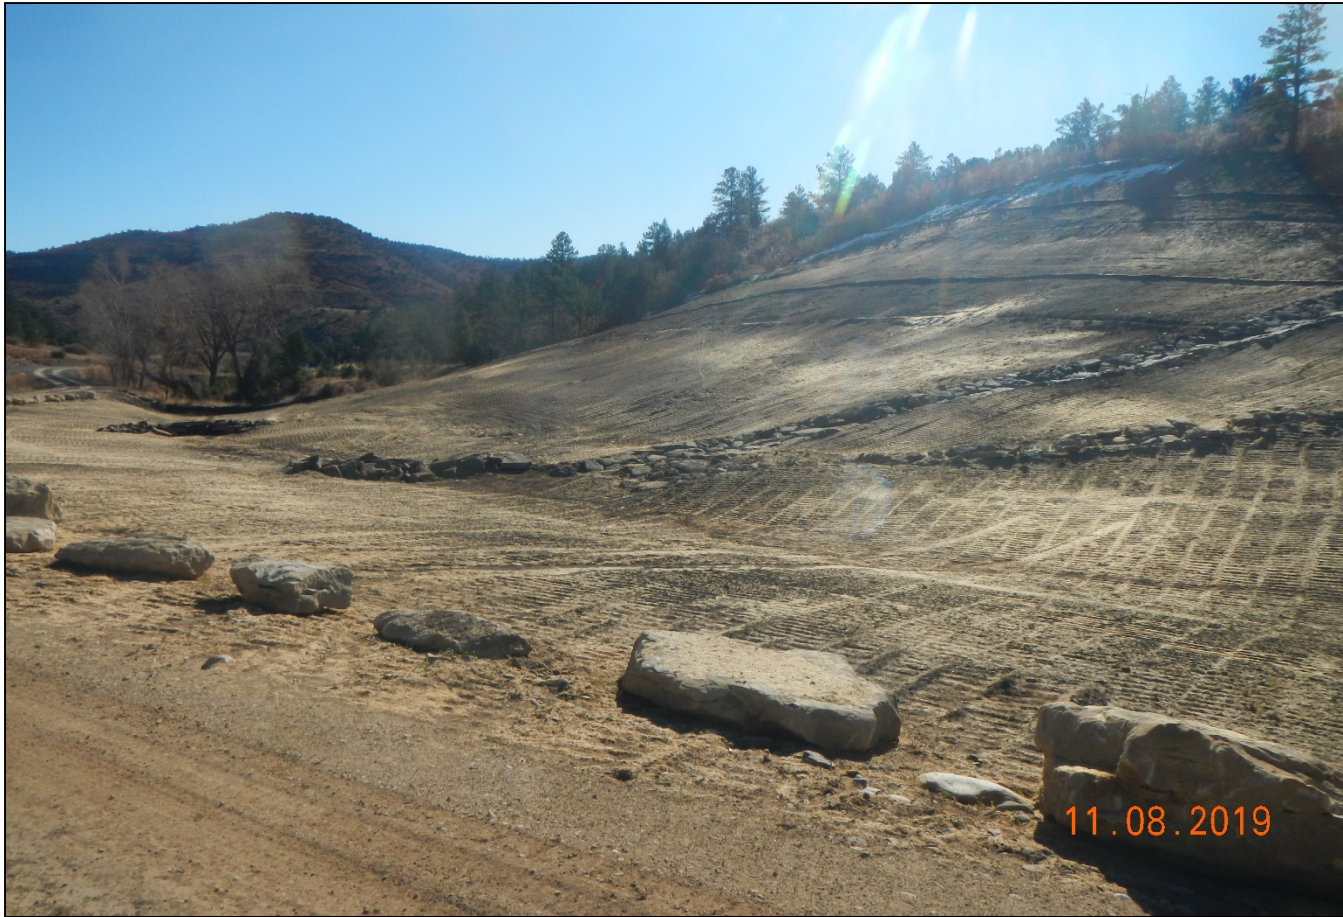
**Photo 2.** Facing southeast toward the location which has been recontoured and reclaimed.

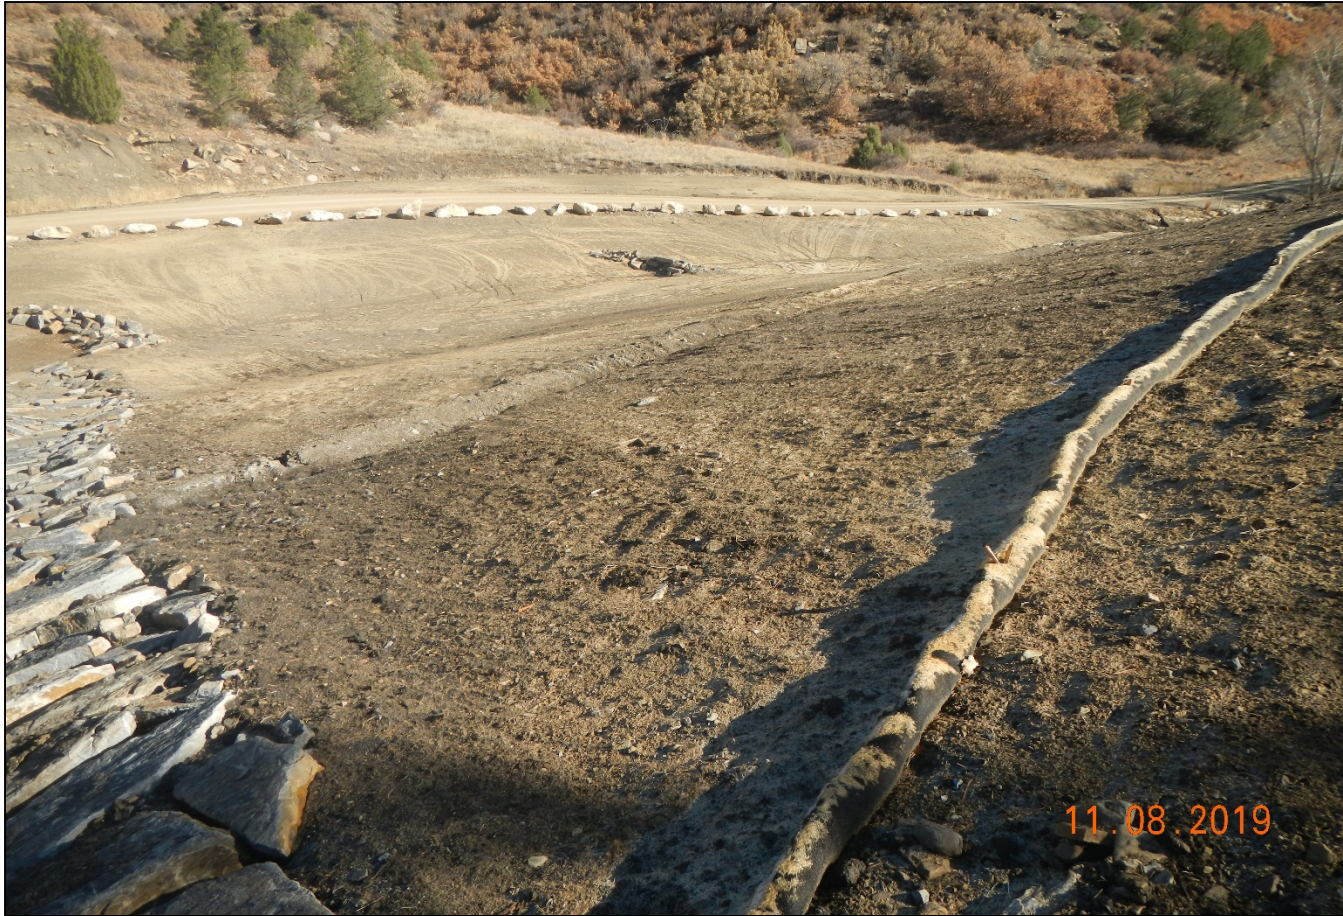
**Photo 3.** Erosion controls are installed along the slope.

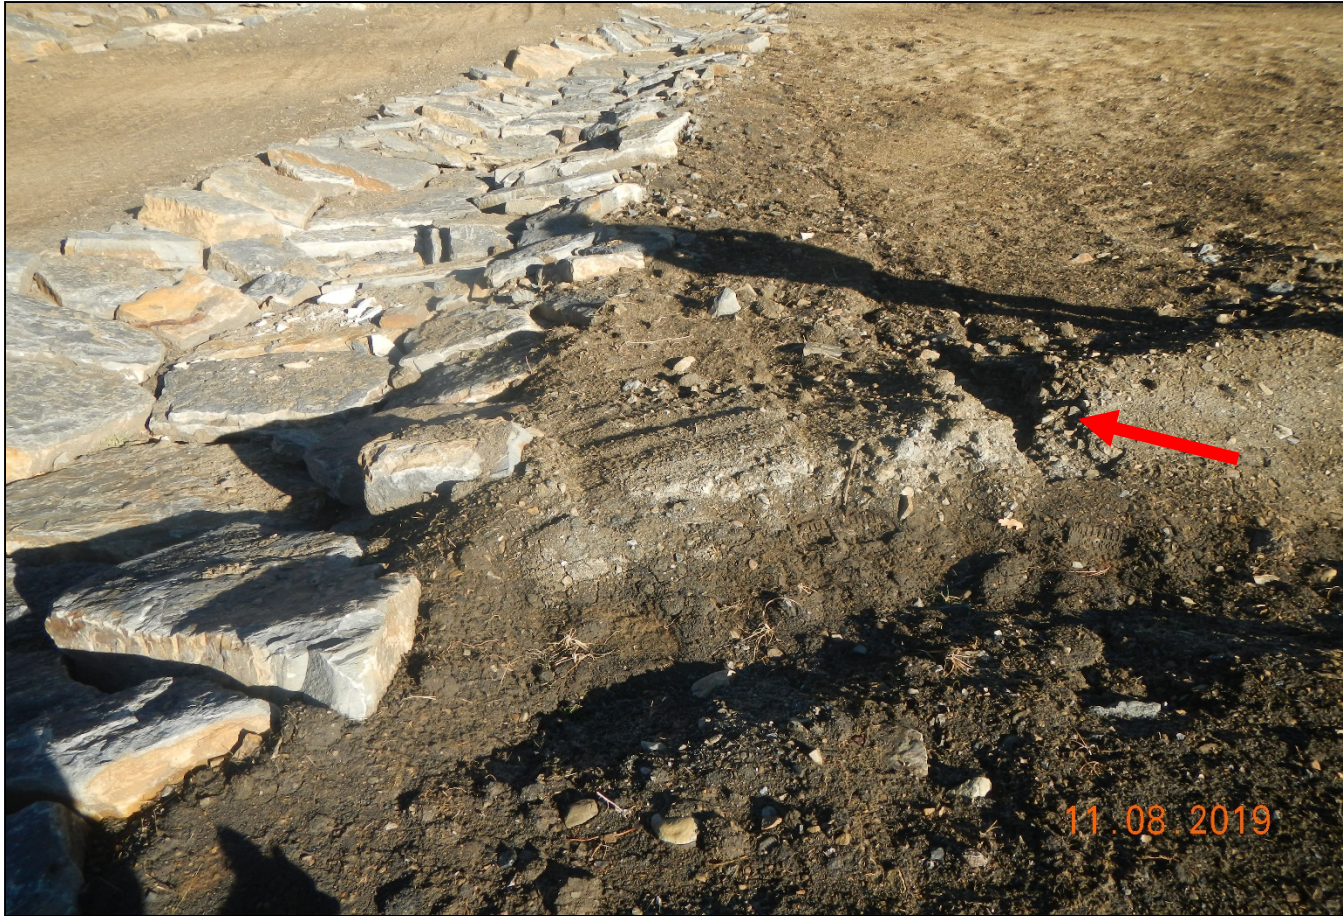
**Photo 4.** Stormwater has begun to degrade the berm. Stormwater should be diverted toward the rock rip rap structure and berm needs to be repaired.

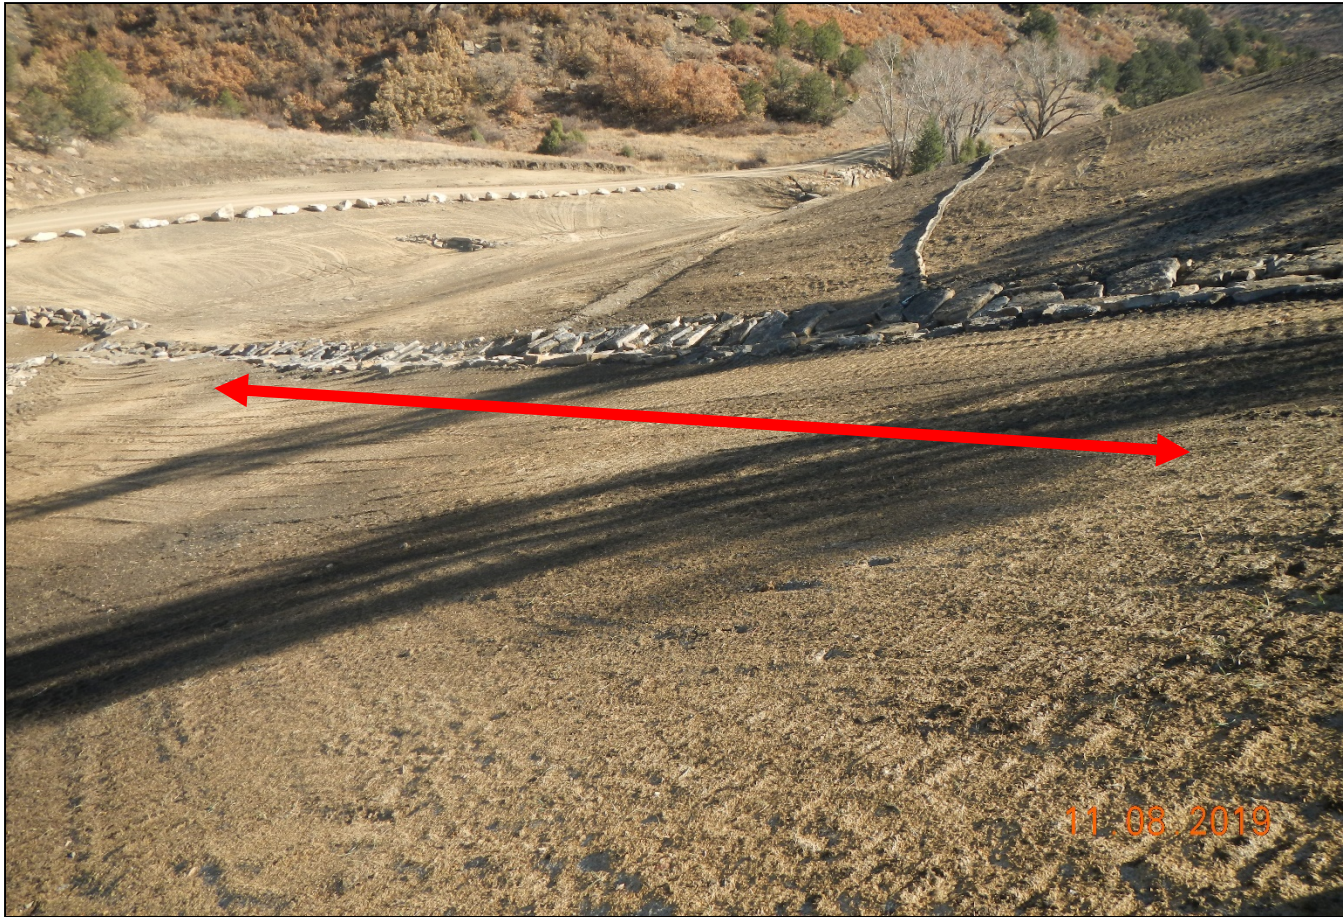
**Photo 5.** Facing northeast along the slope of the reclaimed location. This slope may need additional BMP's (Wattles) to slow the stormwater runoff.
