Inspection Photos
Location Name: Cleveland #8
Location ID: 332926

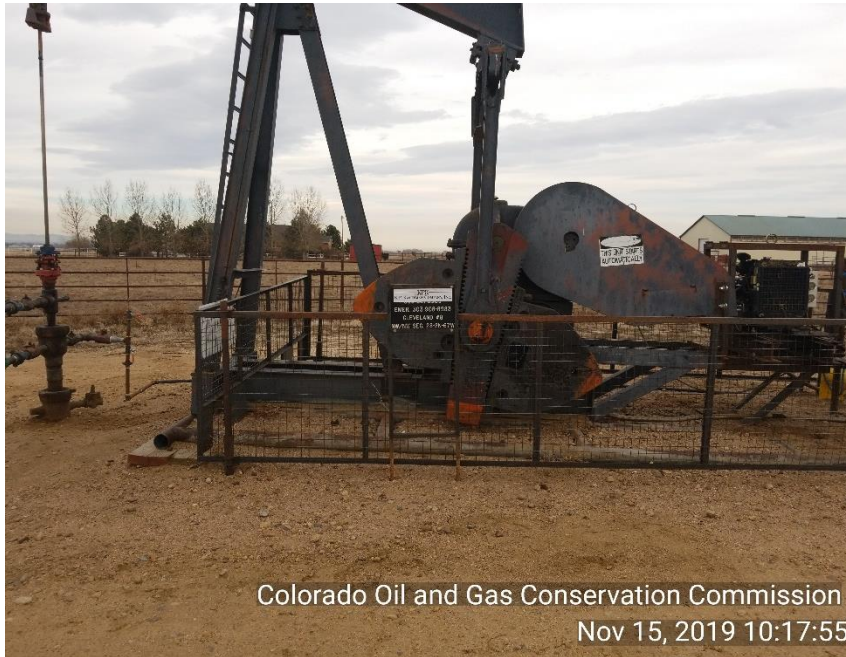
Photo1 Well head and PU

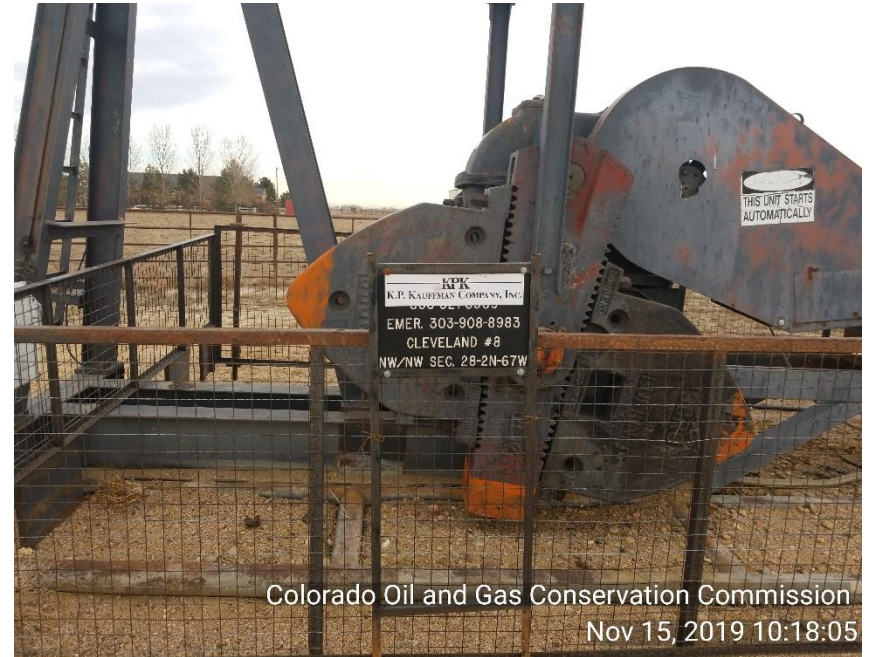
Photo 2 Emergency contact number does not reflect current operator.

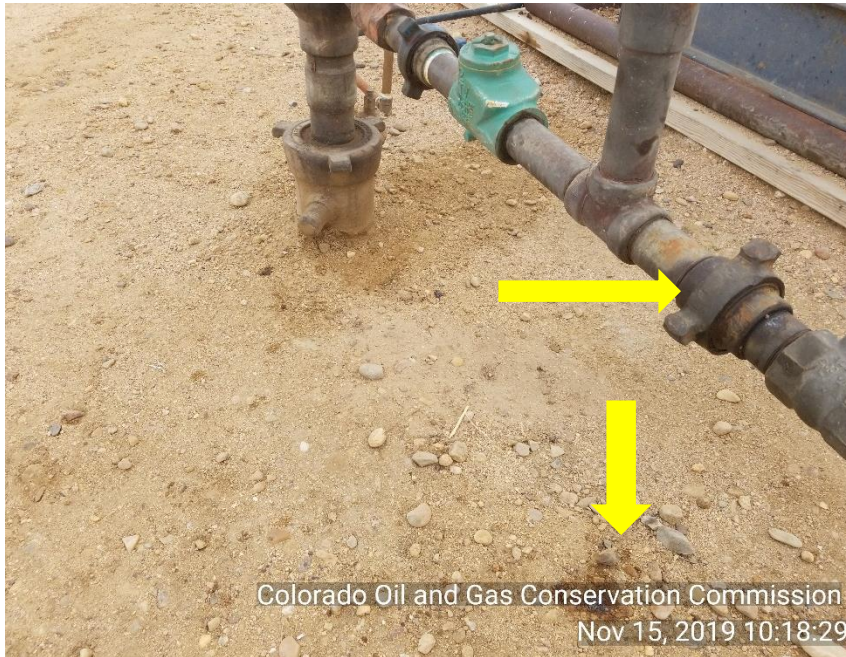
Photo 3 stained soil around well head and mechanical issue; 2" hammer union appears to be leaking

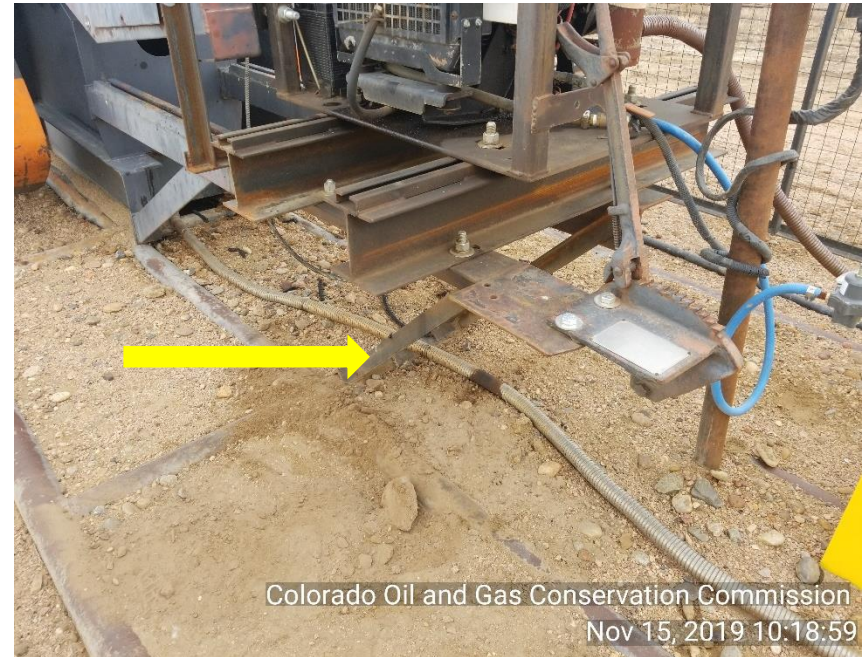
Photo 4 Stained soil under PU motor. Mechanical issue: PU motor appears to be leaking.

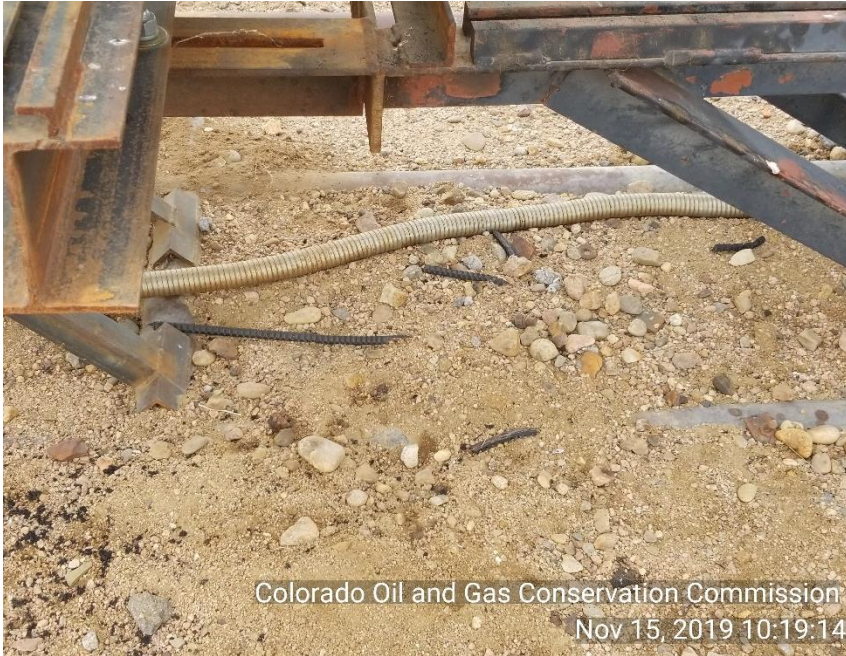
Photo 5 Mechanical issue: PU motor belt appears to be in pieces and laying on ground. PU is not operable.
