# Inspection Photos

API: 05-009-06573

Operator: INVESTMENT EQUIPMENT LLC

Inspection Date: 11/12/2019

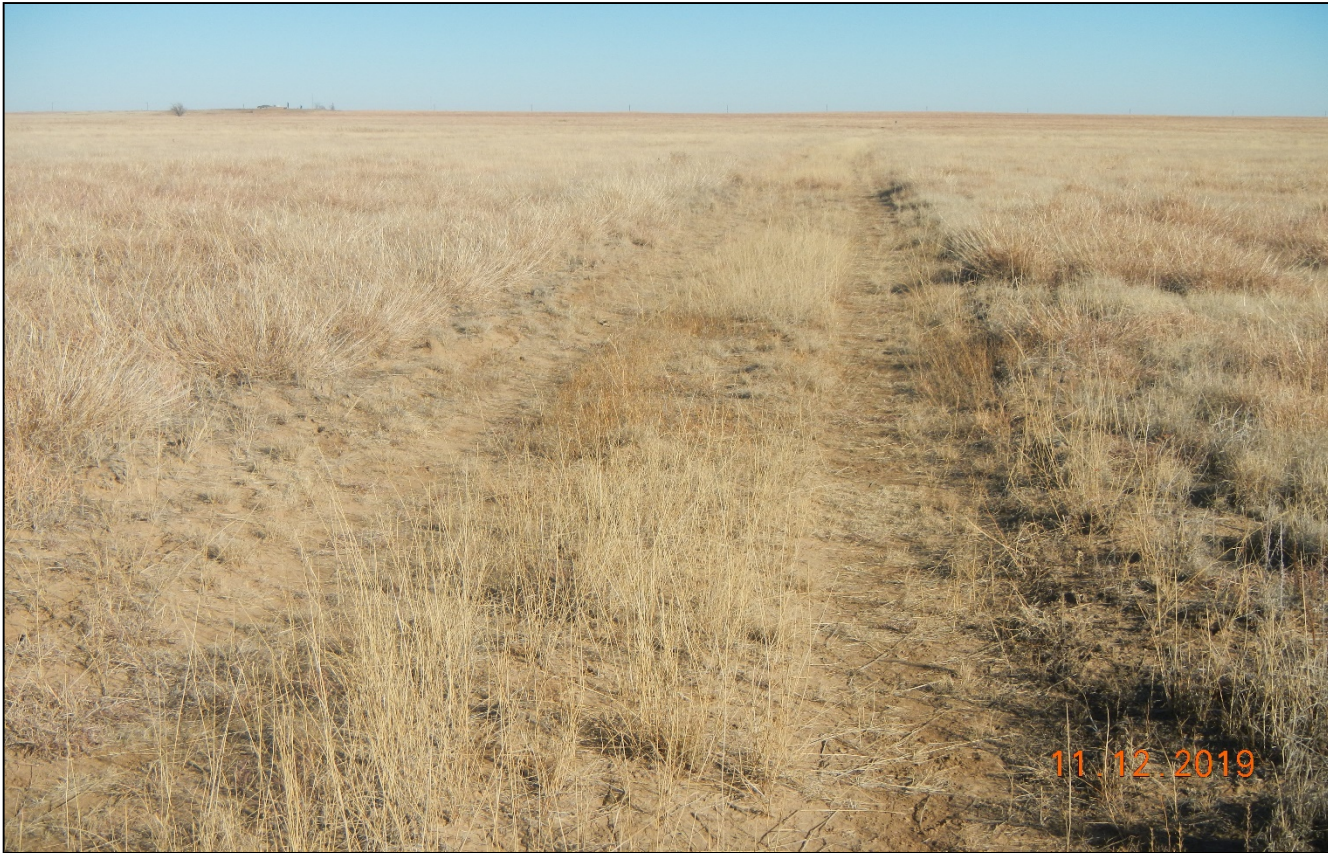
**Photo 1.** There is a two track access road that remains to the location.

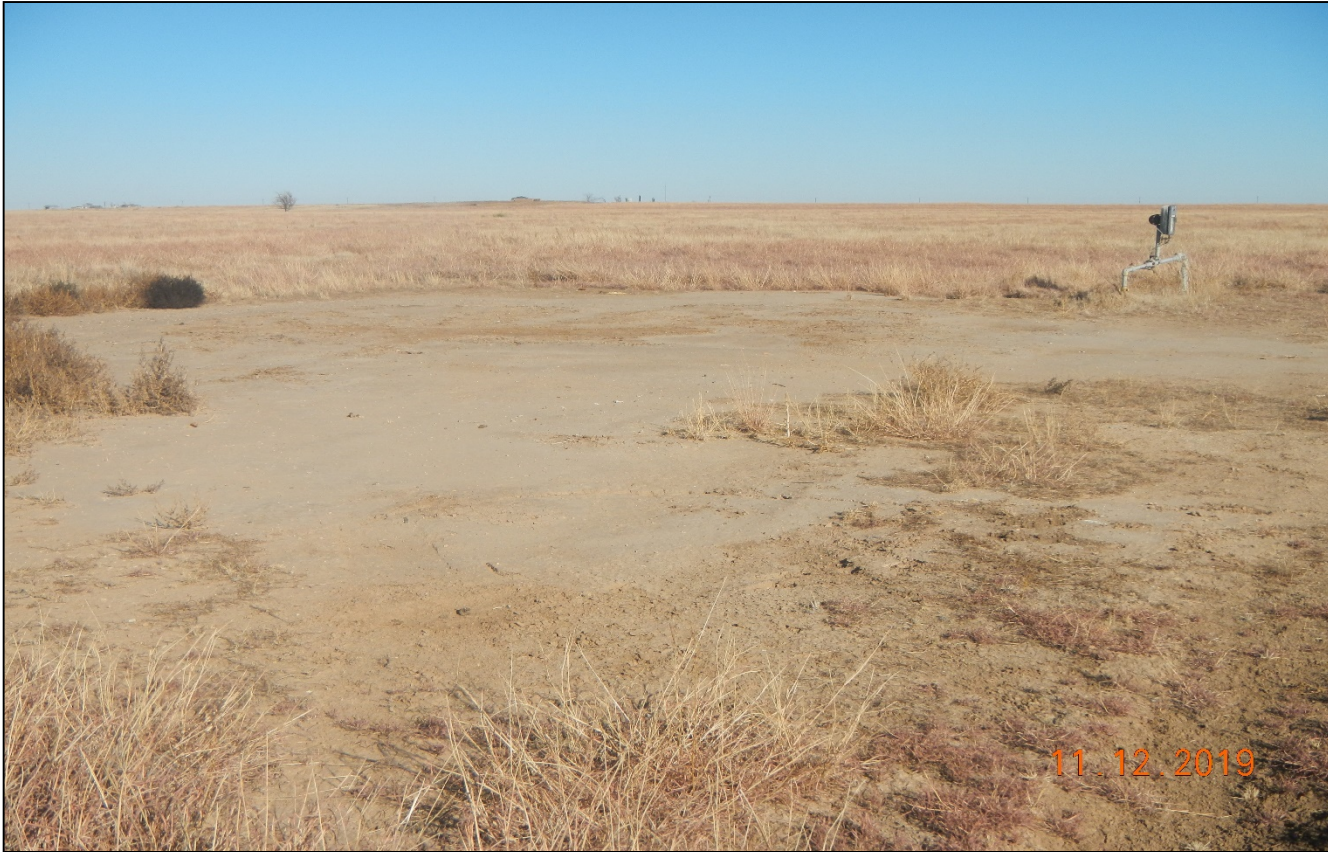
**Photo 2.** Facing northeast toward the location. There is a bare are with no vegetation growth. Reclamation has not been performed.

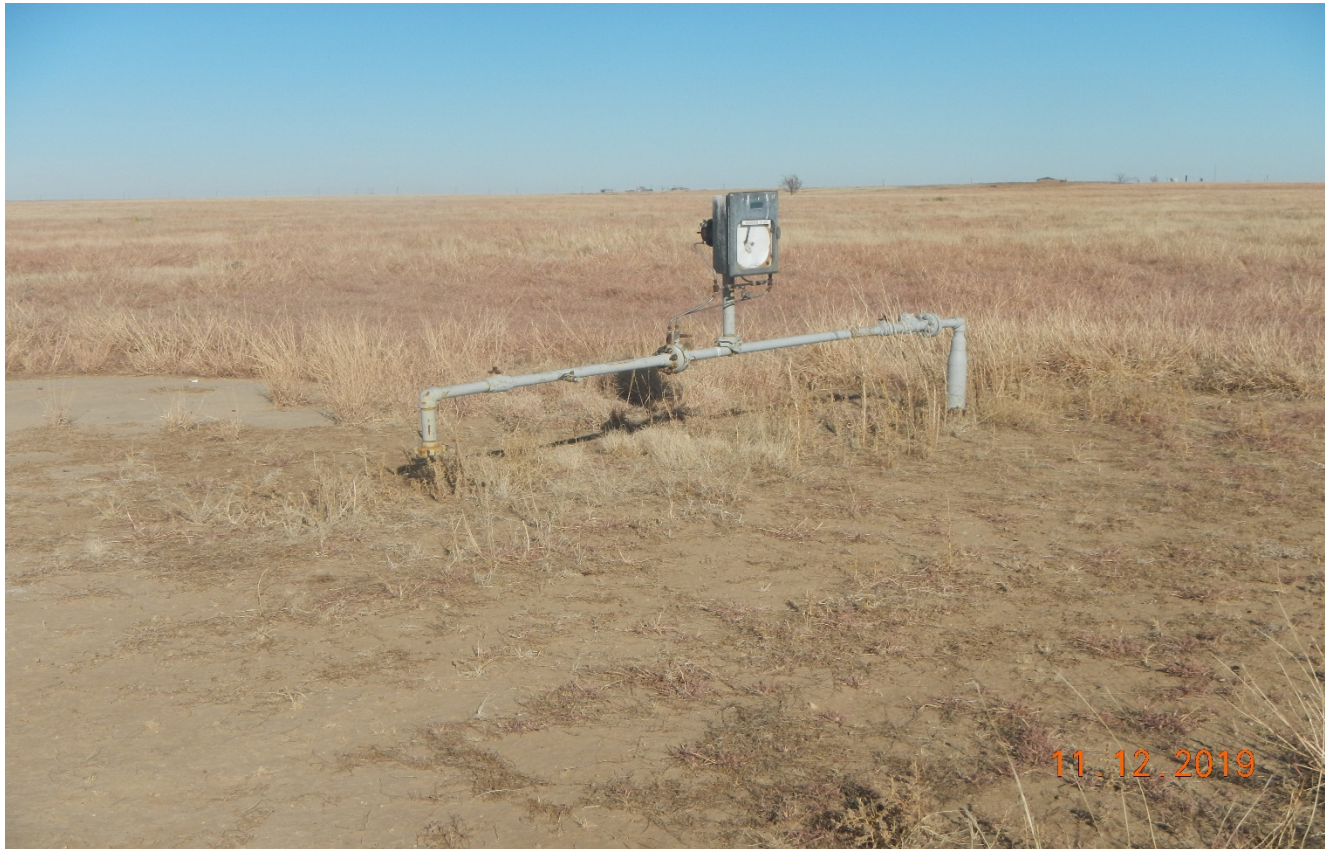
**Photo 3.** There is a meter pipe riser that remains at the location. All equipment must be removed.

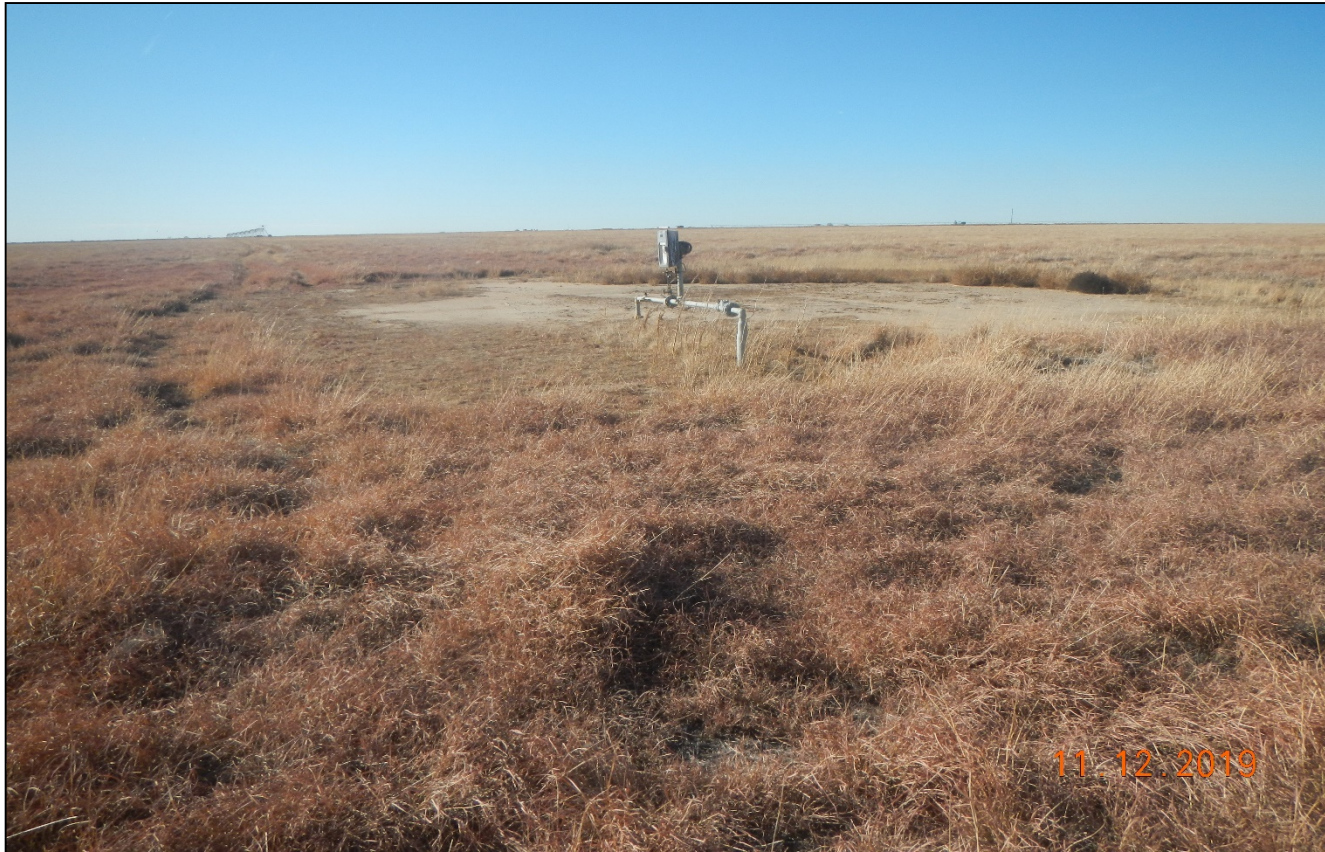
**Photo 4.** Facing back toward the west at the location.

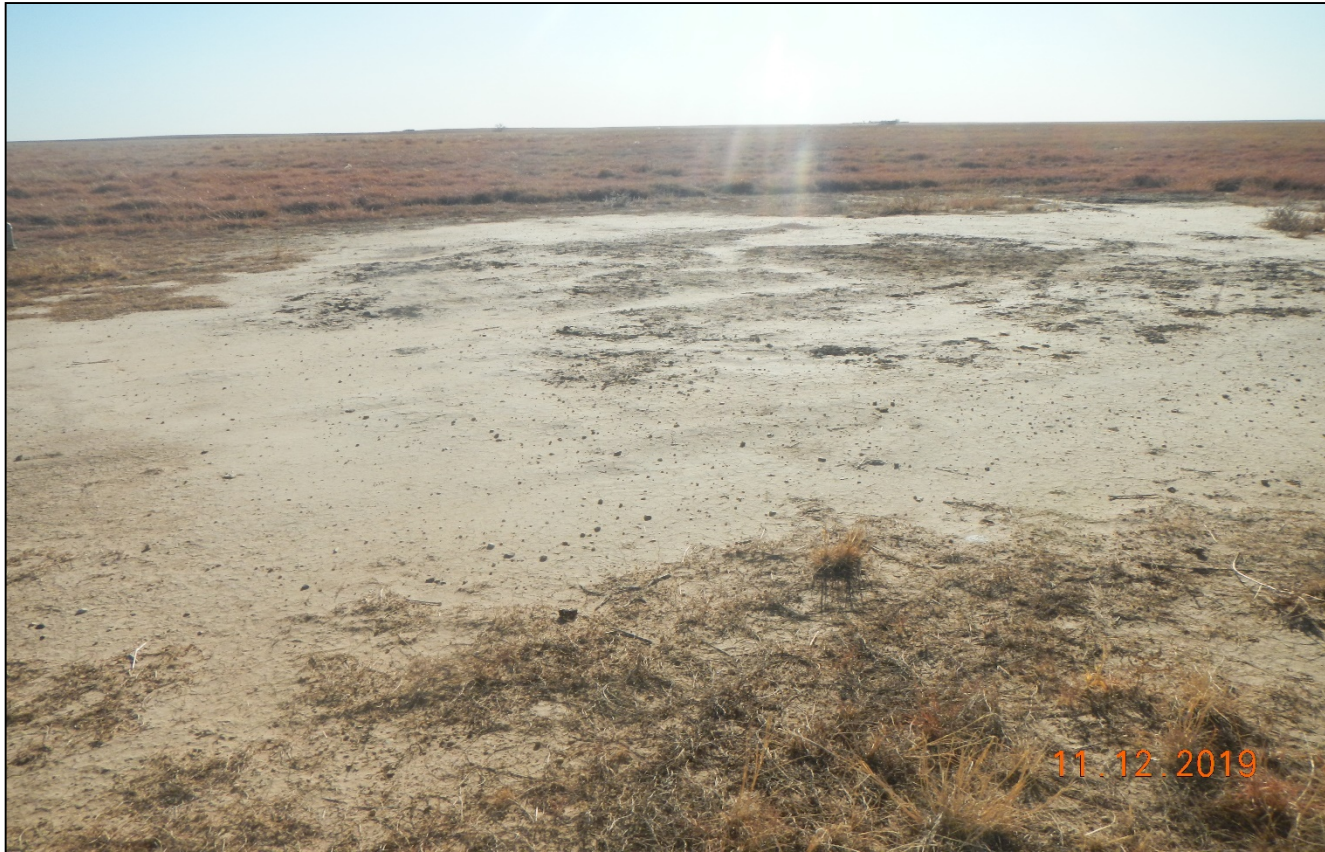
**Photo 5.** View of bare are with no vegetation growth.
