Inspection Photos

API: 05-009-05117

Operator: TINDALL OPERATING COMPANY

Inspection Date: 11/12/2019

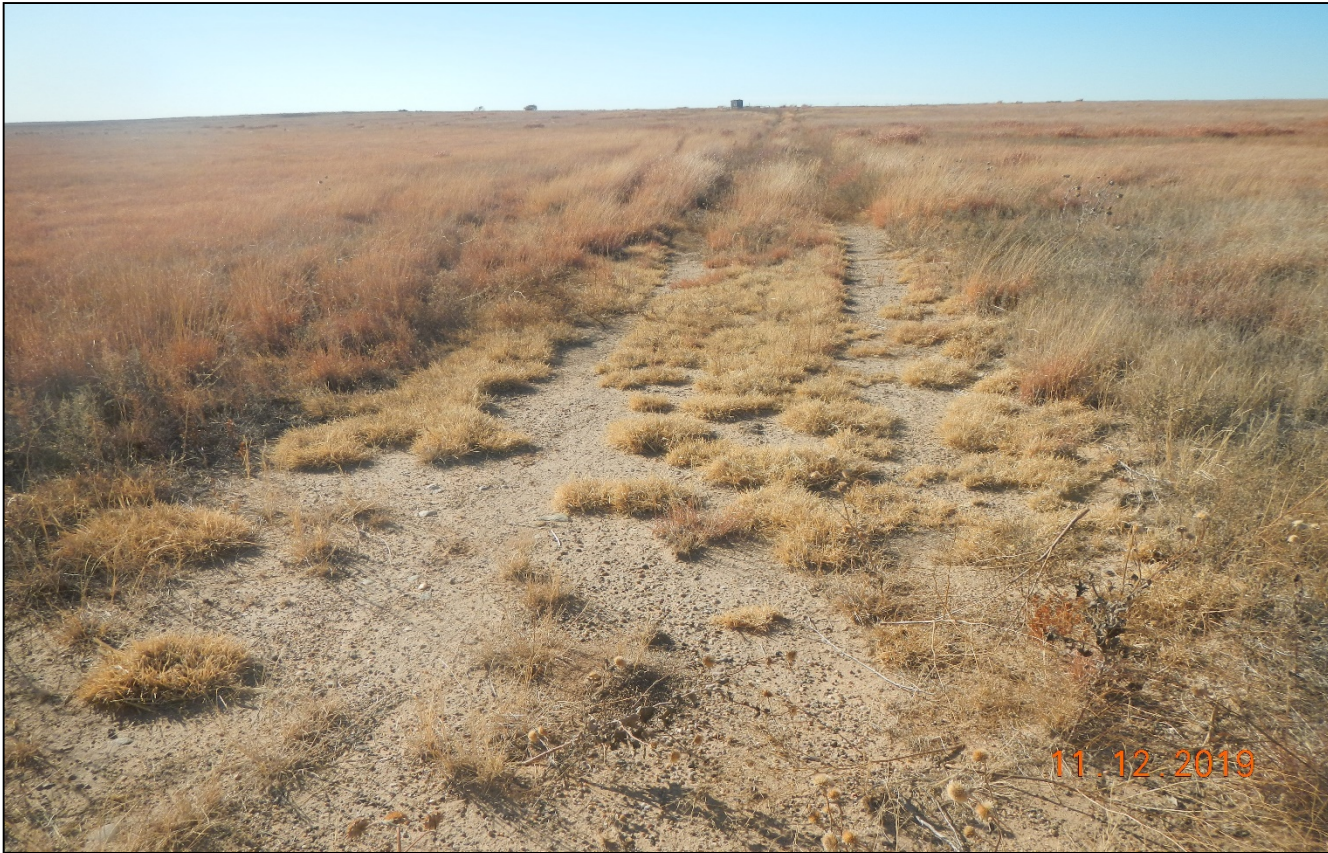
Photo 1. There is a two track access road that remains to the location.

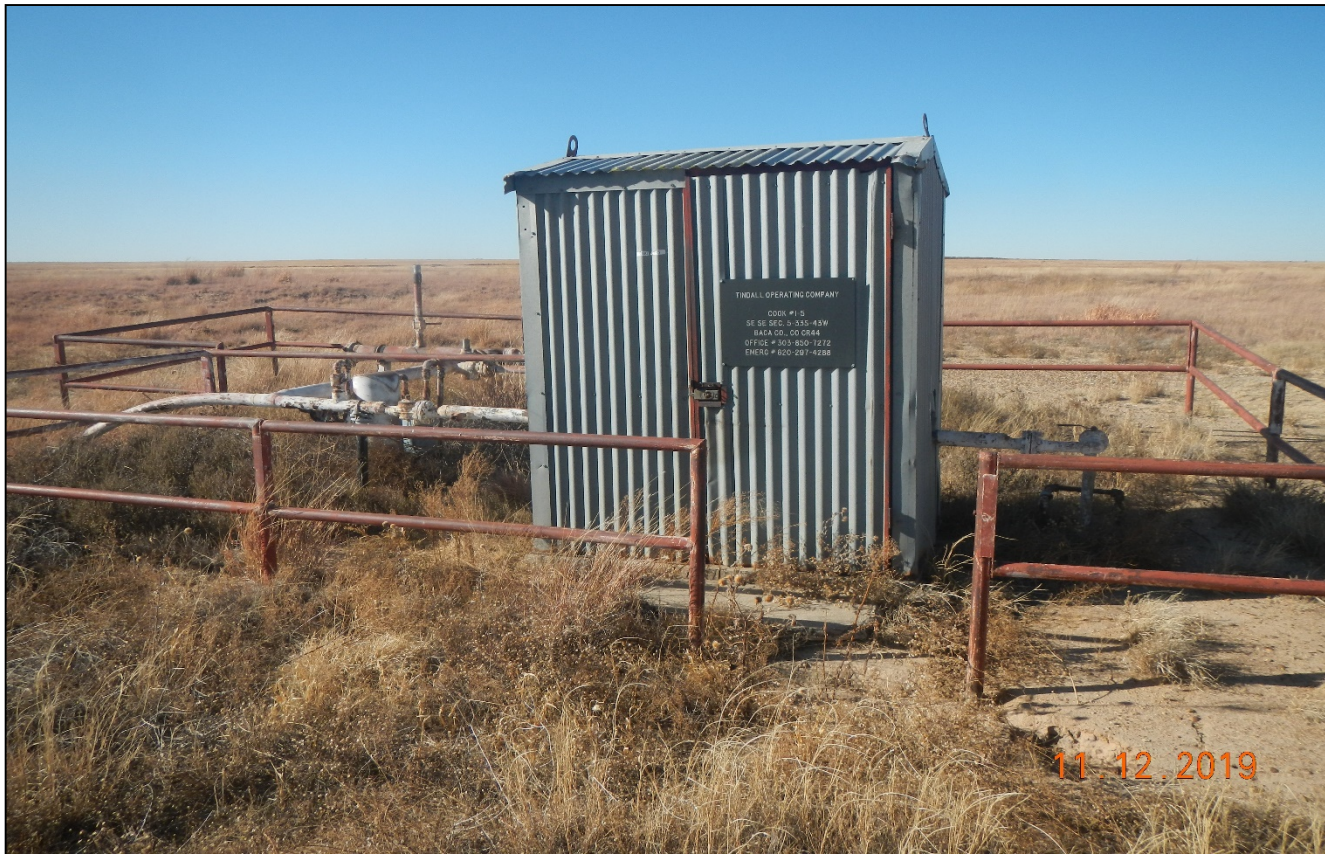
Photo 2. There is a shed and pipe risers that remain at the location. All equipment must be removed.

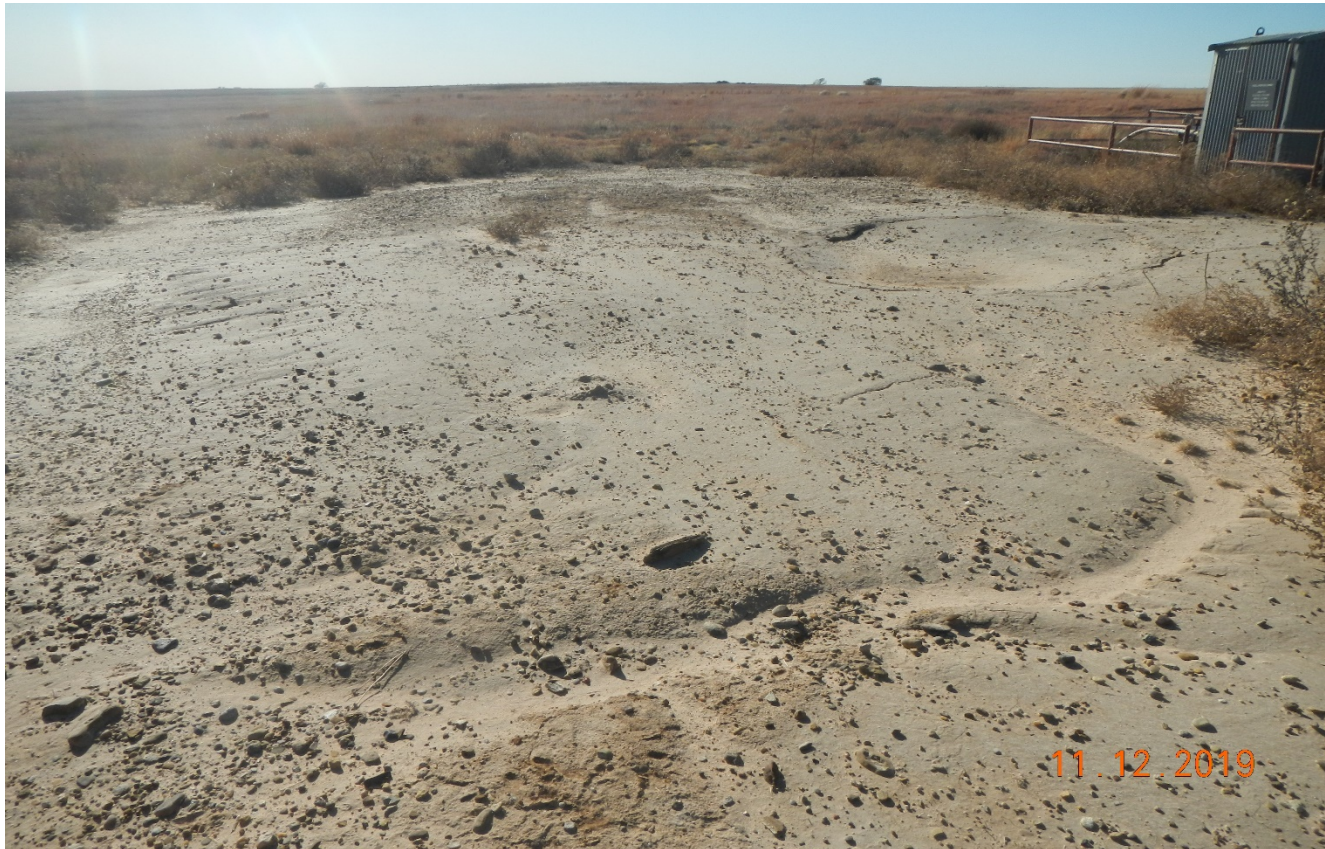
Photo 3. There is no vegetation growth at this area of the location approximately 100 ft. x 60 ft. The location has not been reclaimed.

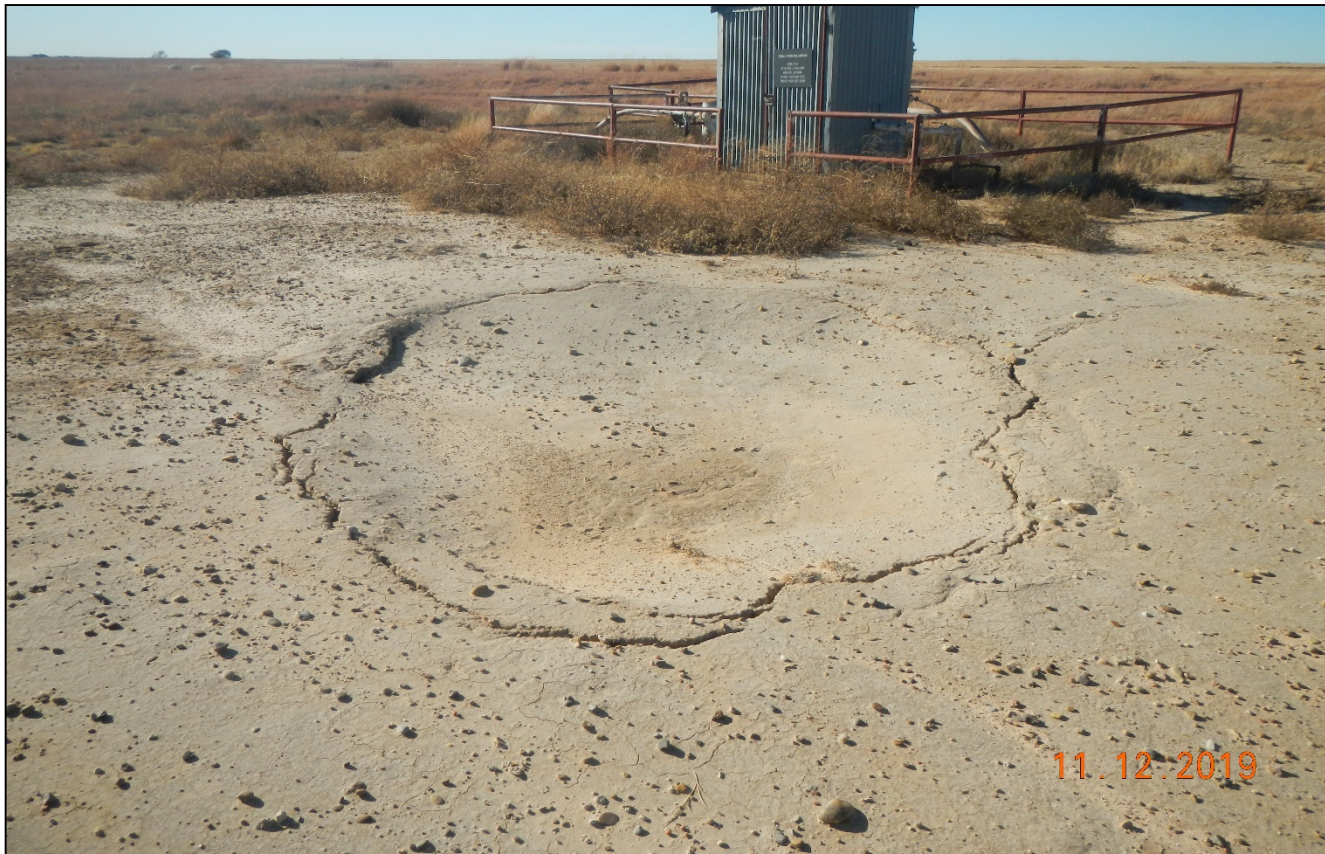
Photo 4. There is an area of subsidence near at the location approximately 8x8 ft.

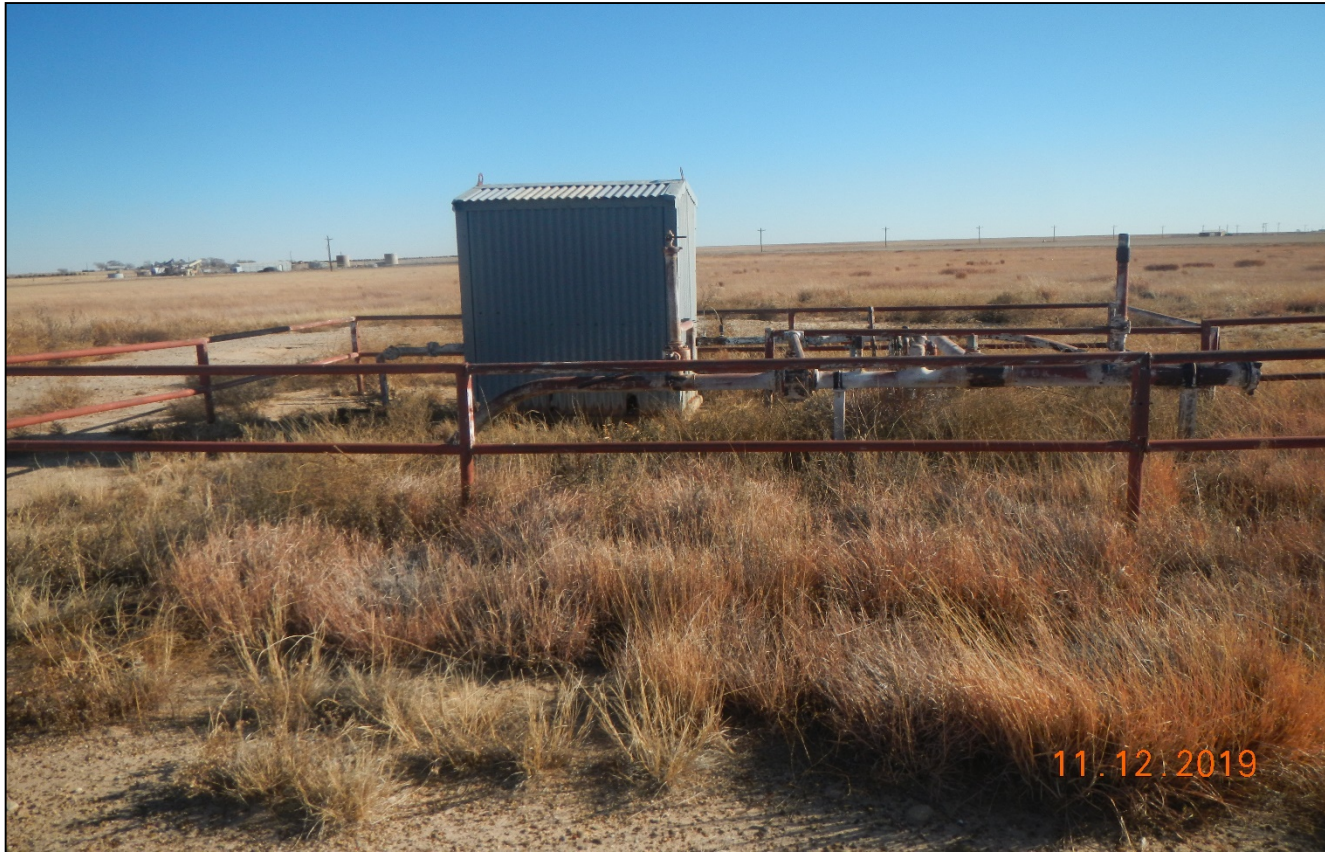
Photo 5. Facing toward the back side of meter shed and pipe risers. All equipment must be removed.
