Inspection Photos
Operator: Hilcorp Energy
Location/API #: 067-07593
Date: 11-6-2019

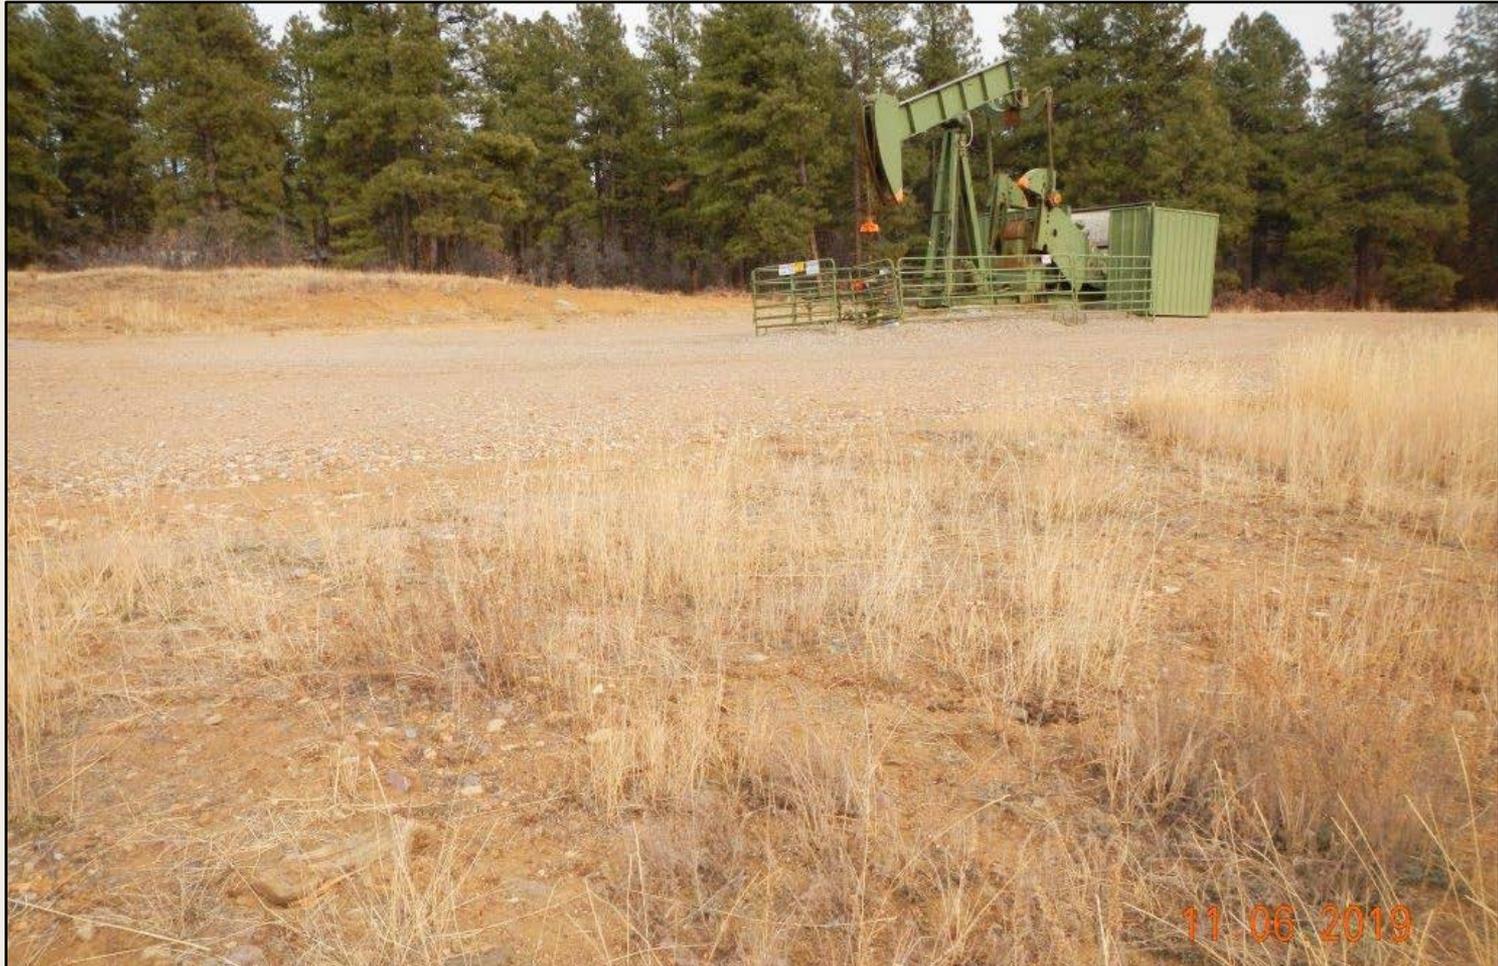
Photo 1. View of the project area from the southwestern corner facing center.

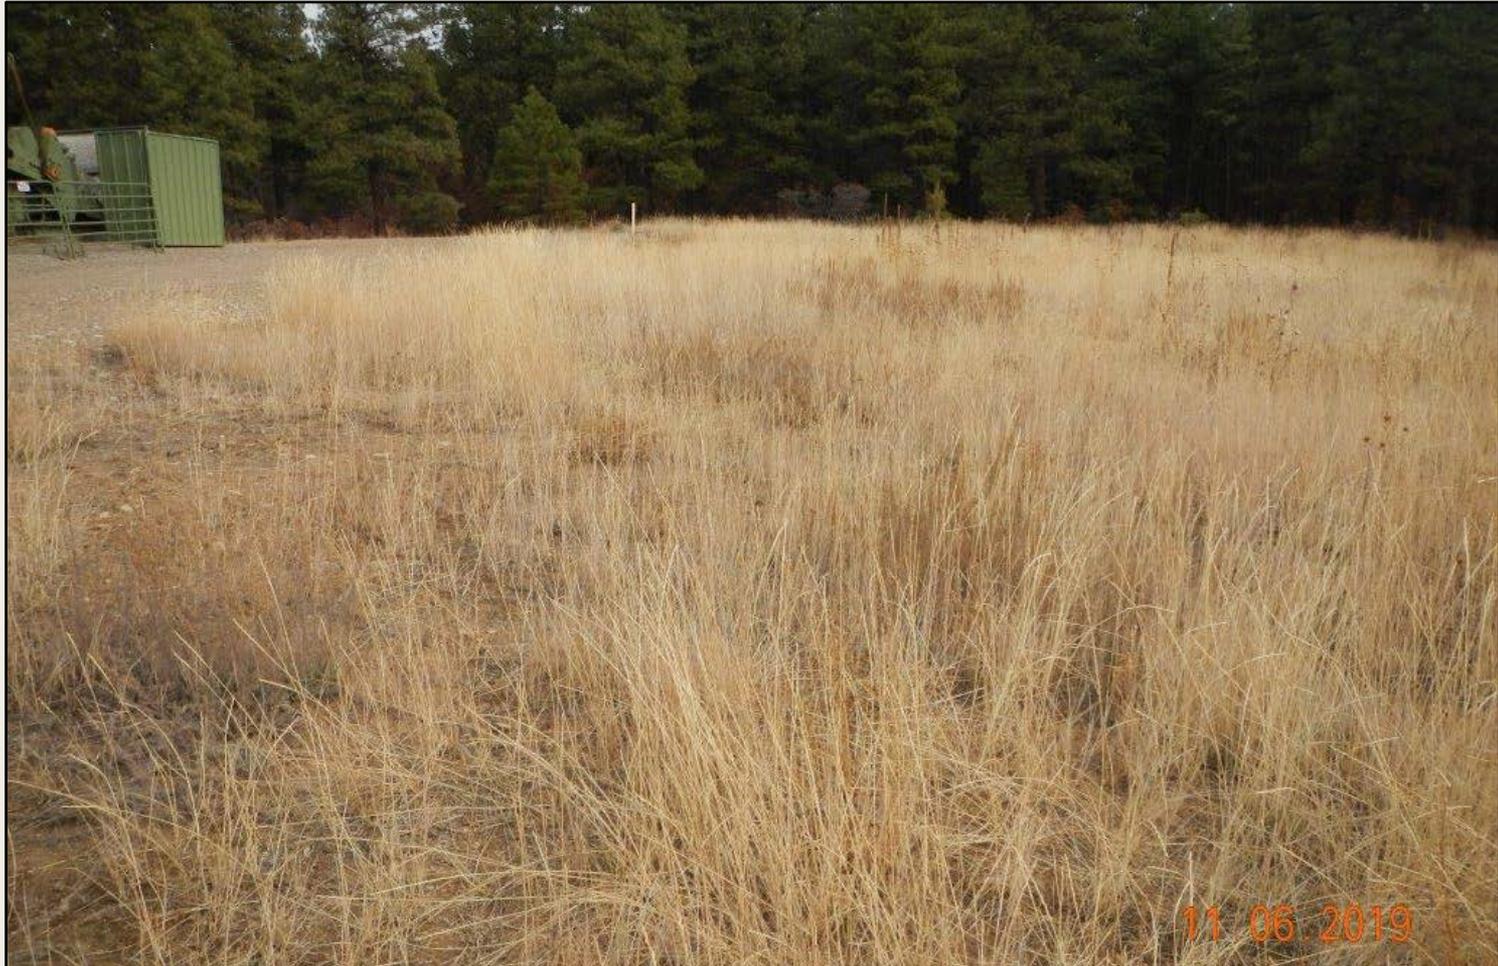
Photo 2. View of the southern project area from the southwestern corner facing eastward. Revegetation is progressing here, largely with western wheatgrass and sand dropseed.

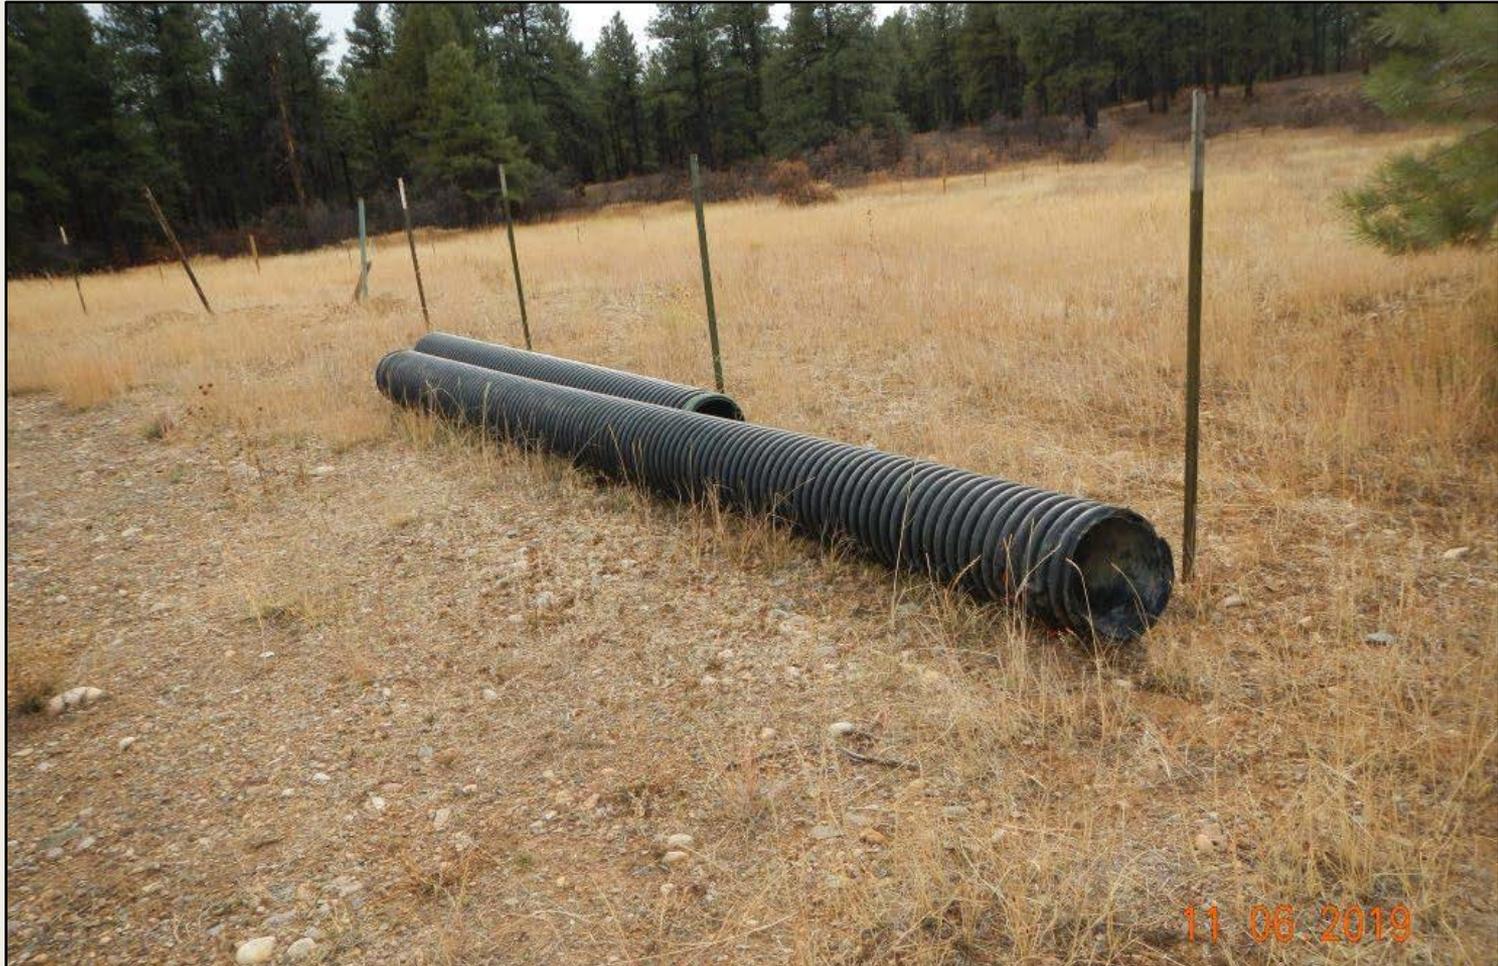
Photo 3. View of black pipes within the southwestern project area that need to be removed.

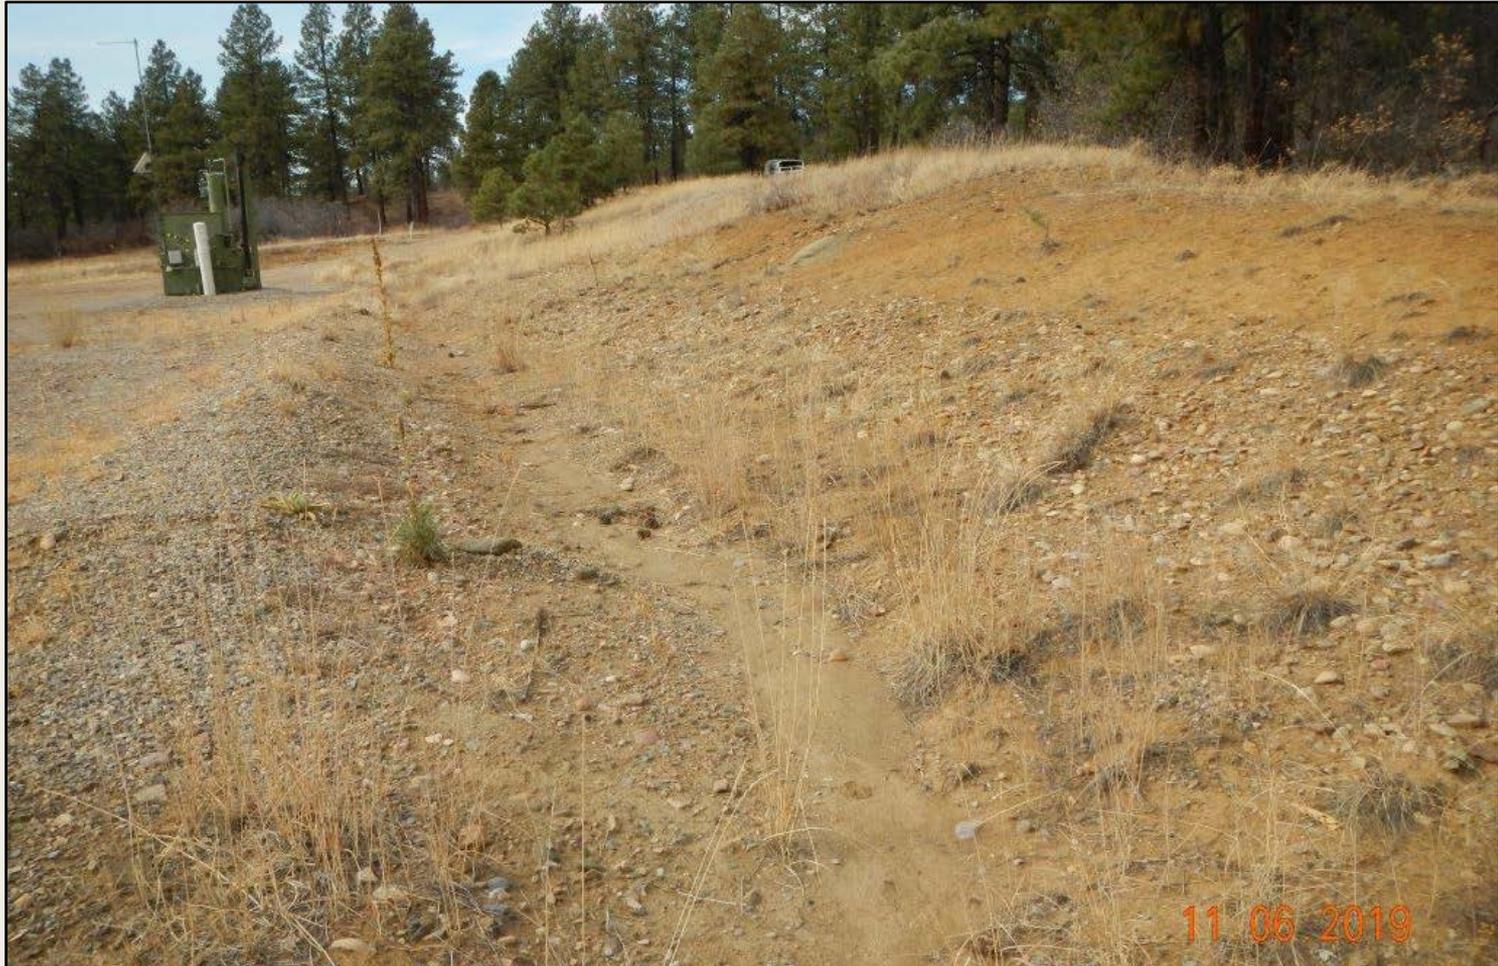
Photo 4. View of area on the well pad cut-slope where erosional rilling on bare soils and sedimentation are occurring, and stabilization measures are needed.

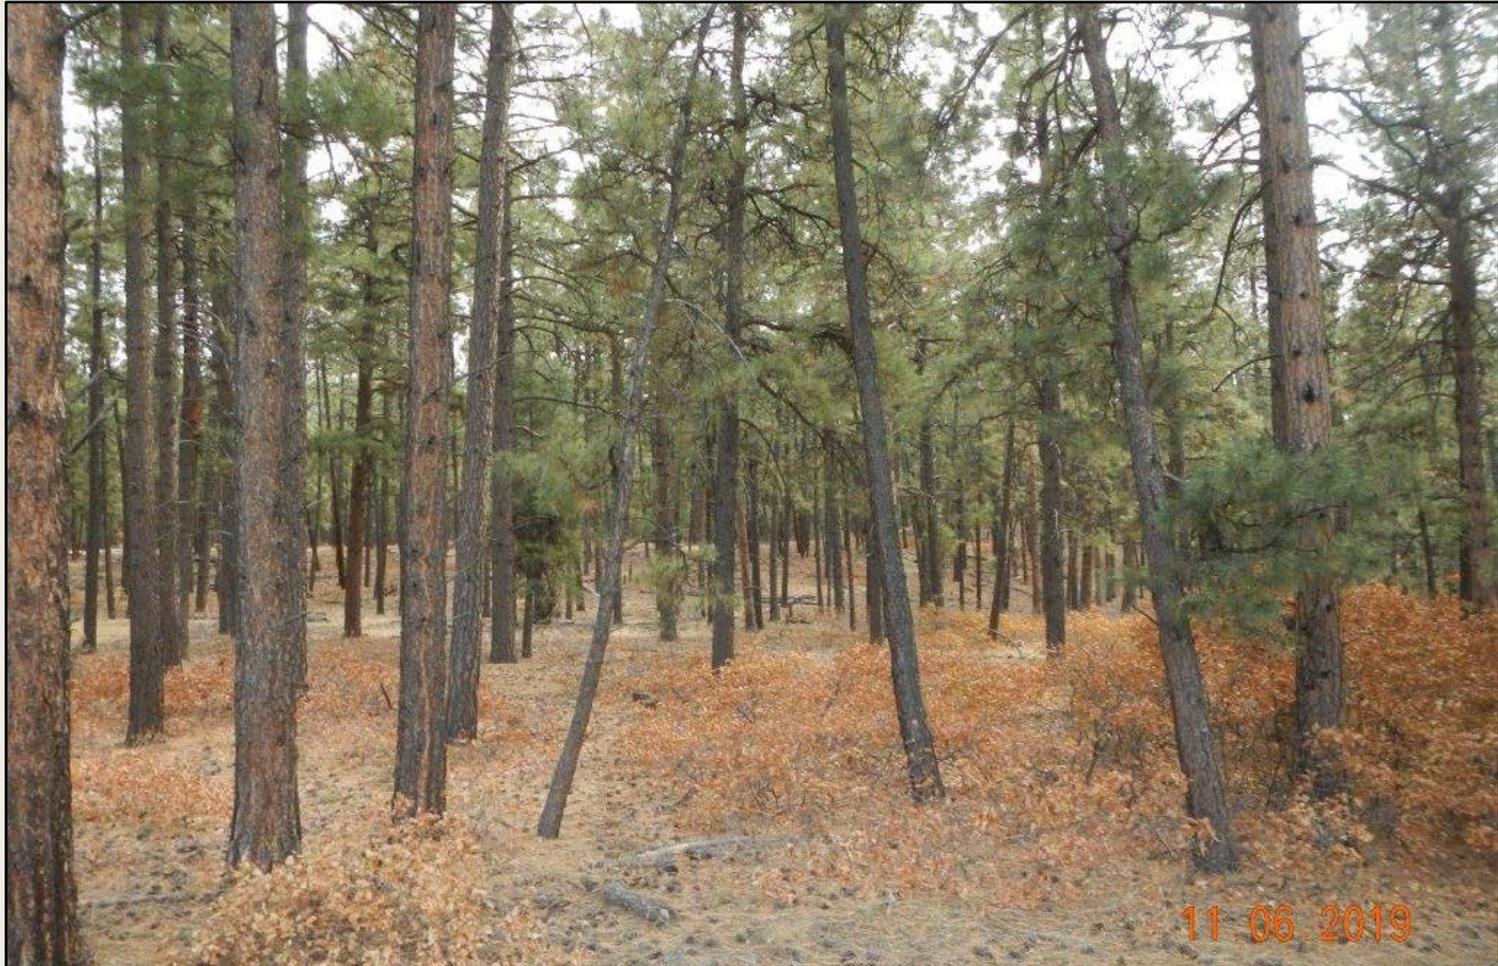
Photo 5. View of reference area west of the well pad, comprised of ponderosa pine forest with gambel oak understory.
