Inspection Photos
Operator: Catamount
Location/API #: 067-10021
Date: 11-12-2019

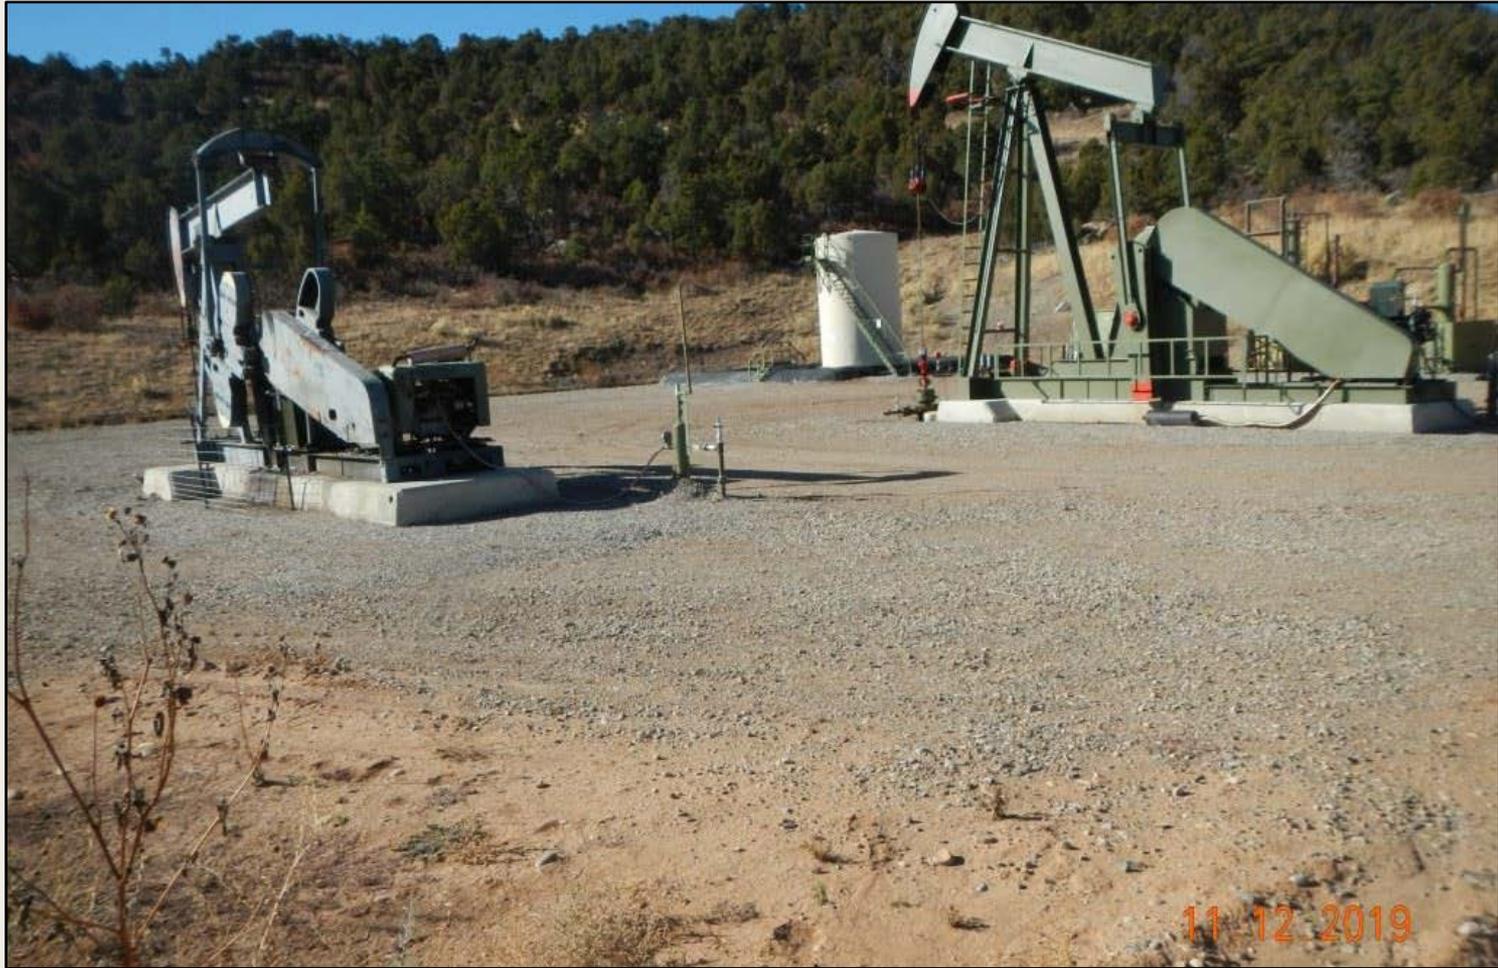
Photo 1. View of the project area from the northeastern corner facing center.

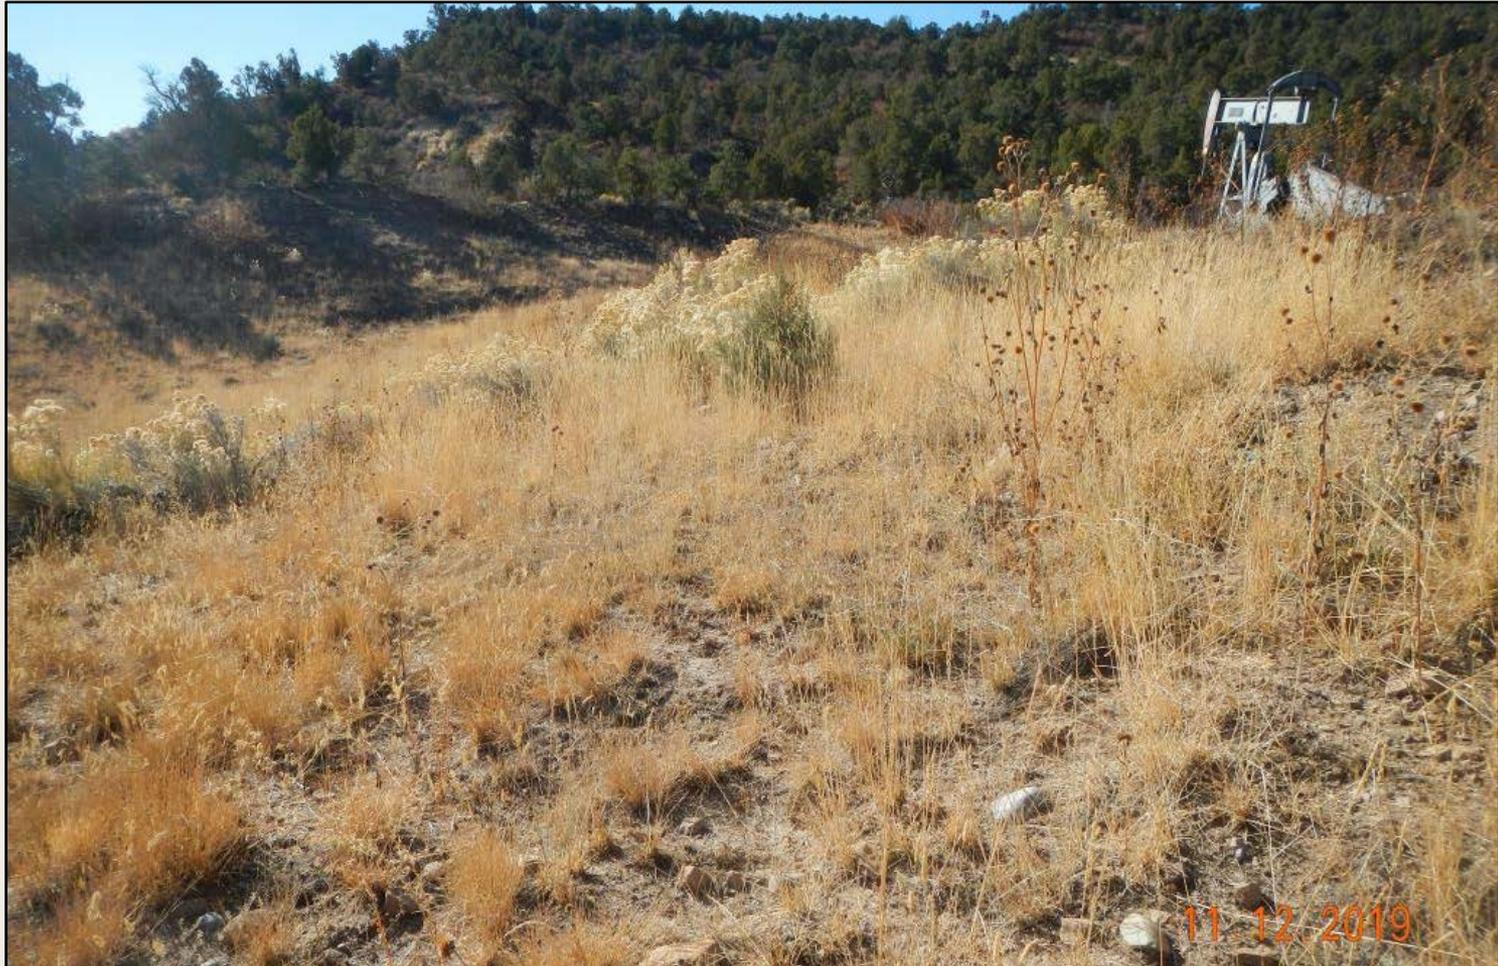
Photo 2. View of the eastern project area from the northeastern corner facing southward. Revegetation is progressing with grasses such as western wheatgrass, crested wheatgrass, and blue grama.

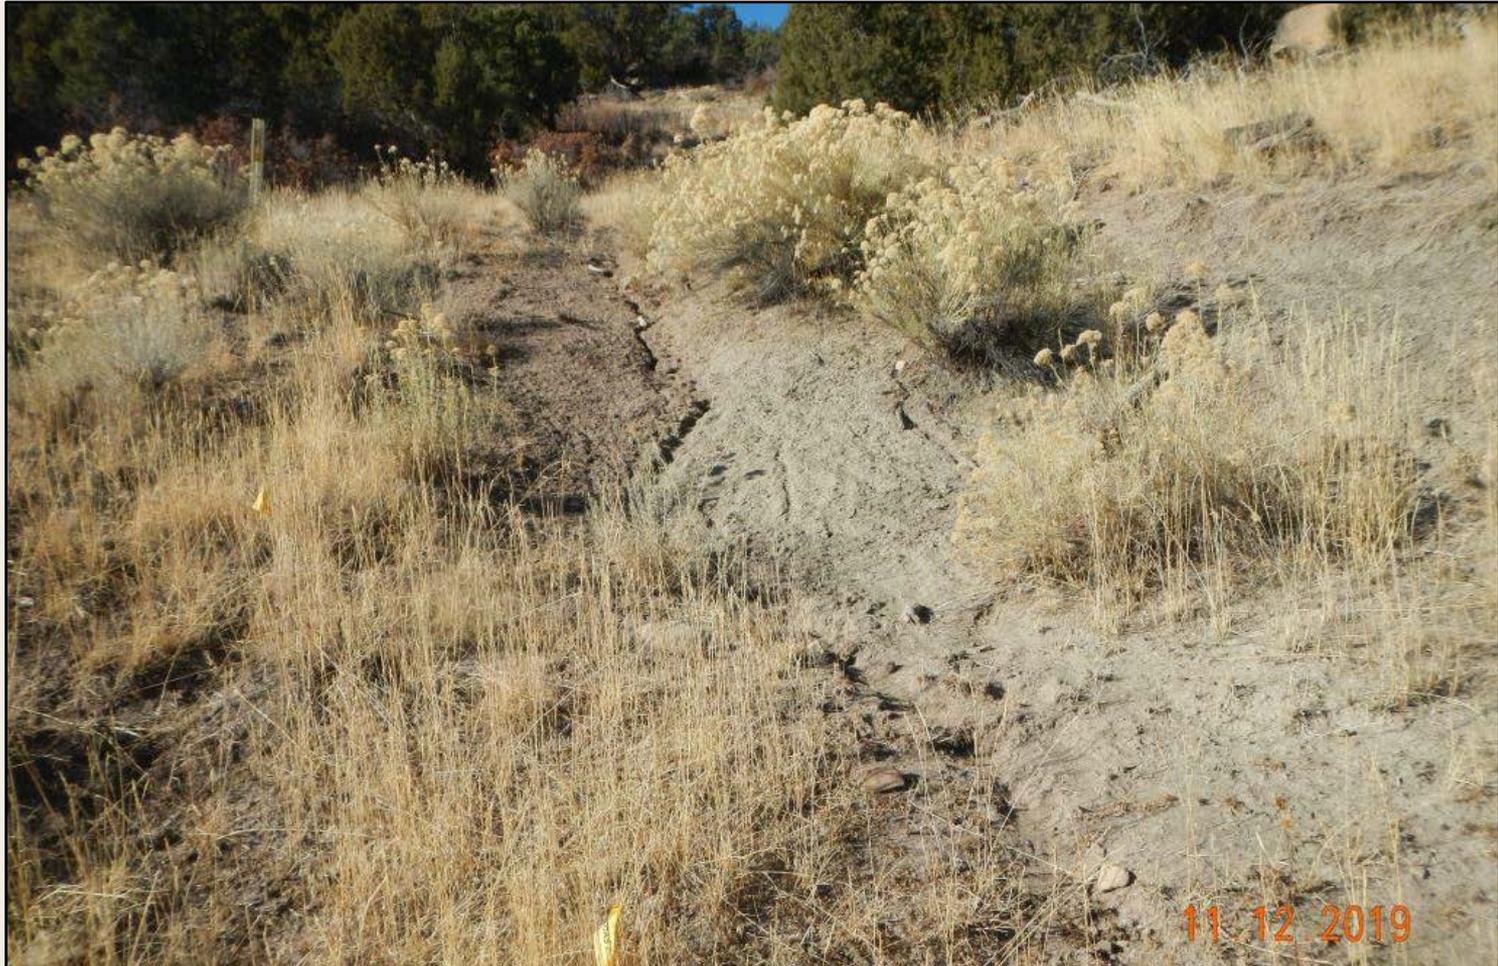
Photo 3. View of erosional rilling within the southwestern cut-slope that is not stabilized.

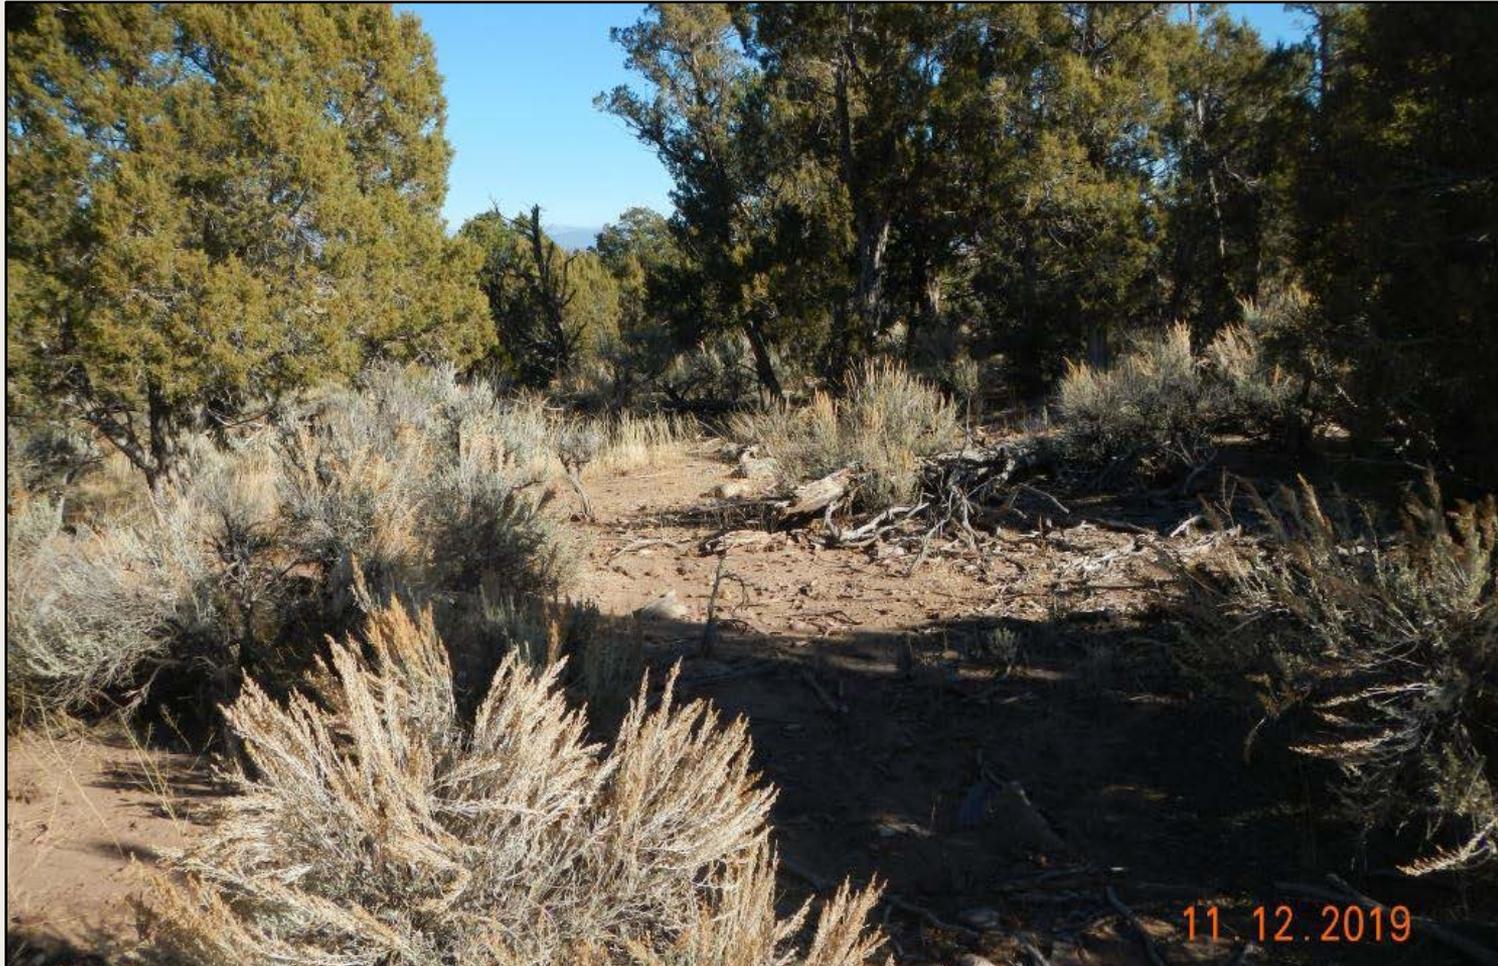
Photo 4. View of reference area vegetation, comprised of pinyon juniper woodland with big sagebrush and gambel oak understory.
