Inspection Photos  
Location Name: Chevron-65S96W 596-31C Pad  
Location ID: #335999  
Inspection Date: November 14, 2019

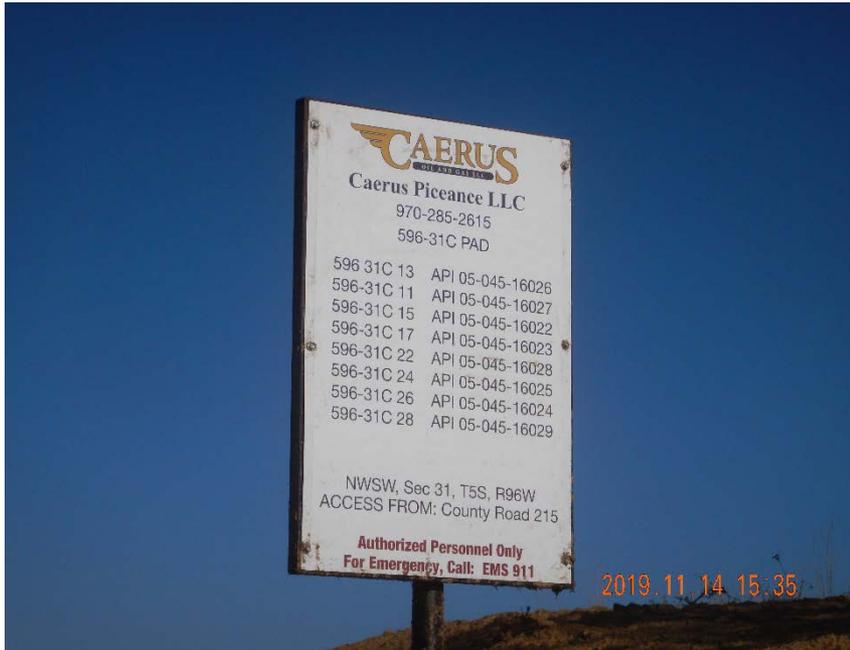
Photo #1 – Facility sign.

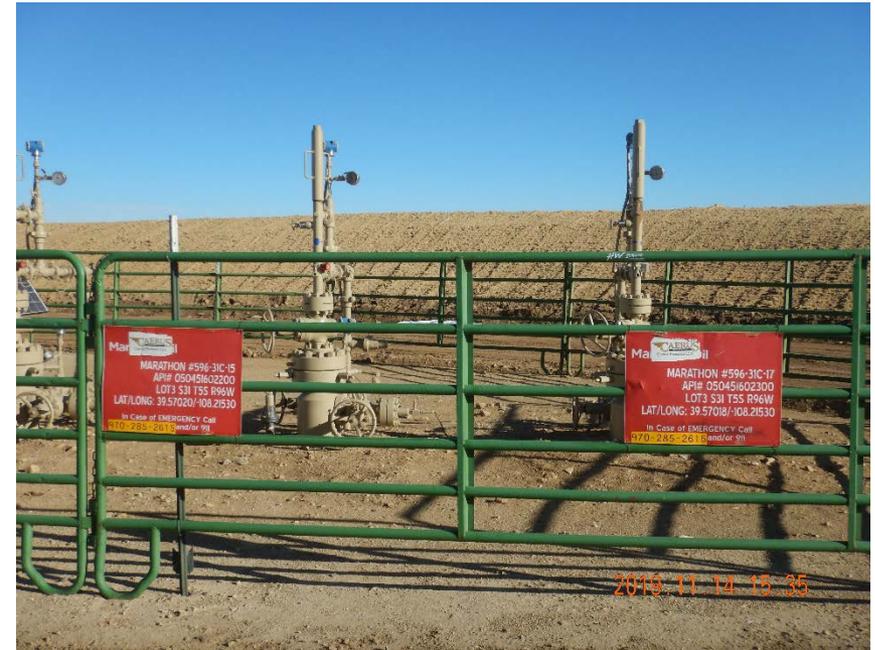
Photo #2 – Corrected well signs (1).

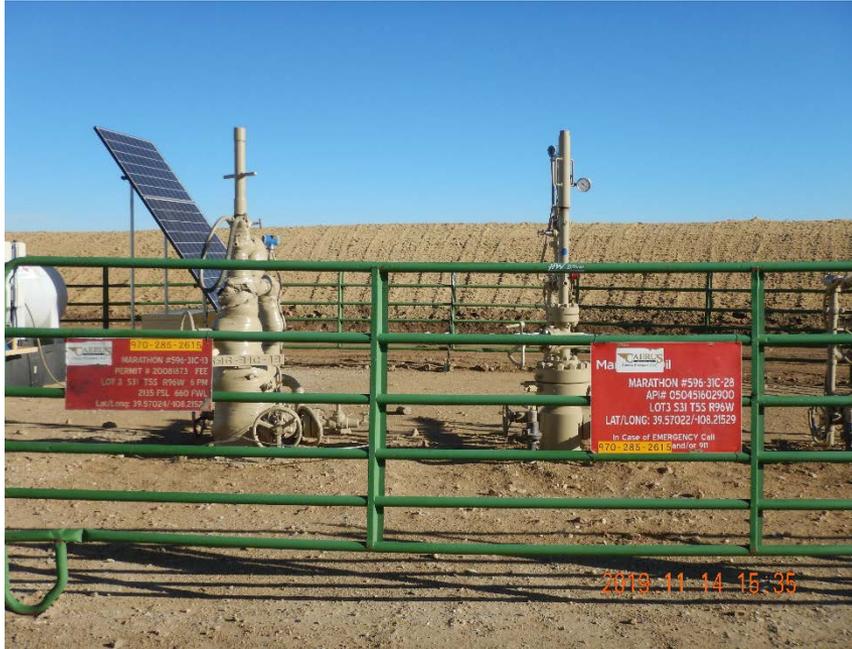
Photo #3 - Corrected well signs (2).

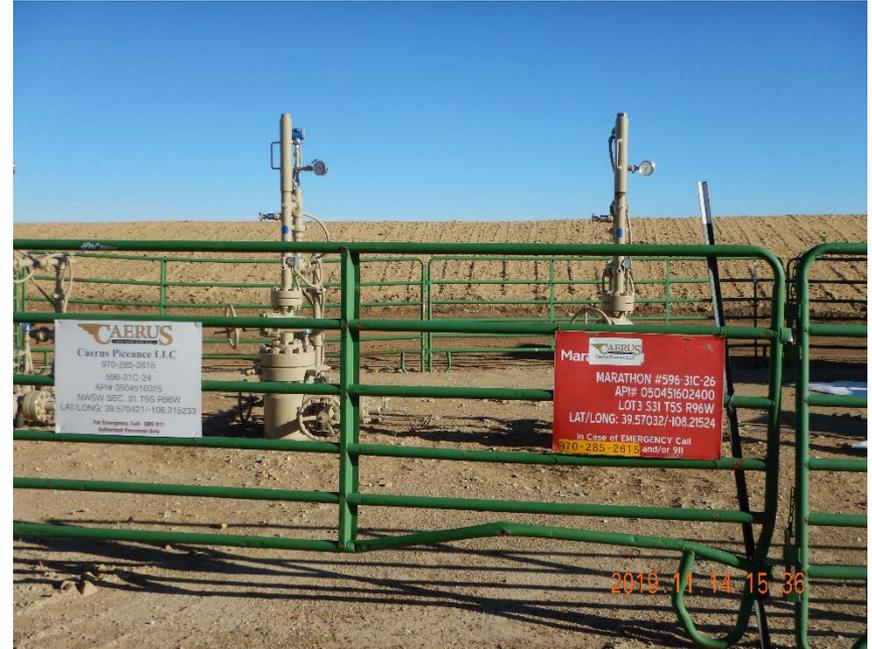
Photo #4 - Corrected well signs (3).

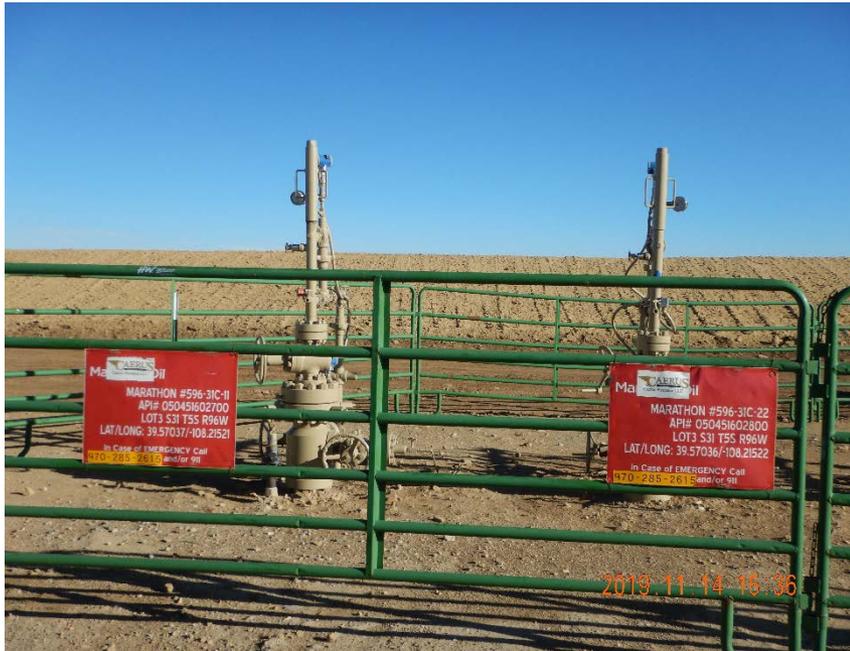
Photo #5 - Corrected well signs (4).

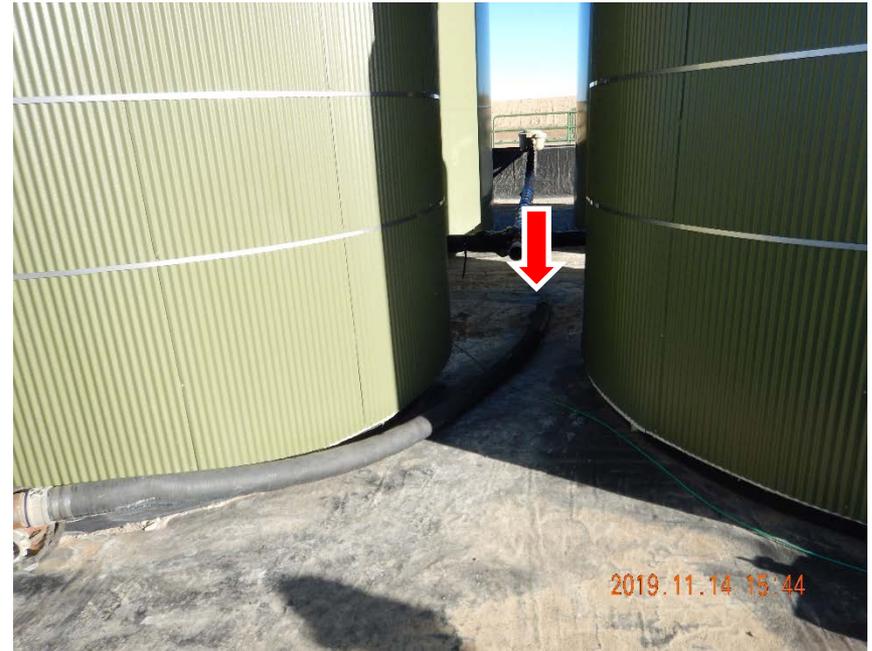
Photo #6 – Hose with metal fitting in direct contact with tank battery liner (1).

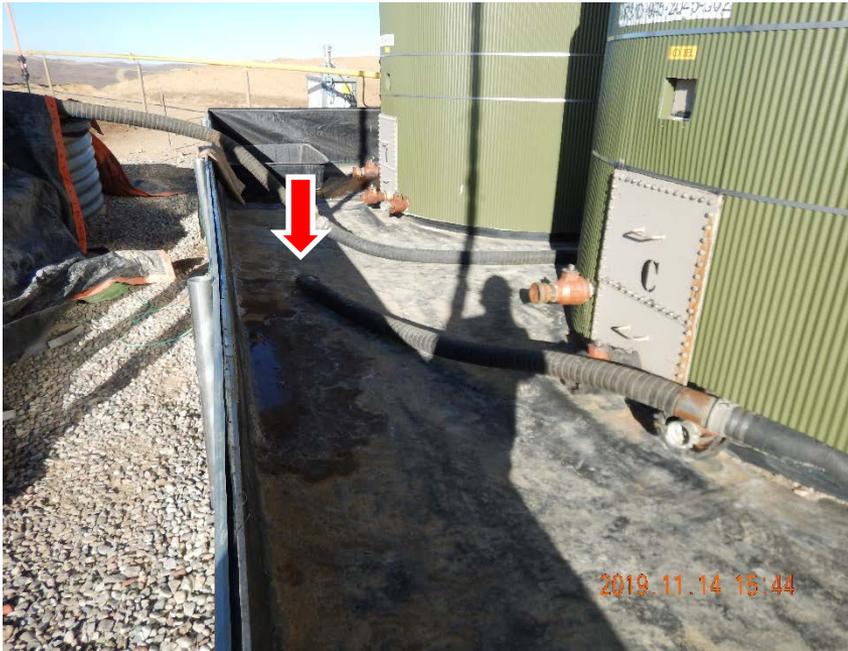
Photo #7 - Hose with metal fitting in direct contact with tank battery liner (2).

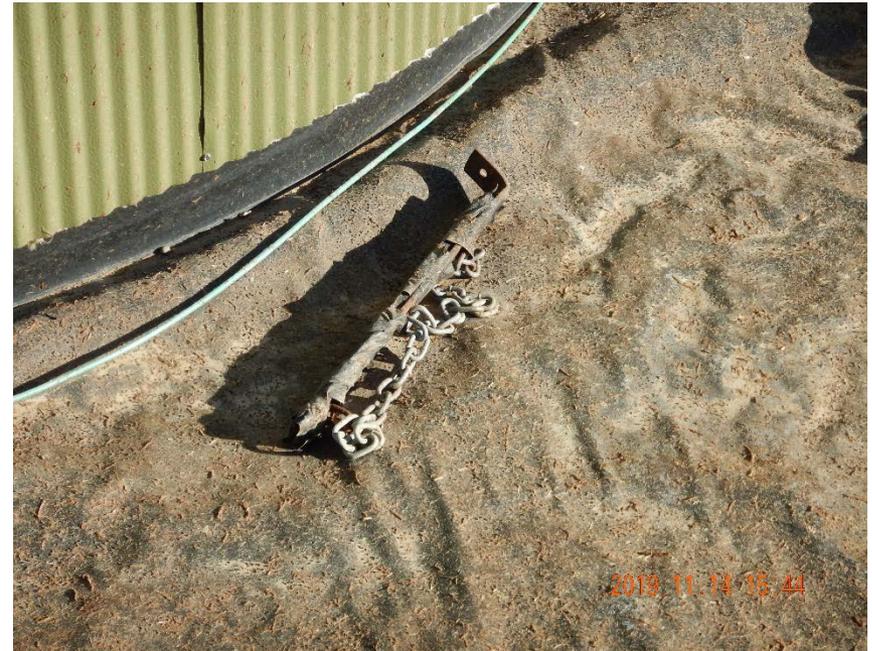
Photo #8 – Metal bar and chain stored on top of tank battery liner.

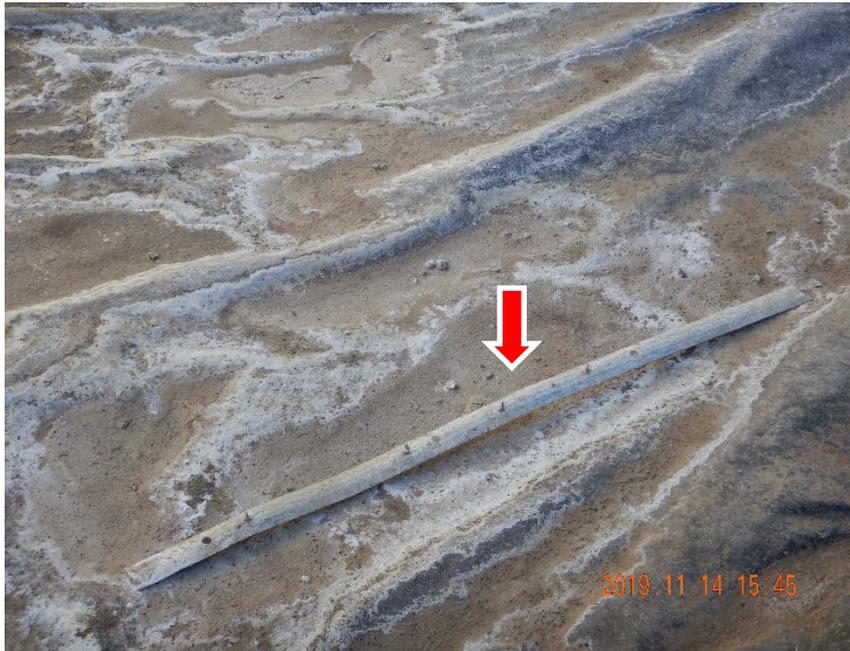
**Photo #9 – Metal strip with nails stored on top of tank battery liner.**

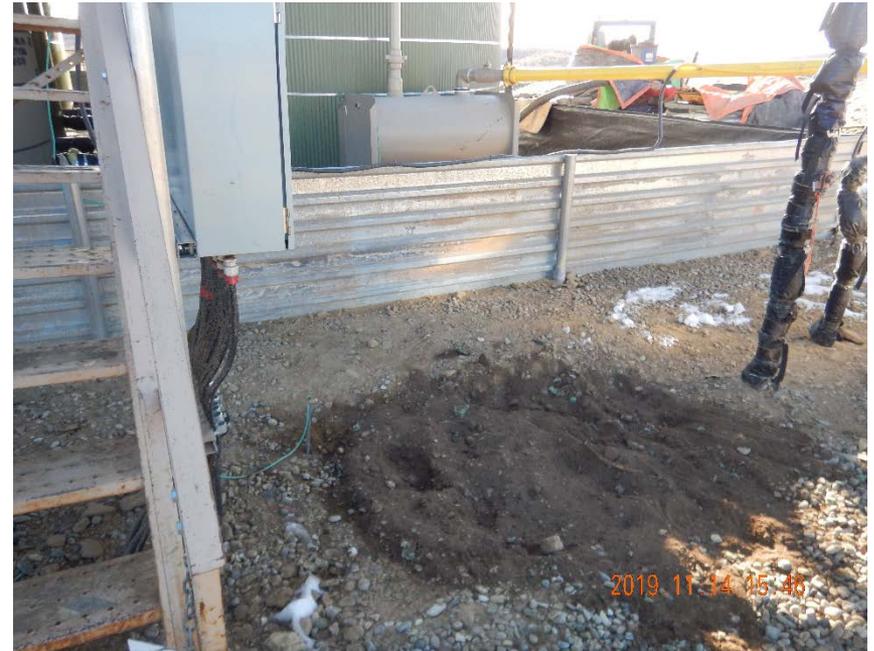
**Photo #10 – Dark soil on north side of tank battery had hydrocarbon odor on inspection date.**
