Response to FIR: Document 697500654

COGCC conducted an inspection of the Ruff C08-27D (Location ID 425070) on September 25, 2019. During that inspection, COGCC made the following observations:

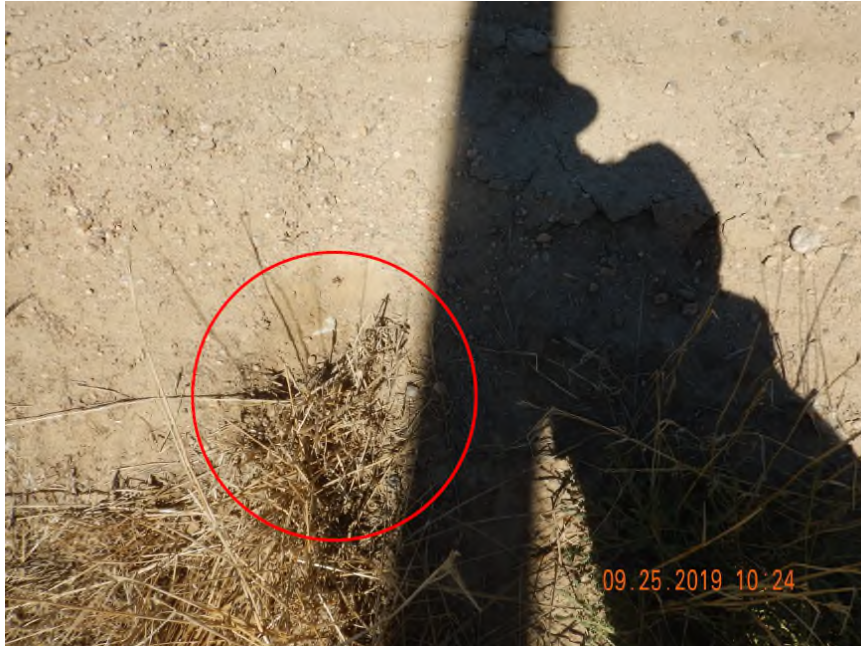
COGCC – 9/28/2019

COGCC Comment: *Stormwater maintenance is required as both culverts are not in proper functioning condition. Refer to the attached inspection photos.*

COGCC Photo 1. Photo taken from the eastern access entrance. Photo illustrates stormwater maintenance is required as the culvert is not in proper functioning condition.

COGCC Corrective Action: *Comply with Rule 1002.f. Corrective action date is the date the location was observed out of compliance.*

Noble Response: Noble removed sediment and augmented stormwater controls at both culverts. Culverts were cleared of sediment to restore functionality, and sediment wattles were added to inhibit sediment buildup. Noble looks to continually improve their location maintenance program, and we welcome further discussion regarding these repairs.

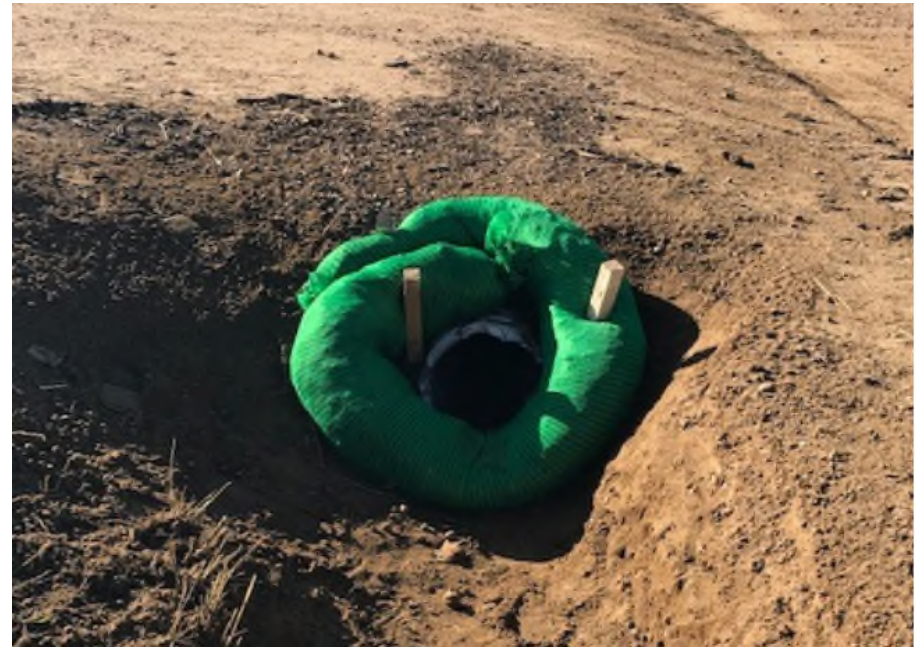
Noble Energy – 11/7/19

Photo NBL1. Culvert cleared, and sediment wattles added.

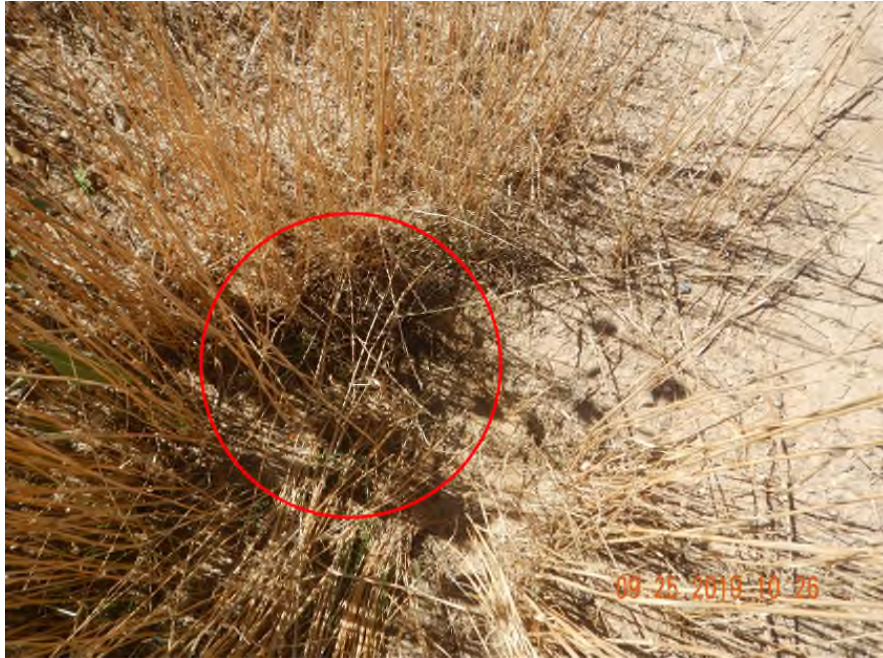
COGCC – 9/28/2019

COGCC Photo 2. Photo taken from the western access entrance. See comments under Photo 1.

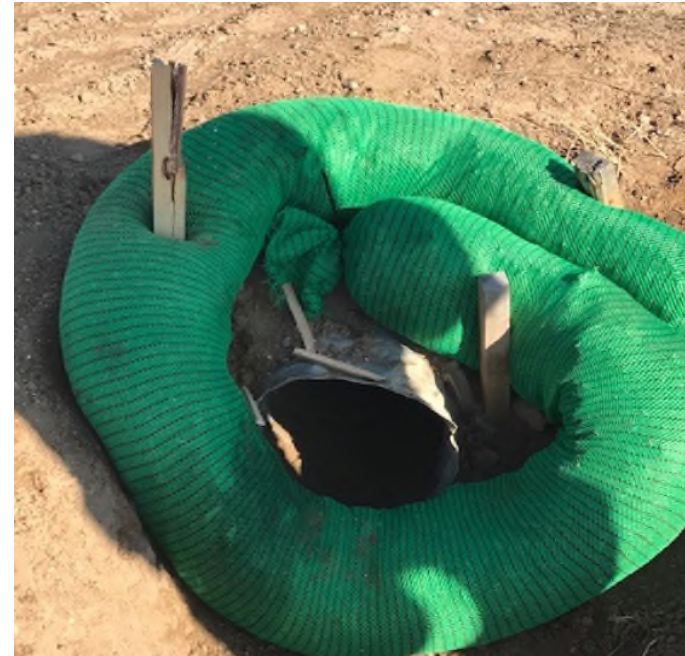
Noble Energy – 11/7/19

Photo NBL2. Culvert cleared, and sediment wattles added.
